# THE CITADEL OF AMMAN

## THE CONSERVATION AND RESTORATION OF THE AYYUBID TOWER\*

by  
Antoni A. Ostrasz

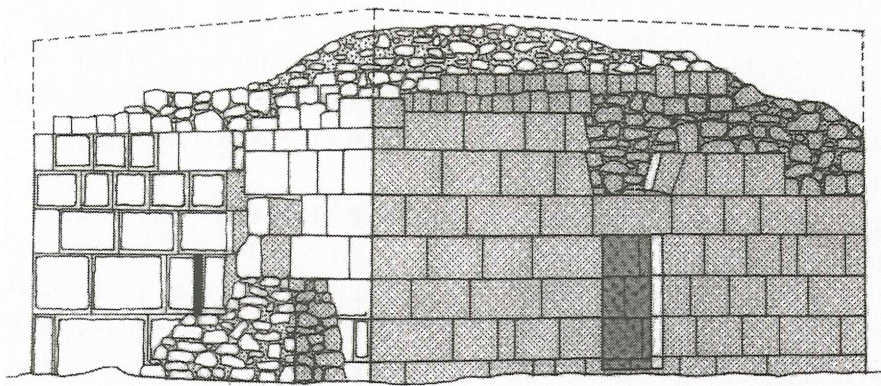
THE TOWER IN THE 1870s  
INTERPRETATION OF BONFILS' PHOTOGRAPH

The earliest record of the Tower, a photograph taken by Bonfils in the 1870s (see Figs. 1-2), shows that since that time, the state of preservation of the monument worsened dramatically. The photograph features the east and north façades of the Tower. In the 1870s, the stonework of the east façade was preserved to the level of course 5. By 1996, all stones of the north section of this course were missing (see Figs. 2-3). The

The north facade suffered much greater damage. In the 1870s, it stood to the level of course 6 (the eastern section), with the lintel of the doorway (course 4), all stones of course 4, as well as many of course 5 still in place. By the 1990s, most stones of courses 4, 5 and 6 were gone and so were many stones of courses 2 and 3 and two stones of course 1.

Bonfils' photograph shows some masonry preserved over the interior of the building. A part of the masonry seems to be the inner stonework of the east and north walls (back side) of the room in the Tower. The feature which is seen beyond that part (southwest of it) seems to be the top of a vault which covered the room. This shows that most of the masonry of the room must have been intact in the 1870s. Only some stones of the lowest courses of masonry of the room survived.

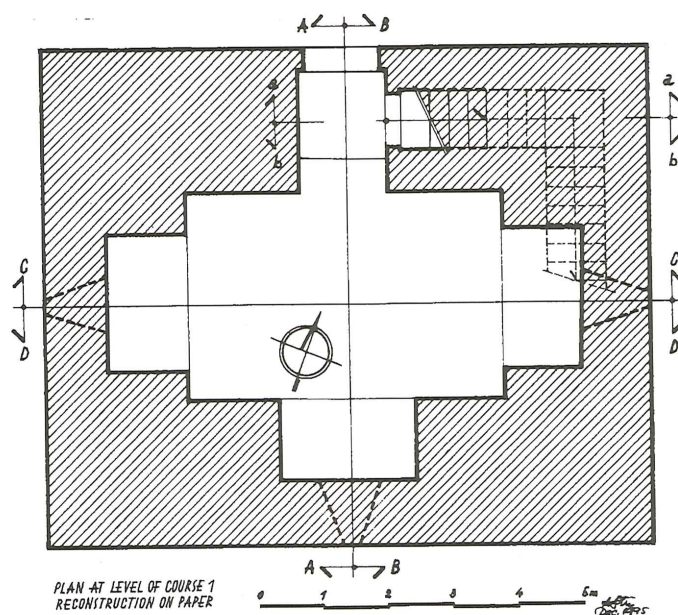
5.

The Tower formed part of the Ayyubid fortifications of the Citadel and was constructed in the late 12th to early 13th century AD. It was built against and over the remains of the temenos wall of the Great Temple, about 28 m south of the temple itself. The Tower was 9.3 m long, 7.6 m wide, and over 5/10 m high (north/south walls). It was a one-room and a one-storey structure (Figs.1-4). The room (4.8 m by 3.1 m) was entered through a doorway (1.1 m wide and 2 m high) placed in the north wall of the Tower. There was a recess (2 m wide and 1.2 m deep) in each of the three other walls. An arrow slit (0.85 m high, 0.16 m wide on the outside and 0.85 m on the inside) was set into each recess. A staircase (0.9 m wide) built within the north and east walls of the Tower led up to the top of it. There was a doorway giving access to the staircase from the inner part of the doorway leading to the room of the Tower. The walls were 2.2 m wide (Fig. 5).

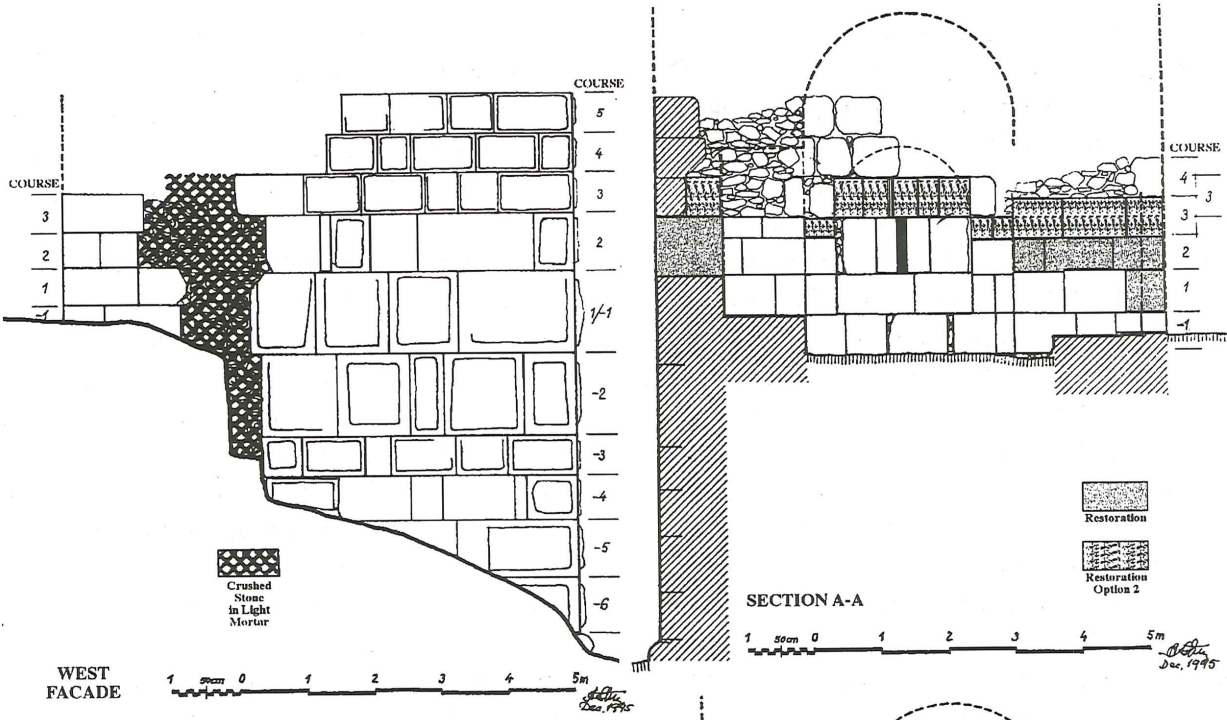
6.

In less precarious, yet endangered, condition were the remains of the uppermost masonry of the median parts of the east and west walls. Only the stones of the facade were in place. The three surviving masonry courses were almost 2 m high, the stones were only 0.5 m wide, and they were not stabilized on the inside by the facing stones of the room nor by the mortar core between the two faces of the wall (Figs. 6-7; courses 3, 4, and 5). That masonry could have collapsed during even a moderate earthquake.

The conservation of the remaining stonework of courses 3, 4, and 5 of parts of the east, south, and west facades would require rebuilding the inner masonry of these courses of the walls (masonry of the face of the room in the Tower). However, there were very few stones *in situ* which attested to the size of the stones in course 3 and there were none attesting to the size for courses 4 and 5. Rebuilding these courses of masonry could be done only on the basis of the restorer's (arbitrary) decision concerning the size of new stones used for the rebuilding; this may be viewed as contrary to the stric-test prin-

ciples of restoration. There was fairly good evidence for the size of stones which made up courses 1 and 2 of the stonework facing the inner and outer façades of the walls of the Tower. Rebuilding these faces would meet no objections of even the most orthodox restorer. This project therefore considered two options, one in which only the strictest interpretation of restoration would be followed. Under Option 1, a program of simply rebuilding the walls, the stability of the surviving masonry above course 2 of the east, south, and west façades would not be ensured. To improve the stability of that masonry, the missing parts of at least course 3 of the face of the room in the Tower would have been completed with new stones. This was the option implemented.

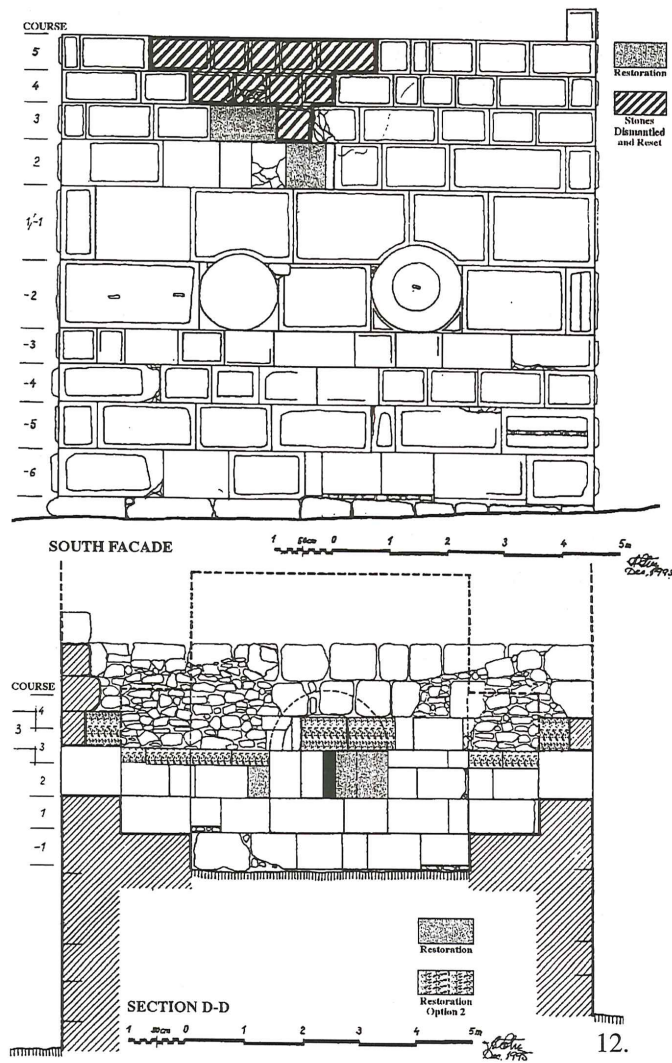
12.

That lack of evidence had a bearing on the rebuilding of the masonry over the three arrow slits. The slits are built in a wall 1 m thick. The external half (0.5 m) of each slit

is covered with a flat stone (see below, Figs. 12 and 14). The stones over the other (interior) half of the slits are missing. The interior aperture of the slits is 0.85 m wide. This span could be easily (and must have been) covered also with a flat stone but the length of the stone was but a matter of conjecture.

The lack of evidence for the length of the stones over the slits did not significantly impede the rebuilding of course 3. The builders of the Towers were haphazard in their choice of lengths of the stones for the courses. The restorer could simply follow their example of there being no principle in this respect.
