# THE CITADEL OF AMMAN

## THE CONSERVATION AND RESTORATION OF THE AYYUBID TOWER\*

Antoni A. Ostrasz

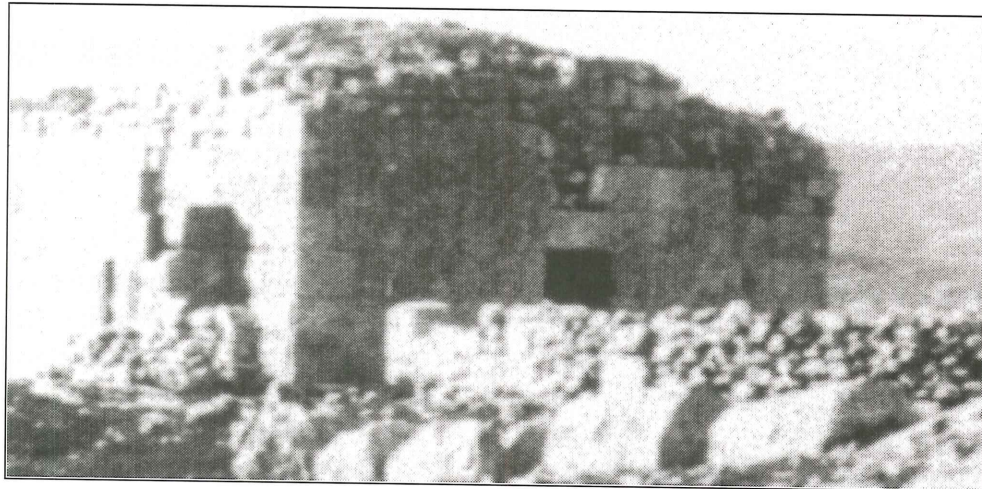
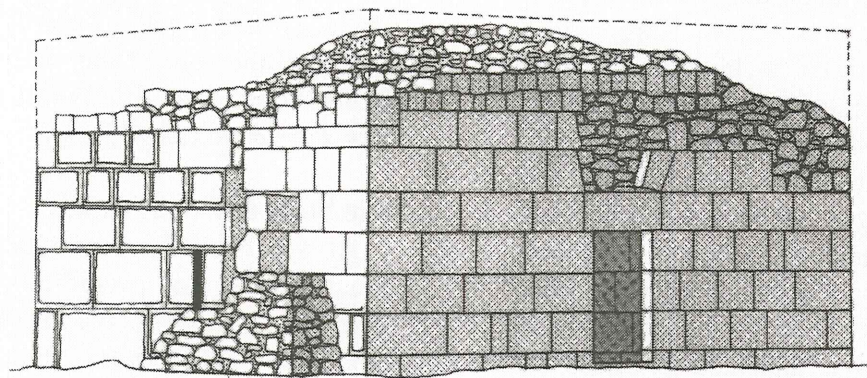
The earliest record of the Tower, a photograph taken by Bonfils in the 1870s (see Figs. 1-2), shows that since that time, the state of preservation of the monument worsened dramatically. The photograph features the east and north façades of the Tower. In the 1870s, the stonework of the east façade was preserved to the level of course 5. By 1996, all stones of the north section of this course were missing (see Figs. 2-3). The

The north facade suffered much greater damage. In the 1870s, it stood to the level of course 6 (the eastern section), with the lintel of the doorway (course 4), all stones of course 4, as well as many of course 5 still in place. By the 1990s, most stones of courses 4, 5 and 6 were gone and so were many stones of courses 2 and 3 and two stones of course 1.

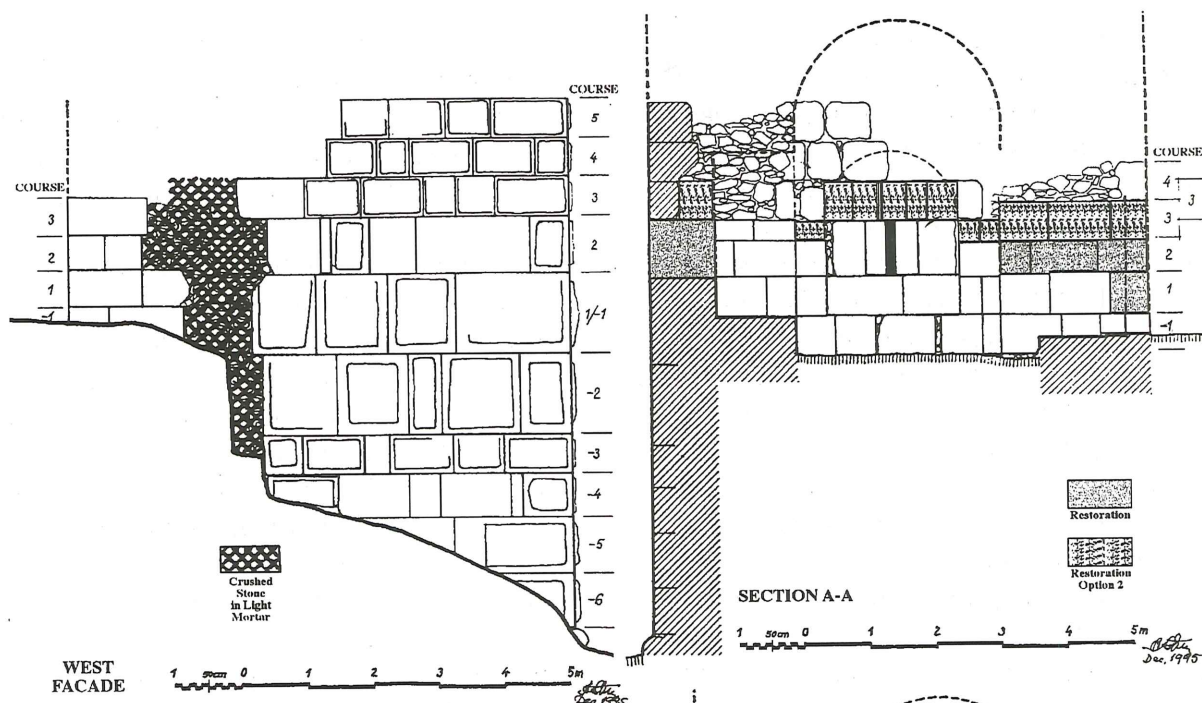
6.

In less precarious, yet endangered, condition were the remains of the uppermost masonry of the median parts of the east and west walls. Only the stones of the facade were in place. The three surviving masonry courses were almost 2 m high, the stones were only 0.5 m wide, and they were not stabilized on the inside by the facing stones of the room nor by the mortar core between the two faces of the wall (Figs. 6-7; courses 3, 4, and 5). That masonry could have collapsed during even a moderate earthquake.

The project for restoration of the Tower had two objectives. One was the conservation of the remaining masonry of the monument and the other one was the improvement of some features of its architecture through partial restoration of missing parts of the structure. The former was paramount to the survival of the monument; the latter aimed at a better understanding of its architecture. The achievement of both objectives was conditioned by technical consideration and by the requirement for compliance with the principles of restoration of ancient monuments. In the case of the Tower, a compromise had to be sought to achieve both objectives. The following illustrates the issues faced in this project:

The conservation of the remaining stonework of courses 3, 4, and 5 of parts of the east, south, and west facades would require rebuilding the inner masonry of these courses of the walls (masonry of the face of the room in the Tower). However, there were very few stones *in situ* which attested to the size of the stones in course 3 and there were none attesting to the size for courses 4 and 5. Rebuilding these courses of masonry could be done only on the basis of the restorer's (arbitrary) decision concerning the size of new stones used for the rebuilding; this may be viewed as contrary to the strict-test prin-

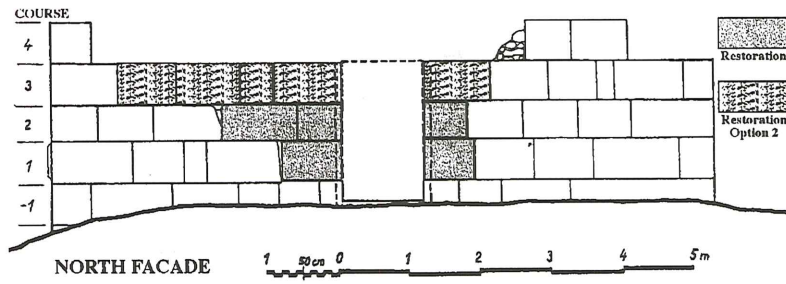
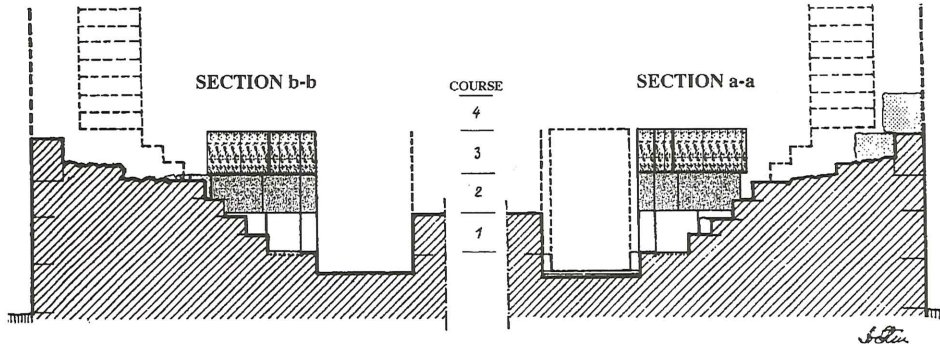
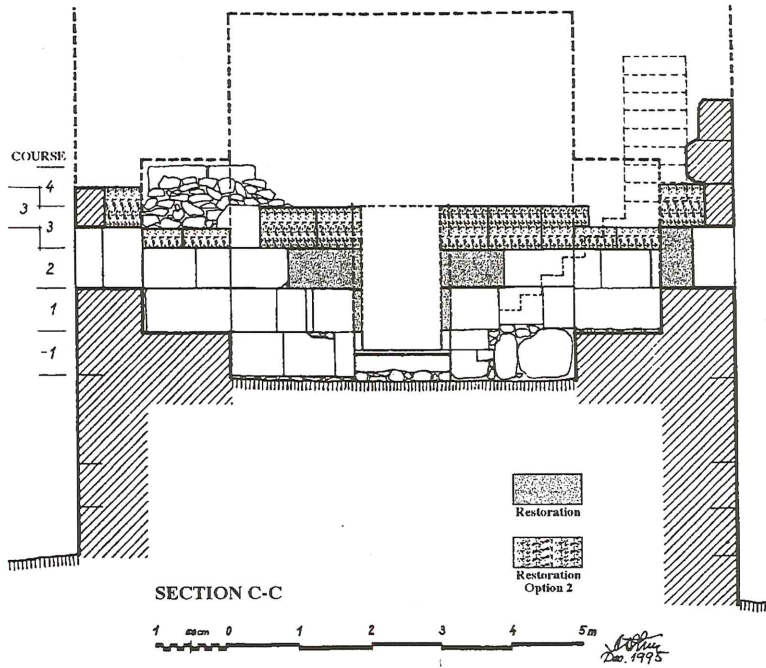
9.

The crucial problem of implementing "Option 2" was the rebuilding of course 3 of the masonry of the room in the Tower. The rebuilding had to be based not only on direct but also on indirect evidence. There was almost complete evidence for the size of missing stones in courses 1 and 2 but in the case of course 3 the situation was different. There is complete evidence for the height of the stones in course 3 of the façades but the length of the missing stones in this course was attested only in a few instances.

ciples of restoration. There was fairly good evidence for the size of stones which made up courses 1 and 2 of the stonework facing the inner and outer façades of the walls of the Tower. Rebuilding these faces would meet no objections of even the most orthodox restorer. This project therefore considered two options, one in which only the strictest interpretation of restoration would be followed. Under Option 1, a program of simply rebuilding the walls, the stability of the surviving masonry above course 2 of the east, south, and west façades would not be ensured. To improve the stability of that masonry, the missing parts of at least course 3 of the face of the room in the Tower would have been completed with new stones. This was the option implemented.

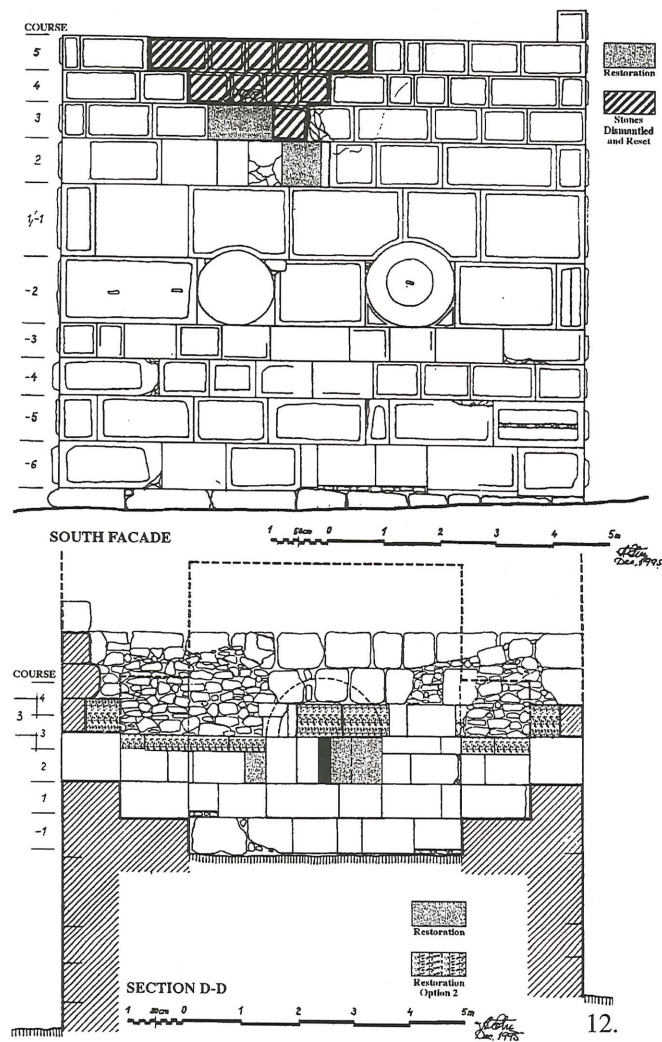
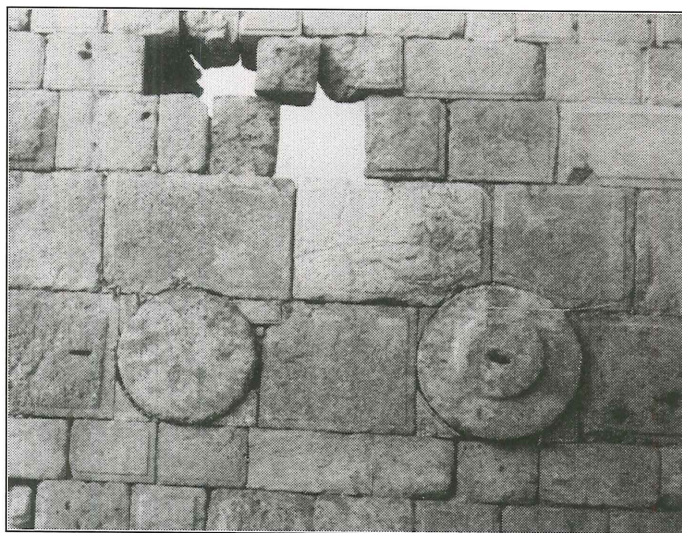
13.

is covered with a flat stone (see below, Figs. 12 and 14). The stones over the other (interior) half of the slits are missing. The interior aperture of the slits is 0.85 m wide. This span could be easily (and must have been) covered also with a flat stone but the length of the stone was but a matter of conjecture.

The lack of evidence for the length of the stones over the slits did not significantly impede the rebuilding of course 3. The builders of the Towers were haphazard in their choice of lengths of the stones for the courses. The restorer could simply follow their example of there being no principle in this respect.
