# MOSAIC FLOORS IN THE BAPTISM SITE (BETHANY BEYOND THE JORDAN)

#### Mohammad Waheeb

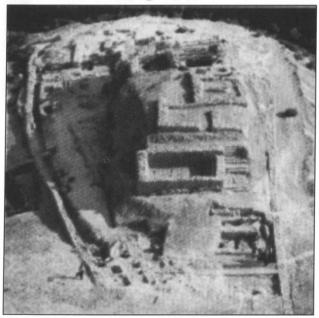
1. General view of Tall al-Kharrār with its churches.

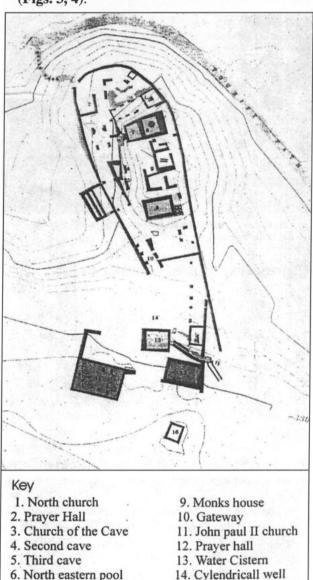
2. Plan of the Tall al-Kharrār.
