1995 ARCHAEOLOGICAL EXCAVATION OF THE SOUTHERN TEMPLE AT PETRA, JORDAN¹

Martha Sharp Joukowsky

Introduction

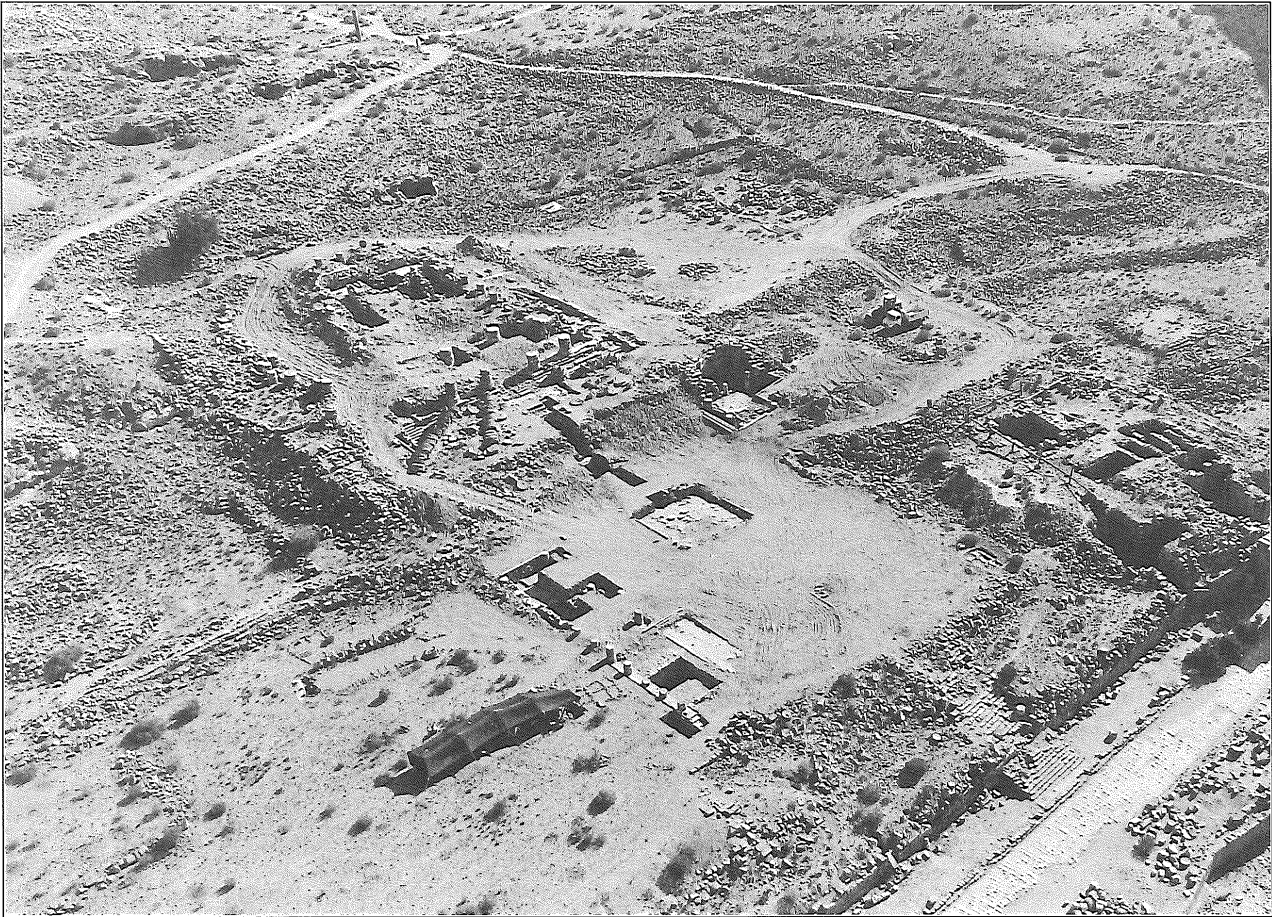
1. Aerial photograph of the Petra Southern Temple, looking southwest (Photograph by A. A. W. Joukowsky).

west by elegantly apsed Exedrae. A partially uncovered 'Grand Stairway' leads up to the Upper Temenos and to the Southern Temple itself (Fig.1). The Southern Temple was opened to exploratory research in 1993, and excavations have continued in 1994 and 1995 with the investigation of several temple areas. In 1995 the focus was on the Pronaos and Adyton in the Temple and other *in situ* features of the Lower Temenos — the West Exedra, the East Colonnade, and the subterranean canalization system.³

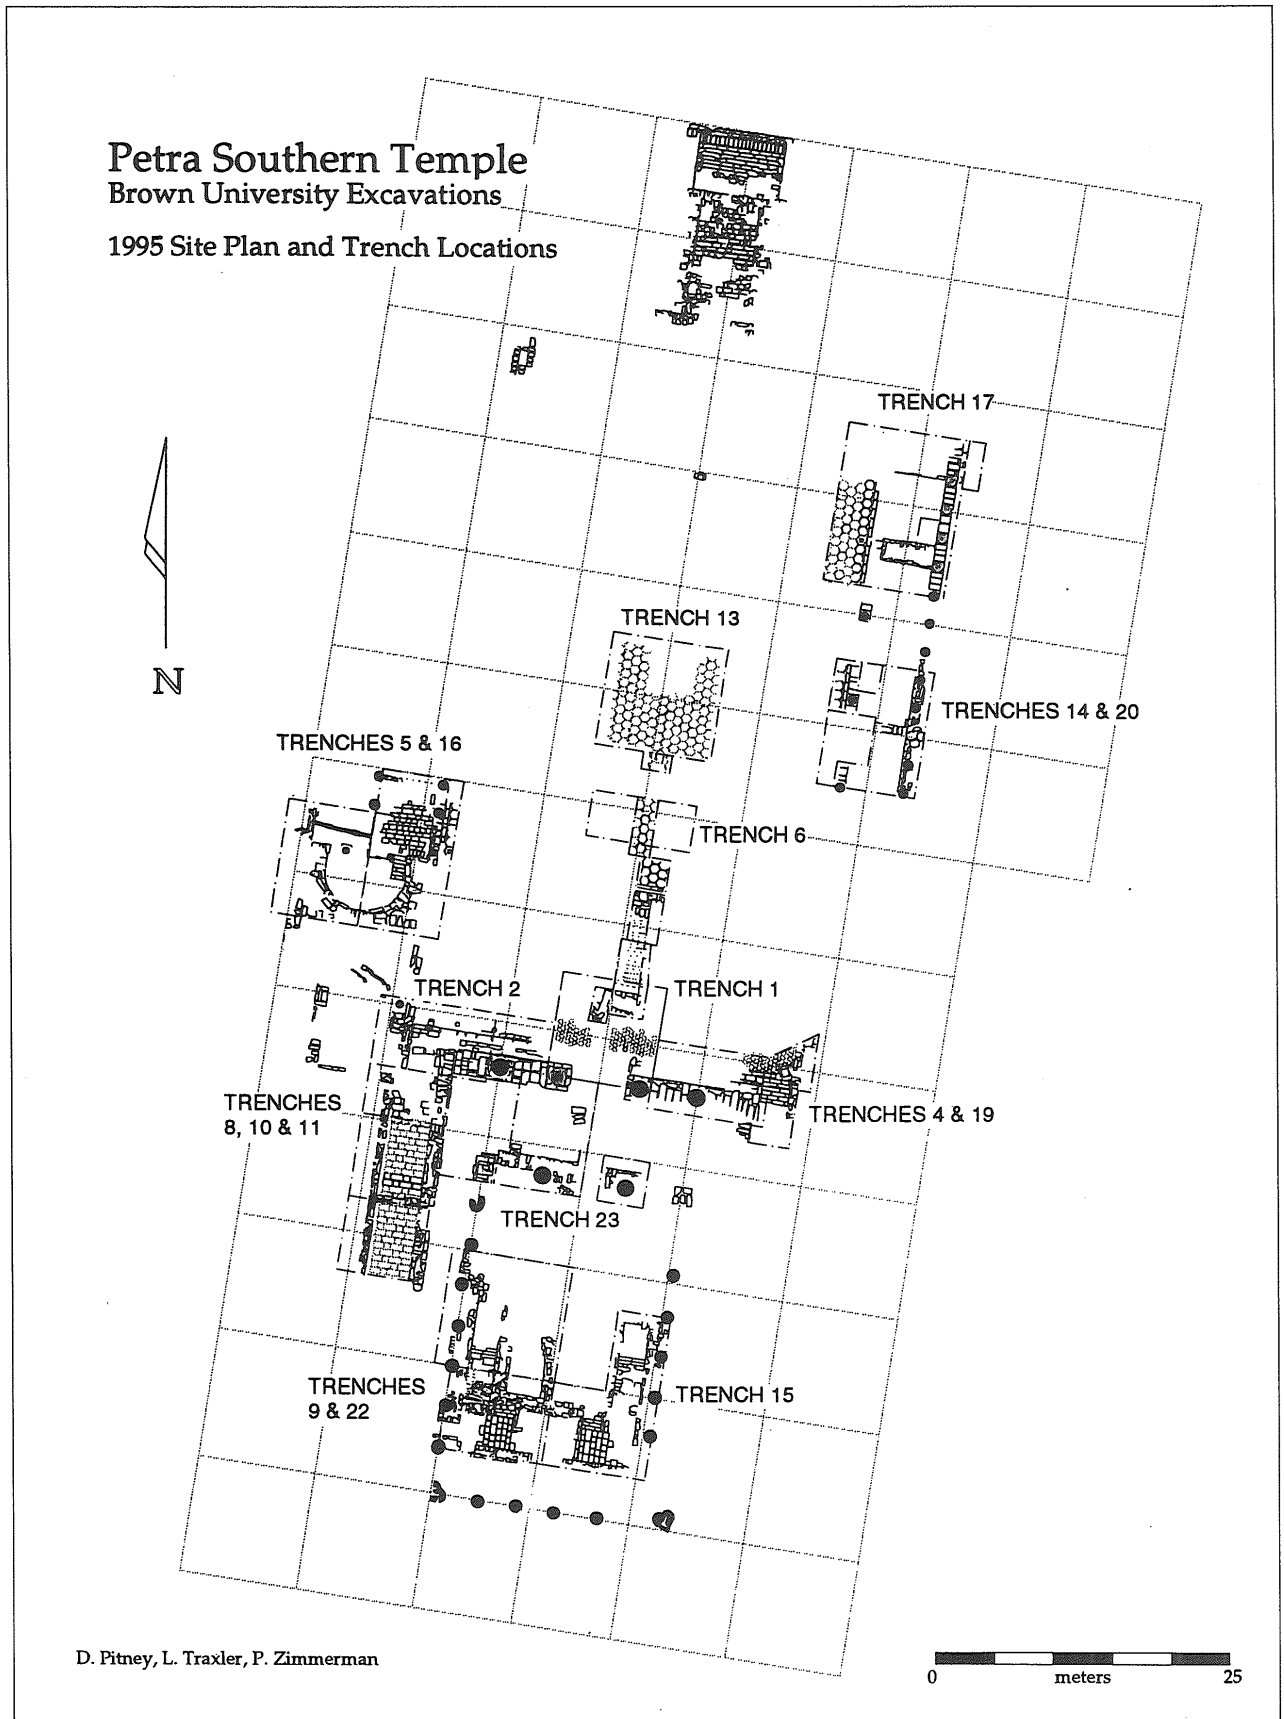
2. 1995 Site plan with trenches. (D. Pitney, L. Traxler, P. Zimmerman).

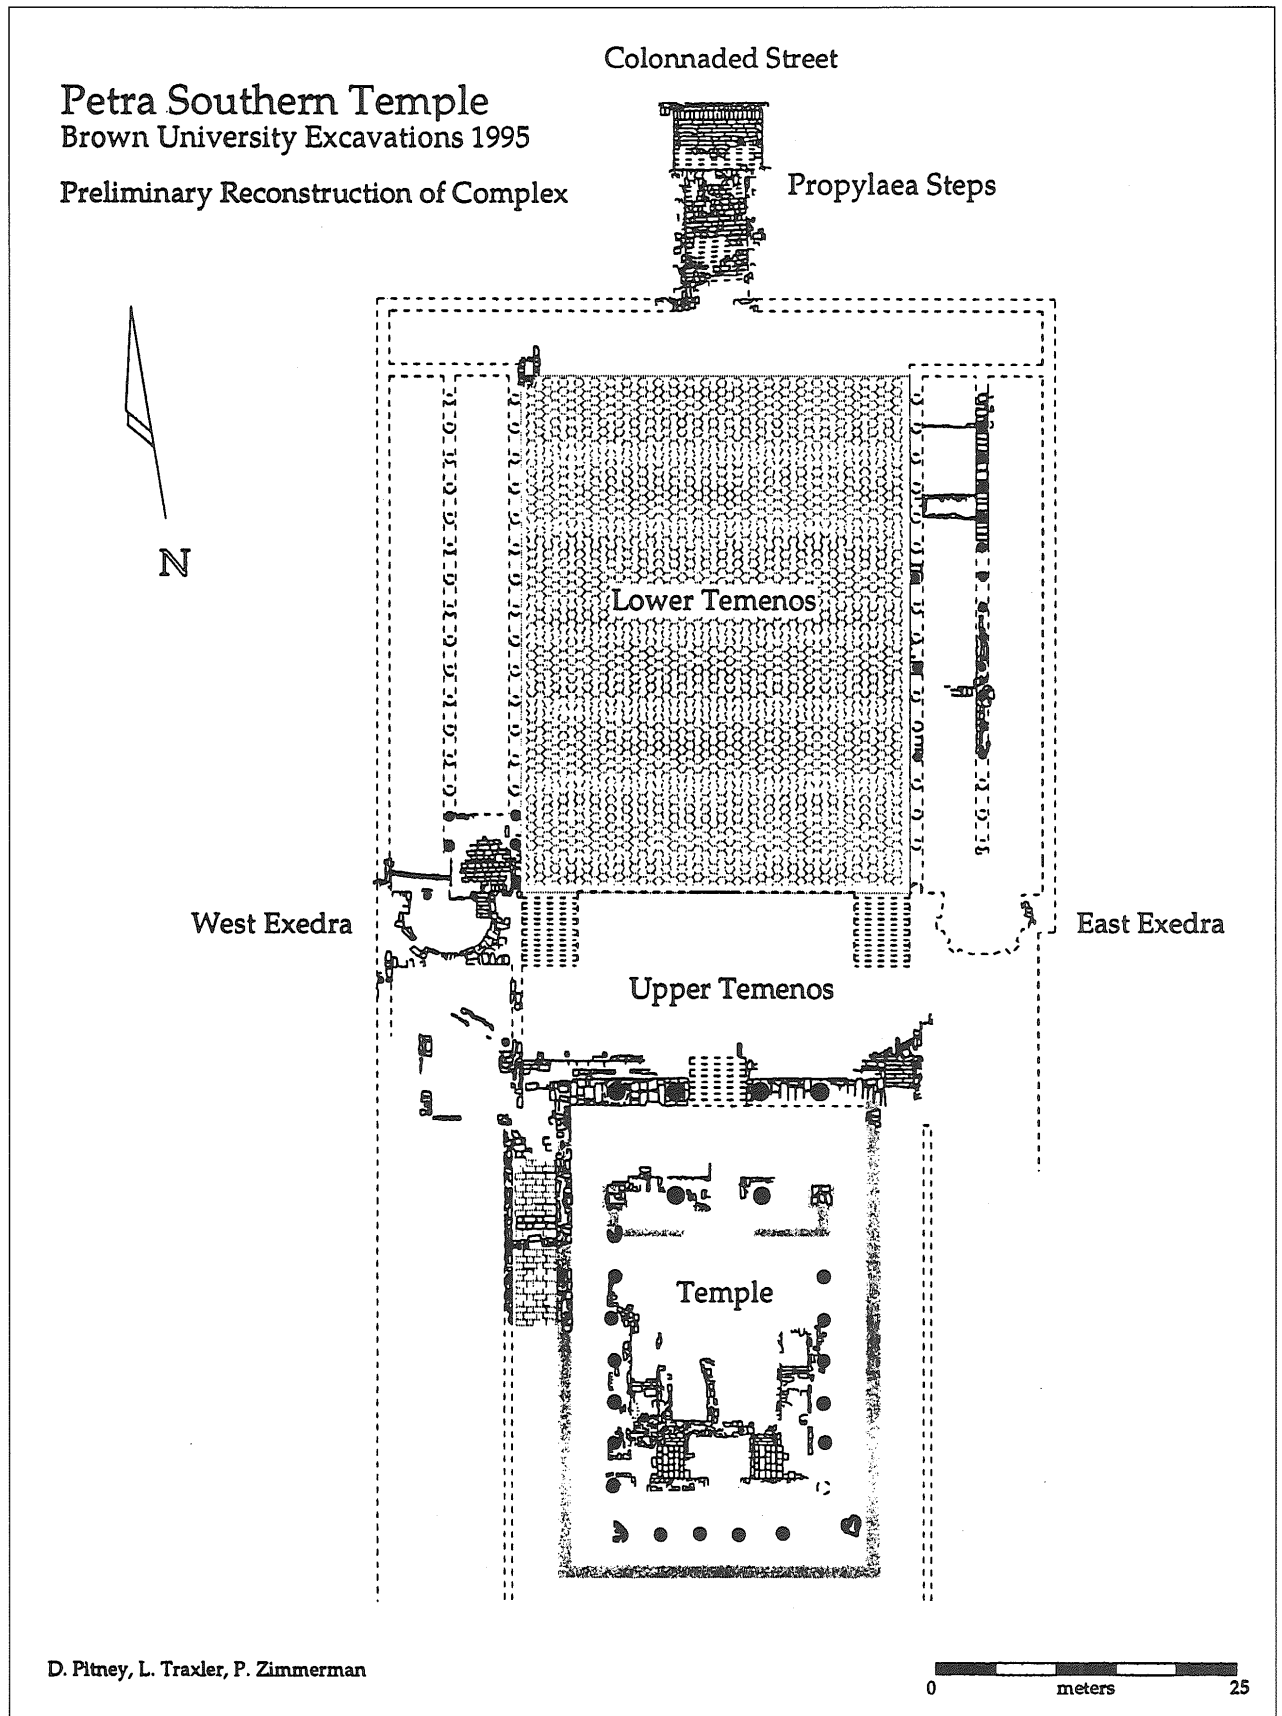
3. Reconstruction of the Late Nabataean reconstruction phase (D. Pitney, L. Traxler, P. Zimmerman).

Phase Ve — Post ca. 106 CE(?) Propylaea Steps; *Lower Temenos*: West Exedra wall repair. Hexagonal pavement. *Upper Temenos*: East and West Walkways;⁷ *Temple*: Forecourt paved with small hexagonal pavers; Adyton walls, Stairways, and Intercolumnar Walls. (Fig. 3 is a tentatively restored phase plan);

Another two subphases included the east and west Stylobate construction for the Double Colonnades of the Lower Temenos. The Stylobate foundation wall indicated two phases of construction; an earlier of close fitting Nabataean dressed blocks, and a later of coarse blocks with a thick mud mortar and stone fill.³⁰ Covered by topsoil in Trench 17, the east Stylobate was revealed at an opening elevation of 878.99m. It was constructed of limestone slabs (0.52m x 0.96m) separating larger, square convex-shaped slabs (0.96m x 0.96m) which supported the columns and served as their bases. The 30m area excavated revealed spacing for 12 columns, but we posit that there were a minimum of 14-to-16 that adorned each line of the double-rowed colonnade (refer to Fig. 3).

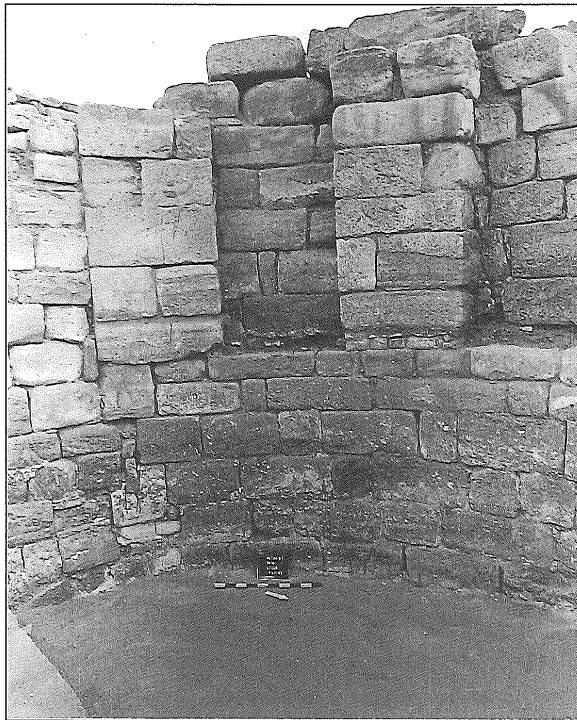
5. West Exedra, looking southwest (Photograph by A. A. W. Joukowsky).

Southern Temple Precinct.¹² Although excavated to a six meter depth, no founding level has yet to be found for this buttressed 13-course structure (Fig. 5). The 1995 excavation of the upper fill layers completely exposed architectural features including the niching and buttressing of the walls and the twin freestanding entry columns. There was further definition of the double columnar entry, the north plaza, the form and depth of the apsidal walls, the staircase discovered in

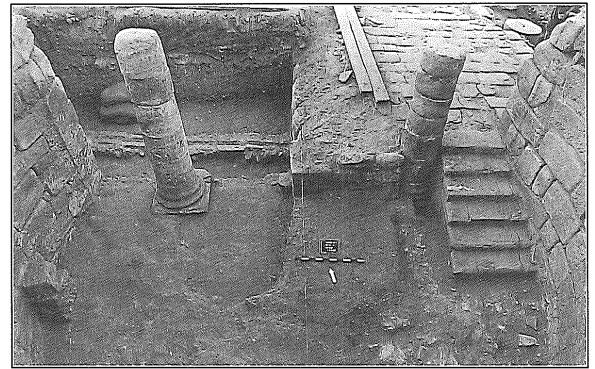
6. West Exedra, looking north (Photograph by A. A. W. Joukowsky).

1994, and the location of floor levels and foundation levels. New architectural components were revealed. As can be seen in Fig. 6, the platform floor uncovered in 1994 did not continue westward, however, a founding floor level for the stairs was recovered. (There was no western engaged column to mirror the east column recovered in 1994 — where the elephant-headed capital was discovered.) Additionally there was the appearance of a north-south wall in the northwestern part of the trench which was partially contemporary with the apsidal wall, and formed a natural boundary in the extreme northwestern corner of the trench. Between two floors of later re-use was a sealed fill layer containing significant numbers of bones, shells, charcoal deposits, and ceramic remains. In addition, under the packed surface north of the West Exedra proper, a shallow water channel (Fig.7) was excavated, resting on a footing of pebbles. There was

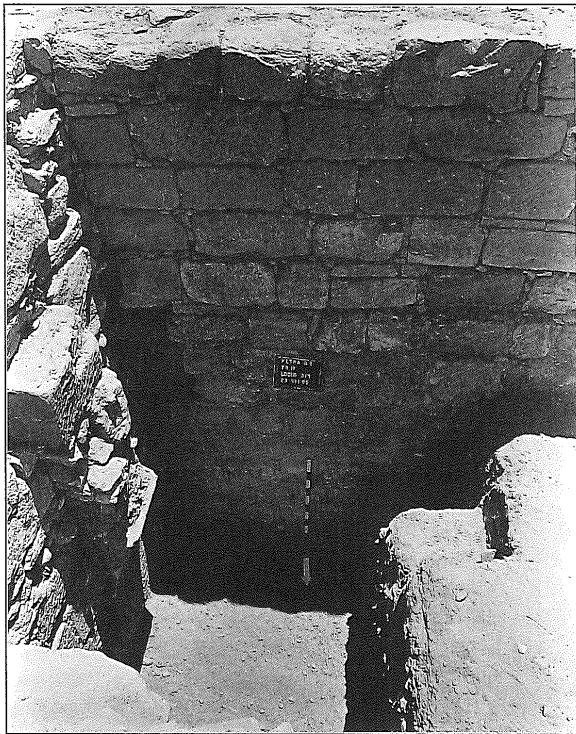
9. Lower Temenos E-W Wall N sondage with N-S wall with arch springers, looking south (Photograph by A. A. W. Joukowsky).

In Phase Vd the Lower Temenos was constructed. This was a time of major rebuilding for east-west walls were erected both in the north, E-W Wall N (Figs. 9 and 10), and south, E-W Wall S. We presume that the purpose of these walls was to provide extra structural support for the Stylobate and serve

as retaining walls for the fill and build-up against the Phase I North-South Wall with arch springers.²⁷ The depth of E-W Wall N was determined by a Trench 17 sondage.²⁸ At a 873.52m elevation, an 0.80m x 0.50m sondage was excavated to determine the depth of the North-South Wall and E-W Wall N in Trench 17. E-W Wall N was found to have been constructed on a layer of rubble. At a depth of 3.86m the evidence suggested that the fill was intentionally brought

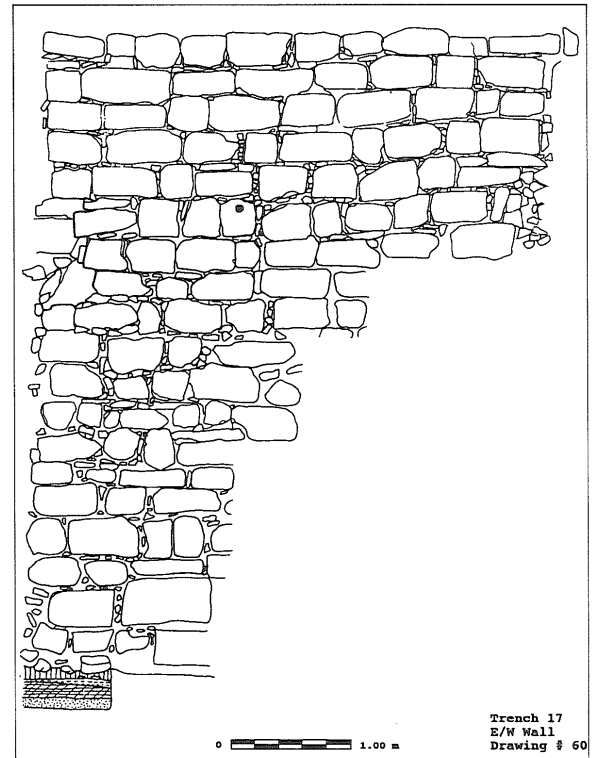
10. Lower Temenos E-W Wall N section (Drawn by L. Payne, Drafted by A. H. Bedewy).

27. The 19 course E-W Wall N opened at 879.07m and closed at 873.67m elevation (5.40m in height). It is 4.43m in length by 2.10m in width, and was built on a level of rubble sandwiched between layers of compressed soil. The top course of this wall overlaps the East and thus post-dates it. The top courses consist of medium sized, rounded sandstones packed in an irregular pattern in a hard mud-mortar. The north face, however, exhibits careful construction technique with a facing of headers and stretchers with neatly packed fill in between them. The average size of the ashlar are 0.31m x 0.28 m (headers) and 0.52 x 0.27 m (stretchers). The majority are diagonally dressed, all from top right to bottom

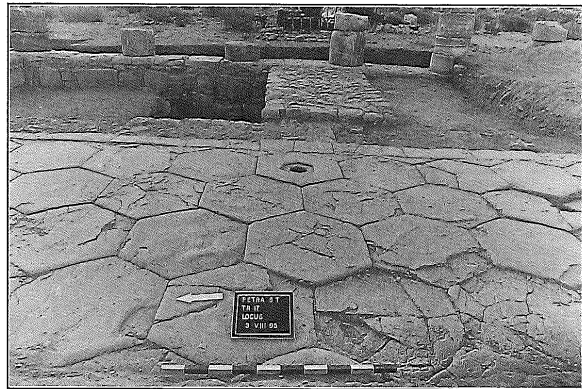
11. Lower Temenos hexagonal pavement with drain, looking east (Photograph by A. A. W. Joukowsky).

Lower Temenos with large hexagonal pavers. These pavers were the eastern perimeter of the hexagonal pavement which extended from the east across to the West Exedra and its Double Colonnade. Set into a complete paver was an hexagonally shaped drain (Fig. 11), 0.28m to a side with a central hole of 0.12m in diameter serving as the evacuation point.³¹

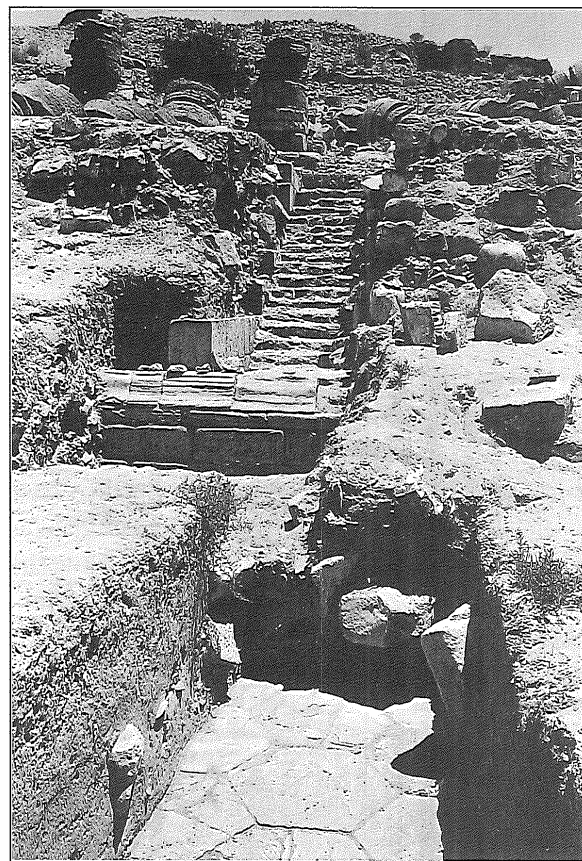
12. 'Grand Stairway' linking the Lower Temenos to the Upper Temenos (Photograph by A. A. W. Joukowsky).

Initiated in 1994, in 1995 we completed the test excavation and surveyed and cleaned a portion of the Stairway bedding from the Upper Temenos to the Lower Temenos. The subdatum was fixed at 882.49m on the seventh step, and the trench was extended 5.6m north to ascertain the length of the Stairway and its east ashlar support wall. The Stairway itself measured 9.5m in length, and the hexagonal pavement at the foot of the retaining wall was 2.5m in width.

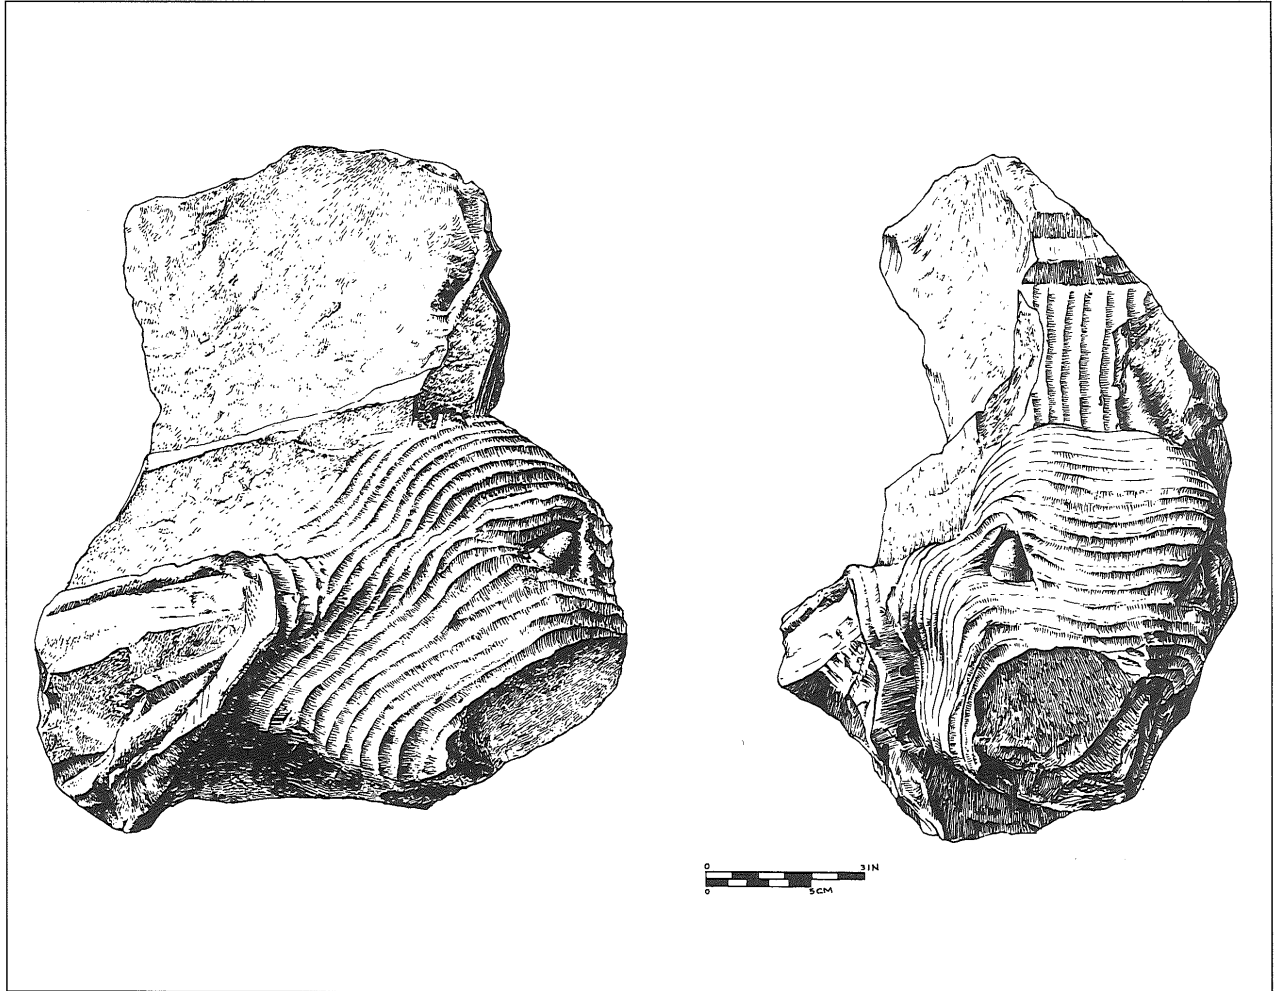
13. Elephant-headed capital fragment (Drawn by L. Sisson, Drafted by J. Blackburn).

A change in soil consistency was noted while excavating the second course of ashlar at an 880.71m elevation. Significant amounts of cultural material unearthed included Nabataean forms as well as jar and jug fragments, along with 23 carved architectural fragments, and a capital fragment of a limestone elephant head (Fig. 13).³⁷

37. Catalog no. 95-S-16, measurement L. 28.9cm x W. 29.6 cm. Present is the right ear, two eyes, one with its eyeball, and forehead. Another elephant trunk fragment was found in the same area as the head.

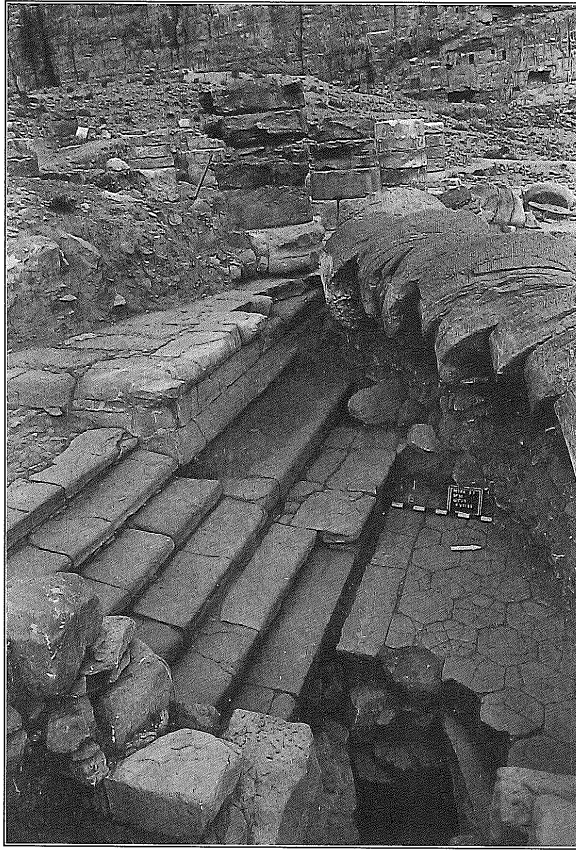
15. East Walkway with Canalization, Temple Podium and Stylobate, looking west (Photograph by A. A. W. Joukowsky).

At elevations of 884.46m and 883.09m, just east of the stairs, the underground canalization was discovered extending north-south with an northerly descent and a slight northeasterly curve (Fig.15). Slightly askew hewn capstones were found at 884.46m, indicating that they had been moved in antiquity perhaps to repair or clean the system. The tunnel walls consisted of three course dressed sandstone ashlar, covered by a 4cm thick mortar. The depth of the tunnel was 1.20m, and its floor width measured 0.63m. Its approximate length was 12m. We assume that this tunnel served as an eastern artery for the main subterranean Canalization system, but the area excavated, unfortunately, was

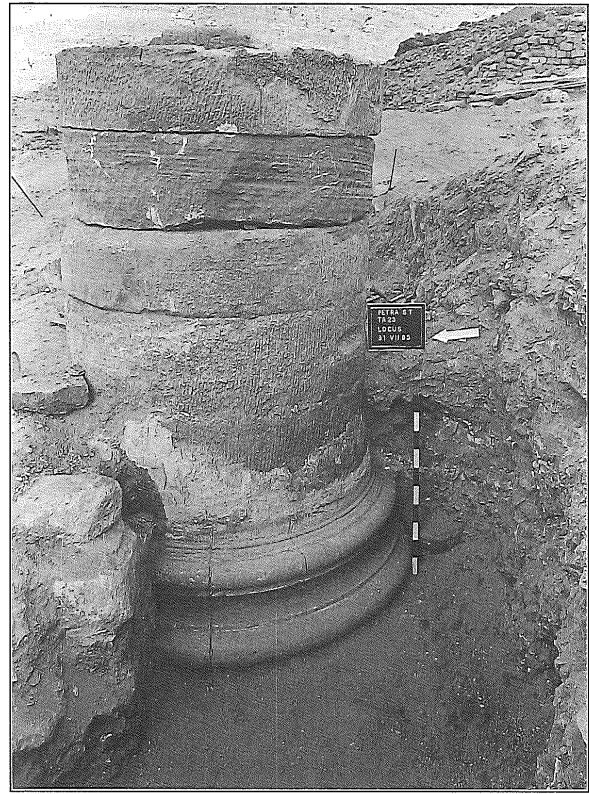
16. Pronaos West Column, looking east (Photograph by A. A. W. Joukowsky).

In Phase Vc the Pronaos plan was clarified. Resting on finely carved Attic bases were massive interior temple columns (Fig. 16) which we have identified with the original Temple construction.⁵⁰ Both sandstone columns were supported by well-preserved limestone Attic bases, 2.10m in diameter, carved in two pieces and perfectly preserved to a 0.70m height.⁵¹ The Attic bases rested on leveling blocks, and their elevation confirmed the Pronaos was at the same elevation as the Stylobate. The West Pronaos column's top elevation was 888.64m and its founding

elevation, 886.00m.⁵² Traces of white and red stucco up to 11cm in thickness still adhered to the lower diagonally dressed column shafts.

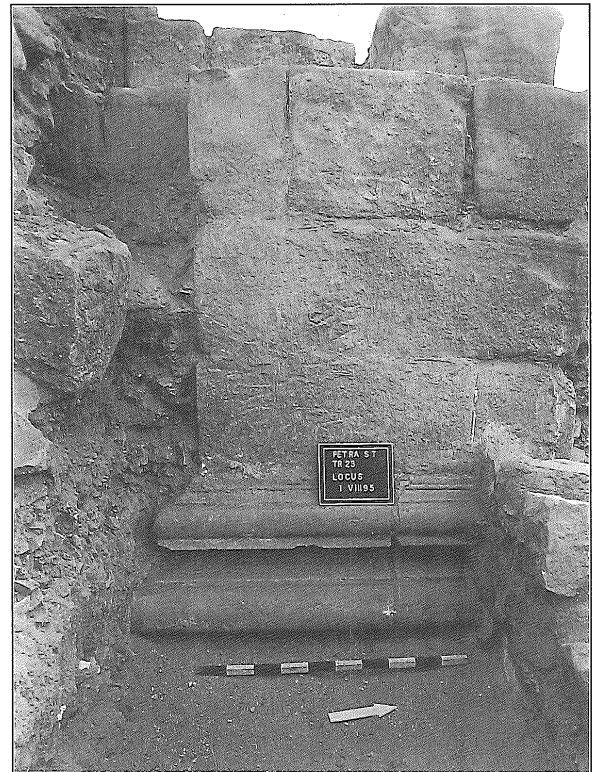
17. Pronaos West Anta (Photograph by A. A. W. Joukowsky).

tion was 886.57m, its maximum preserved height was 1.30m, and its width was 1.28m. Composed of hewn and unhewn sandstone blocks, ca. 0.30m-0.50m in length, a few reused ashlar (the only dressed stones), were set into a mud mortar to form a division wall, not a load-bearing wall, for where it abutted the northwest face of the West Pronaos column, it preserved the column's red plaster decoration. A doorway, (now filled) 1.42m wide originally pierced the wall 2.0m from its west end.

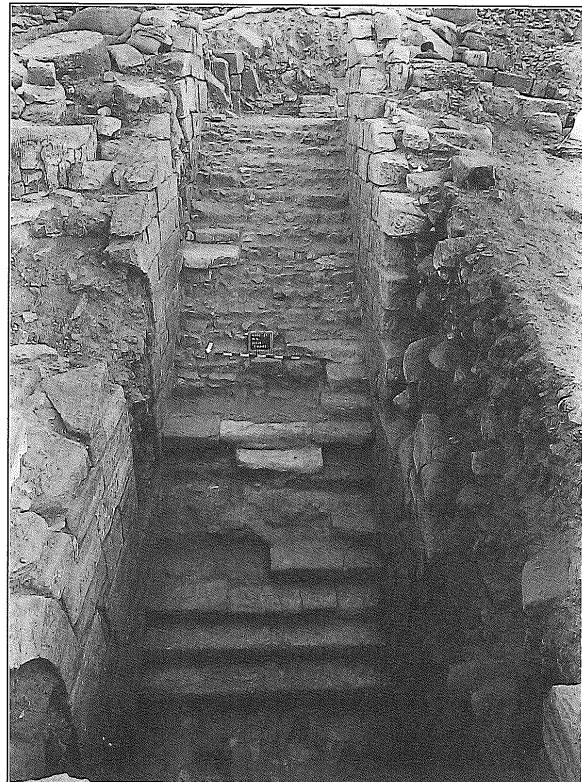
19. Adyton East Stairway, looking south (Photograph by A. A. W. Joukowsky).

shown in (Fig. 19). At a later date, in Phase VIb, there was the re-building of the upper courses the West Adyton as well as other interior walls. Phase VIIb was a period of abandonment with a level of clean fill just above the floor surface; Phases VIIc-VIIId were a series of destruction/collapses, the robbing out of floor pavers; the subsequent accumulation of fill and topsoil occurred in Phases VIII and IX. Each of these phases is briefly discussed with emphasis placed on the more completely excavated West Adyton.

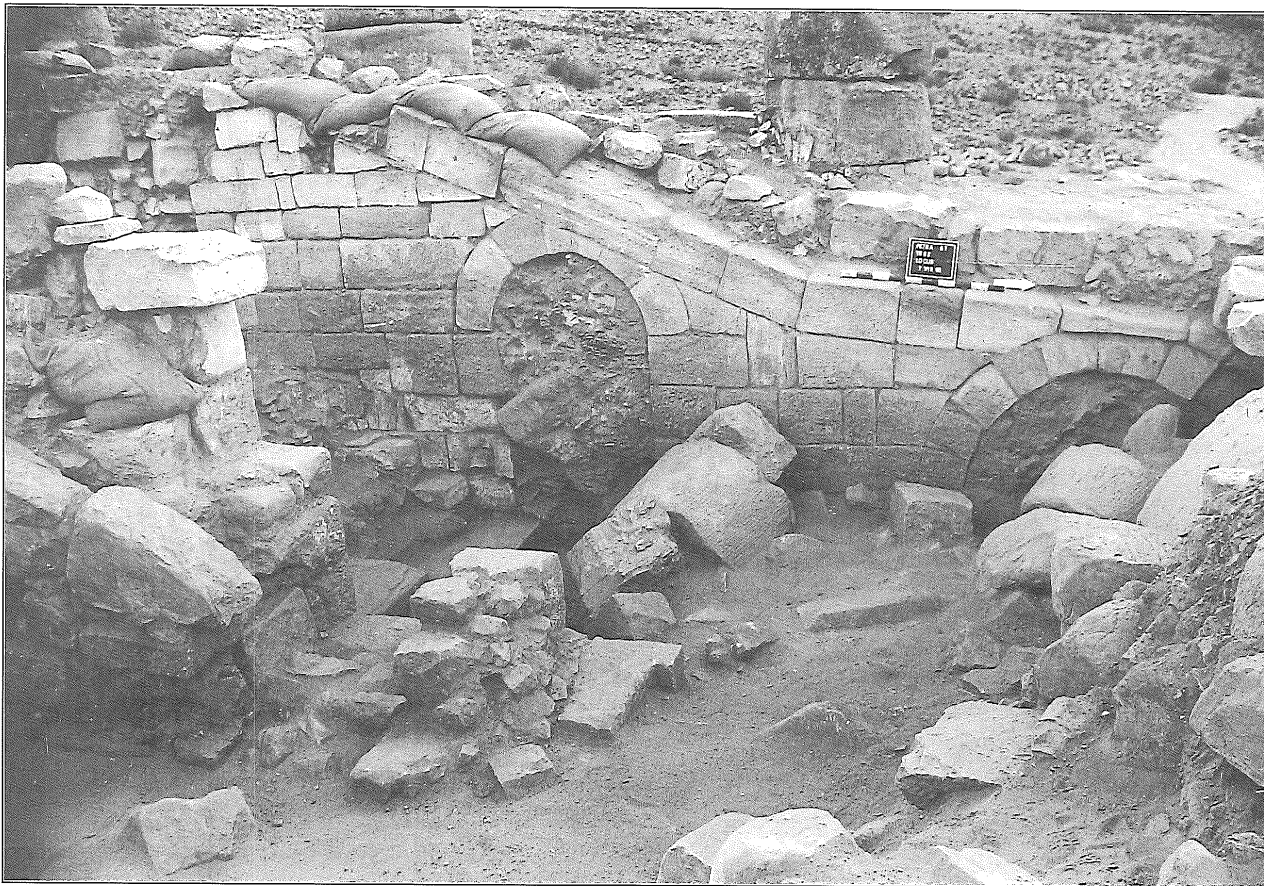
20. Adyton West Stairway with arched window and door, looking west (Photograph by A. A. W. Joukowsky).

la's exterior walls due to the fact that they abutted the exterior walls and were not bonded to them. The fact that these windows and doors were built into the intercolumnar wall suggests that Phases Ve and VIa were part of one major restructuring of the temple.

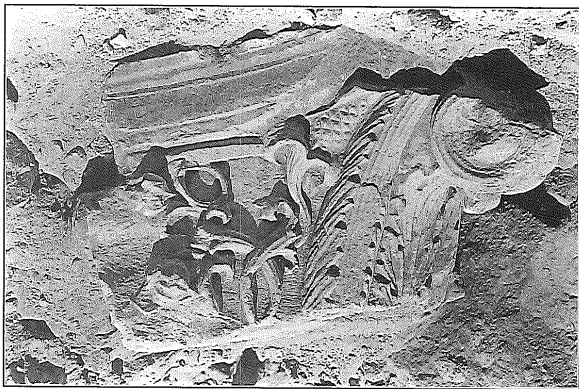
24. Cella Capital (Photograph by A. A. W. Joukowsky).

fruit motifs was recovered in four parts, one of which is shown in Fig. 24.
