QUŞAYR ‘AMRA WORLD HERITAGE SITE: PRELIMINARY REPORT ON DOCUMENTATION, CONSERVATION AND SITE MANAGEMENT ACTIVITIES IN 2012-2013

Introduction

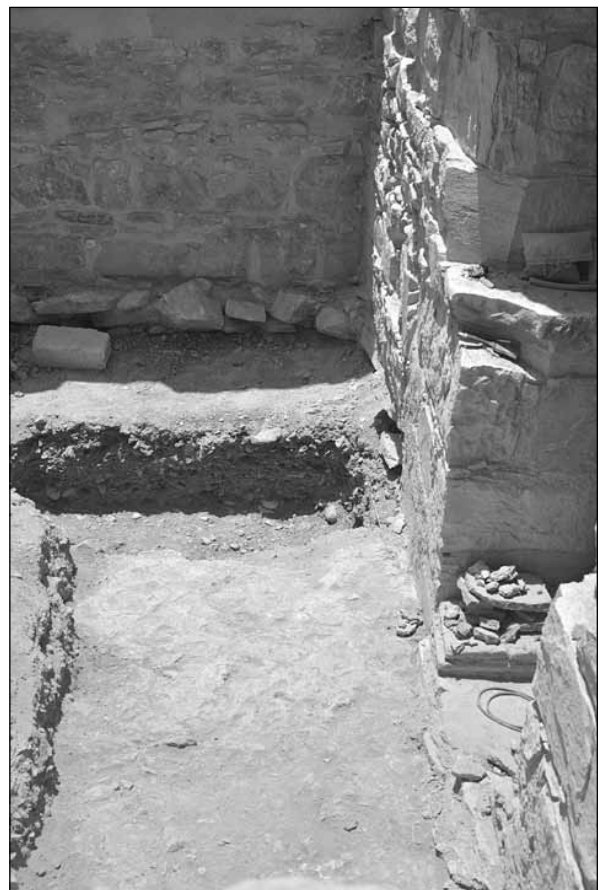
2. Remains of a preparation for a floor in the *prae-furnium*. found mixed with ashes and charcoal (Fig. 2). A charcoal sample was carbon-dated at Geochron Laboratories (Chelmsford, Mass.). Sample GX-33763-AMS, from the *prae-furnium*'s north-west corner gave a date of 1,270 BP +/-20 (680 AD

Soundings were also conducted on the western side of the room, where the bedding mortar of an ancient floor (now disappeared) was

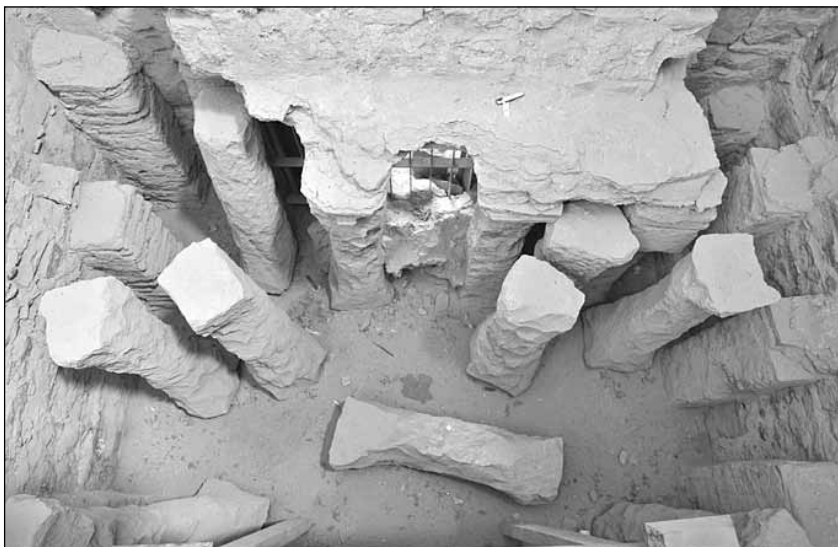
3. Scattered *pilae* in the *caldarium* before intervention.

The *pilae* in the middle of these rooms were made of basalt cut in one piece and were found lying on the floor. Mortar traces on the floor allowed the repositioning of the *pilae* in their original location, thus allowing a better presentation of these two rooms (Figs. 3, 4).

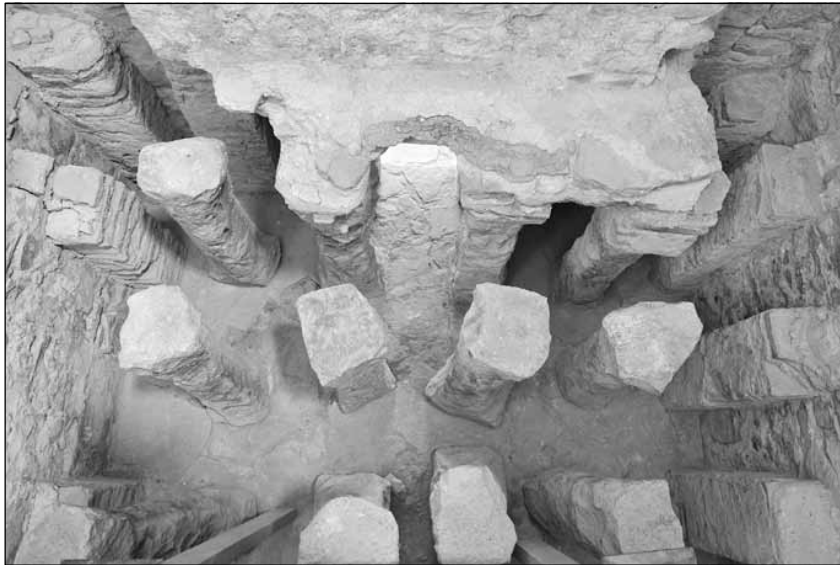
4. The caldarium floor after cleaning and conservation.

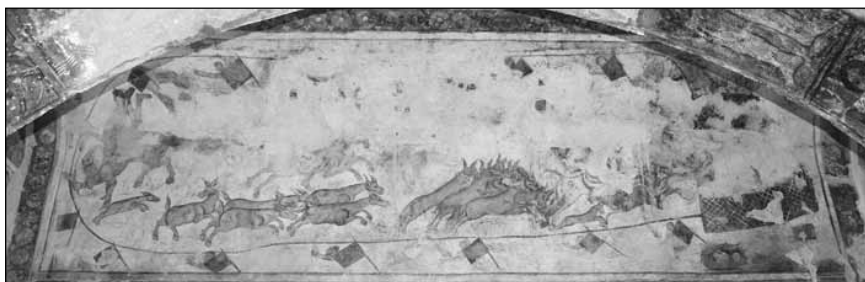
8. Hunt scene on the upper register of the western wall after conservation.

The cleaning of the hunting scene above the kings' figures facilitated the discovery of previously unknown details, such as small plants and bushes, the complete figure of a falling horseman

(at the extreme left of the composition) and the 'disappearance' of two tents drawn by Spanish conservators. In place of the latter, the conservation intervention allowed for the discovery of a different detail, *viz.* the presence of three men hiding in a hole dug in the ground. This type of hunting technique is described in historical texts (Bisheh personal communication). Moreover, under the yellow layer of paint the rest of the hunting scene was discovered, allowing the complete scene to be read for the first time (Fig. 8). The scene discovered under the paint layer includes other flame- and flag-bearers scaring the animals into a trap, as well as the rest of the trap made of long ropes terminating, on the right side of the composition, in a netted area where the onagers are eventually killed.

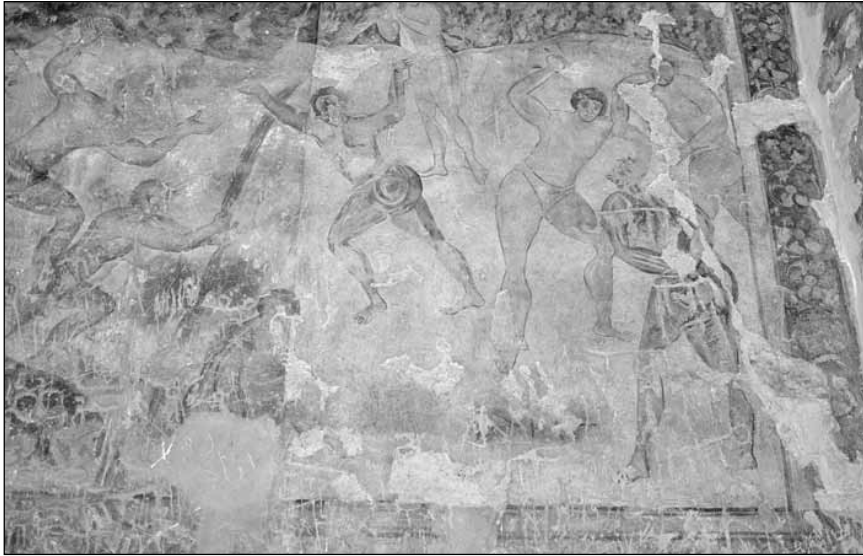
9. Representation of a game (?) on the middle register of the western wall.

Cleaning showed that the two 'teams' have different skin tones, the first 'whiter', the second 'darker'. Moreover on the extreme right of the scene, something violent seems to be happening: one of the characters has his hands tied behind his back and another character seems to be in the act of hitting him with his fist; the latter is being held back by another character, the only one that seems bearded¹⁰ (Fig. 9).

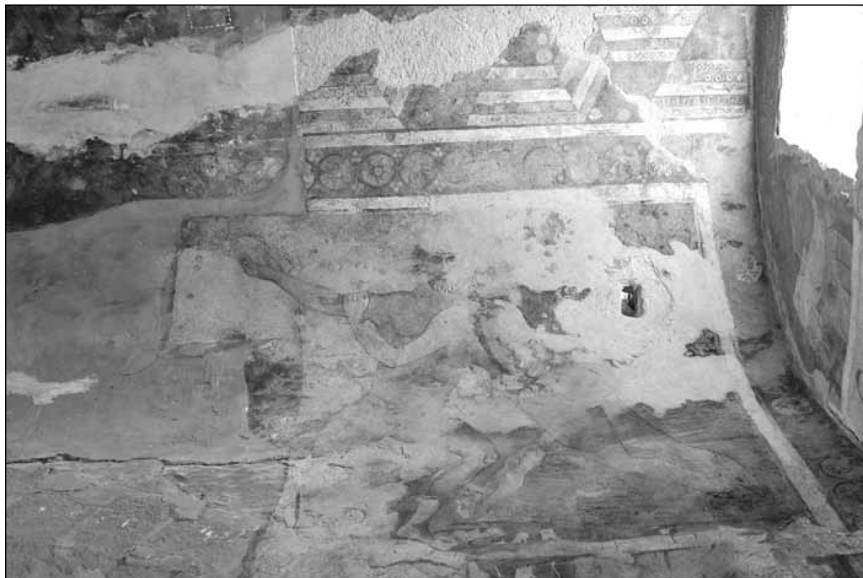
10. Previously unknown scene on the vault of the western aisle.

On the portion of the wall above the arch and immediately below the vault, cleaning brought a previously unknown scene to light that – although severely compromised – remains clearly legible. It portrays two standing figures: a man wearing only a light-blue loincloth and a naked woman he is helping out of the water. He is holding her up by slipping his left arm around her waist. She shows her back partly covered by long, dark and curly hair. Her face is missing, but a few fragments suggest that she was portrayed in profile, her face close to the man's. She is clinging to him, with her left hand grabbing his right, extended arm and the other slipped around his neck. He leans his foot on the rocky bank of a stretch of water, painted in deep blue, while the river banks are covered with small branches, leaves and round fruits (Fig. 10).

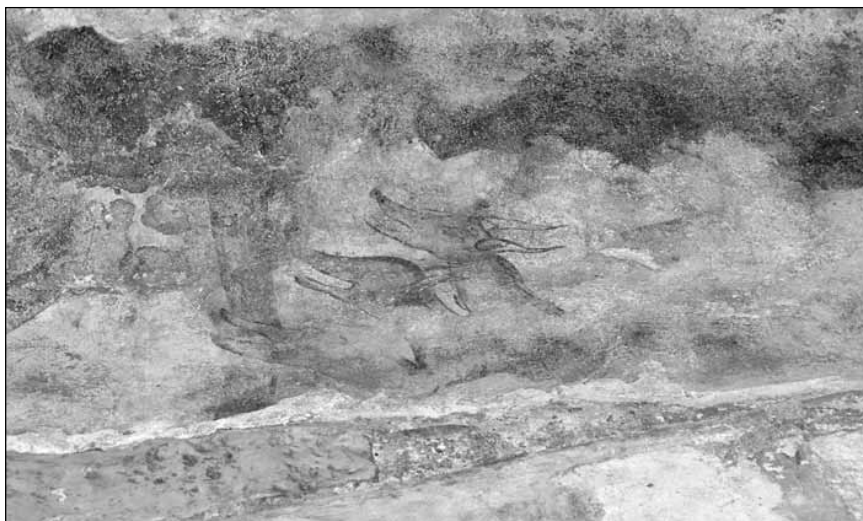
11. A newly discovered representation of Cerberus on the vault of the western aisle.

To the left of this scene the wall is severely damaged, but a garden with trees and fruits seems to be represented. Further to the left, just above the top of the arch, a three-headed dog is recognizable. Unfortunately most of its body is missing, but the three heads clearly belong to the same animal and it is certainly not a representation of three separate animals near each other. We are actually facing Cerberus, the guardian of Hades in classical mythology (Fig. 11). Further to the left, above the northern spandrel of the arch, two standing figures were al-

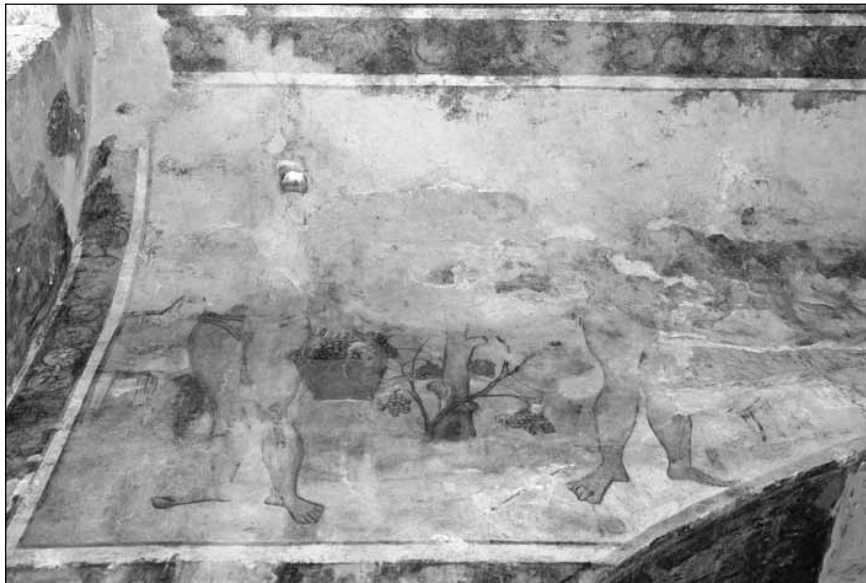
12. A newly discovered representation of a panther near a standing figure with grapes.

ready known to exist, but cleaning has revealed that one of them clearly carries a basket full of grapes and that this personage is flanked by a panther standing on its hind legs (Fig. 12). It is logical to recognize here the figure of Dionysus, who is often represented with a panther besides him. The meaning of this entire scene is still being investigated and more careful readings of this entire portion of the monument will be necessary to achieve a correct interpretation. The presence of Dionysus in the pictorial representations of Qusa'ir 'Amra was already presented as hypothesis by scholars (Blazquez 1981), based on interpretation of other scenes in the monu-

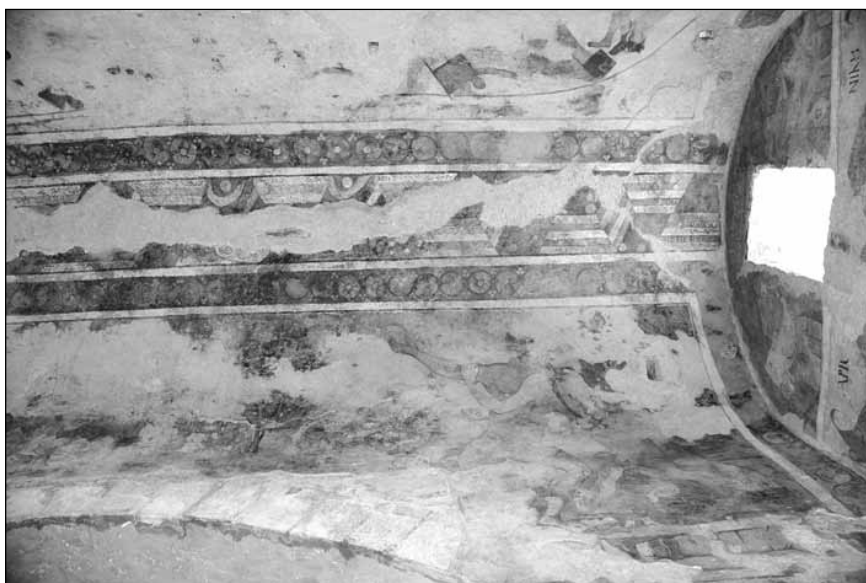
13. Geometric and architectural representations on the vault of the western aisle.

The conservation intervention finally eliminated the yellow paint and soot on the vault, revealing a geometrical / architectural decoration in perspective view, framed by rosettes whose complex pattern runs all along the vault's crown (Fig. 13).

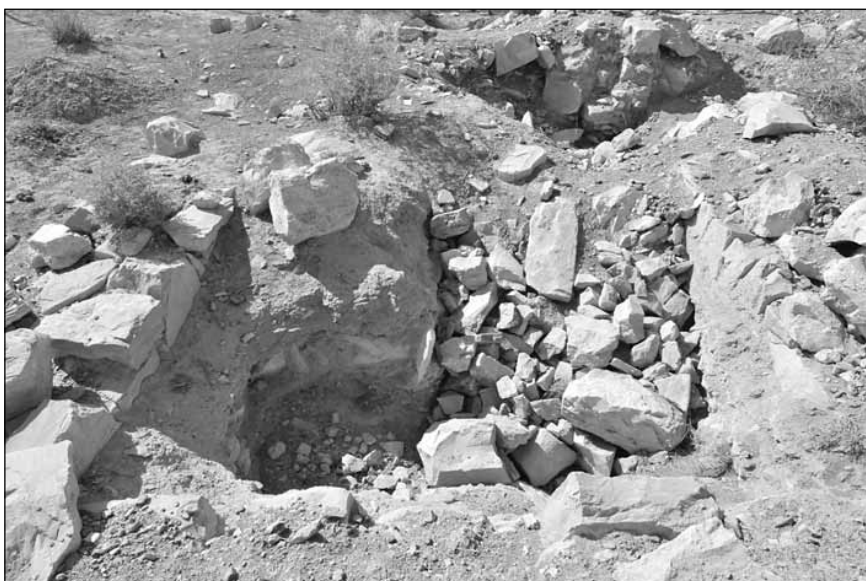
14. Poor state of conservation of the second *saqiya*.

Aerial photographs from the mid-1970s were also procured from Spain and used to identify buried features which were disturbed ten years ago by Ministry of Tourism activities on site (construction of paths, visitor center etc.). This assessment was very useful in the placement of the emergency intervention described below. A condition assessment was also conducted on the second *saqiya*, east of the road, which is in a very disturbed condition (Fig. 14). Measurements and analysis of the structure and of architectural elements still present *in situ* allowed the preparation of a project for its anastylosis.

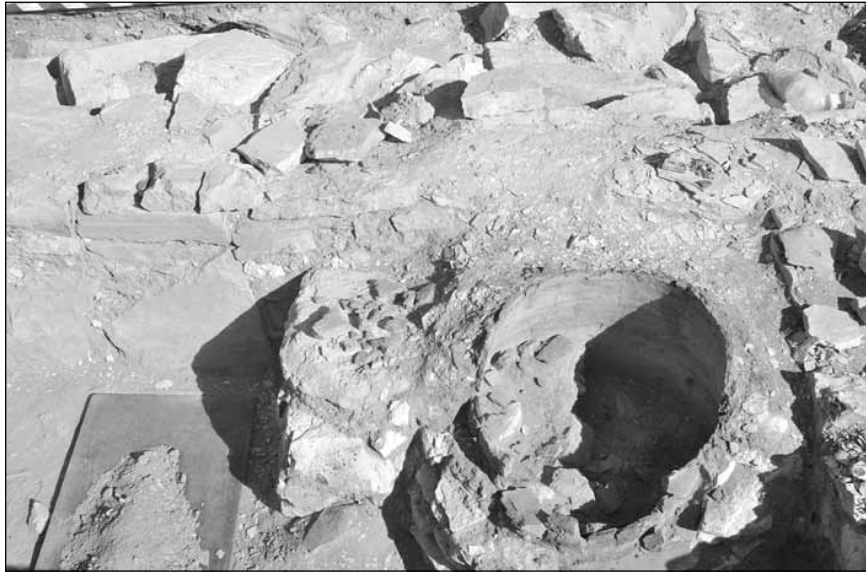
15. A tannour discovered inside a room of the newly identified building.

and perhaps separated by color. At this stage it is impossible to say whether the oven found in one of the rooms was used for the production of *tesserae* or other material, or was instead used for cooking. It is however almost certain that this was a service building associated with the use of Qaşayr ‘Amra or with its construction. This hypothesis may also find confirmation in the mural paintings of the eastern aisle of the main hall, where artisans and workmen are represented performing various operations at what seems to be the Qaşayr ‘Amra building site. Unfortunately the southern side of the building found in these soundings was bulldozed dur-

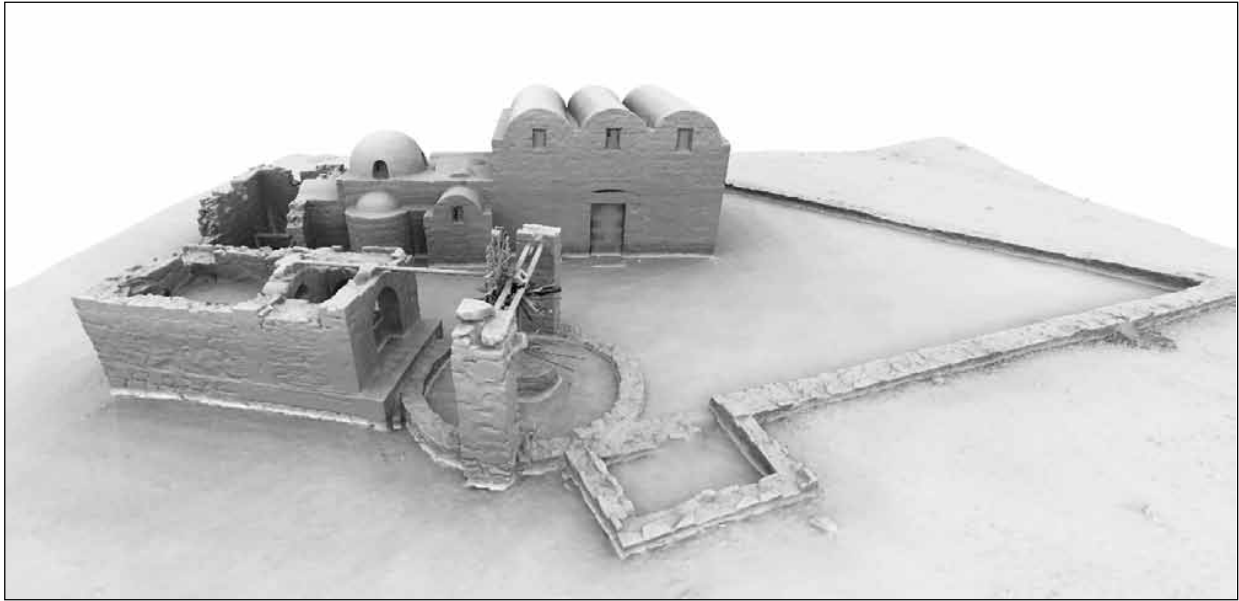
18. 3D model generated from a laser scan of the site (Department of Antiquities).

A 3D laser scan of the interior and exterior of the monument and its immediate surroundings was carried out by a Department of Antiquities team. The resulting digital model was elaborated by Departmental experts and by the Zamani project at the University of Cape Town. Orthorectified photographic documentation of the internal and external elevations and a 3D didactic model were produced¹¹. These are being used to assist with the documentation of the building, the preparation of a database of images of the site and for presentation purposes (Fig. 18).
