CHANGING CITYSCAPES IN CENTRAL JARASH – BETWEEN LATE ANTIQUITY AND THE ABBASID PERIOD

Louise Blanke, Patrick Dan Lorien and Rune Rattenborg

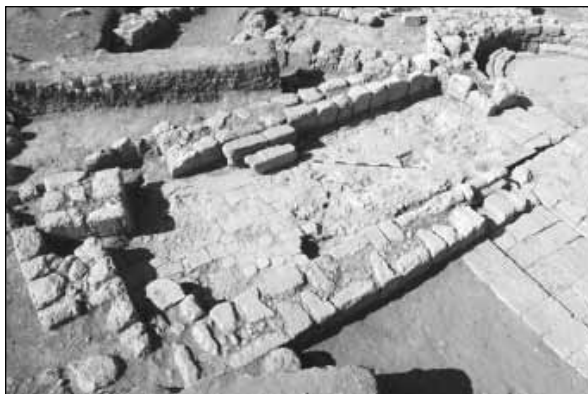
3. Entrance hall to Central Baths with remains of staircase in the western part of the room and doorways to latrine and bathhouse proper in eastern end (by IJP).

Excavations in 2008 and 2009 were successful in locating an entrance hallway giving access to the bathhouse and an adjacent latrine (Figs. 3, 5). Measuring 7.10 EW by 2.80 NS the hallway was accessed by way of two steps leading down from the street level. The entryway was accessed from a laneway of stamped earth, seemingly running south from the *decumanus* to the baths. A sondage dug into the street surface revealed a corpus of Roman period ceramic material dating solely up to the third century. This context has provided a rough *terminus post quem* for the layout of the street, somewhat corresponding to the 3rd century date proposed for the construction of the Central Baths (Blanke *et al.* 2007).

A single preserved stone along with a line of plaster in the western end of the room has been interpreted as remains of a bench that spanned the entire west wall (Fig. 3). The eastern end of the room contains the remains of two entry points, one leading south to the bathhouse proper and one providing access to a semicircular communal latrine. Remains of a door post by the latrine and a threshold in the bathhouse entrance demonstrates that both areas could be closed off independently of the other. This architectural arrangement would have enabled the visitor to use the latrine without paying a potential fee to access the bathhouse. Concurrently, the entryway was organised so that it was not possible to peek into neither the latrine nor the changing room from the access giving laneway.

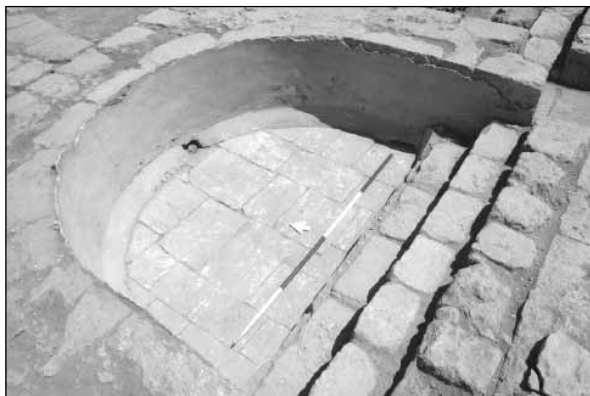
4. Western semicircular basin flanking north side of frigidarium (by IJP).

allowed water to spill into the bath's east-west running sewer. These features inspired the interpretation that the rectangular room was, in fact, the remains of the bathhouse *piscine* (Barnes et al. 2006: 300-305). The archaeological data retrieved in 2008 firmly established a different scenario as two semicircular basins were uncovered immediately north of the presumed *piscine*. (Figs. 2 and 4)

The western basin measured 2.60 NS by 2.60 EW and 0.87 metre in depth. The bottom of the basin consisted of large stone pavers and the sides were protected from water with a pink *opus signinum* (Fig. 4). A lead drain was excavated in the northern end of the basin, leading waste water into a sewer running below the adjacent latrine. The drain was uncovered with a plug still in situ. Three steps, also functioning as benches, gave access to the basin from the south, allowing an estimate of four persons to comfortably use the basin at the same time.

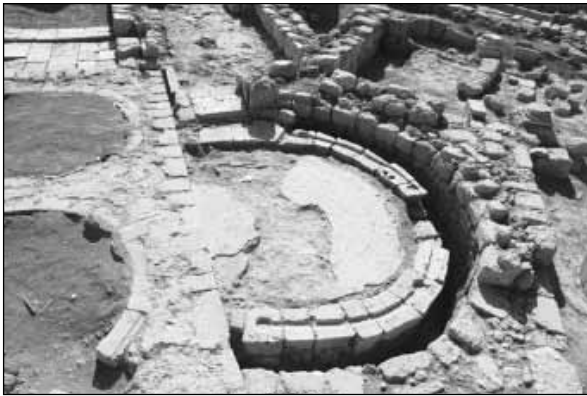
5. Remains of semicircular latrine. Note ledge for insertion of seating (by IJP).

The latrine was identified through the combination of a sewer spanning the northern edge of the room along with a ledge in the stone wall for the insertion of seating (Fig. 5). Measurements of the room are 5.10 EW by 4.05 NS with a 0.38 metre wide sewer, which reaches a depth from 1.48 metre in the southeast end to 1.55 metre in the southwest end. A small channel, currently interpreted for the purpose of hygienic cleaning

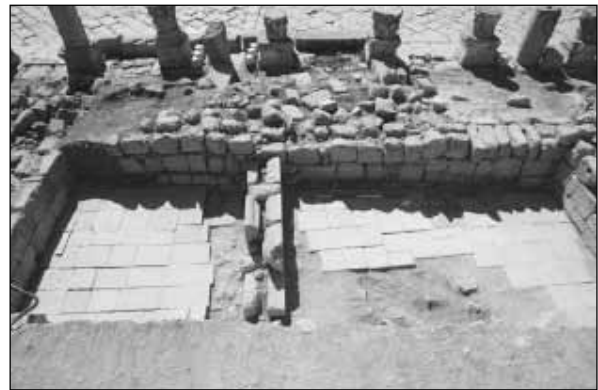
7. Overview of EA southern paved rooms C (by IJP).

To date, two distinct rooms have been uncovered within Building A. Each room displays an evenly well-constructed paved floor (**Fig. 7**). However, the pavement of the rooms varies in layout and size and it can therefore be suggested that either their construction is not contemporary or that *spolia* of different origin is responsible for the mixed result. The northern room corresponds to the two paved floors **B**, and the southern to the two paved floors **C**, as visible in Figure 9.

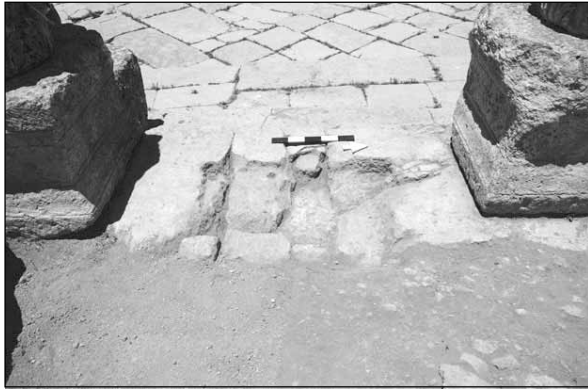
8. Doorsill in area EA giving access from the *cardo* to shop D (by IJP).

Cut into the *cardo's stylobate* several door holes, probably corresponding to the placement of each expected shop, have been found (**Fig. 8**).

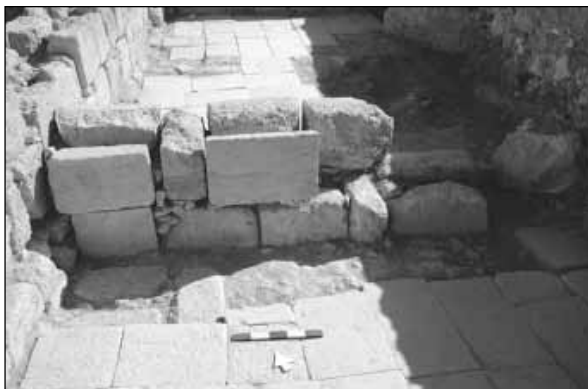
9. Detail of wall 5 in area EA (by IJP).

1. The paved floor in room 3 and 4 was partially removed, in order to create a foundation trench for Wall 5 (Fig. 9). Several of these pavers were incorporated in Wall 5 itself. This is easily visible because of the thickness of the pavers (0.30-0.40 metre), as well as they possessing one side that has been worn smooth, and having been cut to fit each other. Also Wall 4 has been constructed by breaking

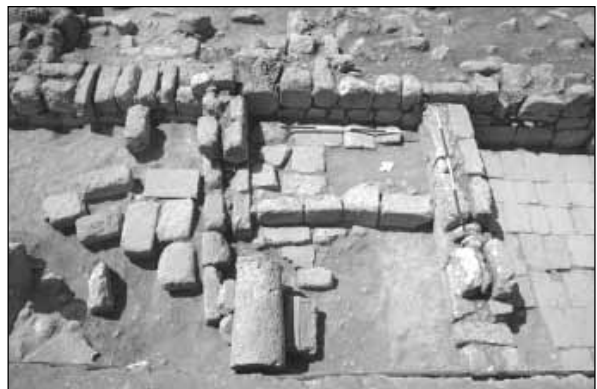
10. Overview of phase 4 platforms in area EA (by IJP).

Reuse of Building A is documented within two adjacent areas. The first area could be the remnant of production activity, as it consisted of a stone platform, centred on a hearth (Fig. 10). The platform was roughly 2 by 2 metres, and was built with large uniform rectangular stones. In the soil around the platform a high proportion of glass sherds were found, along with minor pieces of charcoal.

The second area, on level with the first, consisted of another stone platform. The stones used in this platform were of varied size and thickness, but also here, the platform itself measured 2 by 2 metres. The platform was set on a foundation layer of rough stones and clayey sand, which continued for about 0.20-0.30 metre. A similar layer might be found underneath the first platform. The soil above both platforms has been severely disturbed by modern activity, and as such it has been difficult to conclude any-

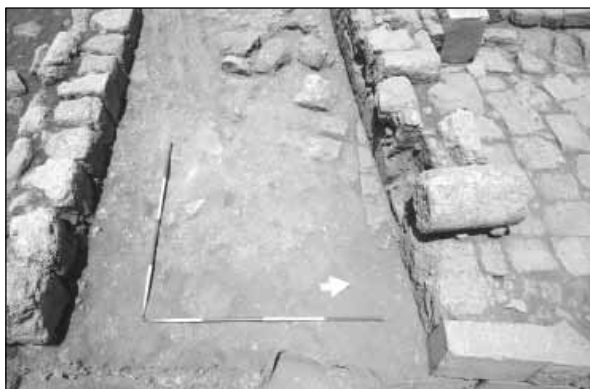
12. The laneway junction at the southeastern corner of the GO/4-structure seen from the east. Note the top course of the earlier phase 4 wall protruding from below the phase 3 structure (by IJP).

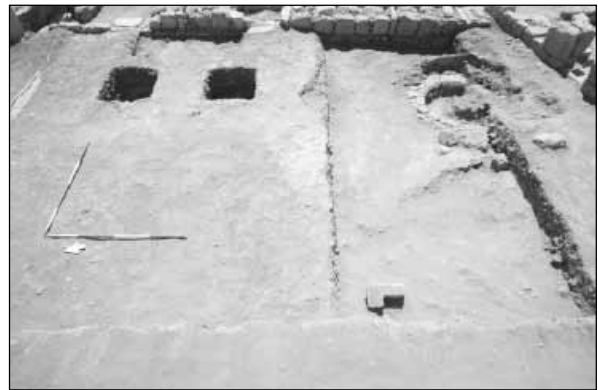
13. GO/5 at the end of the 2009 season, seen from the west, with the two sondages (top left) and the phase 2 pit (top right) next to the kiln excavated in 2007 (by IJP).

copper coins, and occasional pieces of shell and beads. The sondage sections indicate the deposit to have been compiled by a series of well-defined interchanging strata of yellow clay and ashy layers with a very high density of ceramic material. As indicated by the trench in southern GO/5, the extremities of the deposit were later covered by a substantial brownish clay layer in the process of levelling the courtyard following the demise of the phase 4 structures (**Fig. 13**).

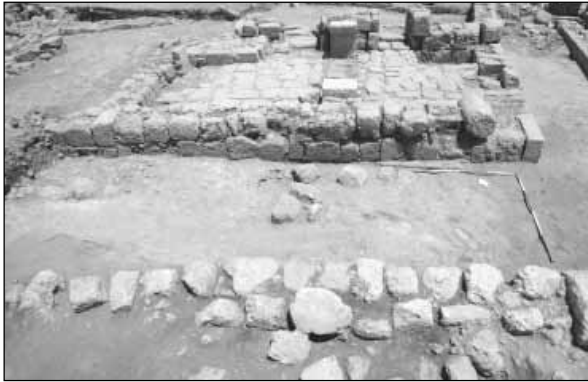
14. Overview of the western laneway and the phase 3 housing from the south (by IJP).

The phase 3 complex (**Fig. 14**) comprises a rectangular building exposed in GO/4 and adjoining courtyard spaces to the west and north, forming one structural unit covering an area roughly 25 by 15 metres in extent (**Fig. 11**). The building, measuring 9 by 5 metres, is located at the northwestern corner of the laneway junc-

platform approximately 1.8 by 1.3 metres in extent and raised some 0.40 metre above the floor level (**Fig. 14**), the surface partly covered with flat rounded stones of which some had clearly been exposed to fire. Though no substantial ash deposits or charcoal remains were found in relation to this feature, the outline may suggest a possible hearth.

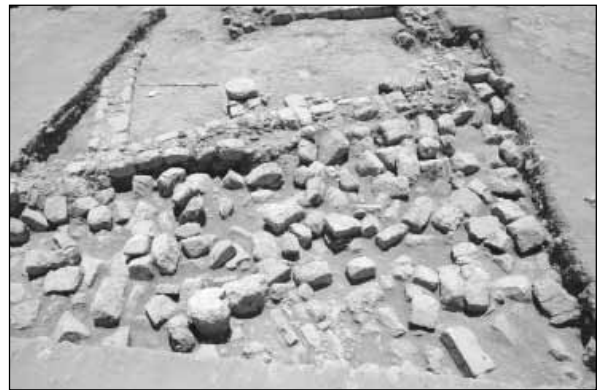
15. GO/6 at the end of the 2009 season, seen from the west. Note the cistern drain in the bottom of the picture (by IJP).

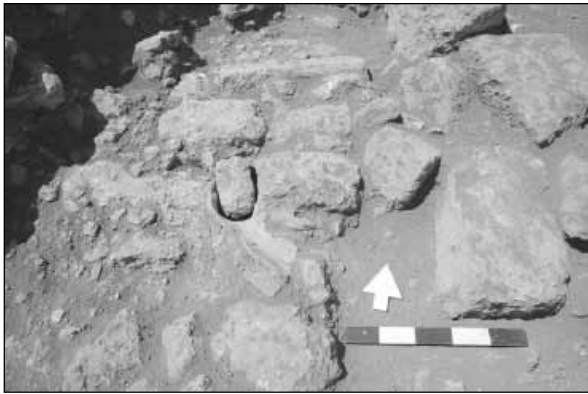
16. Close-up of the cistern drain with plug in situ (by IJP).

No architectural features within the rectangular GO/6 structure were identified, and excavation only encountered a thick and fairly uniform layer of building stones, stemming either from collapse or used as fill. Below this layer, the upper arch of a presumed cistern, with a plastered drain hole for allowing water to run into the cistern still intact (**Fig. 16**), was partially exposed towards the very end of the 2009 season. The drain hole was plugged with a single stone, placed in such a way that it seemed unlikely to have fallen there by accident, and initial measurements upon removing the stone suggested the cistern to be approximately 3 metres deep.

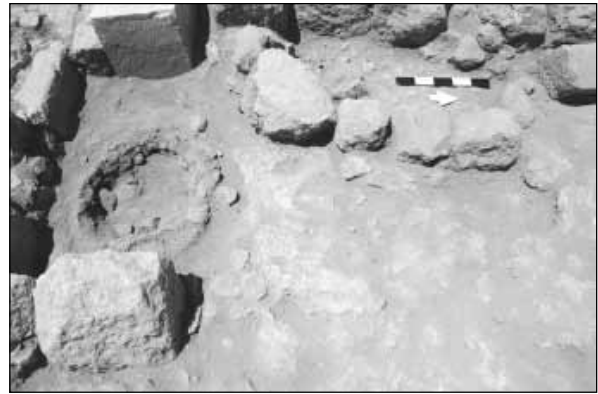
17. Remains of phase 2 occupation in GO/4, seen from the east. With oven outline (left) and stone bin (right) (by IJP).
