# SIQ AL-MUDHLIM STUDY SURVEY, 2002

*Petra National Trust*

## **Introduction**

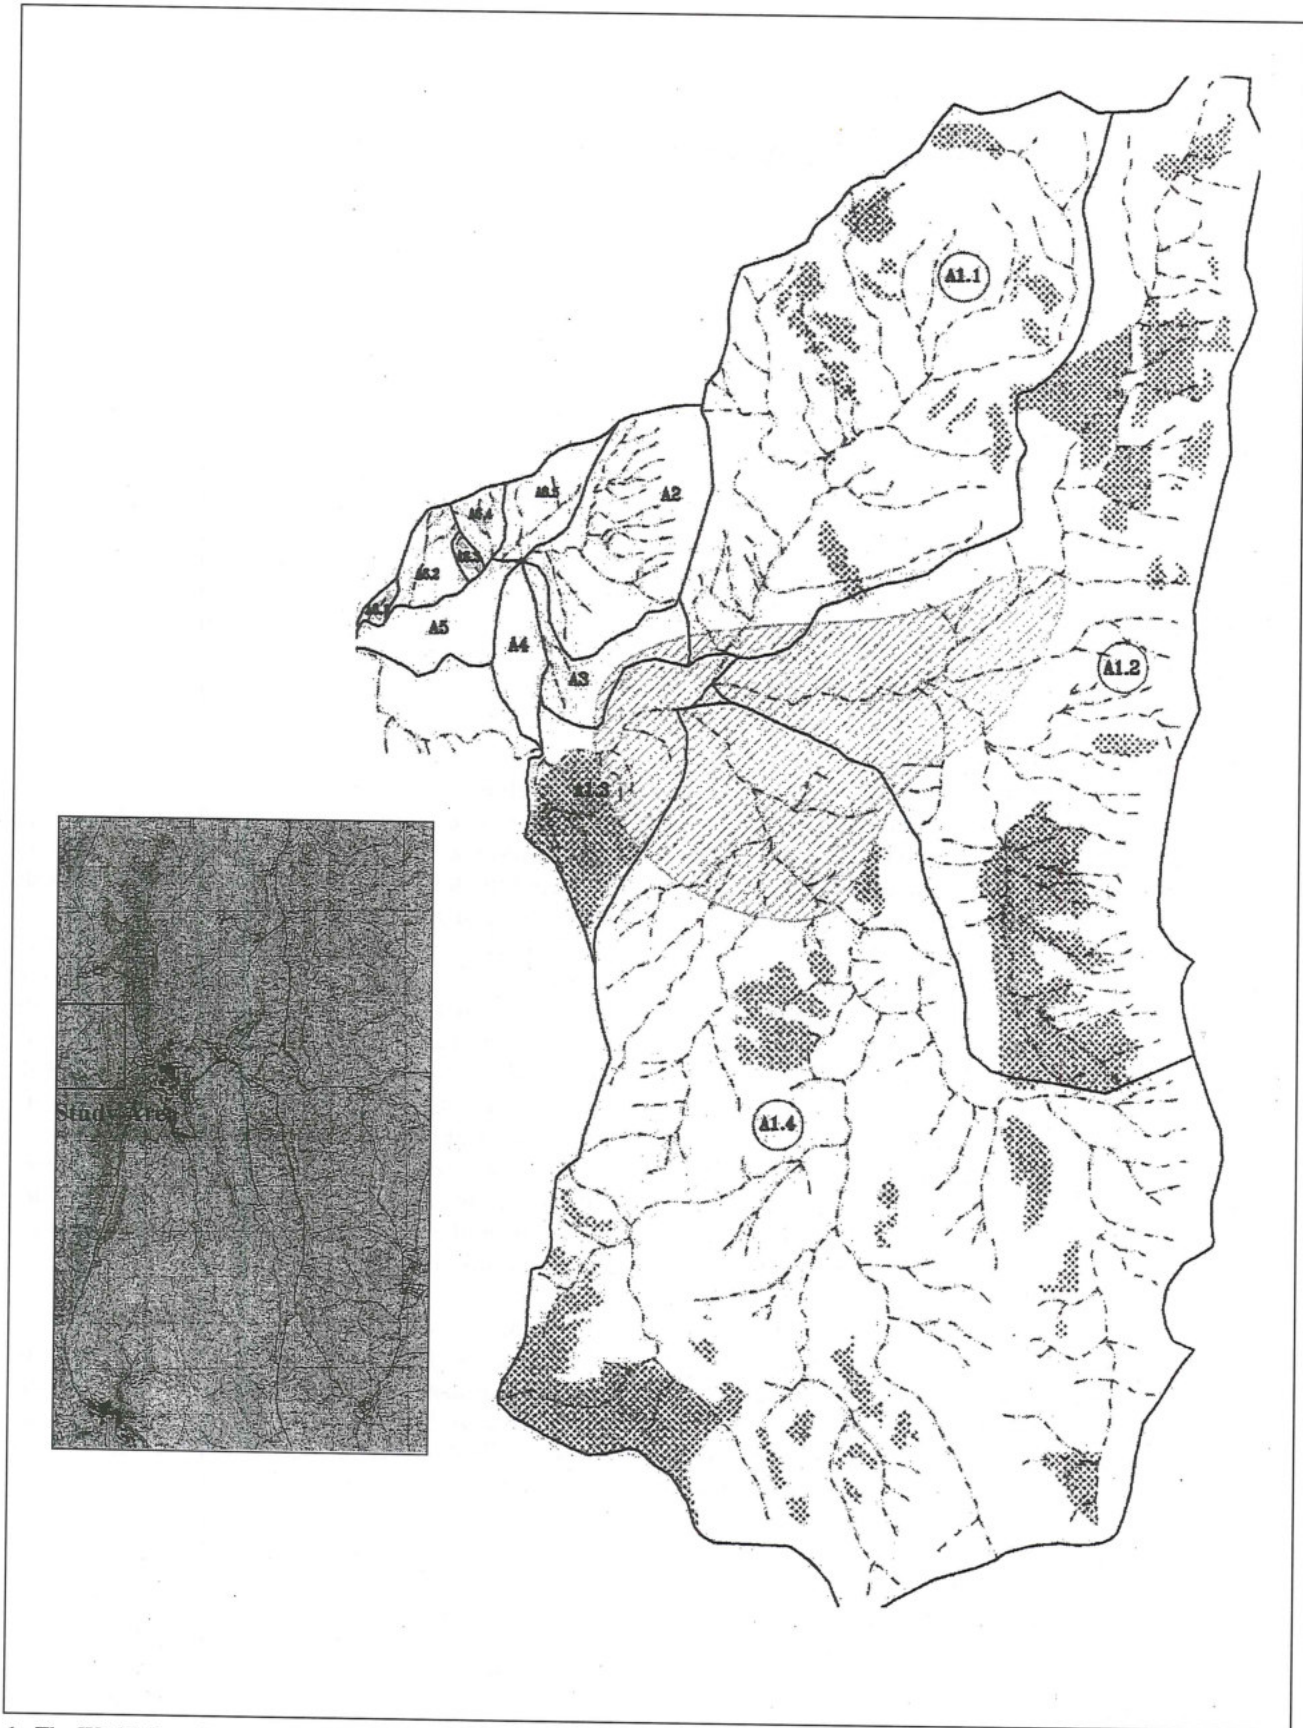
1. The Wādi Mūsā Catchment Area at Petra with the whole study area inset.

In 2002 Petra National Trust (PNT) carried out a study in Petra in co-ordination with the Department of Antiquities of Jordan (DoA) and a specialist team of consultants in the private sector, Middle East Engineering Management (MeeM). The study assessed the impact of flash floods and the possibilities for flood protection of the Wādi Mūsā along its diversion into the Wādi al-Mudhlim and Wādi al-Maṭāḥa. The Wādi Mūsā catchment area extends east of Petra to both the north and south (**Fig. 1**).

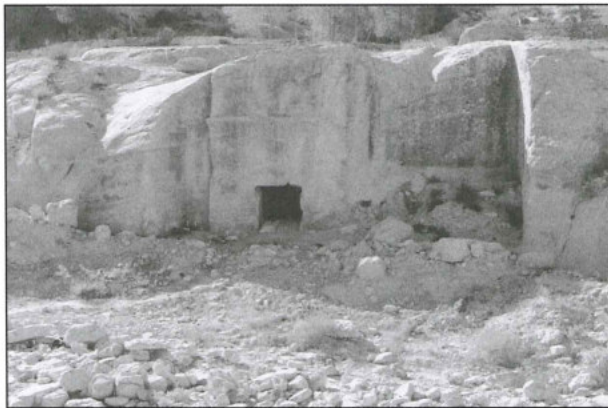
3. Partially buried tomb façade in the southern bank of sector MS 2, with an extended forecourt cut into the cliff.

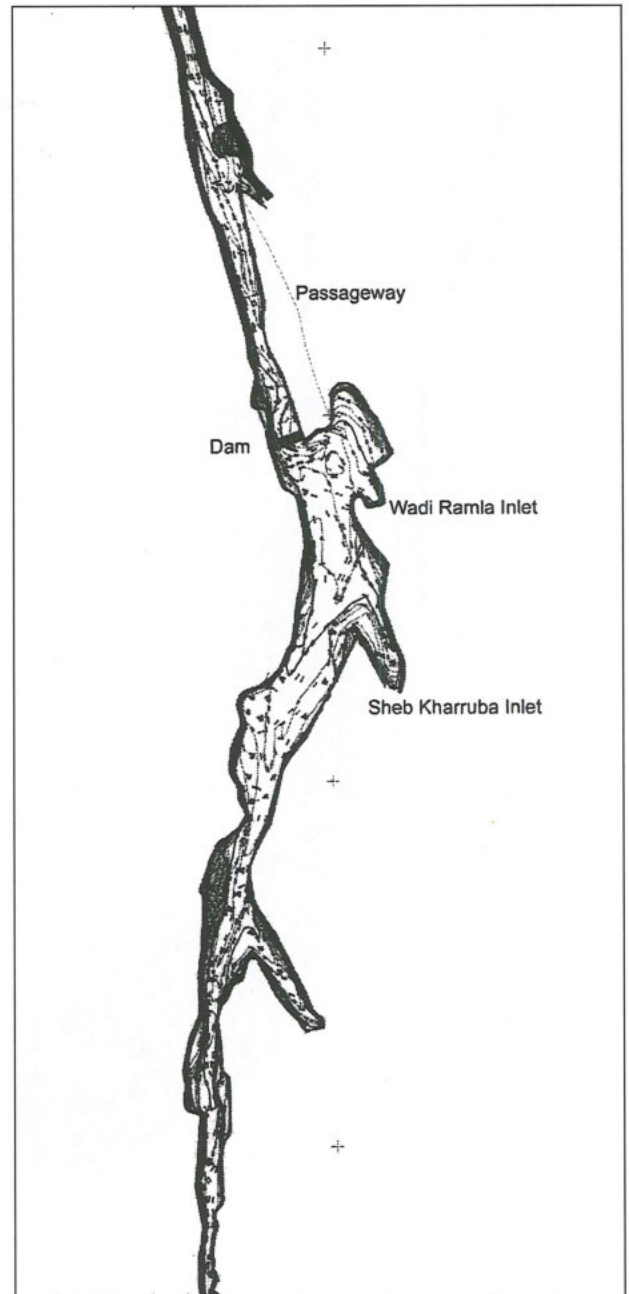
10. Plan of sector 5 showing the location of the dam and the passageway downstream of the inlets of *Sadd al-Kharrūba* and *Wādī ar-Ramla*.

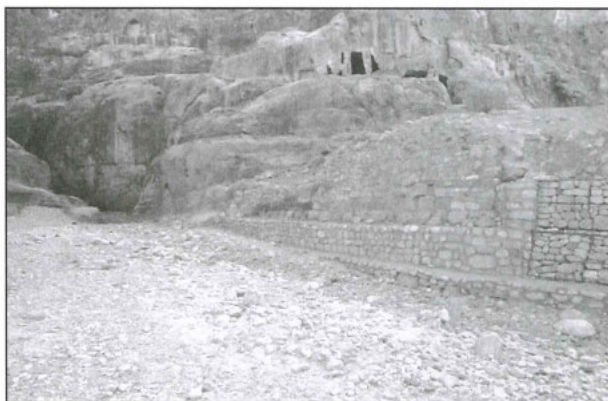
14. The retention wall reinforcing the southern bank of Wādī al-Maṭāḥa at the outlet of Sadd al Ma'jan. The original masonry is visible on top of the restored foundation.

As mentioned above, the entire unstable southern bank of sectors 10 and 11 was fortified by a retention wall in ashlar masonry, of which long sections are still visible and others must be well preserved below the covering debris. In front of this wall the ruins of a cistern were found just upstream of the inlet of Wādī Umm Ṣayḥūn (وادي ام صيحون) (Fig. 16). The cistern is oriented parallel to the reinforcing wall and is 4.8m long and 2.6m deep. At its south-east corner the remains of a cylindrical feeding shaft are preserved. The interior surfaces of the cistern and the shaft still show the original hydraulic plaster. The bottom of the cistern is not exposed, but its level is most probably

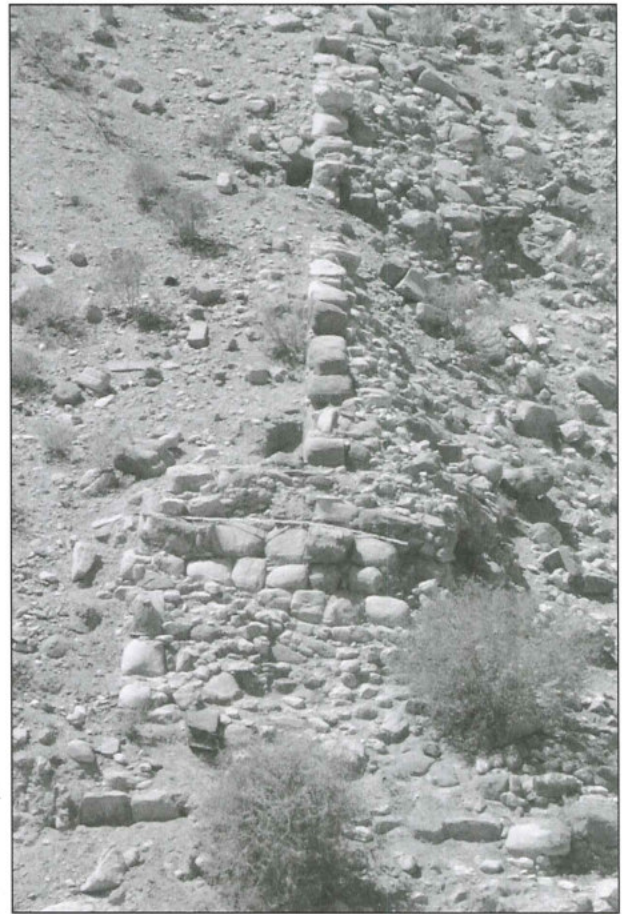
15. The dam below Mughur an-Naṣāra, view from the wadi bed towards the north. At the bottom, the full thickness of the dam, exceeding 6m, is visible. The narrow stone line above is part of the water channel which crossed Wādī al-Maṭāḥa on top of the dam.

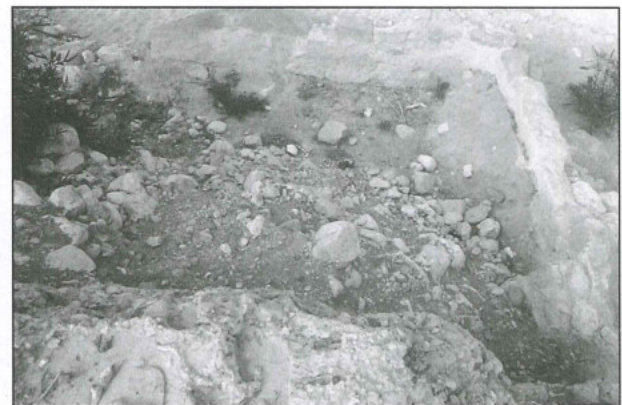
16. The ruins of the cistern opposite the inlet of Wādī Umm Ṣayḥūn. At the bottom right the cylindrical inlet shaft is visible.

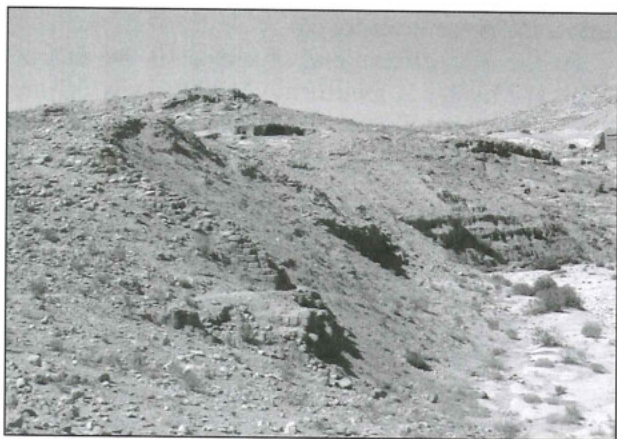
17. The remains of the two dams at both ends of the lentiform section of Wādī al-Maṭāḥa at the downstream end of sector 10, view upstream.

At the downstream end of sector 10, the bed of Wādī al-Maṭāḥa is lentiform. At both ends of this area, abutments of dams emerge from the debris of the northern bank (Fig. 17). There is an extensive

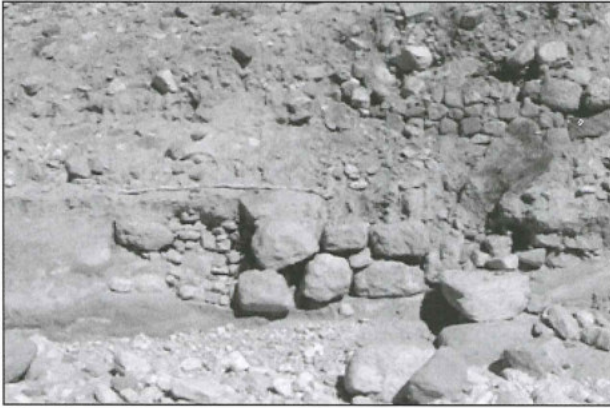
20. The northern abutment of the lowest dam in Wādī al-Maṭāḥa, which prevented runoff water from damaging the northern Nymphaeum. These fragments are now no longer visible, as they have been hidden behind a protecting wall built by the DoA in the summer of 2002.

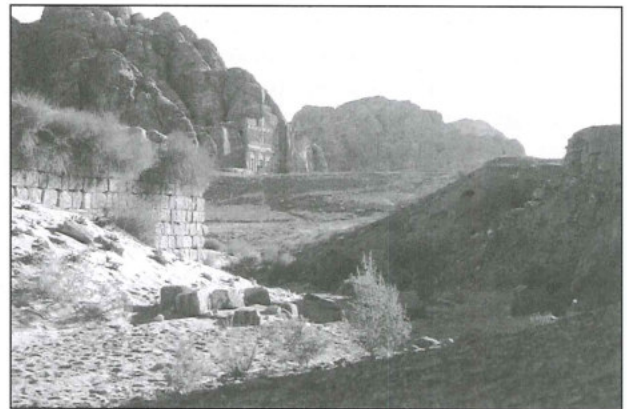
22. The dam structure at the outlet of the canalized section of Wādī Umm Ṣayḥūn, view from upstream in the direction of Wādī al-Maṭāḥa and the Palace Tomb. The rectangular building was erected on the left section of the dam structure.

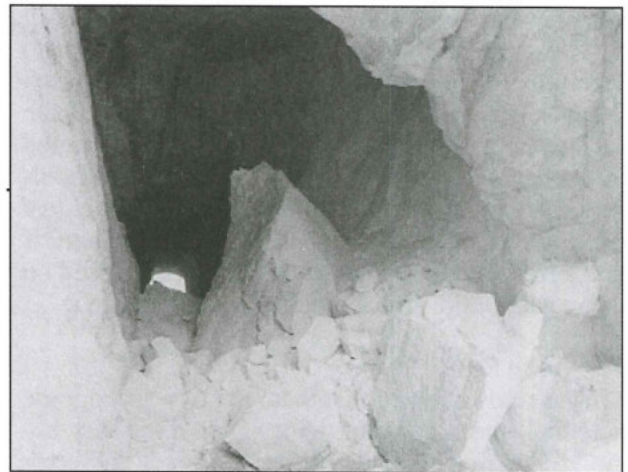
24. Tunnel entrance before clearance of rock fall.

Flow through the tunnel was investigated in detail and revealed a very critical condition. The geological study showed a delicate situation regarding falling rocks from the tunnel ceiling (See below). Some blocks had fallen in December 2000 and it was essential to clear the tunnel bed to smooth flood flow through the tunnel and enhance its flow capacity by reducing the roughness coefficient. The roughness coefficient is inversely proportional to the flow capacity.

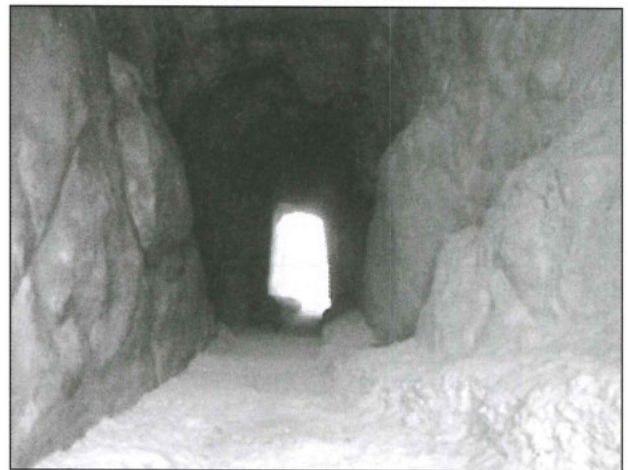
25. Tunnel entrance after clearance of rock fall.

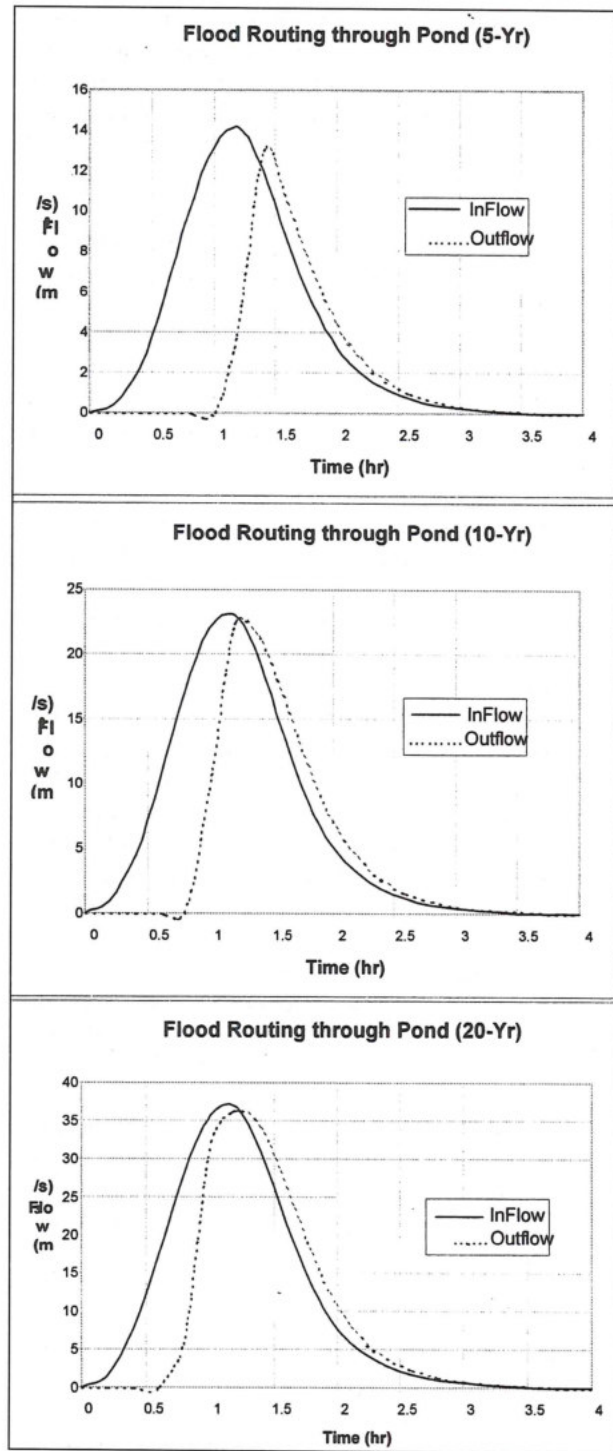
26. Flood flow through the basin.

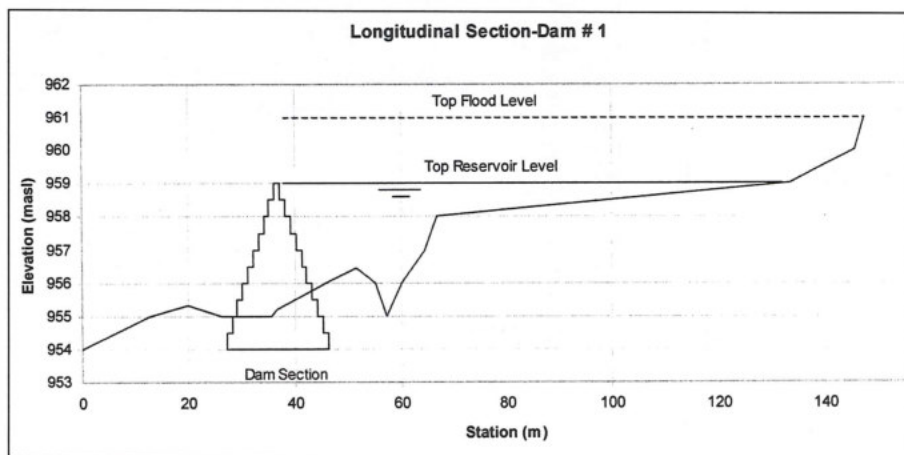
27. Longitudinal section of Dam 1.

The dams were designed to suit the archaeological site and to fit the geological conditions. The major constraint is the stability criteria, which makes a cascade section a reasonable option. A cascade section was thus designed, creating a stable structure on both upstream and downstream sides. The dam crest is 1m wide with 2 horizontal

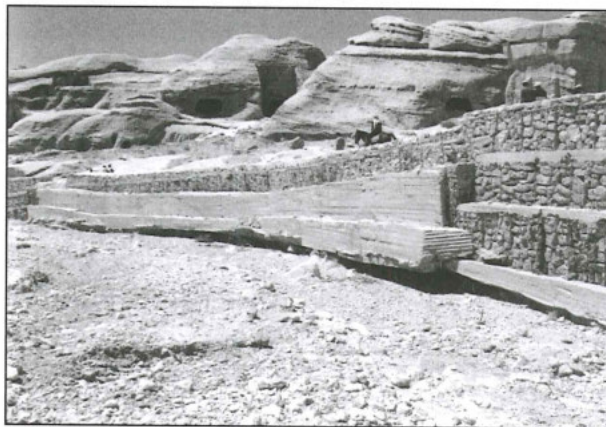
28. Erosion cavity below the foundations of the sidewalls of Wādi Mūsā, in the Bab as-Siq area.

- Continued earth removal from just downstream of the arched culvert near the Mövenpick Hotel will result in the downstream blocking of the existing culvert and damage to the tunnel along with many of the archaeological remains.
- Figure 28 shows significant erosion of the foundations of sidewalls, which could lead to a failure. This risk can be reduced dramatically if the present management plan is executed.
- Another example is the erosion of wall foundations and gabion failure along the wadi in different sectors.
- The sediments are another hazard along the wadi, which can act as an erosion machine driven by the flood flow.
- Future activities can easily be damaged if there is no flood management plan for Wādī al-Mudhlim.

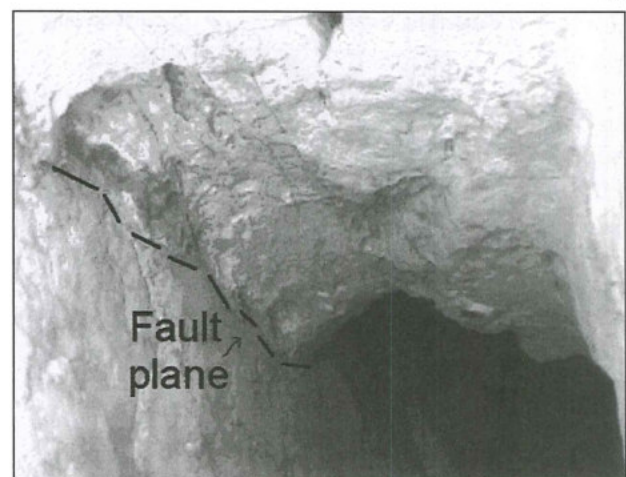
30. The Wādī al-Mudhlim fault plane.

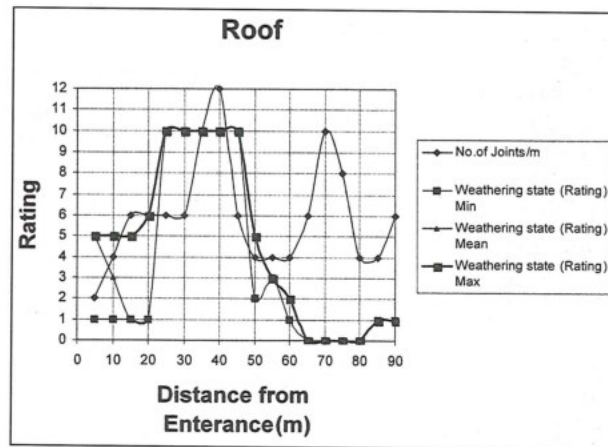
40. Risk rating of block fall in tunnel ceiling.

The conditions in the ceiling are more complicated and the risk is much higher than for the walls because of joint sets. The state of weathering of the joints is the main controlling factor, along with the number of intersecting joint sets. The ceil-
