THE 2003 FINNISH JABAL HĀRŪN PROJECT: PRELIMINARY REPORT

Jaakko Frösén, Zbigniew T. Fiema, Mika Lavento, Christina Danielli, Richard Holmgren, Jaakko Latikka, Anu Rajala, Erko Mikkola, Antti Lahelma, Maija Holappa and Kai Juntunen

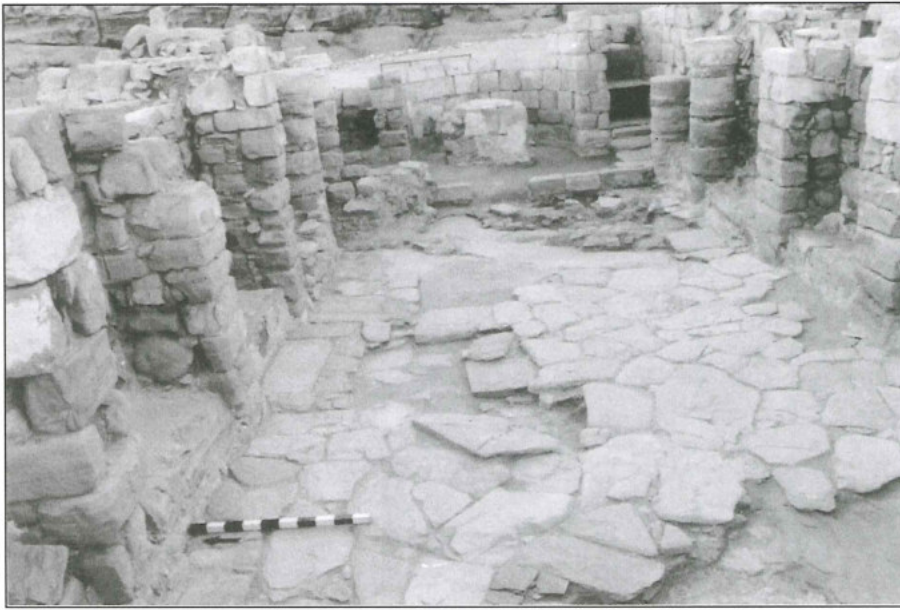
3. General view of the chapel, looking east; the masonry altar base is in the center inside the apse (photo by M. Mustonen).

Trench Y covers the central and NE parts of the chapel. The trench forms an L-shaped area between Trenches C and I, previously excavated. Perhaps the most interesting features of the chapel are the two cruciform baptismal fonts found inside it, and a masonry-built altar pedestal, half of which was already exposed in 1998. The first baptismal font, found in Trench I, was situated in the western end of the chapel. It was later replaced by the second font built in the area of the bema. The altar pedestal appears to have been built at the same time as the second baptismal font (**Fig. 3**).

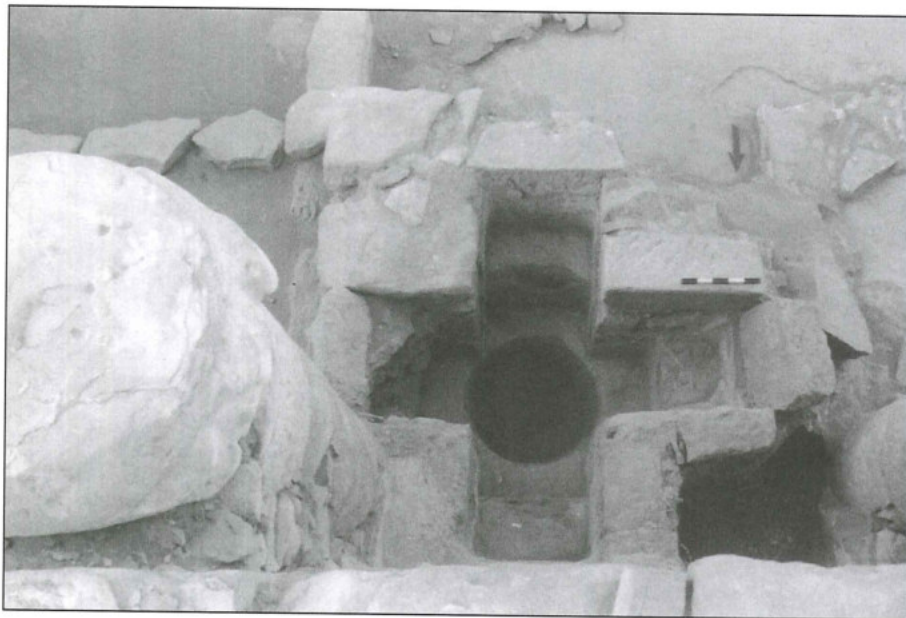
4. The cruciform baptismal font uncovered in the chapel in 2003 (photo by M. Mustonen)

This marks a clear change in the use of the chapel. Two significant, new features were added in the bema area: a cruciform baptismal font (locus 26) and a masonry-built altar pedestal (locus 7). The font, which is remarkably well built, has a round bottom with a water outlet, and two steps leading down from each cardinal point (Fig. 4). A small basin for water or oil is located in its north-western corner. The old baptismal font in the west-
