## THE 2000 FINNISH HĀRŪN PROJECT: PRELIMINARY REPORT

The Finnish Jabal Hārūn Project (FJHP) carried out its third fieldwork season between August 4 and September 21, 2000. The project is directed by Prof. Jaakko Frösén, University of Helsinki. The archaeological fieldwork was supervised by Dr. Zbigniew T. Fiema, University of Helsinki, with Dr. Mika Lavento, University of Helsinki, in charge of the survey part of the project. In total, five archaeologists, one architect, and 13 students from the University of Helsinki, and four professional cartographers from the Helsinki University of Technology (HUT), as well as one Swedish archaeologist and one Jordanian student have participated in the fieldwork. Dr. Christina Danielli, a senior conservator from Italy and two students from the Department of Conservation, Espoo-Vantaa Institute of Technology have also taken part. The DoA representative for the FJHP was Mr. Hani Falahat. Up to 20 local laborers were employed in the excavations and the survey. The project is sponsored by the University of Helsinki and by the Academy of Finland.

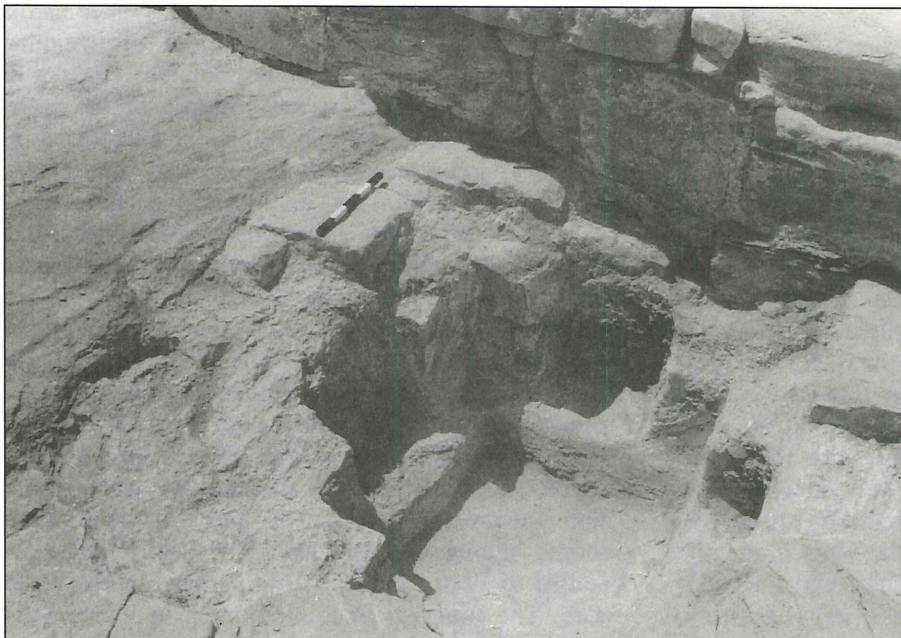
3. The baptismal font in Trench I (by M. Mustonen).

tain; it could have been situated farther west than the extant Wall OO. Inside the room, a roughly octagonal pit was chiseled out of the bedrock and the cruciform masonry-built baptismal font (locus 26) with masonry-built upper part was installed and further integrated with the bedrock with mortar (Fig. 3). The font is small in size: ca. 0.92m (N-S) x 0.89m (E-W) at the opening, and no more than 0.6m deep. It is possible that the fragments of the painted plaster with floral decorations and Greek inscriptions, recovered from loci 08, 10, 12, 16, were originally associated with this installation. For example, the stone 1I.10/13, plastered on the front and side faces, may have originally been a

as well, and the baptismal font was abandoned and backfilled with the mixture of sand — with pottery and bones — and stones. The extant western wall was probably built partially on the remains of the baptistery, and abutting the early plaster of Wall GG, which is visible in the sounding made through the bench (locus 19). The interior of Wall OO was filled with the debris of an earlier wall and/or the baptistery, which contained pottery, mortar, bone, glass and painted plaster. This material spilled over when the wall finally collapsed, mixing with natural deposits and forming matrix loci 02, 08, 10, 12, 15 and 16, which contained mainly fifth-sixth century pottery. On the northern and western sides of the exterior, a retaining wall/buttress was added to support the walls. The pilasters (loci 06, 07, 09, 11) were built in this phase at the latest, and before the final wall plaster was applied. The pilasters supported arch springers for N-S arches. Also, benches 20 and 22 were probably built in this phase, definitely after the pilasters. There were two layers of plaster on bench locus 20, and the outer plaster lips out onto the foundations of the floor (*infra*). Benches 19 and 24 were built abutting Walls OO and GG, probably somewhat later than benches 20 and 22, since they do not feature plaster. The step (locus 21) north of the doorway could have been built in this phase but before the benches. The foundation layer (locus 18) for the floor was laid out to even up the bedrock and to cover the remains of the baptismal font. The flagstones of the foundation layer appear too unstable to serve as an actual floor; the latter must have been completely removed at some point.

Another significant find was the baptismal font associated with the earliest phase of occupation inside the chapel. The font belongs to the cruciform type which is usually masonry-built and generally earlier in date than the monolithic fonts (Ben-Pechat 1989: 173-174; 1990: 510; Piccirillo 1985: 355). A close parallel is the large canopied cruciform font found in the baptistery of the Petra church (Fiema, *forth.*). Although cruciform fonts are unknown in Jordan in the area north of Mādaba-Mt. Nebo, these were popular in southern
