# PRELIMINARY REPORT ON THE FOURTH SEASON OF THE DANISH-GERMAN JERASH NORTHWEST QUARTER PROJECT 2014

*Georg Kalaitzoglou, Achim Lichtenberger, Rubina Raja*

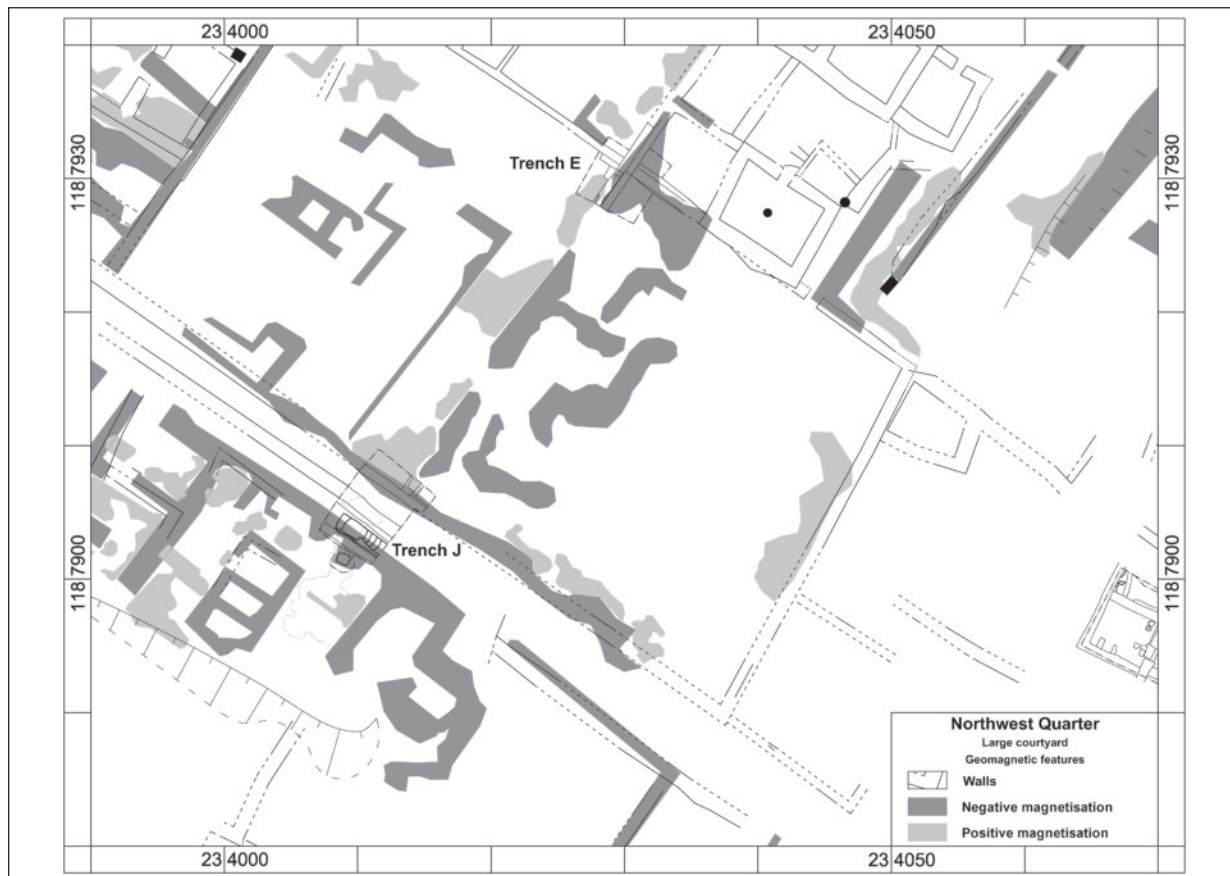
5. NW-Quarter Courtyard magnetic.

Trench J<sup>30</sup> was opened on the southern side of the large courtyard, on top of the hill and opposite the 2013 Trench E (Fig. 1 and Fig. 5). This courtyard is a large plateau which stretches from the so-called Ionic building to the east.

The main reasons for opening the trench were to explore the long east west running walls and the room-like structures detected in the geomagnetic survey, as well as to find the probable continuation of the north-south running clay water pipe found in Trench E in 2013 (Fig. 5)<sup>31</sup>.
