PRELIMINARY REPORT ON THE 2014 AND 2016 EXCAVATIONS REVEALING PROCESSIONAL WAYS IN THE ABILA AREA E PILGRIMAGE COMPLEX

Robert W. Smith

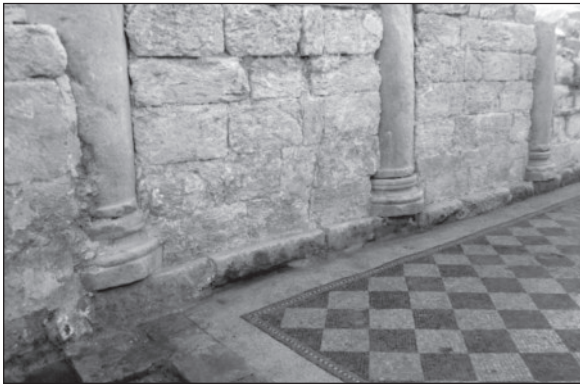
4. Wall D, built on the stylobate, with ashlars filling the inter-columnal spaces and the mosaic flooring of Passage C in Square E108. (Photo: the author, 2014).

Wall A of the processional passage continues to the north in Square E98. On the west side of the passage, just past the previously mentioned projection, a c.1.3 meter wide doorway punctures the wall. The ritual spaces exposed in units E88 and E87 which lie to the west will be the subject of a later report. Subsequently, Wall A proceeds c. 1.5 meters northward from the threshold, until it encounters a west-east wall line, which is subsequently identified here as “Wall D.” On the east side of Square E98, from the northern exterior wall of the Pilgrimage Church (Wall C) to a point three meters to the north, there is an opening with no obstructing wall until the previously mentioned west-east Wall D is encountered. Wall D is comprised of six uniform courses of limestone ashlar, custom-fitted to fill the gaps between standing limestone columns set at c. 2-meter intervals. The column drums have a torus at the bottom, and rest on bases which have an octagonal plinth surmounted sequentially by a torus, fillet, scotia and a double torus. Wall D stands c. 2 meters in height, and continues east into Squares E108 and E118. Wall D rises from a founding course of hard hematitic limestone. The octagonal bases of the limestone columns also stand on this course of stones, which is the lowest exposed course, and appears to be the stylobate of a previously existing colonnade. The gap between the northern exterior side wall of the five-aisled pilgrimage church (Wall C), and the parallel Wall D formed of ashlar filling inter-columnal spaces, creates a c. 3 meter wide passageway extending to the east which is exposed in the southern half of Squares E108 and E118 (**Fig. 4**).

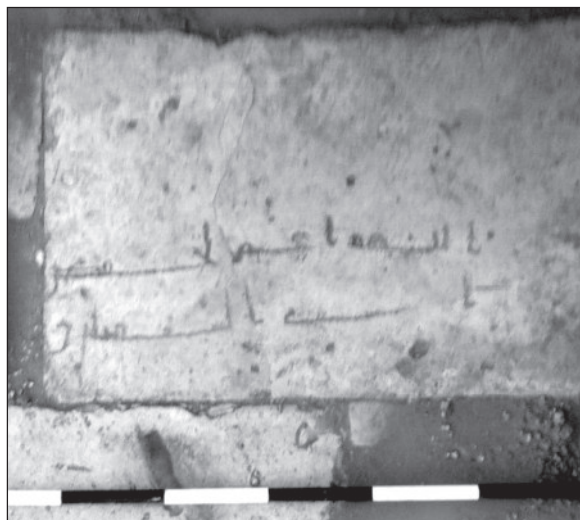
6. Kufic prayer inscription found in Passage A, Square E97. (Photo: the author, 2016).

In Square E97 in Passageway Section A, the fill contained some body sherds from Byzantine and Umayyad forms, but none that were whole or possible to reconstruct. They also included random body sherds which had been embedded in the plaster finishing of Wall A. As mentioned above, no ritual objects were left *in situ* on the floor of the passage by the salvagers who removed the marble opus sectile. The most significant find in this passage is the two-line kufic inscription which is deeply scratched into a c. 80 centimeter by 40 centimeter hard, hematitic limestone paver in the flooring (Fig. 6). Using a well-known prayer formula, the writer calls upon "Allah" for forgiveness in Arabic. The inscription is located near Wall

A and never endured significant heavy foot traffic. The orthography is somewhat informal, but the edges of the inscription are very sharp. This suggests that the Arabic-speaking person who made the inscription did so in the mid-eighth century, close to the time of the severe earthquake. At least five other kufic inscriptions, which are similar in orthography and content to that found in Square E97, were discovered in the Pilgrimage Complex. A full discussion of all these inscriptions should be available soon, when the inscriptions from Area E are published (Smith, Zerbini and Firas, forthcoming).

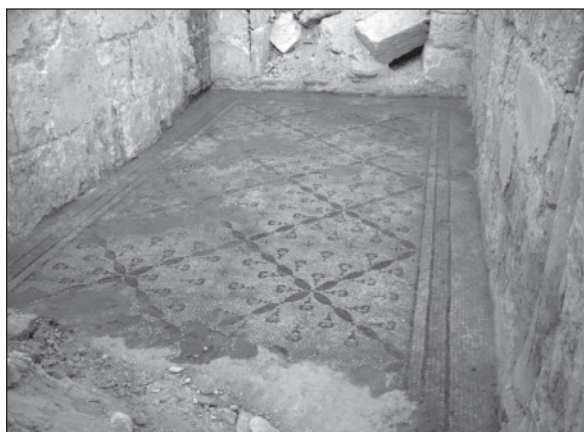
7. Carpet mosaic in Passage D, between Walls D and E, in Square E108. Looking east towards the threshold into Passage E. (Photo: the author, 2016).

A carpet mosaic also covers the floor of Passage D. The generally c. 2.3 meter-wide mosaic between Walls D and E is currently exposed for a distance of 7.5 meters from Square 98 and across Square E108. The western section of the floor in Square E98 currently remains unexcavated, since it is covered by fallen ashlar which support a compromised section of Wall D. An exterior band of light medium size tesserae forms the outer frame of the mosaic. The two inner frames have a combined width of c. 14 centimeters. The central field is comprised of a repeated pattern of c. 88 centimeter wide squares. Each square is divided diagonally from opposing corners with eight black lozenges, creating quadrants of right-angle triangles. Within each quadrant are six red flowers, which radiate from the center towards four small crosses on the hypotenuse. This repeated pattern thus creates many crosses (Fig. 7). This pattern was widely employed in Byzantine ecclesiastical construction in the Levant; it appears in the Pella Cathedral and

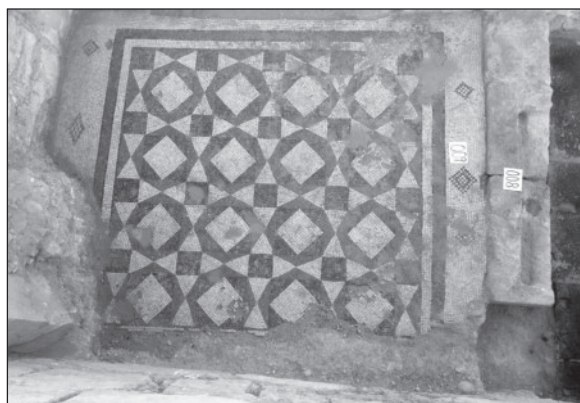
8. Looking down from Wall F to the faux opus sectile mosaic floor at the south end of Passage E in Square E 118, and the limestone and basalt steps in Square E119. (Photo: the author, 2016).

Two carpet mosaics cover the two sections of the floor in Passage E. The first section of the passage lies in the northwestern corner of Square E118; the mosaic here is well preserved on the west side, and extends intact for c. 2 meters until it approaches Wall F. The edge of the mosaic flooring along the base of reconstructed Wall F was unrepaired at the time of the severe AD 749 earthquake. The mosaic in Square 118 consists of a c. 2 meter square field, which is surrounded by white tesserae (Munsell 2.5Y 8/1) and has two inner frames of white and dark red (Munsell 2.5 YR 3/6) tesserae outlined in black (Munsell 10 YR 2/1). The inner field is comprised of the same colors of dark red limestone, white limestone and black basalt tesserae, arranged in a regular pattern of triangles and squares, which create sixteen eight-pointed stars. On the north and south sides of the field, where the outer white framing is wider, four small designs are extant (Fig. 8). On the north side of the first section of mosaic in Passage E, as pilgrims moved northward they crossed a limestone threshold which had once supported a doorway. They then descended onto

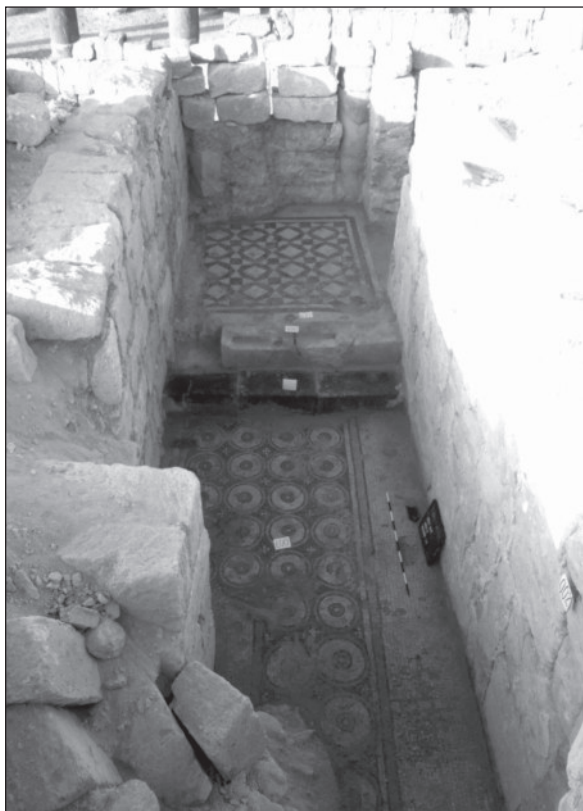
9. The mosaic flooring between Wall F and Wall G in Squares E119 and E118, looking south down Passage E. (Photo: the author, 2016).

The carpet mosaic in Square E119, in the northern extension of Passage E, was in place prior to the installation of the southern mosaic in the passage. That the northern mosaic is earlier is evidenced by the fact that it continues under the basalt steps. The northern mosaic, like that in the south, is preserved intact along the west side against Wall G, but breaks off along the eastern Wall F (Fig. 9). It has a broad, white outer frame on the west side, and inner frames of red and white outlined in black. The inner field has a black background with four rows of superimposed circles. The 34-centimeter diameter circles are comprised of concentric rings of red, black, white, black, red, black and white tesserae. White crosses punctuate the black background between the circles (Fig. 10). This mosaic narrowed at a point 2 meters north of the basalt step, where a pilaster projects into the passage from Wall F. Fallen masonry obscures the northern end of Square E119,
