JARASH: MINIMAL PRESERVATION INTERVENTIONS IN THE EASTERN SECTOR OF THE SANCTUARY OF ARTEMIS, 2009 - 2010

Roberto Parapetti

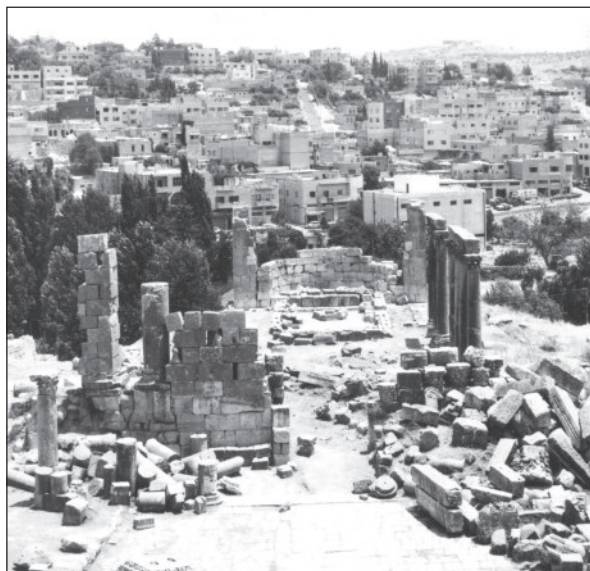
1. West wall of the Propylaea Church in 1977, from the west.

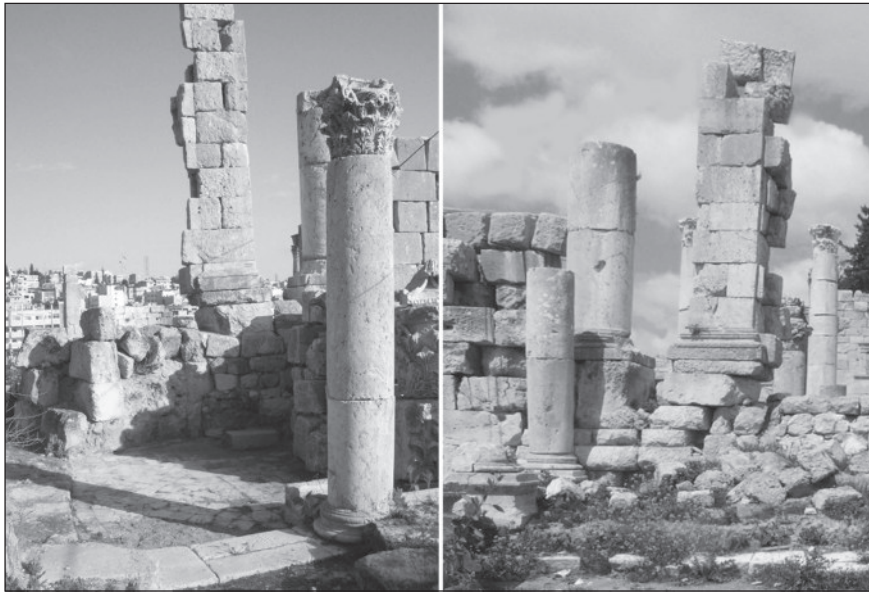
Of greatest concern was the dangerous lean of the pillar *in antis*, which originally belonged to the north-east edge of the trapezoid court of the Roman Sanctuary of Artemis and was incorporated into the west wall of the church in the Byzantine period.

Whatever was responsible for the lean of the pillar, the situation was made worse by severe deterioration and reduction of the load-bearing capacity of the ashlar at the pillar base (Figs. 1-3).

2-3. North-west pillar in antis of the trapezoid court of the Sanctuary of Artemis, from the west and east before preservation intervention.

At this point, the following work was undertaken to ensure the pillar's preservation, as it was considered significant visible evidence of the presence of the *via sacra* approaching the Sanctuary of Artemis (Parapetti 1983-84):

- (1) Removal of the tumble and archaeological excavation of the deposits below it down to the flagstone pavement of the church, on which a *tannūr* was found (Brizzi 2010: fig. 4). This confirmed the hypothesis that the structure had ceased to function as a church some time before the earthquake of 749, which caused destruction throughout the city.
- (2) Construction of scaffolding and removal of the 24 blocks in 12 rows that make up

(3) Replacement of the deteriorated ashlars on which the plinth was originally laid with new ones on both eastern and western sides, and consolidation of the blocking that sealed the entrance to the church nave.

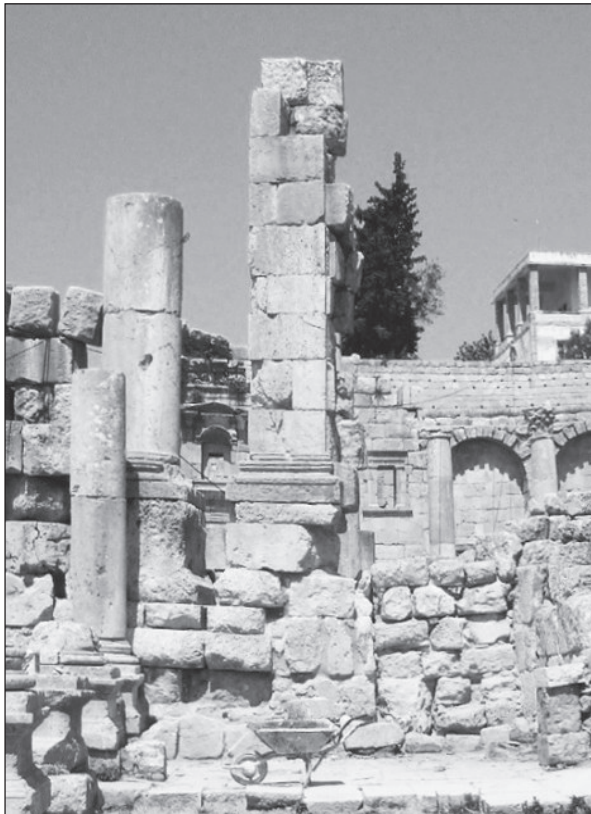
4. North-west pillar in antis of the trapezoid court of the Sanctuary of Artemis, from the east after preservation intervention.

- (4) Repositioning the blocks in their original upright position, without any binding material as per the original construction (**Fig. 6**).
- (5) The following year, in 2010, *anastylosis* of the central portal of the west wall of the church was planned; it is now in progress.

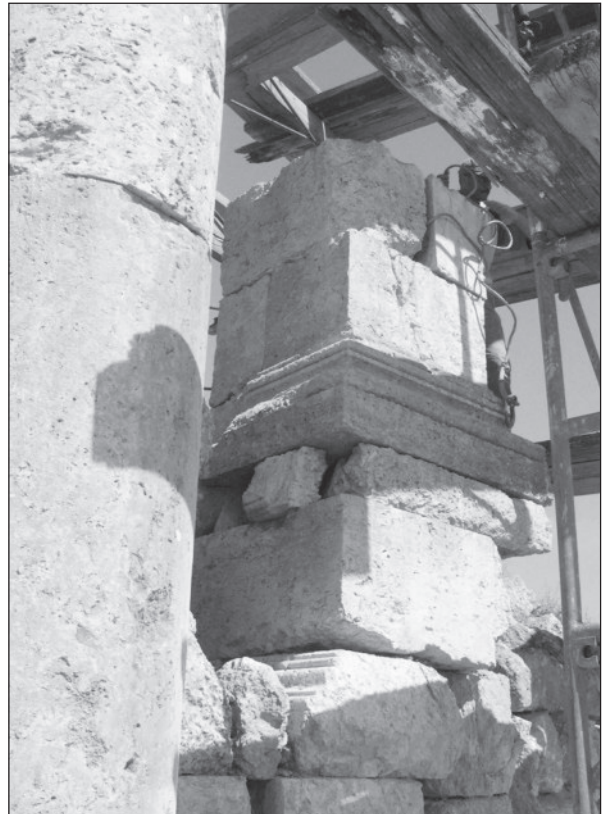
5. North-west pillar in antis during dismantling, from the south-east.

the present pillar and plinth. These were all stacked on the ground, numbered and measured, and the two fragmentary blocks making up the upper cornice of the plinth restored (**Figs. 4-5**).

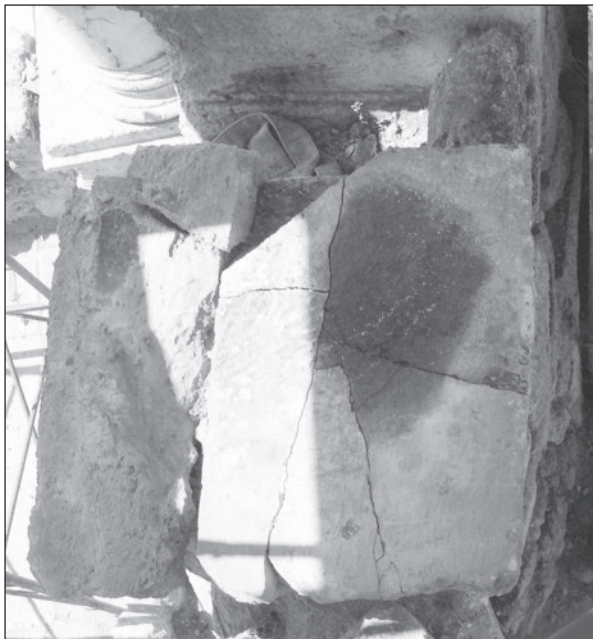
6. North-west pillar in *antis*; upper cornice of the plinth during dismantling, from above.

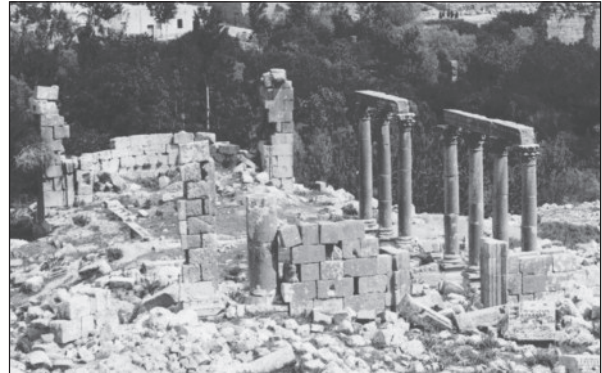
In a late 19th century photograph, the entire portal is standing - even the relieving arch above it (**Fig. 7**). However, in photographs of the 1920s it is decidedly reduced, being evidence for the spoliation mentioned above. In the photo at **Fig. 8**, the lintel is missing while the jambs are entirely preserved. Two blocks from the topmost row of the church's apse are also missing. In two

8. West wall of the Propylaea Church in the 1920s.

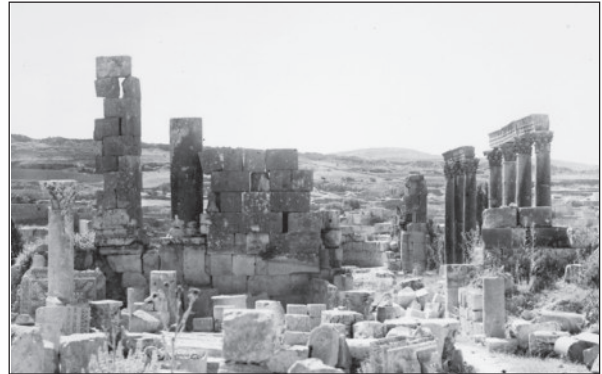
other photos at **Fig. 9**, taken before and after the American excavation there (Crowfoot 1935), more elements of the jambs are missing.

9. West wall of the Propylaea Church in 1934 after excavation.

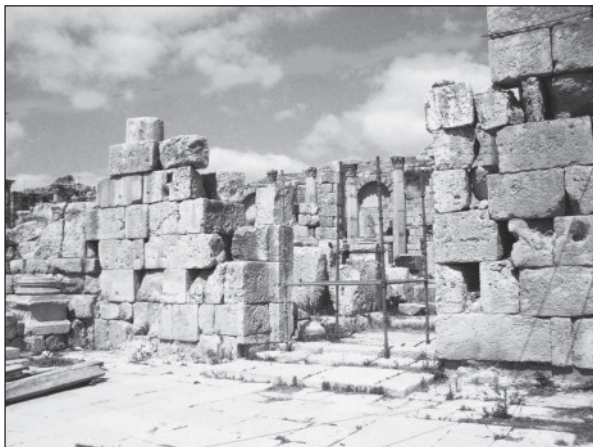
12. West wall of the Propylaea Church in 2009, from the north-west.

- (1) Consolidation of the wall north of the portal. The two uppermost misaligned rows of blocks were taken down - one had deteriorated to such an extent that it had to be replaced - and then reassembled (**Figs. 12-13**).
- (2) New stone blocks have been purchased to replace the missing elements of the jambs; their final shaping will be the next task in the programme of works².

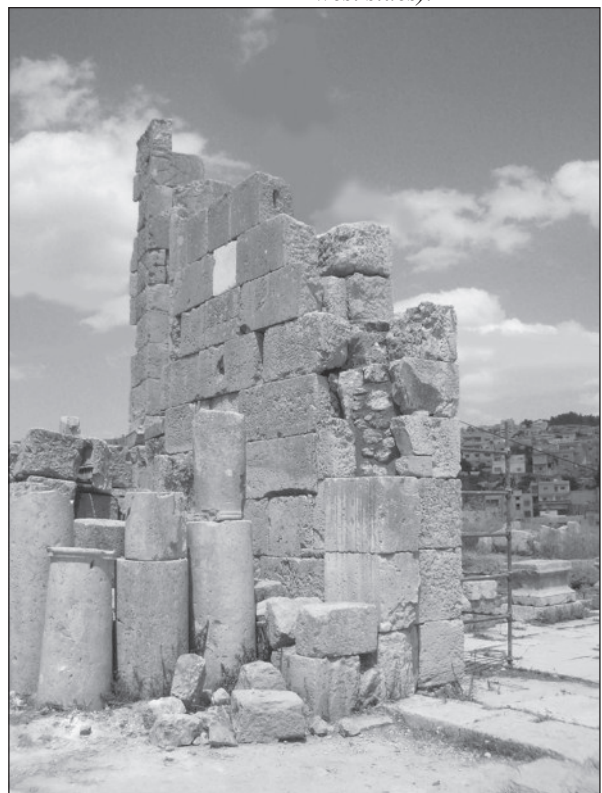
13. West wall of the Propylaea Church; north side after consolidation, from the south-east.
