# QUṢAYR ‘AMRA WORLD HERITAGE SITE: PRELIMINARY REPORT ON DOCUMENTATION, CONSERVATION AND SITE MANAGEMENT ACTIVITIES IN 2010 - 2012

*Giovanna De Palma, Gaetano Palumbo, Carlo Birrozzi, Marie-José Mano, Maria Carolina Gaetani, Asma Shhaltoug and Frédéric Imbert<sup>1</sup>*

## Introduction

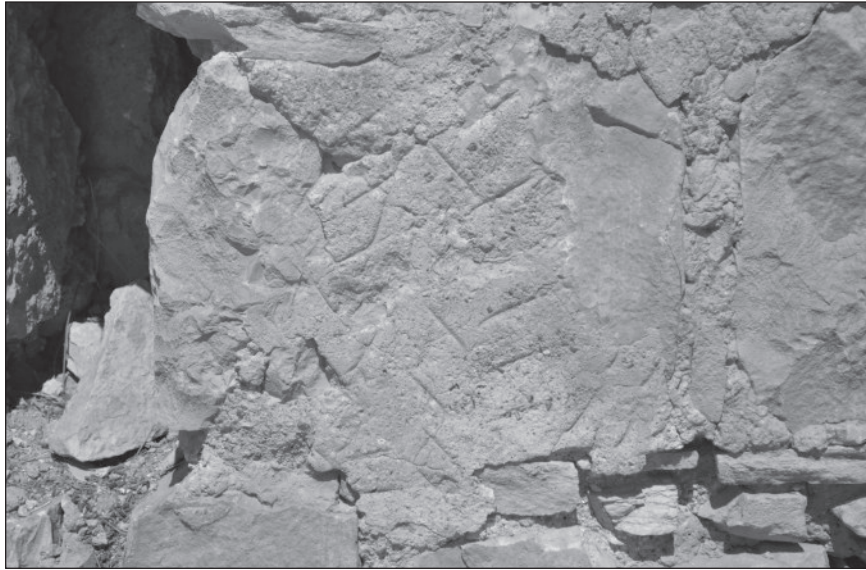
Mortars are still strong and can be broken without crumbling. They are composed of lime with a number of aggregates in different proportions:

4. Original mortar found on the exterior of the monument.

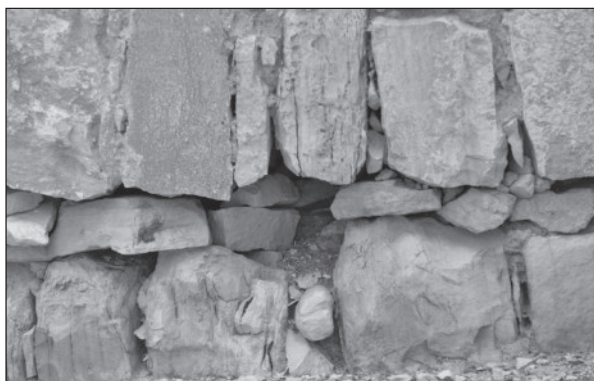
5. Mortar loss at the base of the walls (before intervention).

The monument's state of conservation showed some worrying problems concerning the masonry. First, flooding (including an episode as recently as 1994) seems to have caused the loss, in parts almost total, of the original bedding mortar and the mortar inside the core of the masonry in the lower 60-70cm of the walls (**Fig. 5**).

The first interventions on the exterior of the monument were conducted on the lower sections of the walls, which have been affected by the loss of the bedding and core mortar. Gaps and holes were filled with stone chips up to 60-70cm above ground level. The filling was divided in two distinct operations: one aimed at re-establishing the building's compliance with static safety requirements, the other at protecting the surfaces from future deterioration. Consequently, we examined different mortars characterized by the presence of a lime binder.

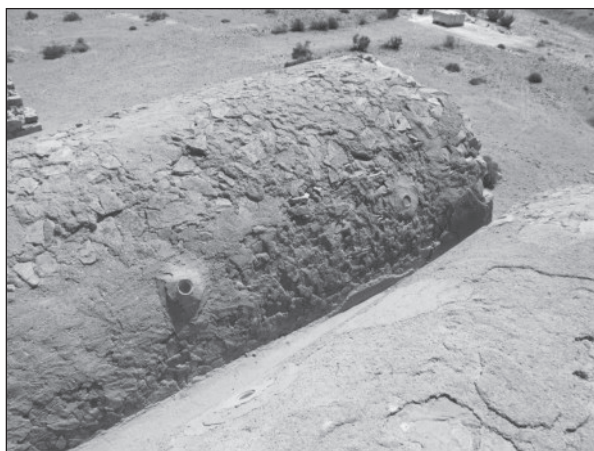
6. Condition of the extrados of the vaults (before intervention).

The extrados of the vaults were in worrying condition, owing to the loss of the original mortar layers. This has exposed the rubble core and allowed water to penetrate deep into the vaults, affecting the painted surfaces inside (**Fig. 6**).

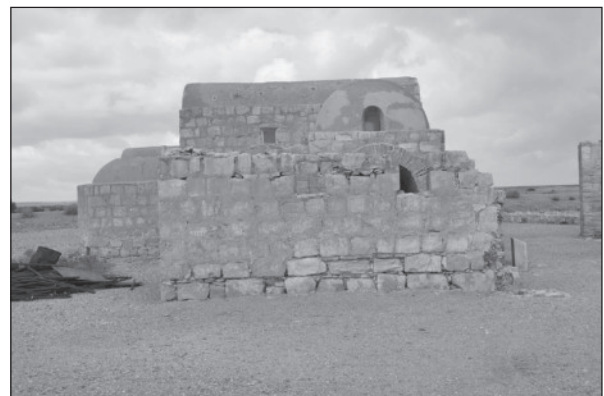
7. Building exterior (before intervention).

- (1) Removal of Portland cement used in previous restoration work and of stones used to fill in gaps;
- (2) Removal of dust and earthy deposits from surfaces using paintbrushes and medium-to hard-bristled brushes;
- (3) Where necessary, the surface was roughened using a mortar made of inert and hydraulic charges of different granularity (binder to charge ratio = 1:3; *grassello*, sand, grit and *cocciopesto*). Stones of different sizes were soaked in water and used to fill the gaps in the core wall. This allowed the restoration of cohesion within the masonry;
- (4) Missing ashlar were replaced by natural stones found nearby, with the intention of restoring a complete view of the surfaces without the 'interference' of missing parts. In order to underline the presence of non-

We paid particular attention to avoid depressions where dampness and roughness might create the right conditions for future deterioration (Figs. 7 and 8).

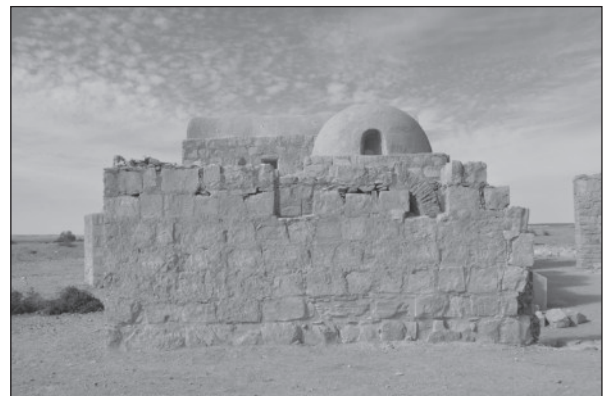
8. Building exterior (after intervention).

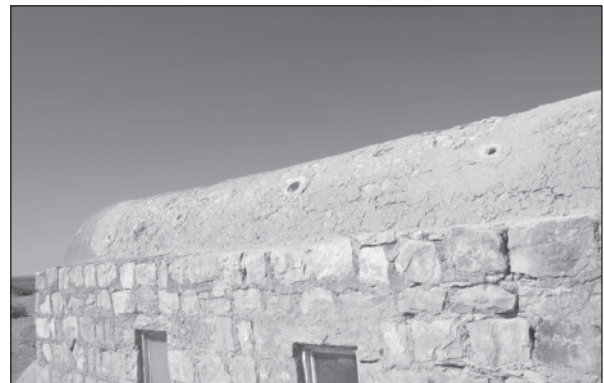
The mortar layers on top of the vaults of the main hall are in different states of preservation. The most exposed, *viz.* the eastern, has lost almost all of the three mortar layers and the stones placed right upon the structure were in plain view, so the risk of infiltration to the paintings was very high.

9. Eastern vault (before intervention).

focused on the roofs. On the barrel vaults, cement layers from previous restorations were mechanically removed with hammer, scalpel and angle grinder with diamond cutting discs. Gaps were filled with mortars similar to the existing ones. A sacrificial layer was constructed in order to protect the original mortars, which are widely cracked and have become fragile over time. During each working day, mortar was spread over approximately 9m<sup>2</sup>. For some of the surfaces, final smoothing was necessary to allow rainwater to drain to the ground. To slow down erosion caused by atmospheric agents such as wind and sand, low and rough areas where water could accumulate were eliminated (**Figs. 9 and 10**).

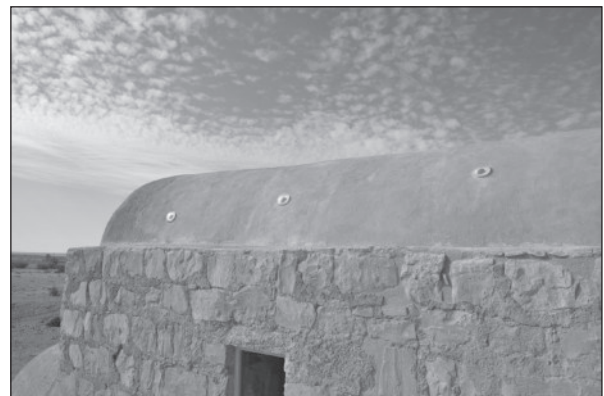
10. Eastern vault (after intervention).

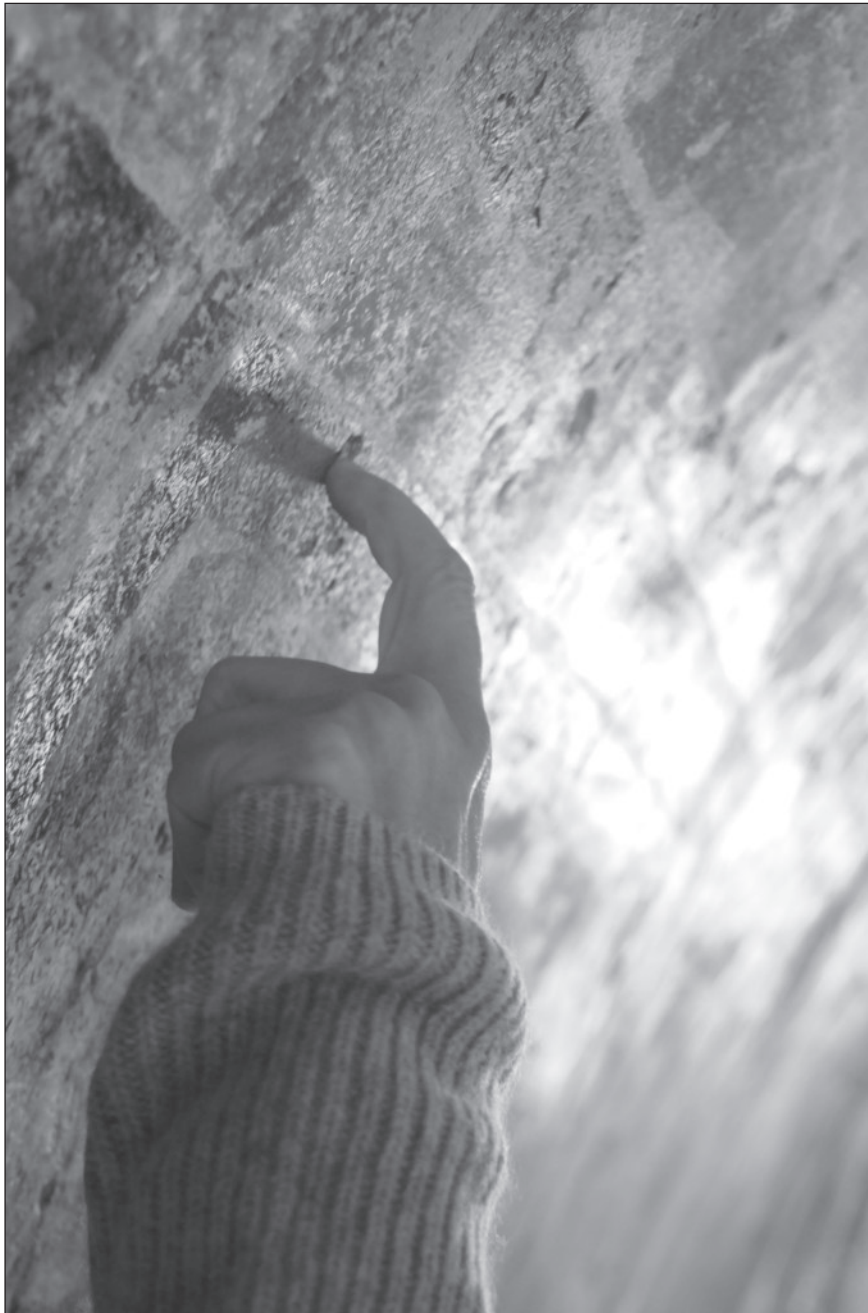
15. Shiny effects of shellac applied on the surface.

After partial cleaning, the paintings throughout the building (with very few exceptions) were covered with a layer of natural resin (shellac) (**Fig. 15**). This substance, more suitable for use on furniture than for protecting mural paintings, must have been applied in order to modify the refractive index of fading colors, made irreversibly opaque by previous interventions. At the time it was applied, the shellac was more transparent, but over the last forty years it has acquired a strong amber tint, worsened by several

layers of atmospheric fine particles owing – in part – to tourism. In addition, the shellac layer is now showing signs of contraction, causing the pictorial layer underneath to lift. This shellac layer has extensive repaintings (Fig.16) in non water-soluble color in some of the *lacunae*. Traces of an older brown shellac layer, a residue of previous interventions, were also found.

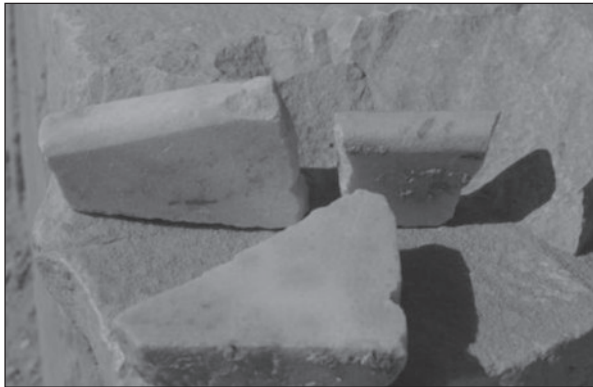
The removal of concretions allowed different marbles to be identified, viz. (1) fine-grained, uniform white marble, (2) gray-veined marble

17. Marble fragments collected outside the monument.

Because of the patina adhering to these fragments, it was difficult to recover any information about them or possible traces of previous intervention. After careful dry removal of incoherent deposits with soft brushes, an ammonium salt solution was used for cleaning.

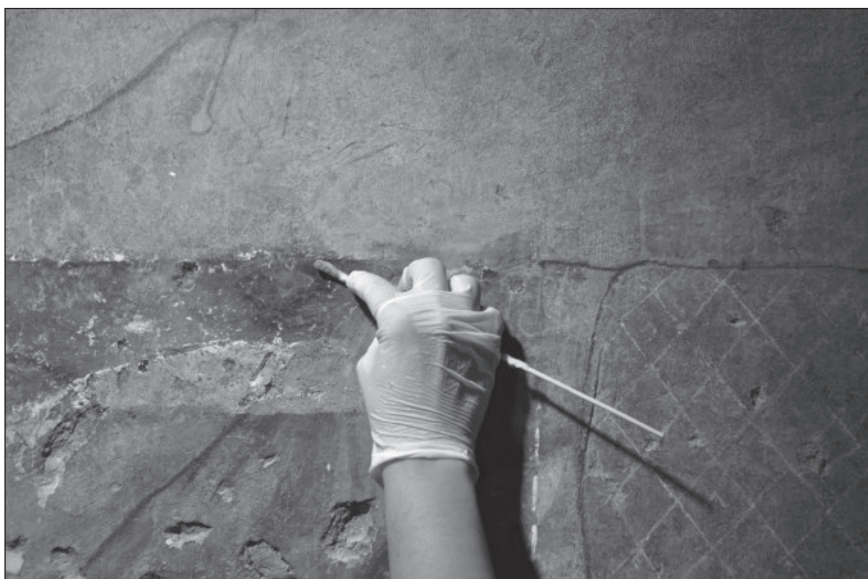
18. Careful cleaning of the mural paintings.

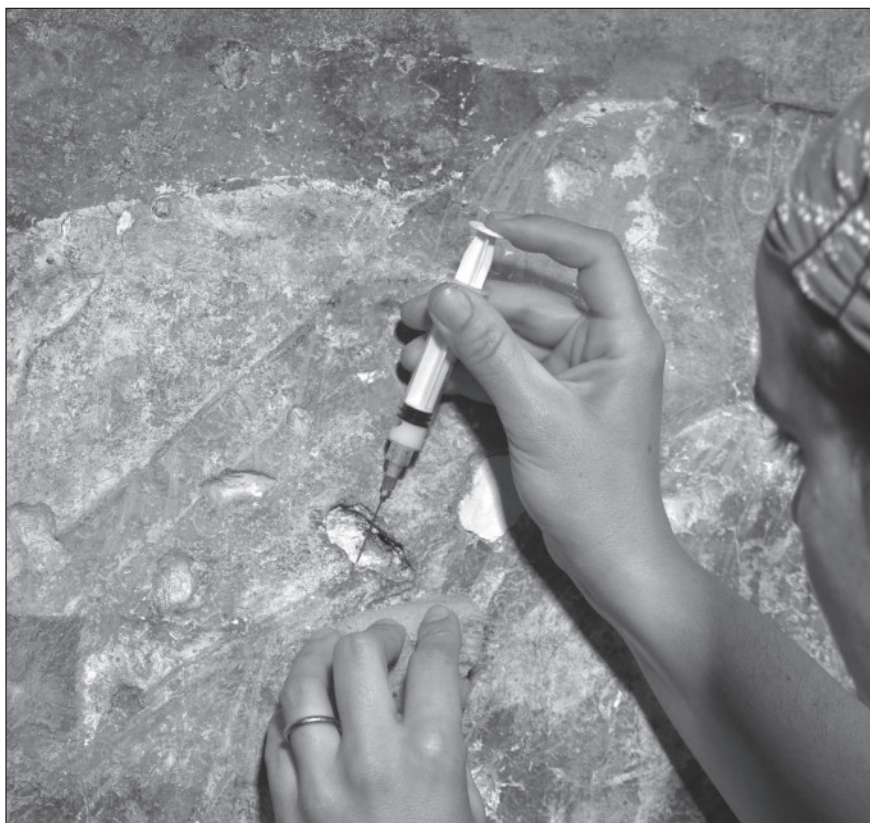
19. *Injection of mortar to consolidate the base of the painted layers.*

sonry were restored using a low-pressure injection<sup>11</sup> of low-salt, ready-mixed hydraulic mortar (**Fig. 19**). Emulsion acrylic resin was used to reattach small-size detachments and adhesion faults on the pictorial film. Before and after the cleaning, the painted surface underwent pH and electrical conductivity measurements.

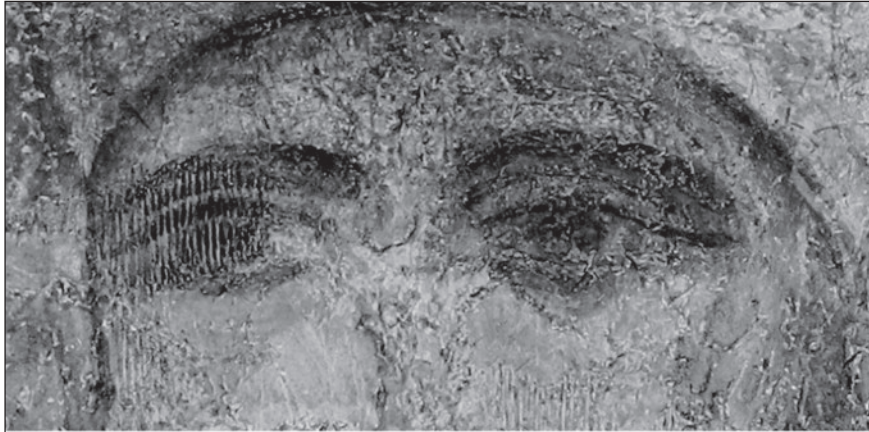
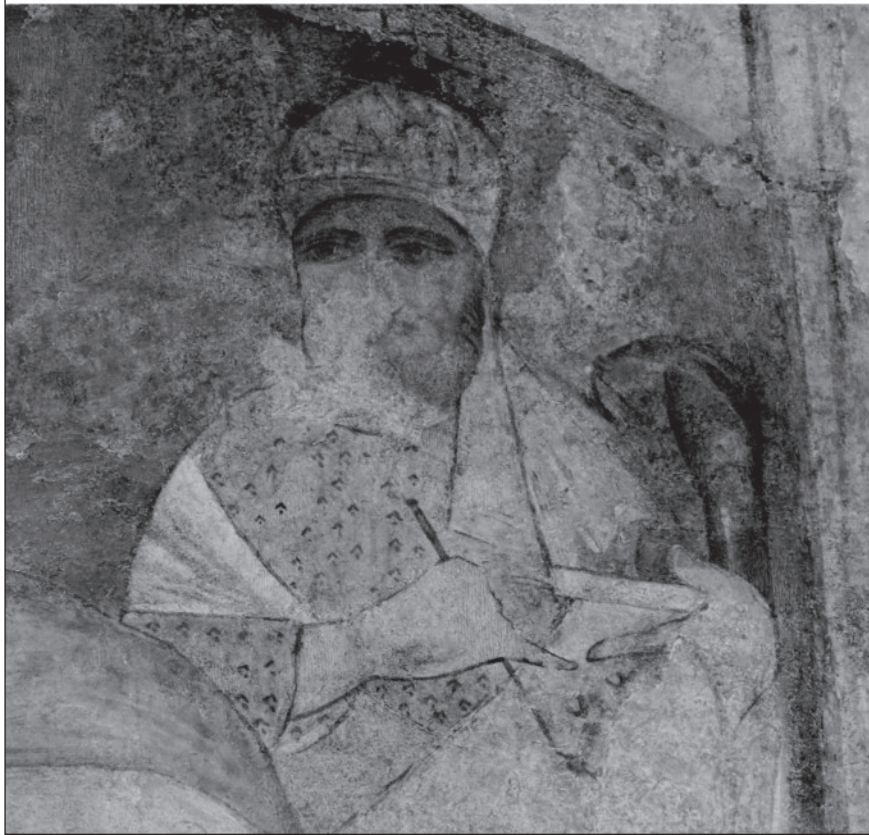
20. An example of *tratteggio* used to improve the visibility of detail.

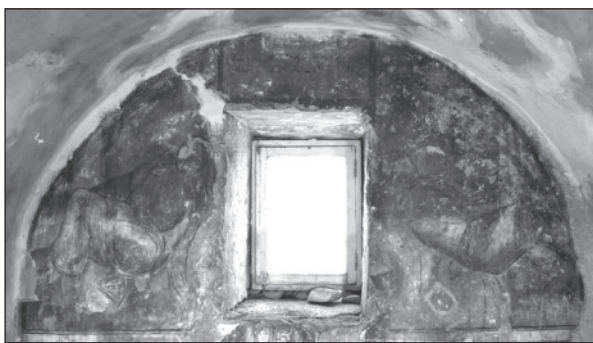
21. Lunette (before conservation).

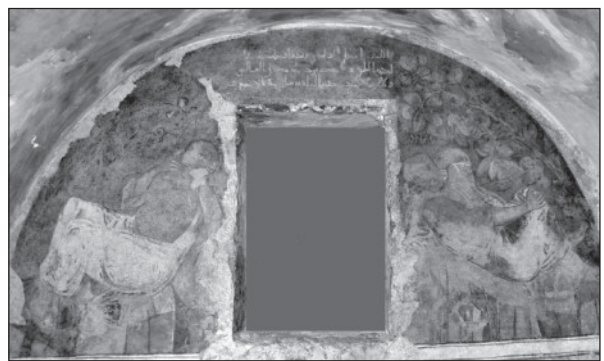
22. Lunette (after conservation).

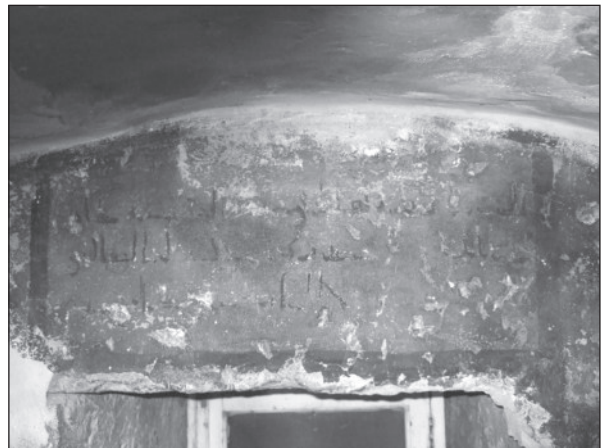
25. Upper inscription (before conservation).

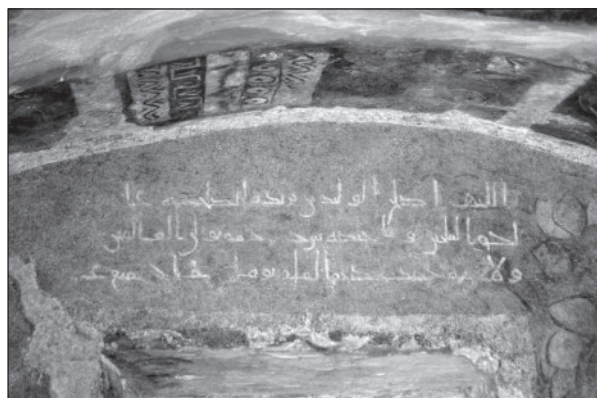
26. Upper inscription (after conservation).

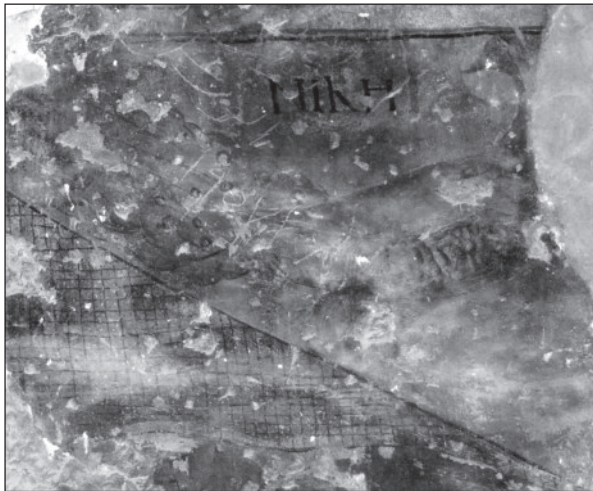
27. Right peacock and Nike inscription (before conservation).

A localized cleaning test was run on the APA inscription, in order to confirm the correct interpretation of the legible letters. The final A turned out to be an I and a C, supporting the hypothesis that the complete inscription was origi-

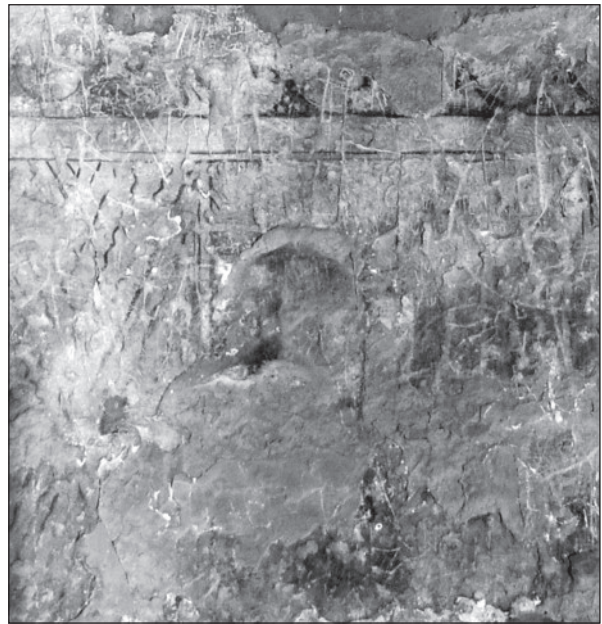
31. The faux marble area (before conservation).

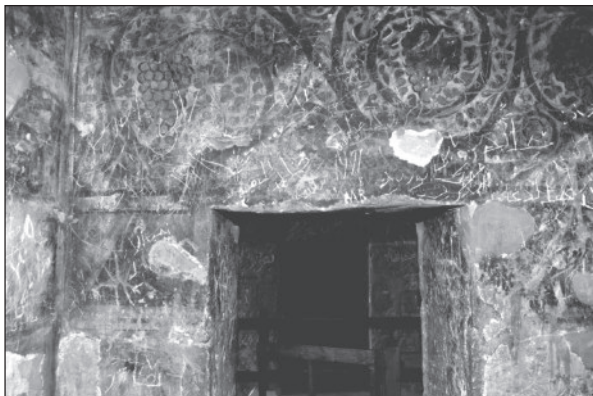
33. Vandalism in the alcove room.

paths and tree planting schemes were unsuccessful and have contributed to make the original landscape more difficult to recognize. This is all compounded by active threats to the main site itself, especially the vandalism and graffiti that remain the most serious threat to the integrity and authenticity of the site (**Fig. 33**).

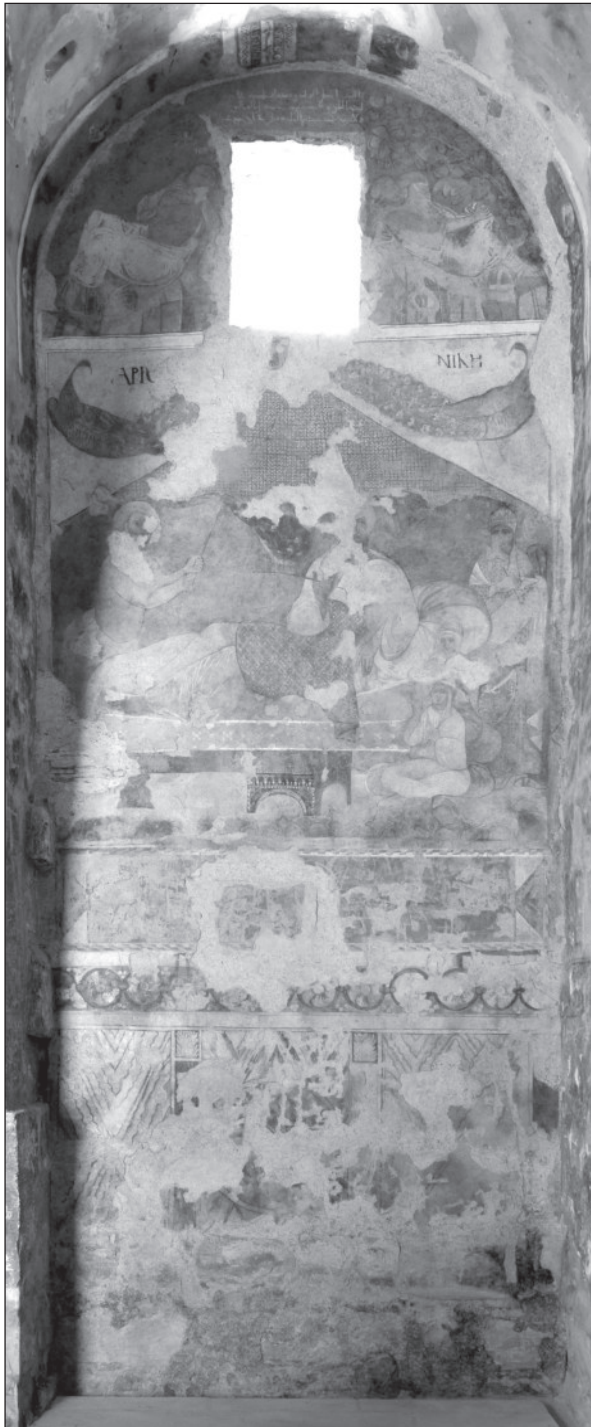
The first three seasons of documentation and conservation at Quṣayr ‘Amra have achieved important results: the exterior of the building is now conserved, water infiltration has been stopped and the monument shows a more balanced palette of color and shadow. Inside, condition assessment and analyses have allowed the recognition of the original painting techniques used by the Umayyad artists, as well as the materials applied in recent interventions. Various experiments have allowed methodologies to be defined in order to reduce or eliminate the repainting and layers of shellac applied in the last century to protect the site, but which now pose a real threat to the conservation of the mural paintings. The results are extraordinary, not only because it has been demonstrated that apparently irreversible conservation interventions can at least be reduced in their negative effects, but also because of the surprising presence of layers of original paint that can still be read and interpreted. The changes in iconography and the discov-

34. South wall of the west aisle (after conservation).
