WĀDĪ GHUWAYR 106: A NEOLITHIC BARRAGE SYSTEM IN THE NORTH-EASTERN AL-JAFR BASIN

Sumio Fujii, Takuro Adachi, Leslie A. Quintero and Philip J. Wilke

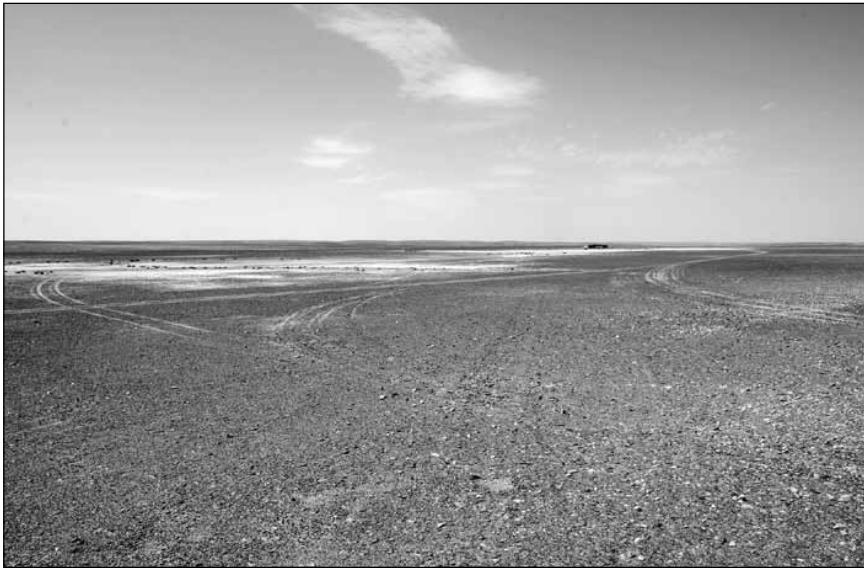
3. Wādī Ghuwayr 106: distant view of the site (looking north-west).

the head of Wādī Ghuwayr. The site is a simple, open-air site that consists only of two elongated freestanding stone-built walls. It is isolated in the middle of a flint pavement desert (Ar. *al-Hamād*) and appears not to have been associated with a settlement in terms of its operation (Fig. 3). The two wall alignments occupy flat terrain on the northern half of an elongated playa (Ar. *Qā'*) (Fig. 4). This playa, *ca.* 550m long and up to *ca.* 100m wide, is the lower component of a semi-open playa system that forms the upper reaches of one of the headwater forks of Wādī ash-Shawmarī. The two walls are located at the lowest part of the semi-open playa system, a key to understanding the location and function of the PPNB barrage system.

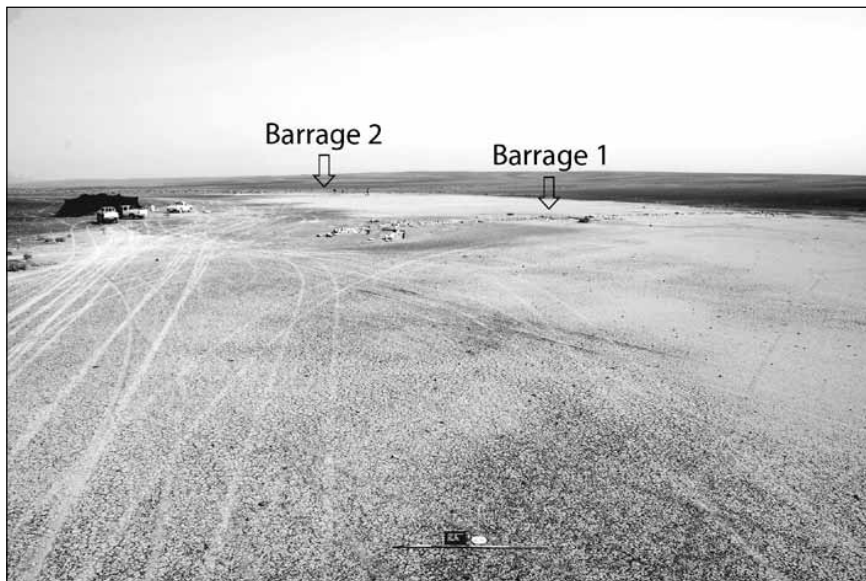
5. Wādī Ghuwayr 106: general view of the barrage system (looking north).

tures Barrage 1 and Barrage 2, in descending order of elevation from south to north (Figs. 5 and 6). Barrage 1 was intensively examined by means of six small trenches. The exposed wall segments had a total length of *ca.* 18m, or approximately one-fifth of the total length of the barrage wall. Barrage 2, on the other hand, was quickly sounded by two small trenches. The two central trenches (i.e. Area 3 of Barrage 1 and Area 1 of Barrage 2) were set up along the major axis of the playa, but the other excavation areas were arranged along a magnetic north - south line. Excavated deposits were not sieved owing to the extreme scarcity of small finds, but a total of 20 liters of basal soil deposits were collected for flotation to retrieve any preserved organic remains. At time of writing this analysis has yet to be completed.

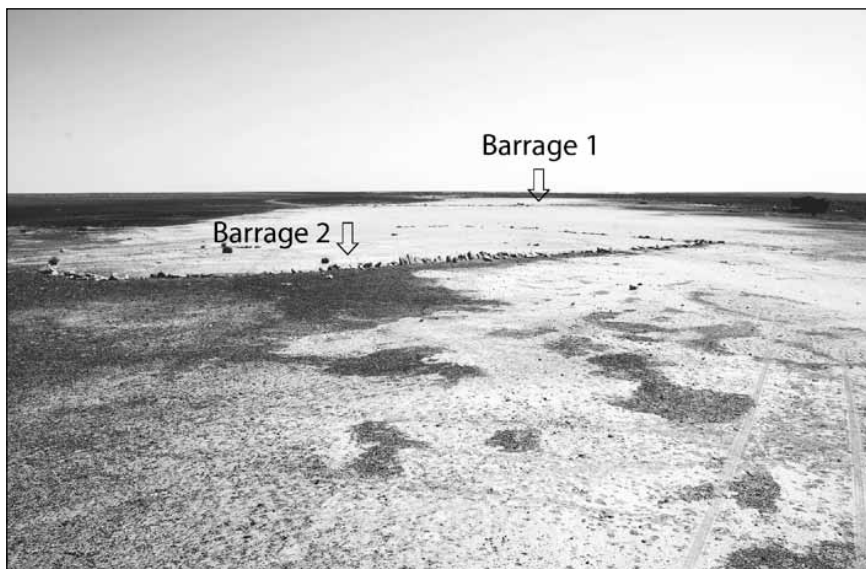
6. Wādī Ghuwayr 106: general view of the barrage system (looking south).

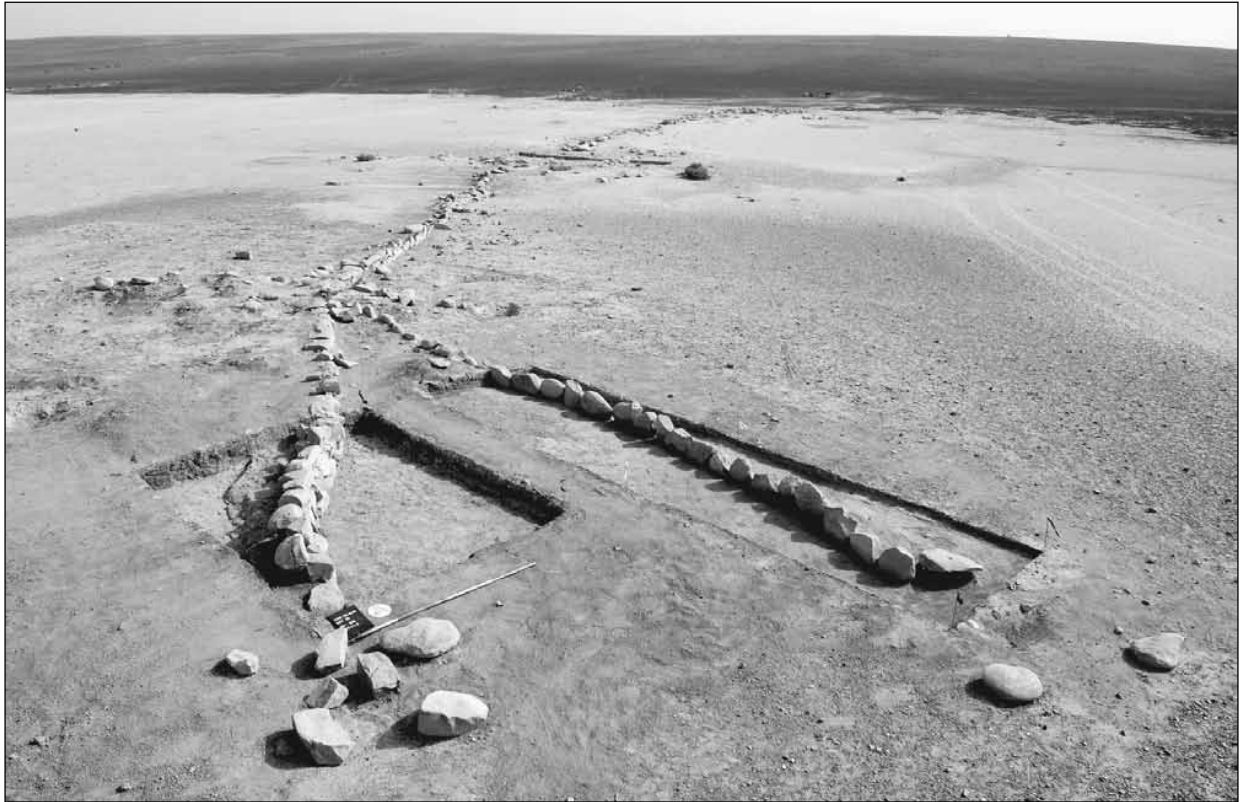
8. Barrage 1: general view (looking north-east).

The barrage wall was constructed of a single row and up to three to four courses of undressed or part-dressed limestone cobbles and boulders *ca.* 30-80cm long. Dry stone walling appears to have been the norm; no clear evidence for clay mortar was found with the sole exception of the retaining bank in Area 1. Construction material probably originated from the wadi bed *ca.* 200-300m downstream, where similar stones are exposed by erosion. Overall, the wall alignment was simple in structure; additional features were limited to a semi-circular reinforcement wall

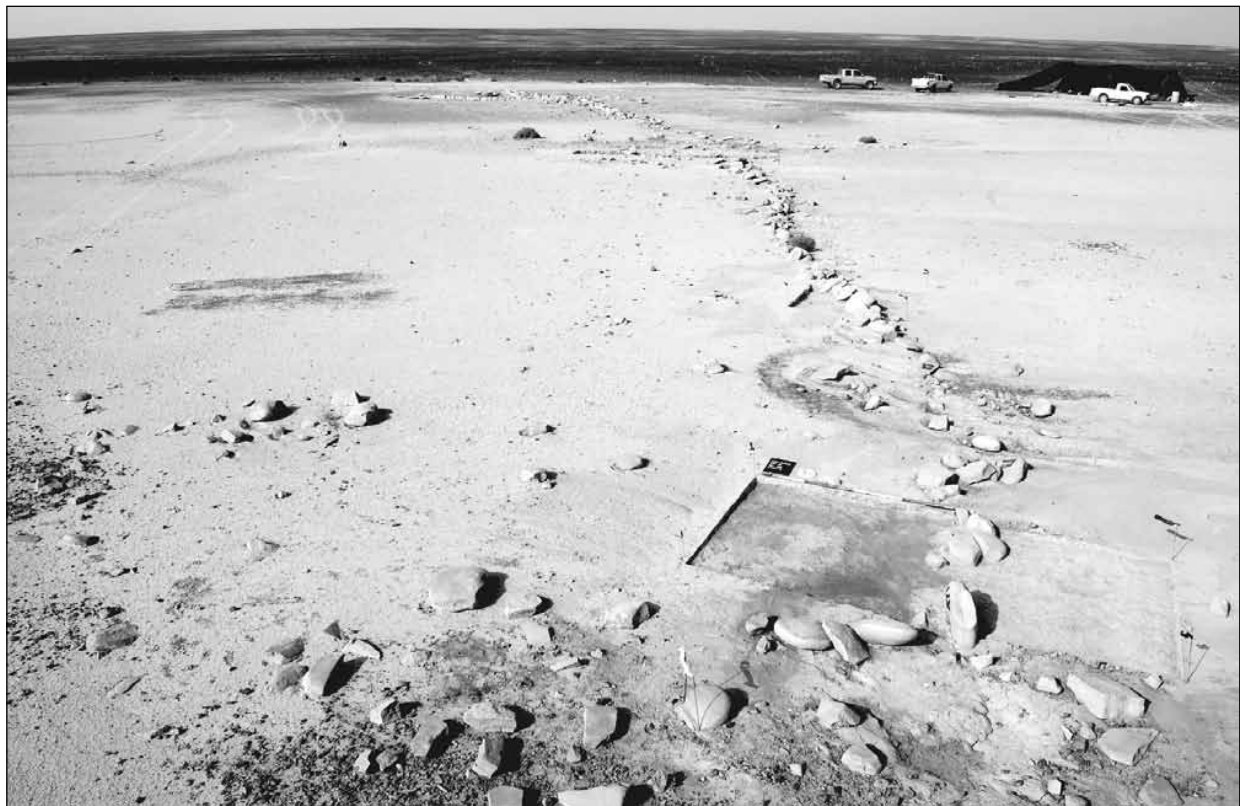
9. Barrage 1: general view (looking south-west).

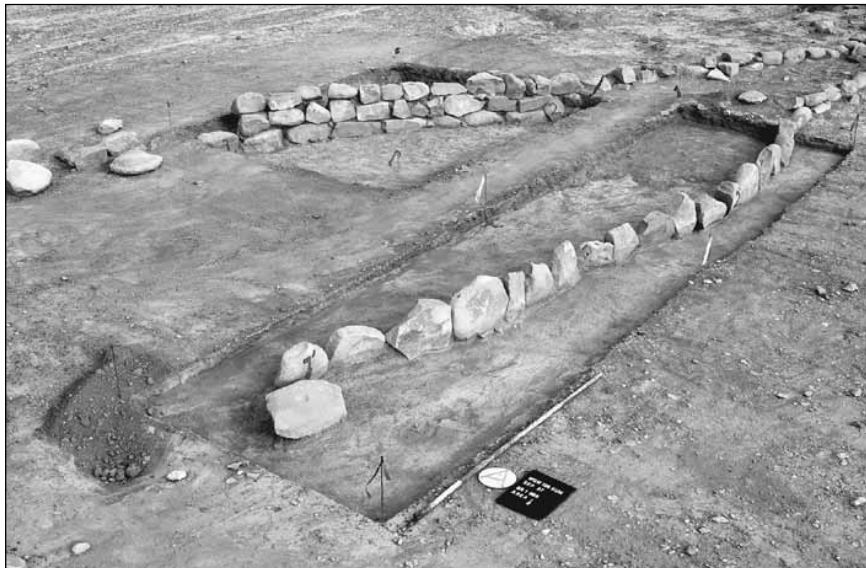
10. Barrage 1: Area 1 (above) and Area 2 (below) (looking north-west).

The excavation at Area 2 explored the nature of a short wall segment attached to the south-west end of the barrage. This additional wall was *ca.* 7m long and up to *ca.* 0.3m in preserved height, being built of a single row of upright limestone slabs (Figs. 7, 10 and 11). Neither foundations

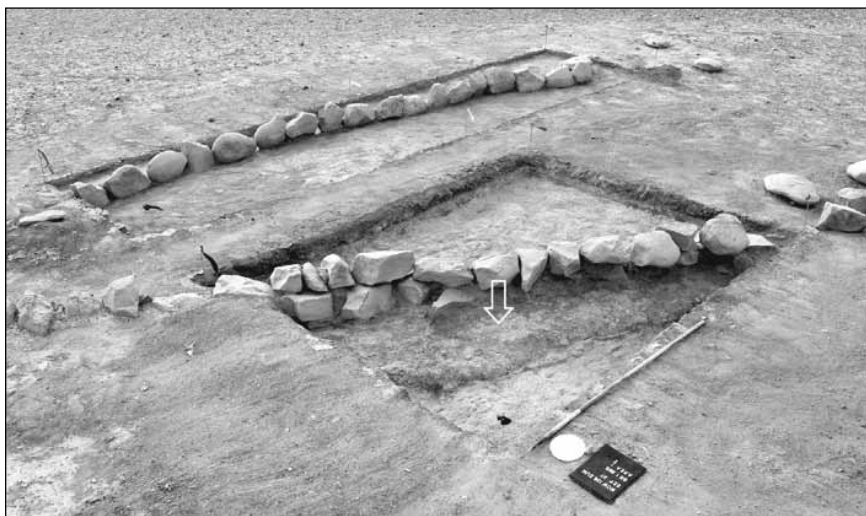
11. Barrage 1: Area 1 (below) and Area 2 (above) (looking south-east); white arrow shows bank to rear.

bond. This construction technique is reminiscent of Barrage 1 at Wādī Abū Ṭulayḥa (Fujii 2007b: Fig. 8, 2007c: Fig. 6). No clear evidence for clay mortar was confirmed, but a clay bank was found to the rear of the wall segment (Fig. 11). This retaining bank, *ca.* 0.3m high and *ca.* 1m wide, was probably added for both waterproofing and structural reinforcement of the barrage wall.

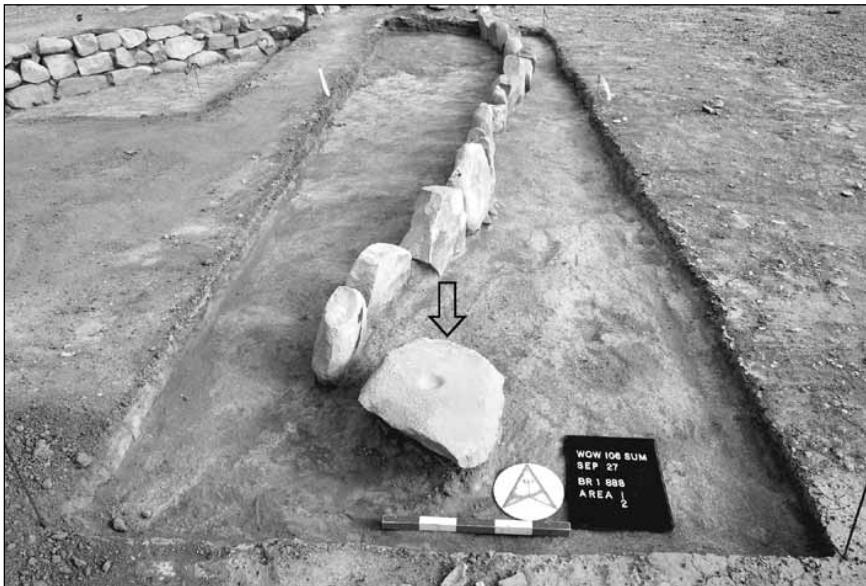
12. Barrage 1: pillar base found at the southern edge of Area 2 (looking north).

The wall segment included two socketed limestone pillar bases (see below): one as a fallen stone at its southern end (**Figs. 12 and 33: 1**) and the other as an *in situ* item incorporated into its northern part (**Figs. 13 and 33: 2**). As discussed below, these diagnostic finds provide a key to exploring the date of the barrage.

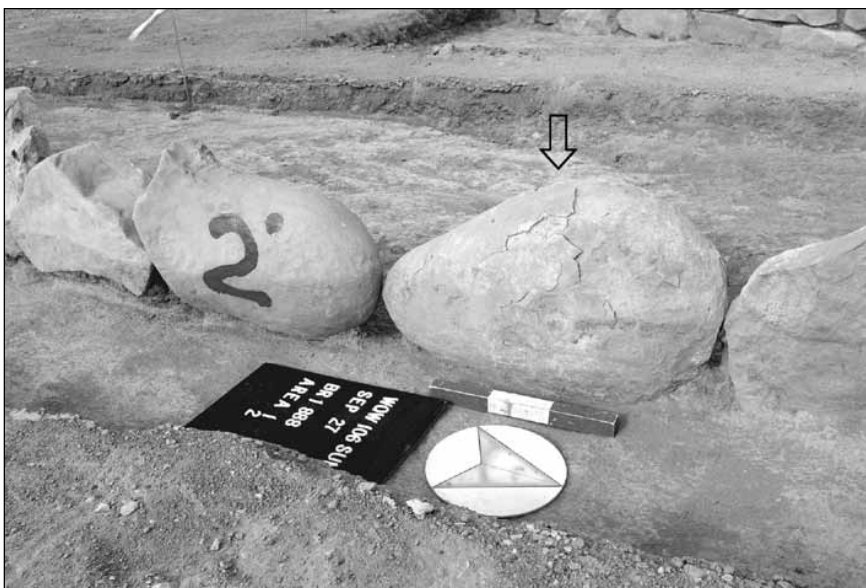
13. Barrage 1: pillar base incorporated into the barrage wall of Area 2 (looking south-west).

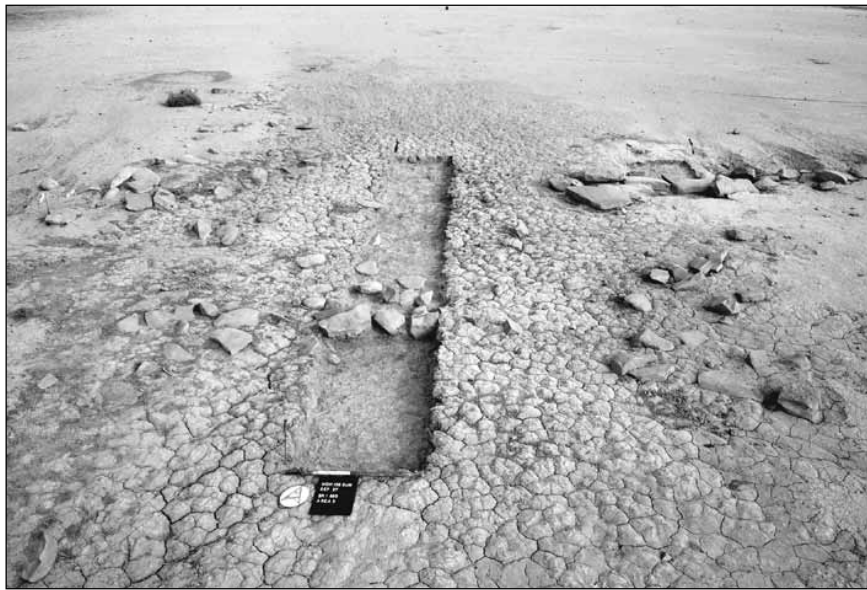
14. Barrage 1: Area 3 (center) and Area 4 (right) (looking north).

tion revealed traces of a semi-circular, protruding reinforcement wall, as well as the aligned foundation stones of the barrage wall (Figs. 14 and 15). The existence of the reinforcement wall at the crucial central part of the barrage, where it would have been subjected to the greatest water pressure, is a feature of all the PPNB barrages discovered to date in the Jafr Basin, suggesting that it may have been a standard element in their construction (Fujii n.d.a). It is probable that, as in the case of Barrage 1 at Wādī Abū Ṭulayḥa (Fujii 2007b: Fig. 9, 2007c: Fig. 5), the inner part of the reinforcement wall was originally packed with clay and rubble.

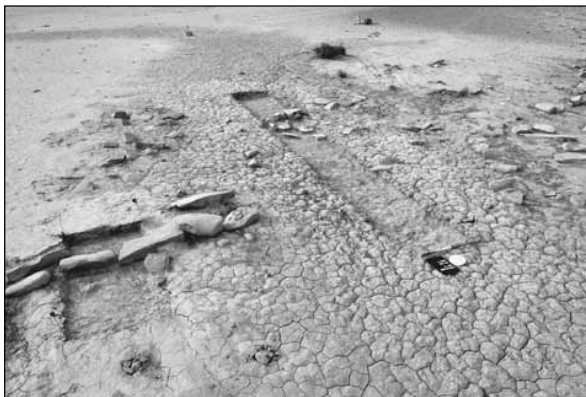
15. Barrage 1: Area 3 (center) and Area 4 (left) (looking south-west).

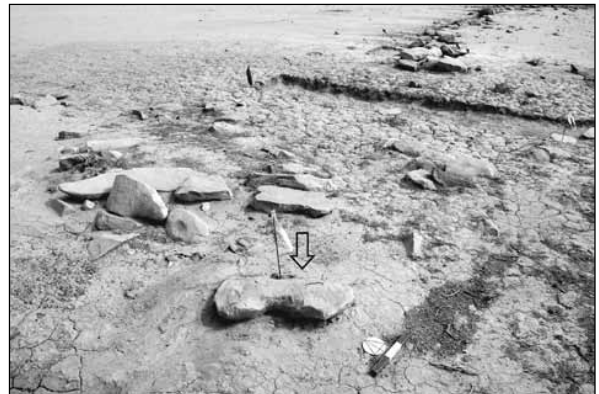
16. Barrage 1: stone weight found beside Area 3 (looking north-east).

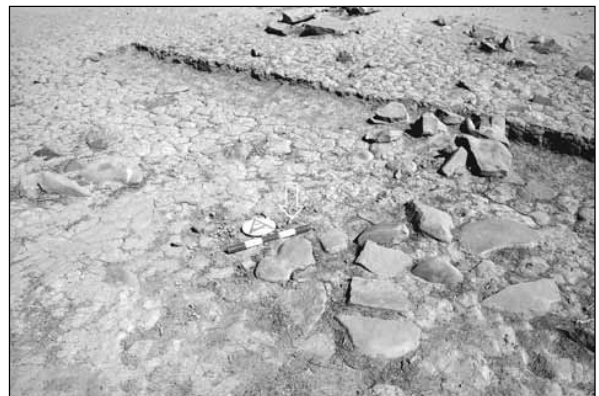
17. Barrage 1: stone weight found beside Area 3 (looking north).

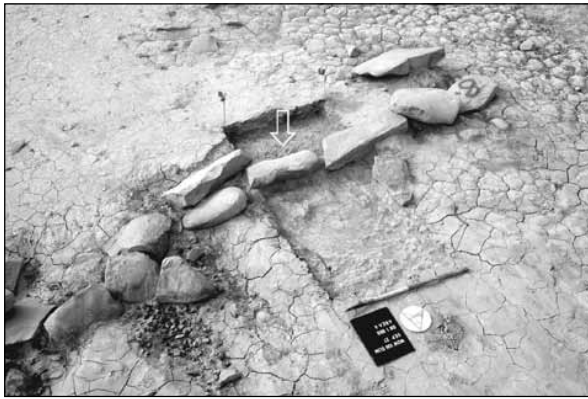
18. Barrage 1: stone weight incorporated into the barrage wall of Area 4 (looking south-east).

the other as a foundation stone in the wall segment of Area 4 (Figs. 18 and 32: 3). The occurrence of diagnostic stone weights – especially in the seemingly ubiquitous reinforcement wall

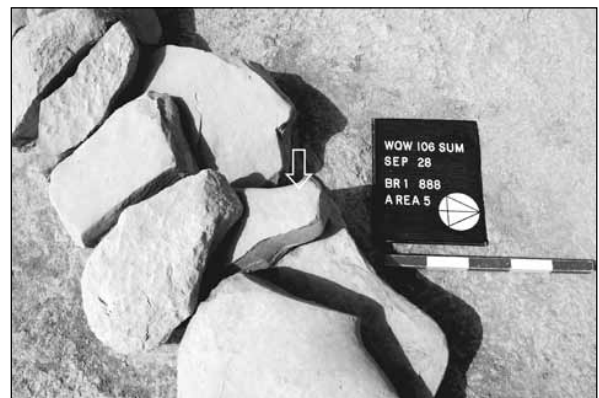
21. Barrage 1: Thamudic inscription incorporated into the barrage wall of Area 5 (looking west).

closer scrutiny revealed that – as was the case with similar stones nearby – the inscribed slab was leant up against foundation stones, with a minor stratigraphic gap between them. Thus, the uppermost stones, including the inscribed slab,

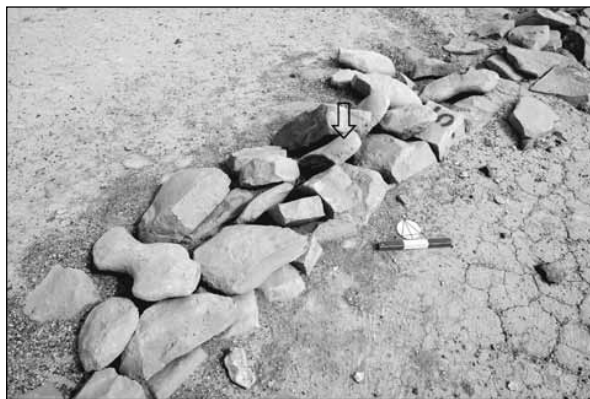
22. Barrage 1: Thamudic inscription incorporated into wall segment 4 / 5 (looking north-east).

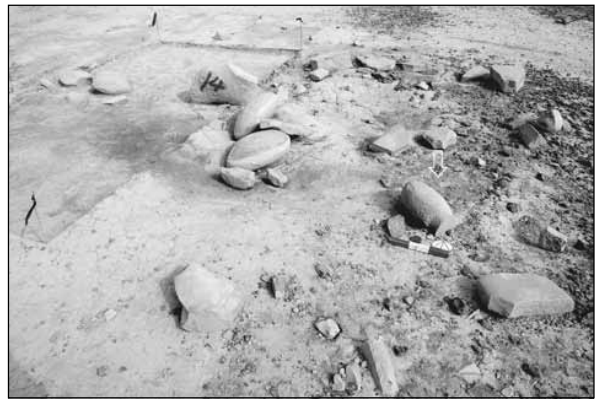
24. Barrage 1: halved stone weight found beside Area 6 (looking south-east).

The excavation in Area 6 examined the archaeological context of a notched and grooved stone weight that was exposed near the north-east end of the barrage. The excavation confirmed that it was among the remnants of the washed-out barrage wall (**Figs. 23 and 32: 4**). In addition, a halved stone weight was found outside the excavation area, at the very end of the barrage wall (**Figs. 24 and 33: 1**). There is little doubt that this artifact also derived from

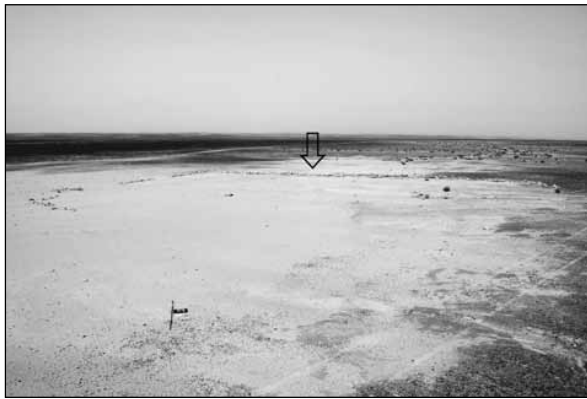
26. Barrage 2: general view (looking west).

The excavation at Area 1 was intended to clarify the structure of an upright slab wall that characterizes the central part of the barrage. The excavation showed that all construction material was placed directly on the playa surface without any foundations or support to the rear (**Figs. 25, 26, 27 and 28**). The wall itself was carefully constructed so as not to leave a significant gap between any two adjacent stones, but no clear evidence for clay mortar was found. This was also the case with Barrage 1 and the other parts

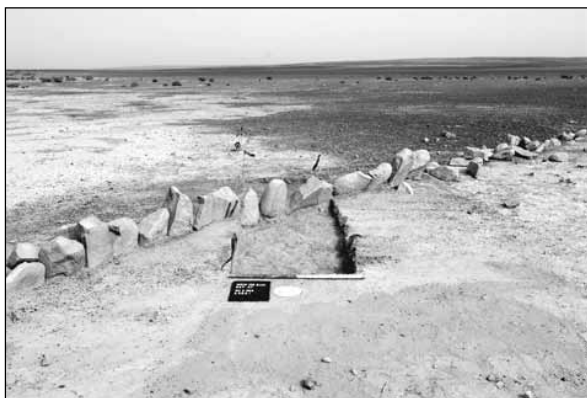
28. Barrage 2: Area 1 (looking north).

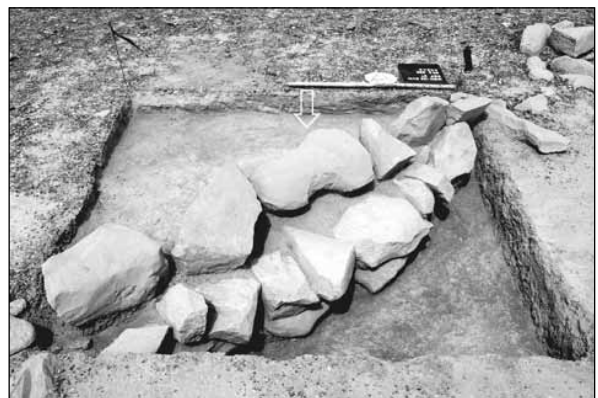
29. Barrage 2: stone weight incorporated into the barrage wall of Area 2 (looking north).

weight that was partly exposed near the north-eastern end of the barrage (Figs. 25 and 29). Excavation confirmed that this diagnostic artifact was incorporated into the wall segment 13 / 14 at the time of its initial construction and can therefore be regarded as a chronological indicator for the barrage.

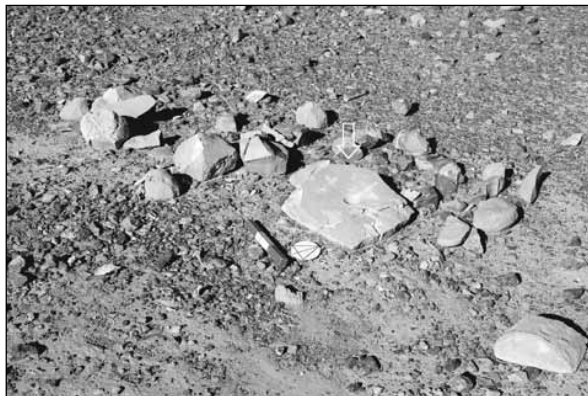
30. Surrounding small features: stone concentration 1 (looking north-west).

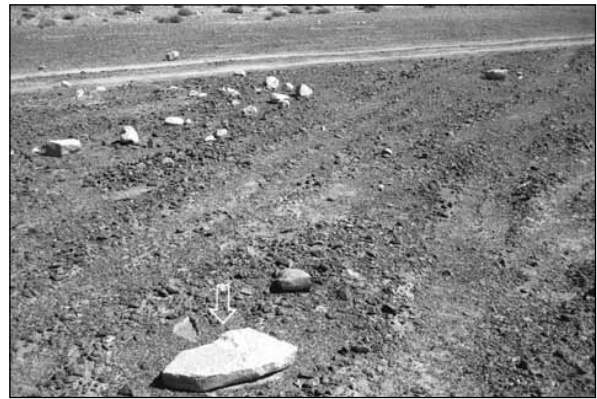
31. Surrounding small features: stone concentration 2 (looking south-east).

This stone concentration was located *ca.* 200m north-west of stone concentration 1 (Fig. 4). A few dozen limestone cobbles *ca.* 20-40cm long were scattered across an ill-defined area measuring *ca.* 5m by *ca.* 3m (Fig. 31). Again, no reliable chronological indicator was obtained. A halved pillar base was found on the modern ground surface *ca.* 10m north of the main stone concentration (Fig. 34: 4). Although a contextual association between the artifact and stone concentration cannot be demonstrated, the fact it was found in close proximity to this possible source material hints at on-site production, as suggested above.

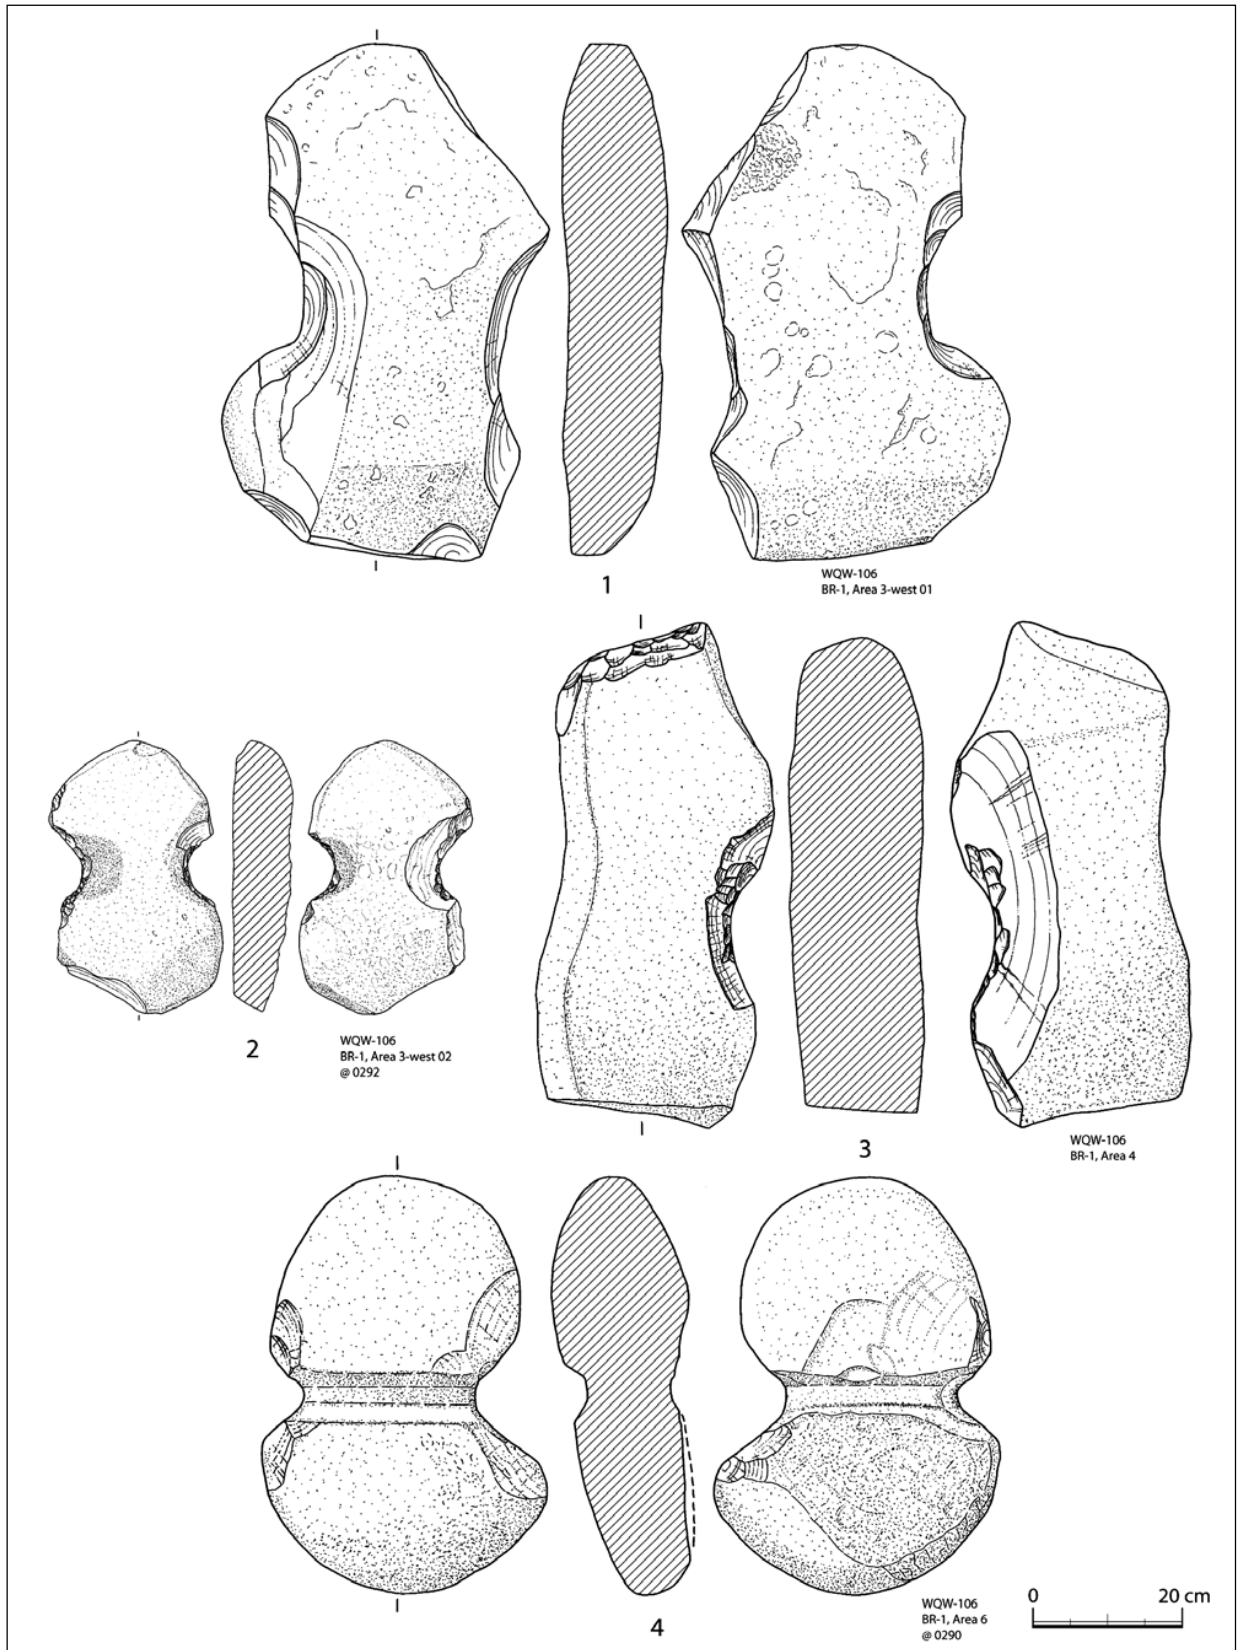
32. Stone weights: Wadi Ghuwayr 106.

The two barrages yielded a total of six bilaterally notched and / or bifacially grooved stone weights (Figs. 32 and 33). Five occurred at Barrage 1 (Figs. 32: 1-4, 33: 1) and the remaining example at Barrage 2 (Fig. 33: 2). In terms of context, three were found incorporated into the wall itself and can therefore be regarded as roughly contemporary with the barrages (Figs. 32: 3-4, 33: 2). The other three were recovered as stray finds, but there is little doubt that they originally were components of a nearby wall segment (Figs. 32: 1-2, 33: 1).

All six of the stone weights were made of relatively flat limestone cobbles or boulders. As already noted, suitable raw material can be still be found in the wadi bed a few hundred meters downstream of the playa. There is a strong possibility that the stone weights were produced at the material source and brought to the barrages. Large examples more than 50cm long (*ca.* 50-60kg in weight) were predominant, but a smaller example *ca.* 35cm long (*ca.* 10kg in weight) was also recovered. In general, they were violin-shaped, being characterized by a pair of lateral notches. A few examples had a pair of grooves connecting the two notches.
