**THE RESUMPTION OF THE ARCHAEOLOGICAL INVESTIGATION
AT QAL'AT EL-MISHNAQA, 1992 EXCAVATION:
A PRELIMINARY REPORT**

Susanna Bianchi and Fabio Faggella

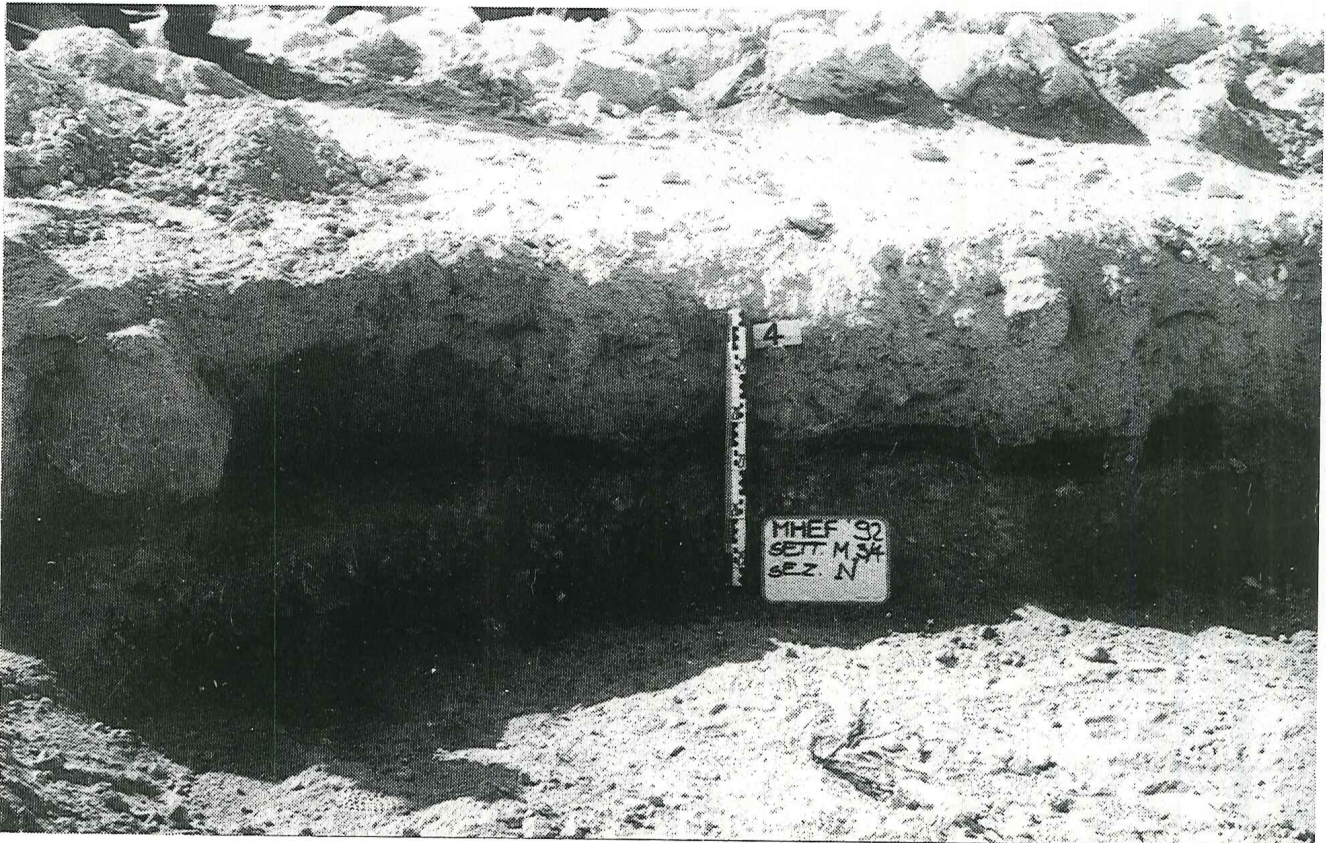
1. Sequence of the destruction levels in Courtyard 5, showing the break between the upper mortar mixing stone layers and the lower, mainly ashes, layers.

Some dry-laid stone walls were found below these levels. They are made of small ashlar laid out edge to edge, set across a layer of charcoal mixed with ashes which overlies a beaten earth level.⁵ The above-mentioned small walls, as the beaten earth level⁶ (Pl. I, 1), must almost certainly refer to the use of other areas or, very likely, coincide with the long period which took the Roman army to finally destroy the fortress. In fact, signs of use of the area are attested since the beginning of the second century A.D., as the finding of a Trajan coin on the paving the corridor 19a testifies⁷ (Corbo 1980; Piccirillo 1980: 403ff; Loffreda 1980: 382).

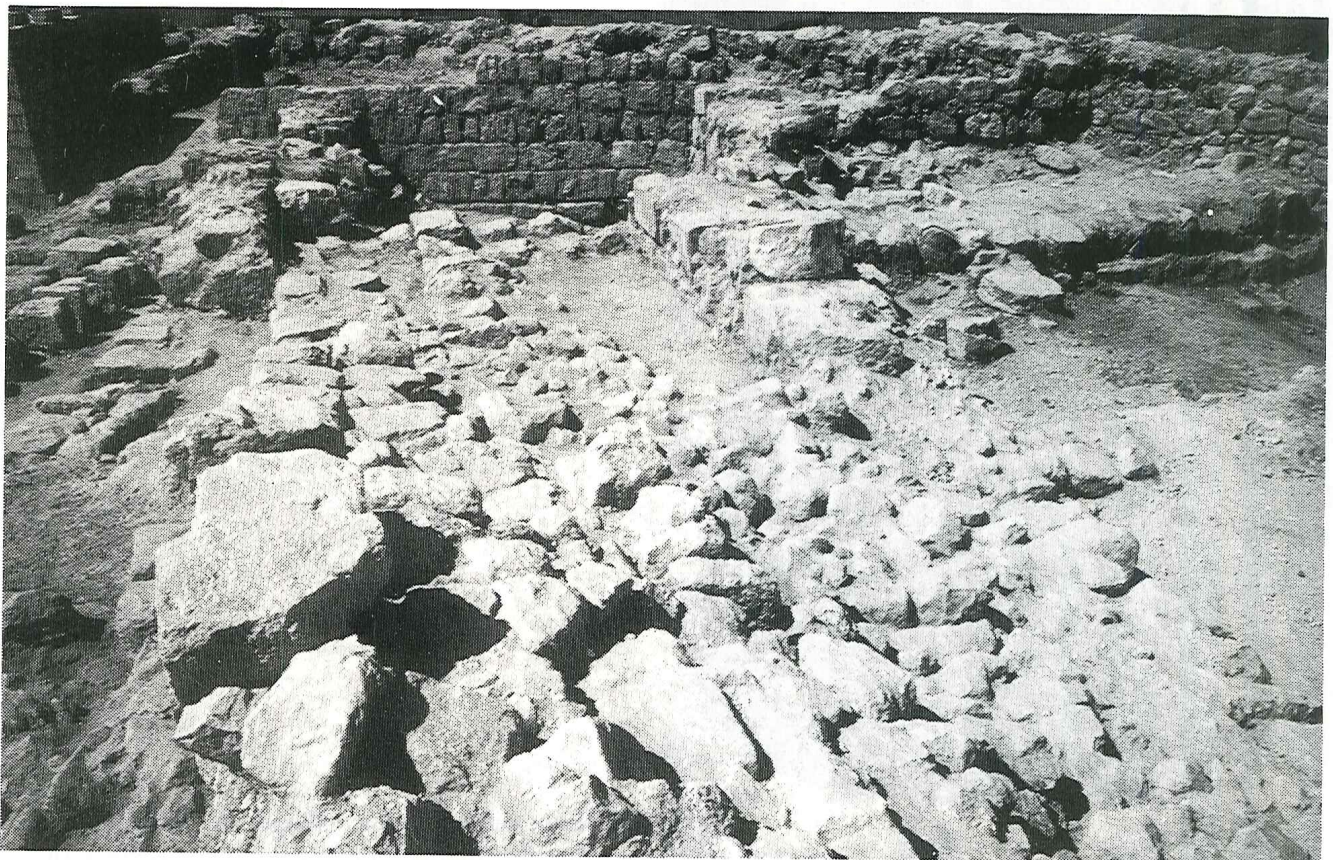
2. The US 40 and US 10 walls leaning against the perimeter wall of the tower.

The excavation of the south-eastern side of Tower 3 allowed us to expose the building structures (Fig. 3; Pl. I, 2) which have been placed against this side of the tower. These structures have remained intact for a maximum height of 250 cm above the paved level, revealing also the continuation of the probable external wall of the rooms set north-west of the peristyle. In this area, the stratigraphy of the levels referring to the destruction reveals the alternation of layers mainly composed of stones (perhaps linked to the final collapse of the elevations of the buttressing structure placed against Tower 3), to layers of sand mixed with ashes and

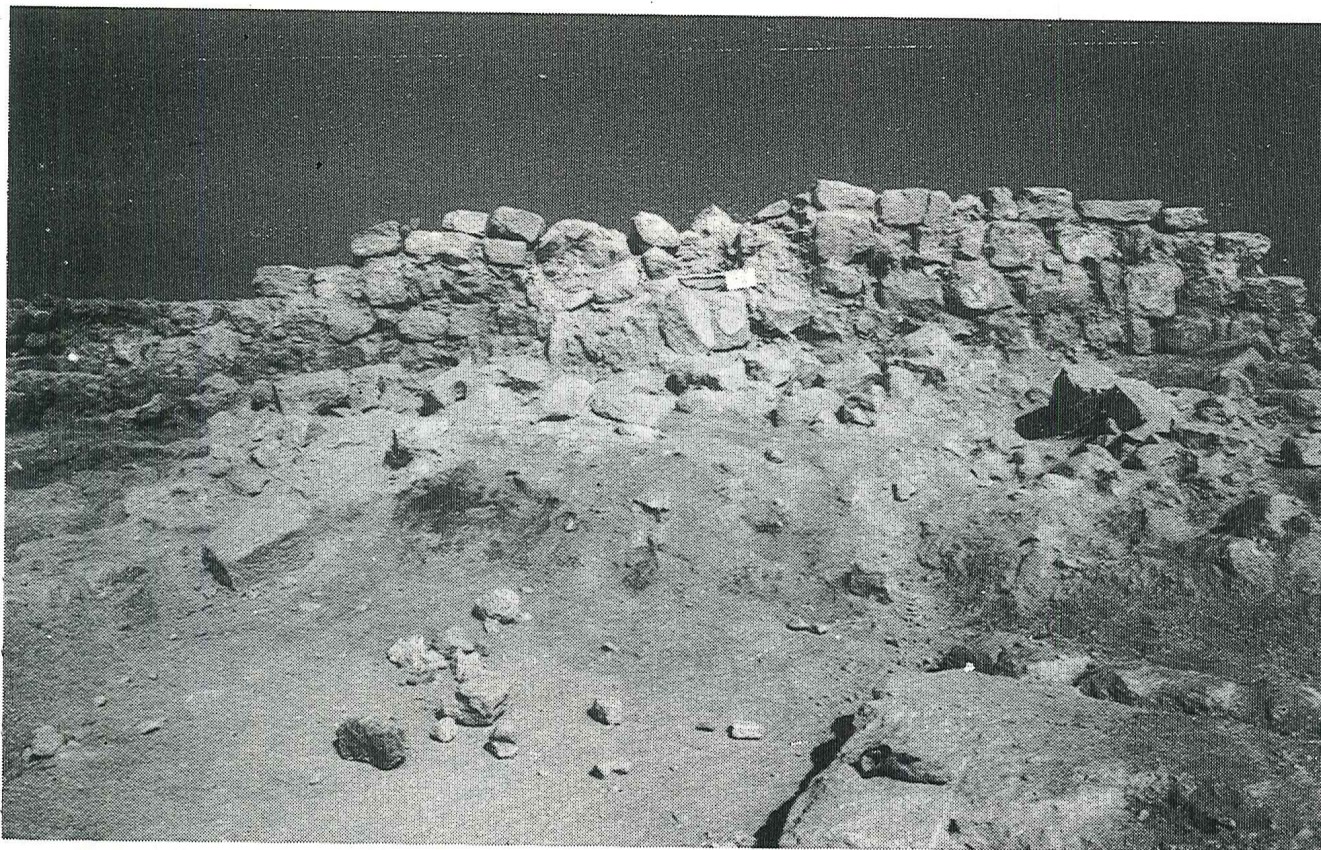
1. The US 10 buttress leaning against Tower 3.

Along the whole length of the south-eastern side of Tower 3, there is a dry-laid stone wall 240 cm wide, with only one side facing to the south-east, and an internal inlet formed by irregular, small to medium size stones (Fig. 1, US 40). A similar technique was used for another structure, somewhat narrower (140 cm) and shorter (25 m), formed by irregular ashlars and large re-used blocks, itself placed against the side facing the previous building, and thus may be considered as a real reinforcement structure (Pl. II, 1).⁹

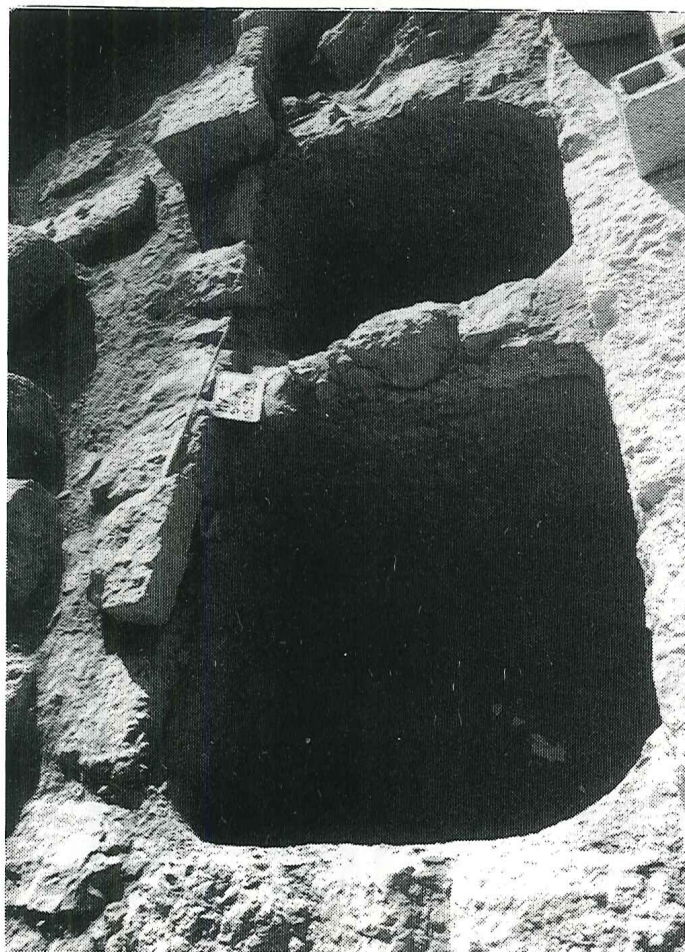
2. Excavation at the village. A detail of the double-chamber cistern leaning against the eastern wall of the church.

At a later date the building underwent some restorations. New partitions were added and, above all, a cistern (US 31-33) was built with a double quadrangular chamber having smoothed corners (Pl. II, 2), placed directly against the external eastern wall of the church, internally covered with plaster. This first restructuring and the succession of new buildings (*f-g*) caused the partial destruction of the mosaics, as in Room *d*, where new partitions were built directly on the previous mosaic floor and later a new double-chambered cistern (US 56) was
