## THE PETRA CHURCH PROJECT, 1992-93 A PRELIMINARY REPORT

by  
Robert Schick, Zbigniew T. Fiema and Khairieh 'Amr

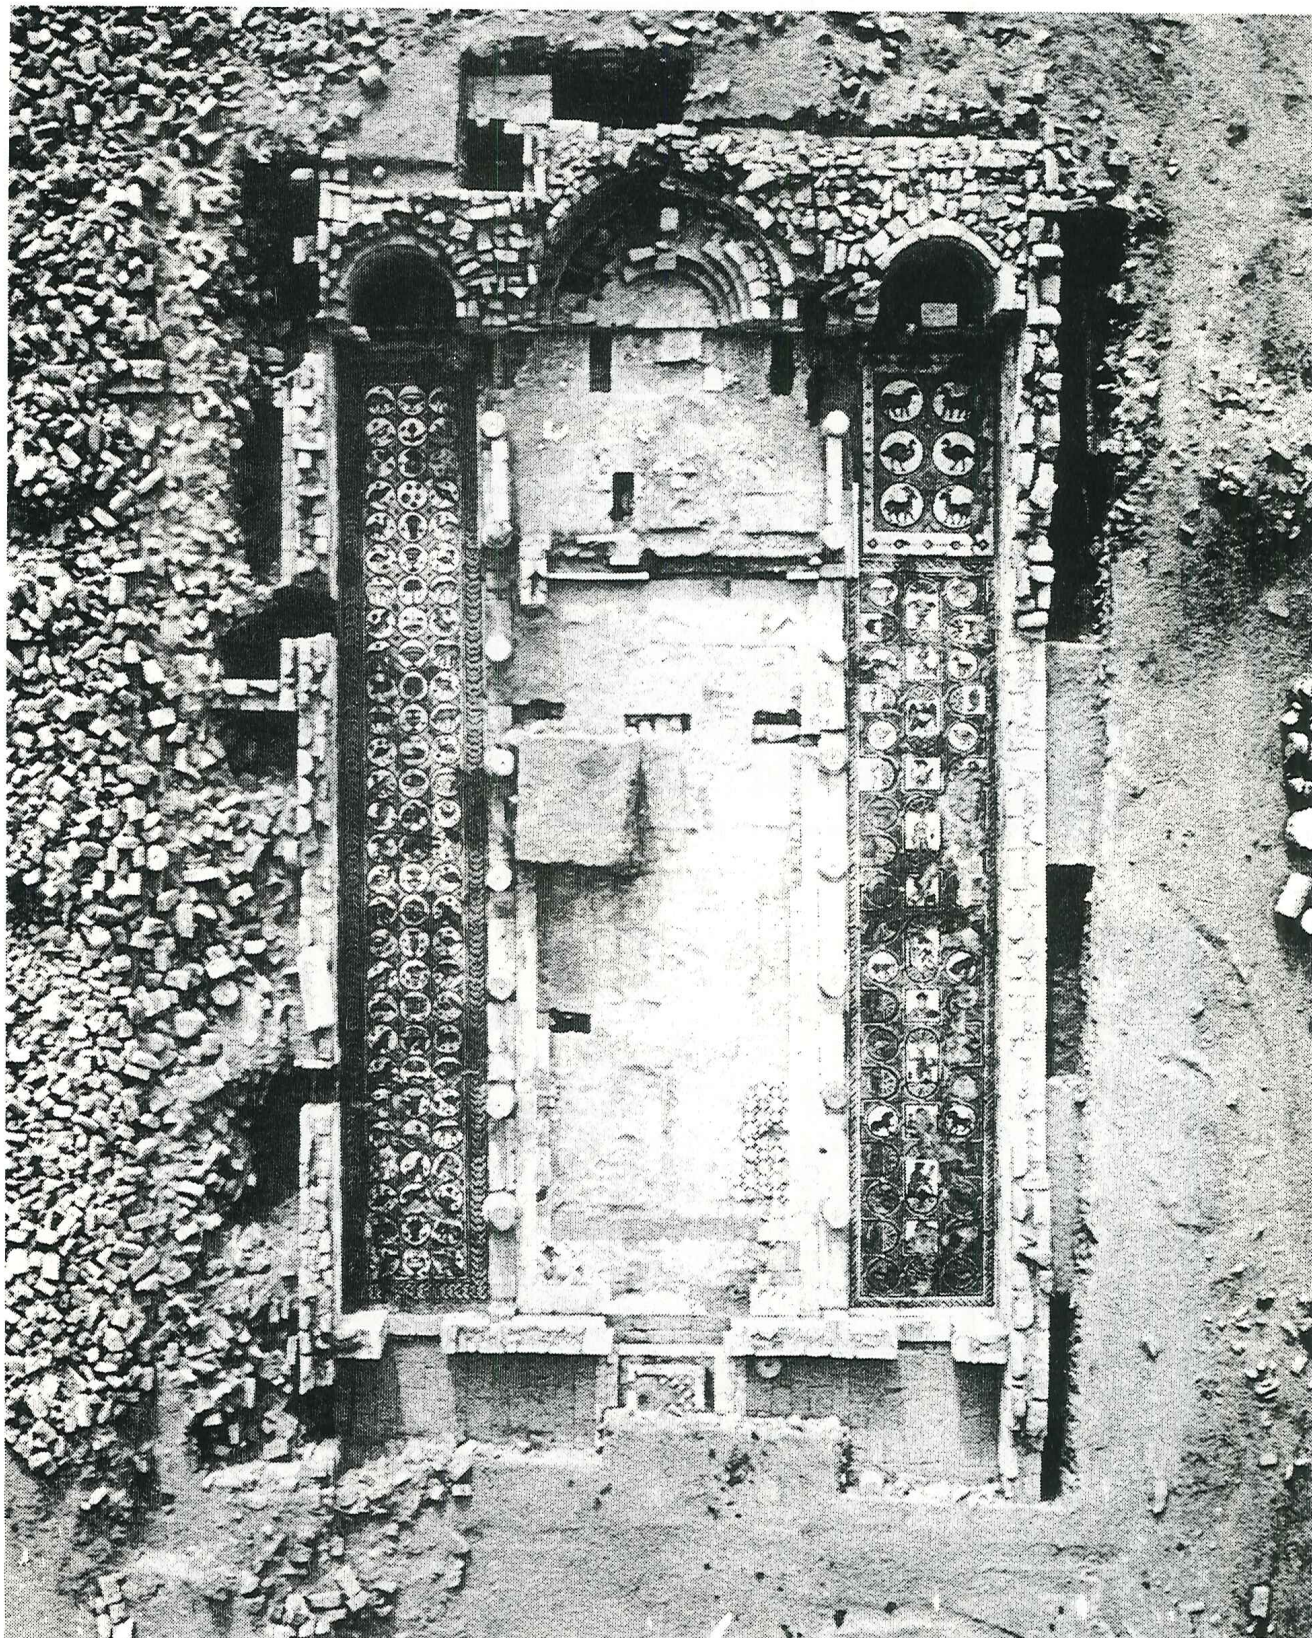
Aerial view of the church. Photo by J. W. Myers and E. Myers.

The church is located in the heart of the city, east of the Temple of the Winged Lions, on a ridge north of the colonnaded street. The building is a standard triple-apsed basilica with the nave divided from the aisles by two east-west rows of eight columns (Pl. I). At the east end of the north and south aisles are semicircular apses, while the nave ends in an elevated *bema*

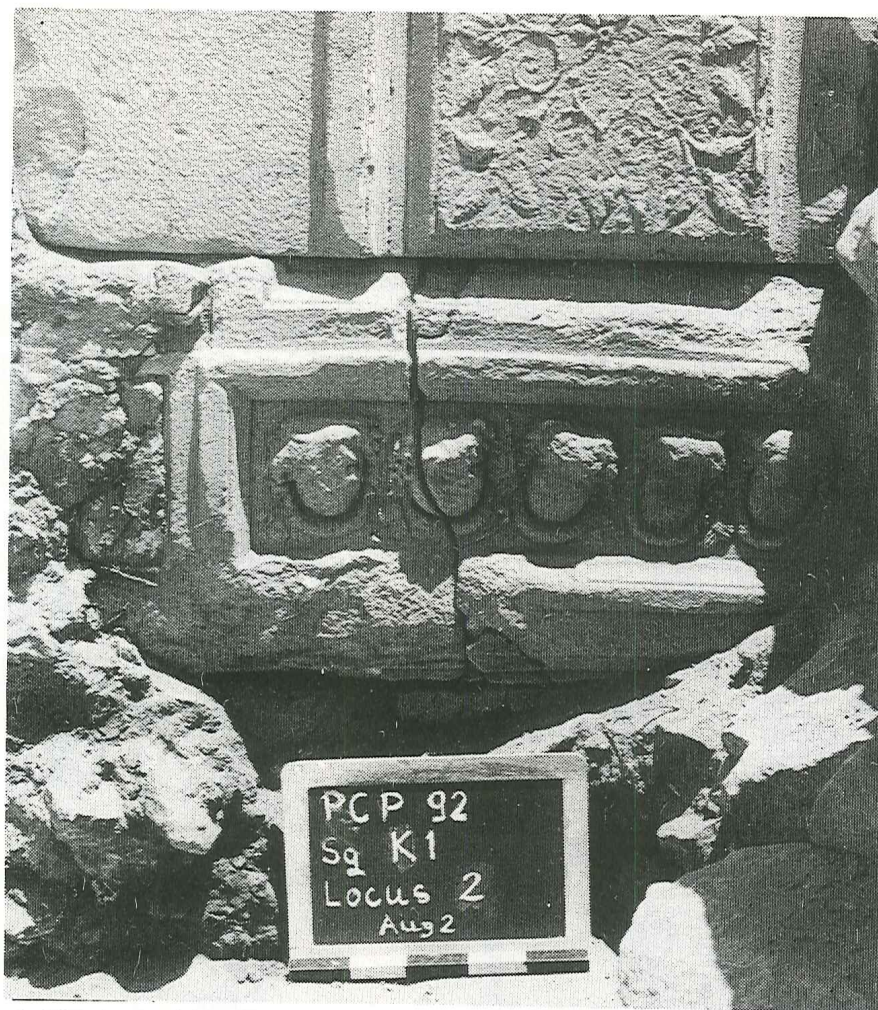
1. Northern door jambs of the central doorway. Photo by B. Douglas.

Three doors lead into the church from the atrium to the west. The door into the nave is wider than the doors into the side aisles, and is decorated with finely carved door jambs, reused from an earlier building (Pl. II, 1). Two doors in the north wall of the church, and a third door in the northeast corner of the atrium, lead to a series of rooms adjoining the church on the north; these were left largely unexcavated. Most of the copper alloy door hinges and sockets were recovered, some found still *in situ*.

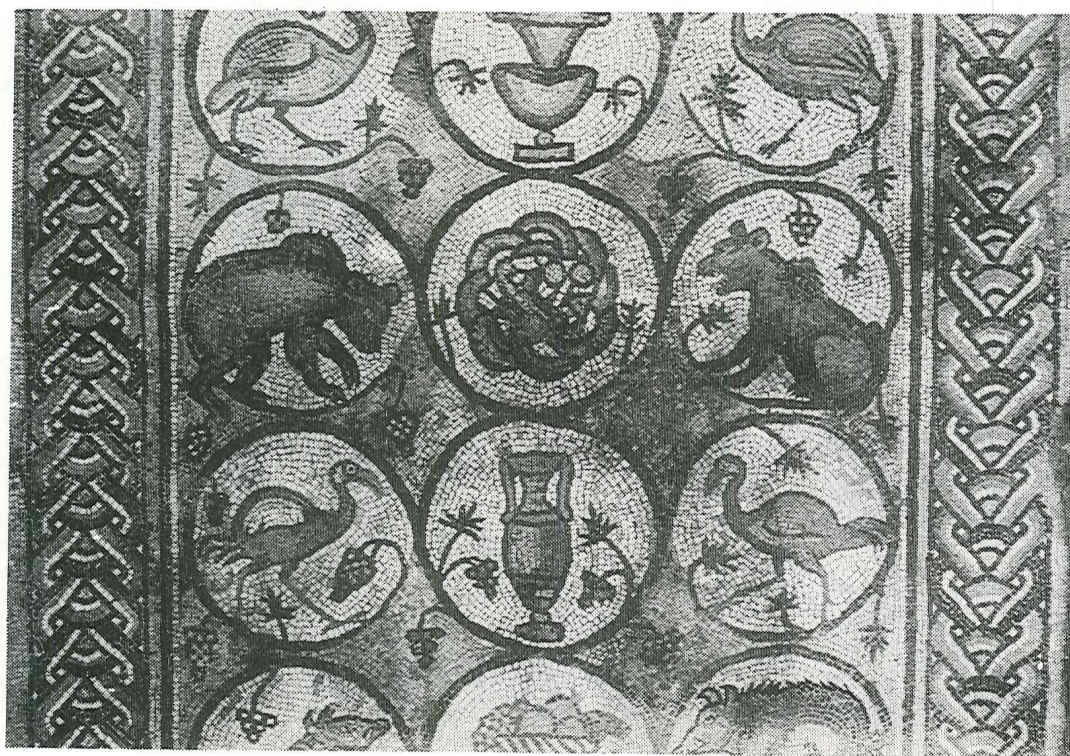
2. Part of the mosaic in the northern aisle. Photo by B. Douglas.

The mosaic floors in the north and south aisles are the major art historical find of the excavation. The mosaic in the north aisle, measuring 22.6 m x 3 m, consists of rows of circular medallions formed by vine scrolls (Pl. II, 2). Each of the 28 horizontal rows contains three medallions. The central vertical row of medallions depicts objects such as amphorae, vases, goblets, candle sticks, baskets, etc. The vertical rows on either side contain flanking pairs of birds, other animals, and people. At the western end two peacocks flank an amphora from which the vine scrolls emanate. The background outside the medallions is yellow, while white marble cubes are used as background within the medallions; the contrast in color is particularly pleasing. Glass cubes are liberally used in the floor, espe-

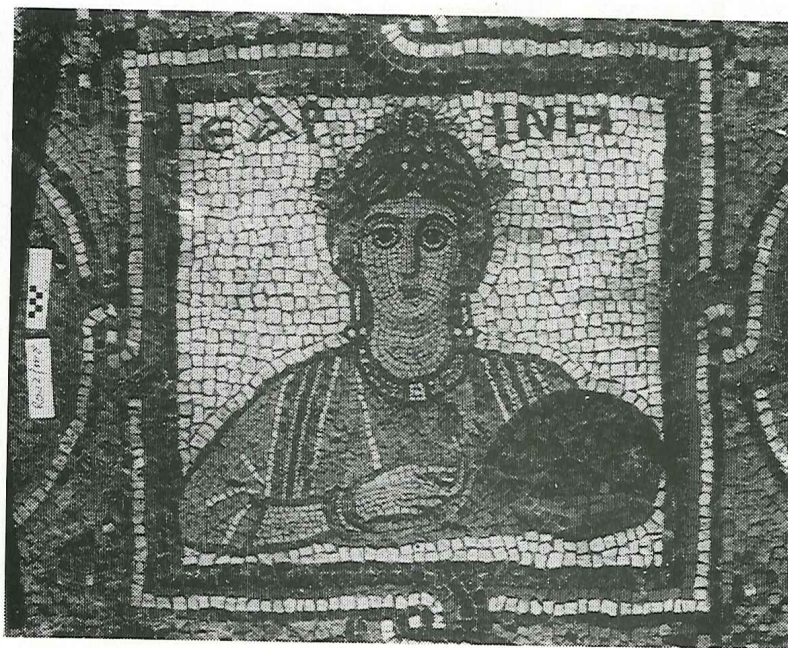
1. Personification of Spring. Southern aisle. Photo by B. Douglas.

The south aisle, measuring 23.2 m x 3.3 m has a central row of rectangular medallions with images of persons, some of which are identified by short Greek inscriptions as personifications of the four seasons, Ocean, Land, and Wisdom (Pl. III, 1). Flanking the central row are square and circular medallions depicting fish, birds and animals. Many glass tesserae are used in this aisle, as well as red-fired ceramic tesserae. Portions of the mosaic along the south wall were broken away and patched with marble pavers.

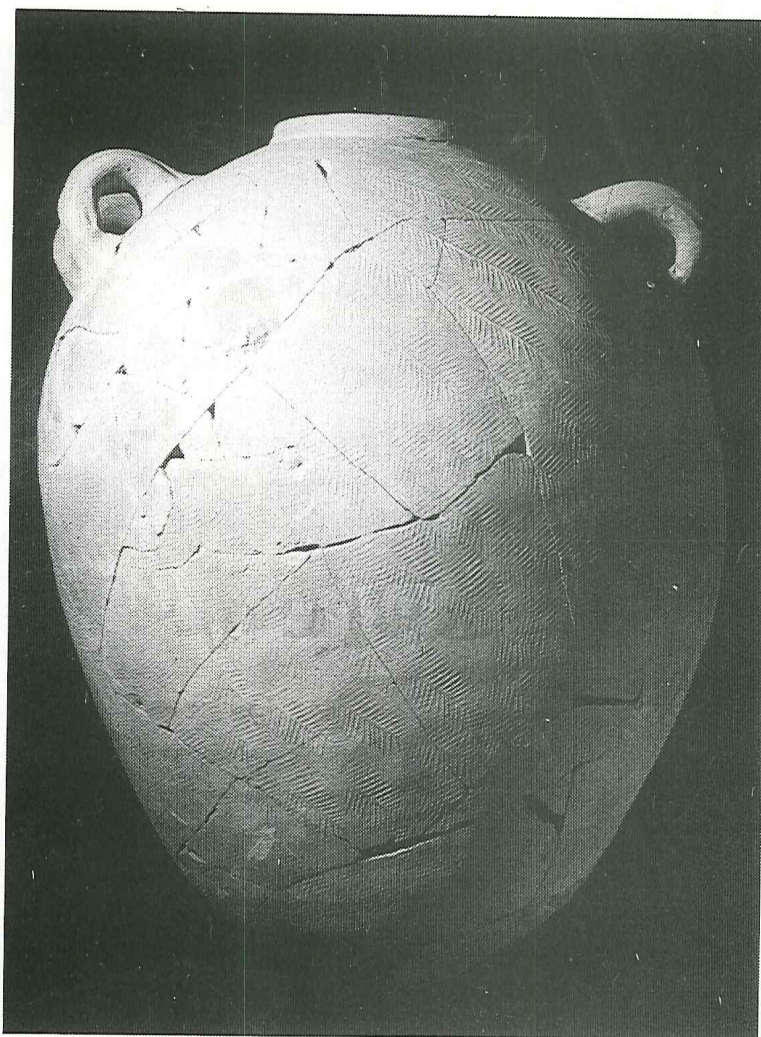
2. One of the storage jars found in the southern aisle. Photo by B. Douglas.

Along the central and western area of the south aisle, sherds belonging to 21 restorable large storage jars, one small jar and two funnels were found. All the storage jars have the same basic form with four handles (Pl. III, 2). They vary in size but the range is not yet known as only three jars were restored. The rim profiles show slight variations although all the jars were made in the same manner, starting with a central plug for the base, around which the body was built up in coils. The rims were wheel turned and then attached to the hand-made bodies. Most of the jars have a slip on the upper body that drips down to a horizontal level, indicating that the jars were supported inside a pit or a large container. All the jars are of a coarse ware with high sand content, but the colours vary through the shades of grey, into olive green and yellow, to various shades of red. Several jars have two contrasting colours on the upper and lower parts due to the applied slip. Three jars, all of a red colour, have an all-over rouletted design (Pl. III, 2).

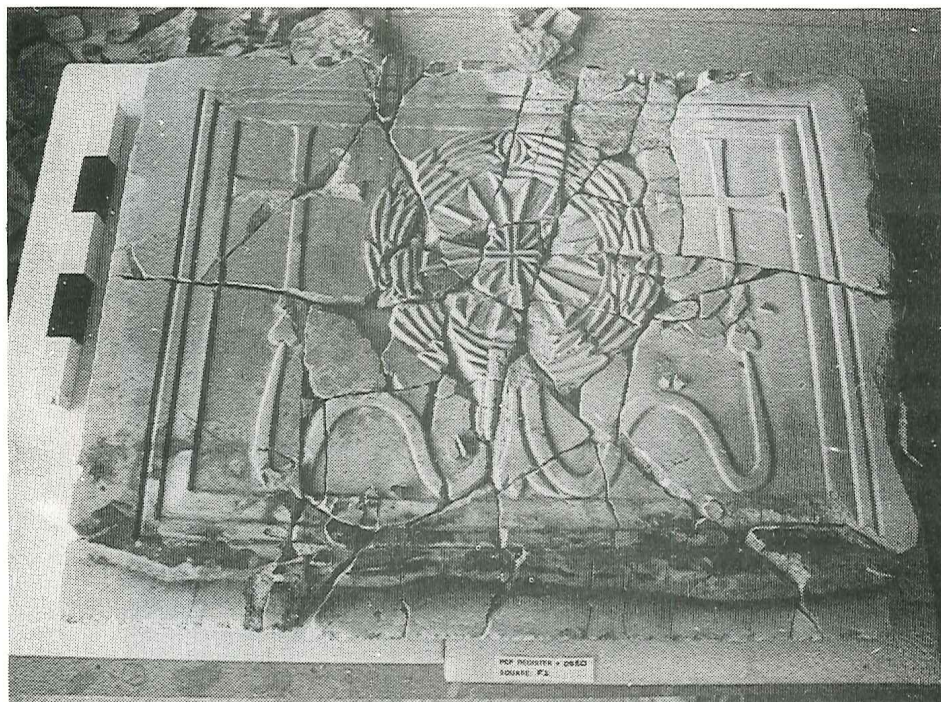
1. Marble panel. Photo by B. Douglas.

Four panels with the identical design were used in the side apses and the *bema*, consisting of a central eight-sided cross enclosed by a wreath, with ribbons that curved from the bottom of the wreath, turned up at the lower corners, and terminated in crosses to the sides of the wreath (Pl. IV, 1). One open work lattice screen with a pattern of crosses within circles was broken up into hundreds of pieces; its reconstruction will take much time. Hundreds of fragments of the altar table from the *bema* were found and also await reconstruction. The broken pieces of a large footed basin with two lion-shaped handles were found along the middle of the stylobate for the south row of columns (Pl. IV, 2). Its function remains unclear and may be reused in the church. Two other complete marble panels of uncertain function were also found nearby.
