BROWN UNIVERSITY 1999 EXCAVATIONS AT THE PETRA GREAT TEMPLE

by
Martha Sharp Joukowsky

Under the auspices of the Jordanian Department of Antiquities, the seventh season of Brown University excavations took place at the Petra Great Temple from June 5 to August 6, 1999. Figure 1 is an aerial view of the site at the close of the 1999 season, and Figure 2 is a plan of the 1999 trenches.

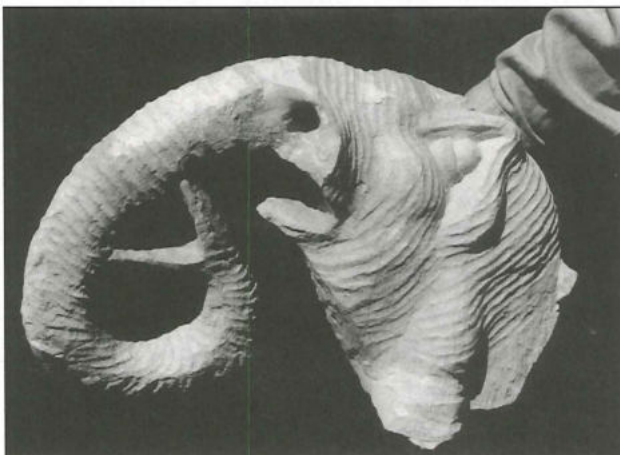
3. Reconstructed elephant-head capital (Photograph by Ueli Bellwald).

As the Lower Temenos provides the true, formal introduction to the Great Temple, its monumental expanse is integral to our understanding of what the Nabataeans sought to achieve in the construction of the precinct. The 1999 excavations saw the Lower Temenos cleared of overburden completely exposing the Hexagonal Pavement and defining the East Triple Colonnade. Not only did we find another bust of a Fortuna pilaster, but we also recovered the first *complete* elephant head from a collapsed capital shown in Figure 3. Added to this were sev-

Thirty fragments, of which nine all belonged to the same elephant head have given us our first true complete picture of a complete Asian elephant headed capital. The head shown in Figure 3 was fragmented into four pieces and the trunk into five pieces. Another elephant head measured 0.35 m in length-by-0.32 m in width-by-0.24 m in thickness. This specimen is in excellent condition with the abacus, acanthus head-dress, forehead, cheeks and eyes in pristine condition, however, the trunk area and the left tusk have been bruised by plow marks and there is a cut on the right side of the head.

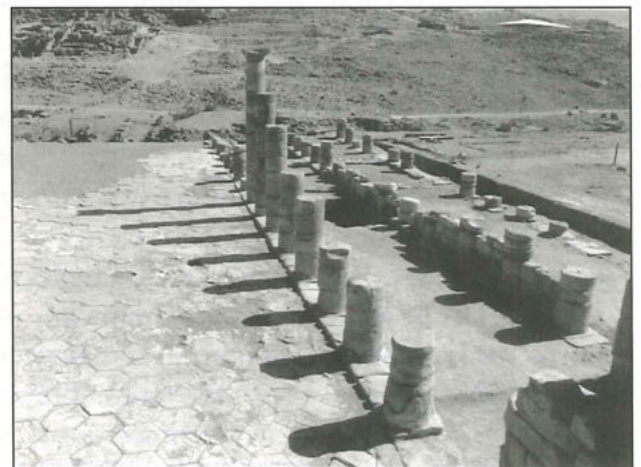
4. View of the Eastern Colonnade of the Lower Temenos, looking north (Photograph by A. A. W. Joukowsky).

Excavation of this section of the Lower Temenos (Fig. 4) provided information about the preserved extent of the Hexagonal

Pavement in the east, and the extent to which this pavement is extant to the north. *Trench 60* is also important, because it is the first extended section of the Lower Temenos that has been excavated next to the westernmost row of the East Colonnade, thus providing the first clear picture of how collapse affected the colonnade, and, by extension, the Hexagonal Pavement. Furthermore the discovery of its unorthodox circular paving stones, provides interesting avenues of explanation regarding repairs and reuse of the Lower Temenos.

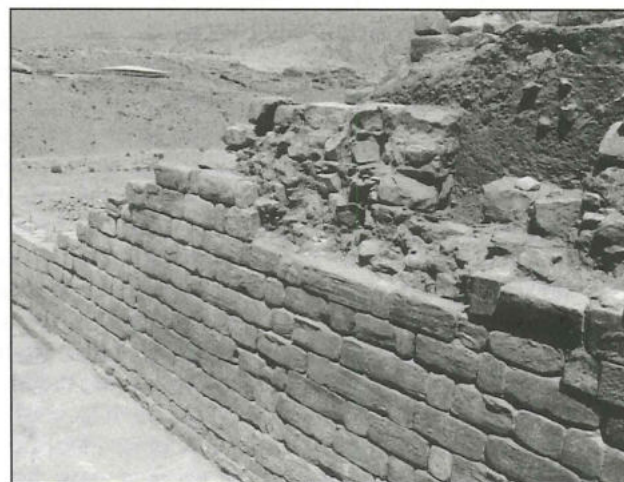
5. The East Perimeter Wall, looking northeast (Photograph by A. A. W. Joukowsky).

Measuring 34 m in excavated length, this wall's west face was 14 courses high and the depth of deposit from its highest point measured 10 m. Set into the wall was a half-excavated well-preserved doorway standing to a 3.39 m height. Buried for 2000 years, its simple entablature and interior variegated sandstone ceiling remained in pristine condition, exhibiting Nabataean workmanship at its best. Sharing the east side of the Perimeter wall and located to the east was a small reservoir, 1 m in depth, measuring 4.8-by-2.8 m. It is unclear if this should be assigned to Site Phase II, but we tentatively assume it is.

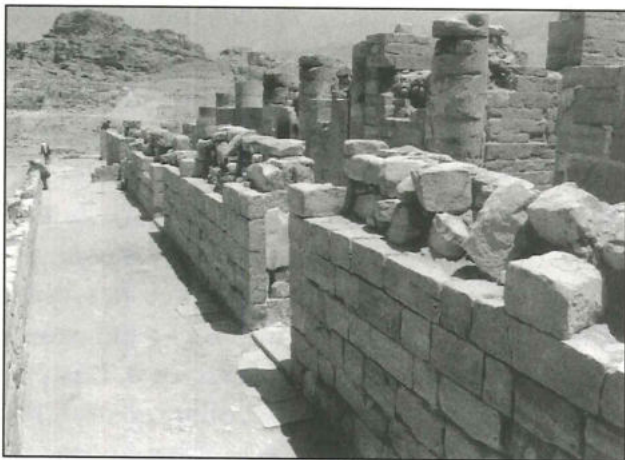
6. The West Walkway, looking north (Photograph by A. A. W. Joukowsky).

Excavated on the Temple West was the completion of the West Walkway in *Trench 63*. Measuring north south 22.70 m-by-3.74 m east west, the depth of deposit was 4 m in the Walkway south. (The overall length of the West Corridor Wall from its point of termination in the south to Doorway 1 in the north, measures a total of 36.05 m in length-by-3.74 m in width). Shown in Figure 6, this was excavated by Artemis and Martha S. Joukowsky. Features here revealed the east face of the West Walkway 'Byzantine' Wall, the West Walkway Pavement and a late East West cross Wall at the south end of the trench which extended across the Walkway abutting both the West Walkway 'Byzantine' Wall and the West Corridor Wall. Uncovered as well was the west face of the West Corridor Wall with four doorways that originally led from the West Walkway through the West Corridor Wall into the West Corridor. These were found to be in an excellent state of preservation.⁷ Important as well was the excavation of the doorways because of the delicate condition of the preserved frescos that in antiquity wrapped around the doorway threshold blocks.⁸ Figure 7 shows the relationship between the West Corridor and the West Walkway.

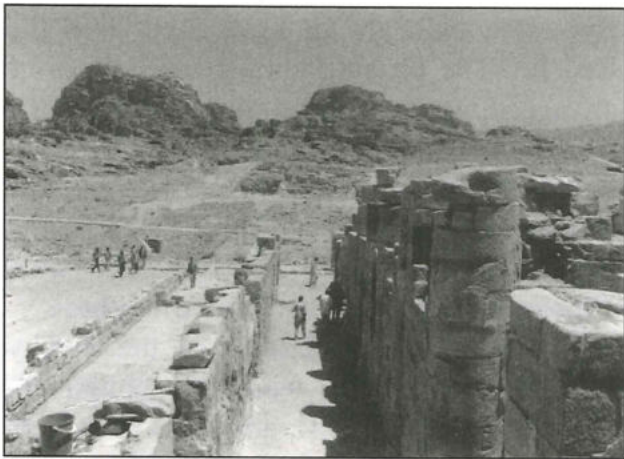
7. The West Walkway (left) and the West Corridor (right), looking north (Photograph by A. A. W. Joukowsky).

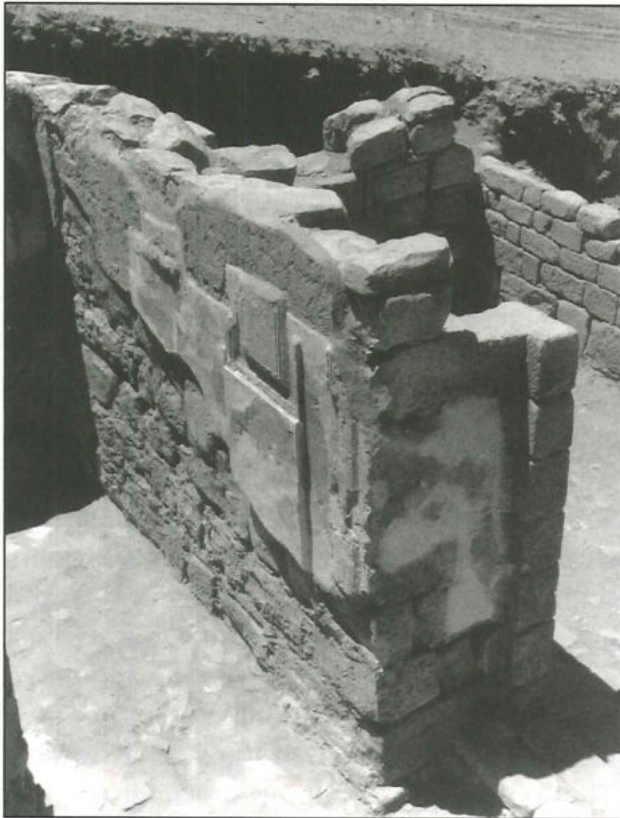
8. Decorative stucco on the West Corridor Wall at Doorway 4, looking southwest (Photograph by A. W. Joukowsky).

promised and damaged by the building of these later walls. Figure 8 illustrates Doorway 4 with the consolidated stucco wrapped around the doorway.

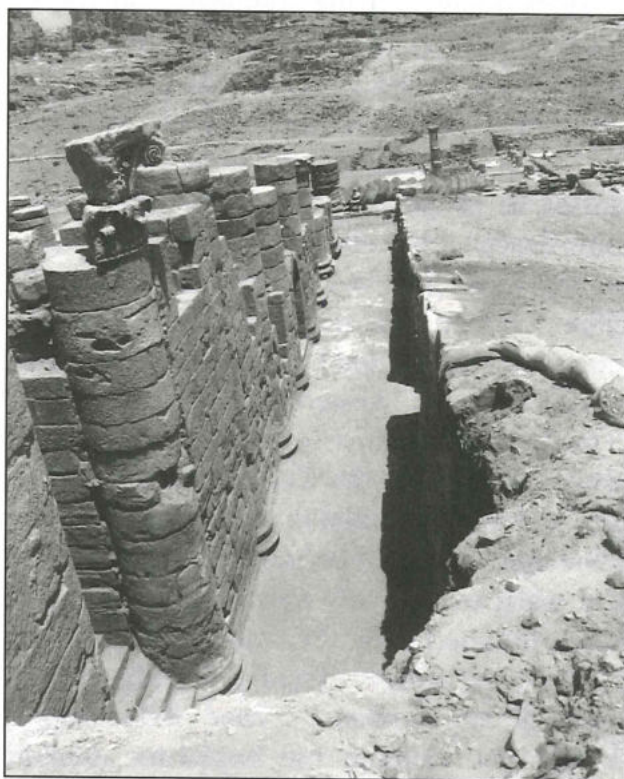
9. The East Corridor, looking north (Photograph by A. A. W. Joukowsky).

Now we turn our attention to the Temple East Corridor (Fig. 9) with standing walls of six meters in depth. Although this Corridor's frescoed walls have been damaged, the decorative program of the East Corridor was found to replicate the West Corridor with stucco panels and wall relief decorative

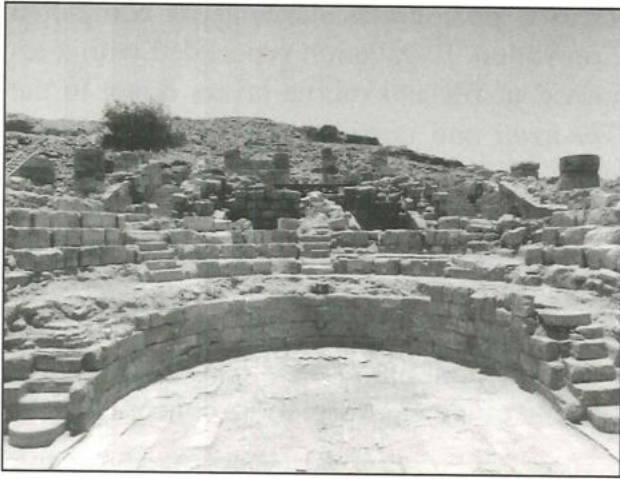
12. Completed excavation of the Theatron, looking south (Photograph by A. A. W. Joukowsky).

12 is a photograph showing its completed excavation. Excavation proceeded with a removal of fill and rubble layers down to the *Theatron* and corridor architecture. In almost every instance, the features were found to mirror those discovered in the west half of the installation - seats, walkways, staircases, orchestra and Pulpitum walls and floors, columns and antae.

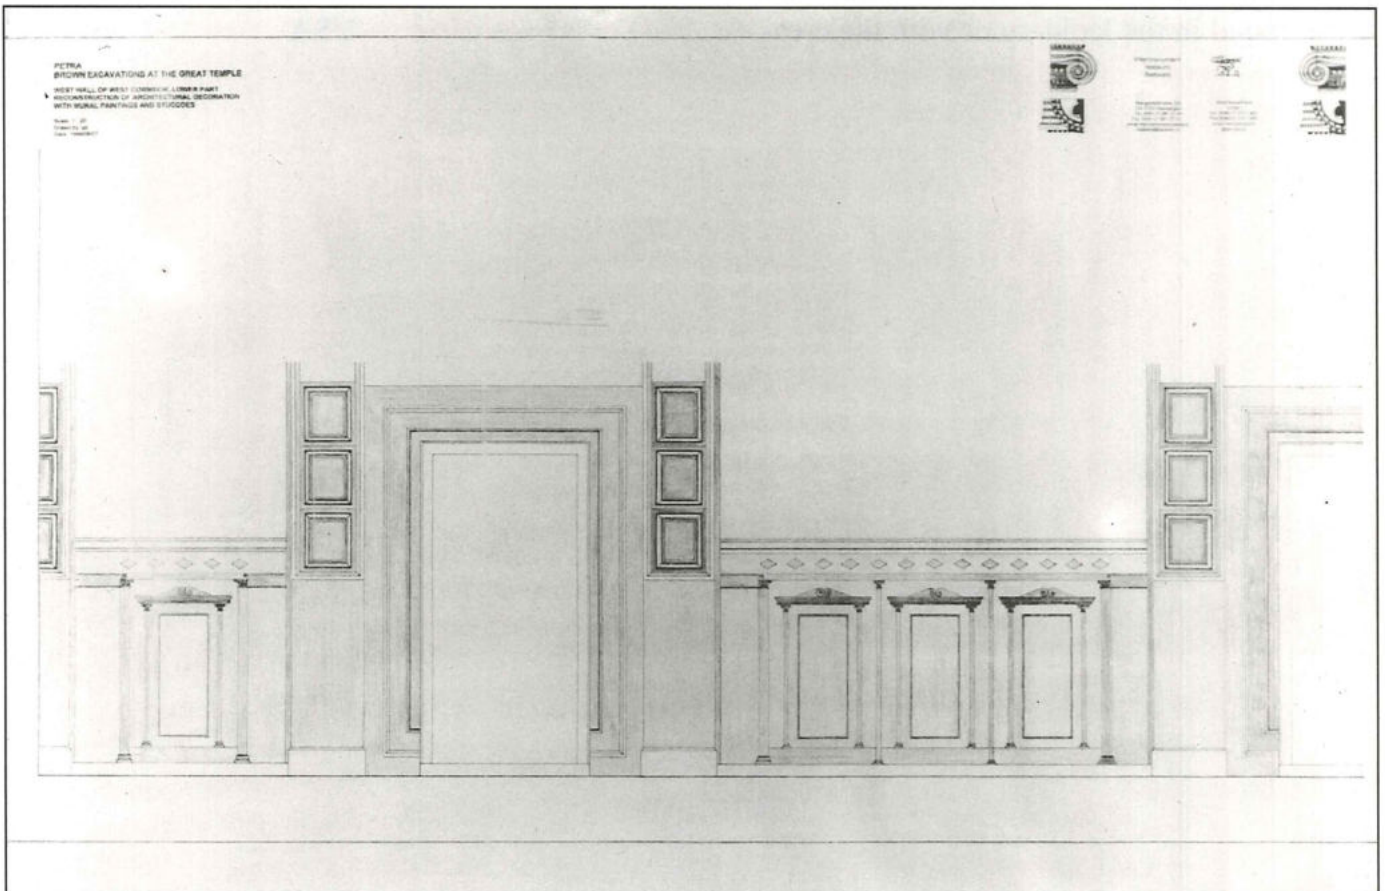
13. Reconstruction of the decorative scheme of the West Corridor Wall, east face (Drawn, drafted and restored by Ueli Bellwald).

The West Corridor Wall, east face required stabilization before the restoration of the stucco decoration. Figure 13 shows its decorative scheme as proposed by Ueli

Bellwald. Cleaning around the stone ash-lars and the use of snecking stones to fill the interstices was integral to this project. Once completed, Ueli Bellwald continued to consolidate and reconstruct the frescos on the east face of the West Corridor wall. Among other projects in the Temple, was the re-erection of the northernmost Temple West Corridor doorway, the repair of the bases of the West Corridor columns, and the re-building of the West Walkway Wall to one height. The rear west heart-shaped column also has been restored to a seven meter height using its original components.
