# THE 1999 FINNISH JABAL HĀRŪN PROJECT: A PRELIMINARY REPORT

The Finnish Jabal Hārūn Project (FJHP) has carried out its second fieldwork season between August 1 and September 23, 1999. The project is directed by Prof. Jaakko Frösén, University of Helsinki. The excavation fieldwork was supervised by Dr Zbigniew T. Fiema, Dumbarton Oaks Center, with Dr Mika Lavento, University of Helsinki, being in charge of the survey. In total, 4 archaeologists, 1 architect, and 11 students from the University of Helsinki, and 3 professional cartographers from the Helsinki University of Technology, as well as one Swedish archaeologist have actively participated in the fieldwork. Prof. Ari Siiriäinen, the archaeologist from the University of Helsinki, and Prof. Henrik Haggrén, the cartographer from the Helsinki University of Technology have participated as senior staff members during a part of the project. Two senior conservators-teachers and two students from the Department of Conservation, Espoo-Vantaa Institute of Technology have taken part in the second part of the fieldwork season. The DoA representative for the FJHP was Mr Hani Falahat. Up to 20 local workers were employed.

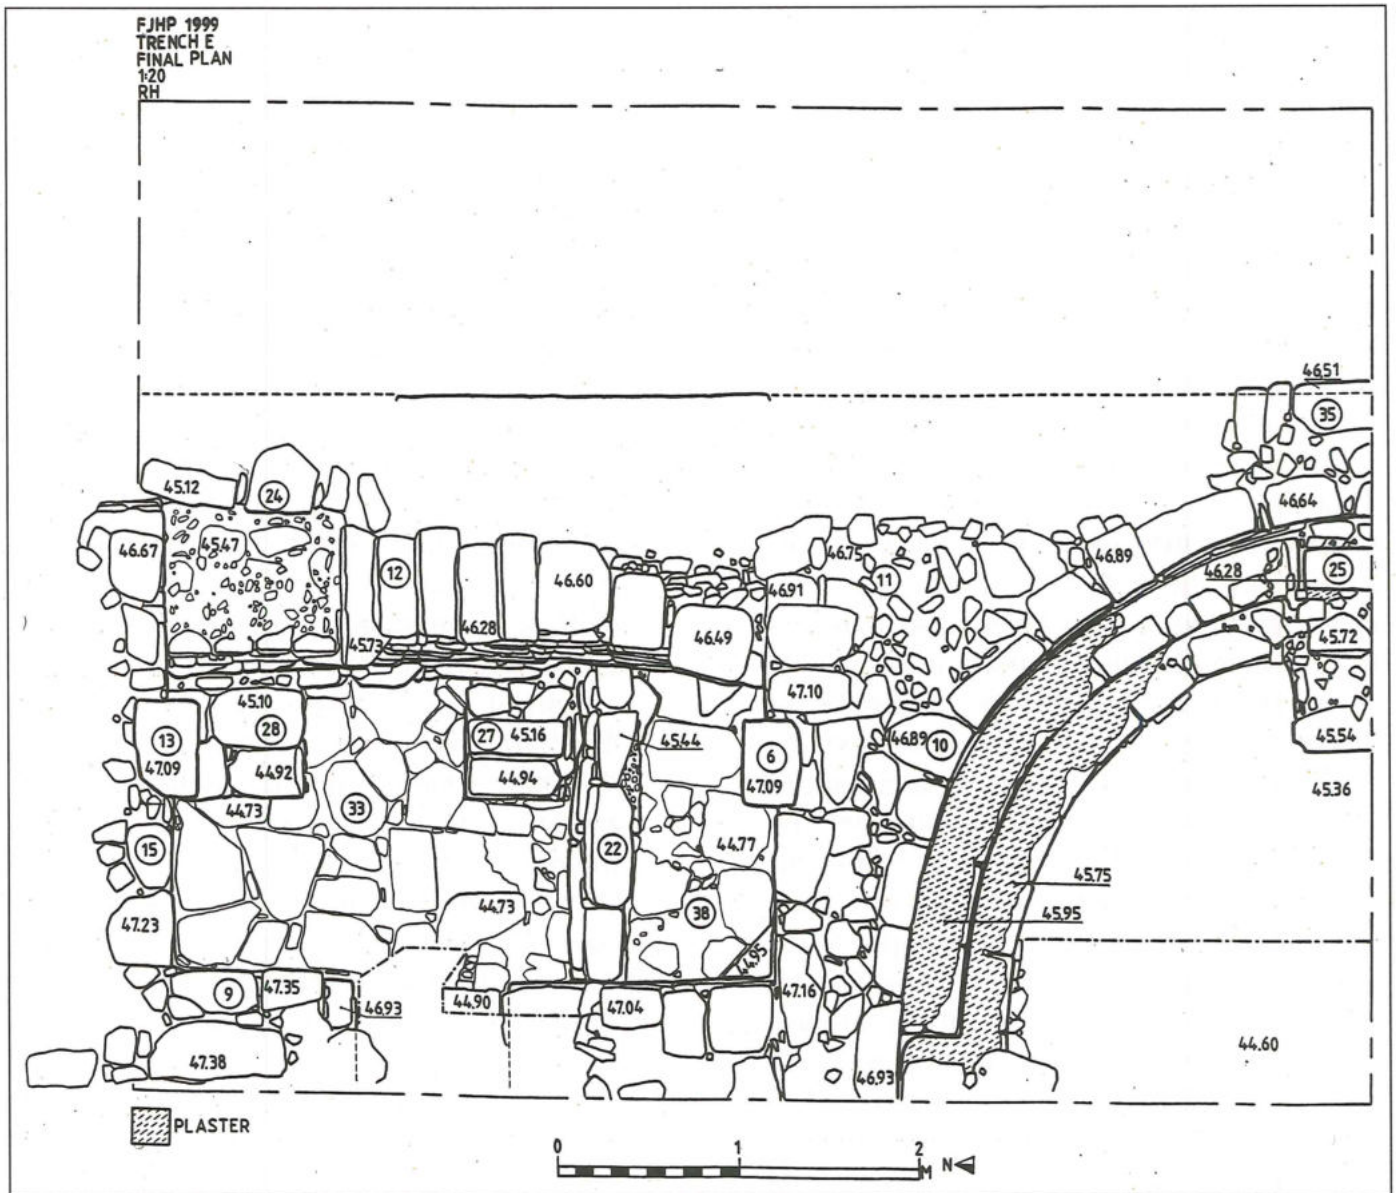
2. Trench E - final plan (by R. Holmgren).

*Phase 1: The Church.* Almost all of the main structures in the trench belong to this phase, i.e., the four walls of the pastophorion (H and R; loci 15 and 4 and U and C; loci 9 and 35), the apse wall (W. T, locus 10), and the synthronon (loci 19, 20 and 25). This phase also includes two arch springers (loci 6 and 13) in Walls R and H, which supported a single arch which spanned the space of the pastophorion, as well as a few remains of the marble floor (locus 31) in the apse, still *in situ* next to the lower step of the synthronon. The mortar bedding (locus 26A) for the floor was much disturbed, but its contents primarily represented fine and

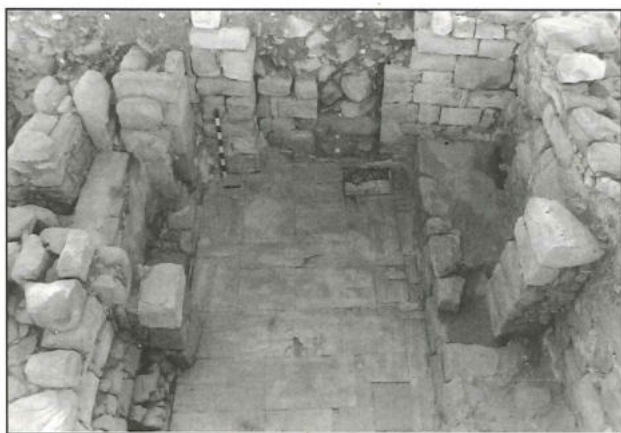
3. Trench F - general view, with the bema on the left and the secondary bench and pilaster on the right (by M. Mustonen).

Trench F was opened in the SE part of the church, including a part of the area in front of the apse, and the eastern part of the southern aisle (Fig. 3).

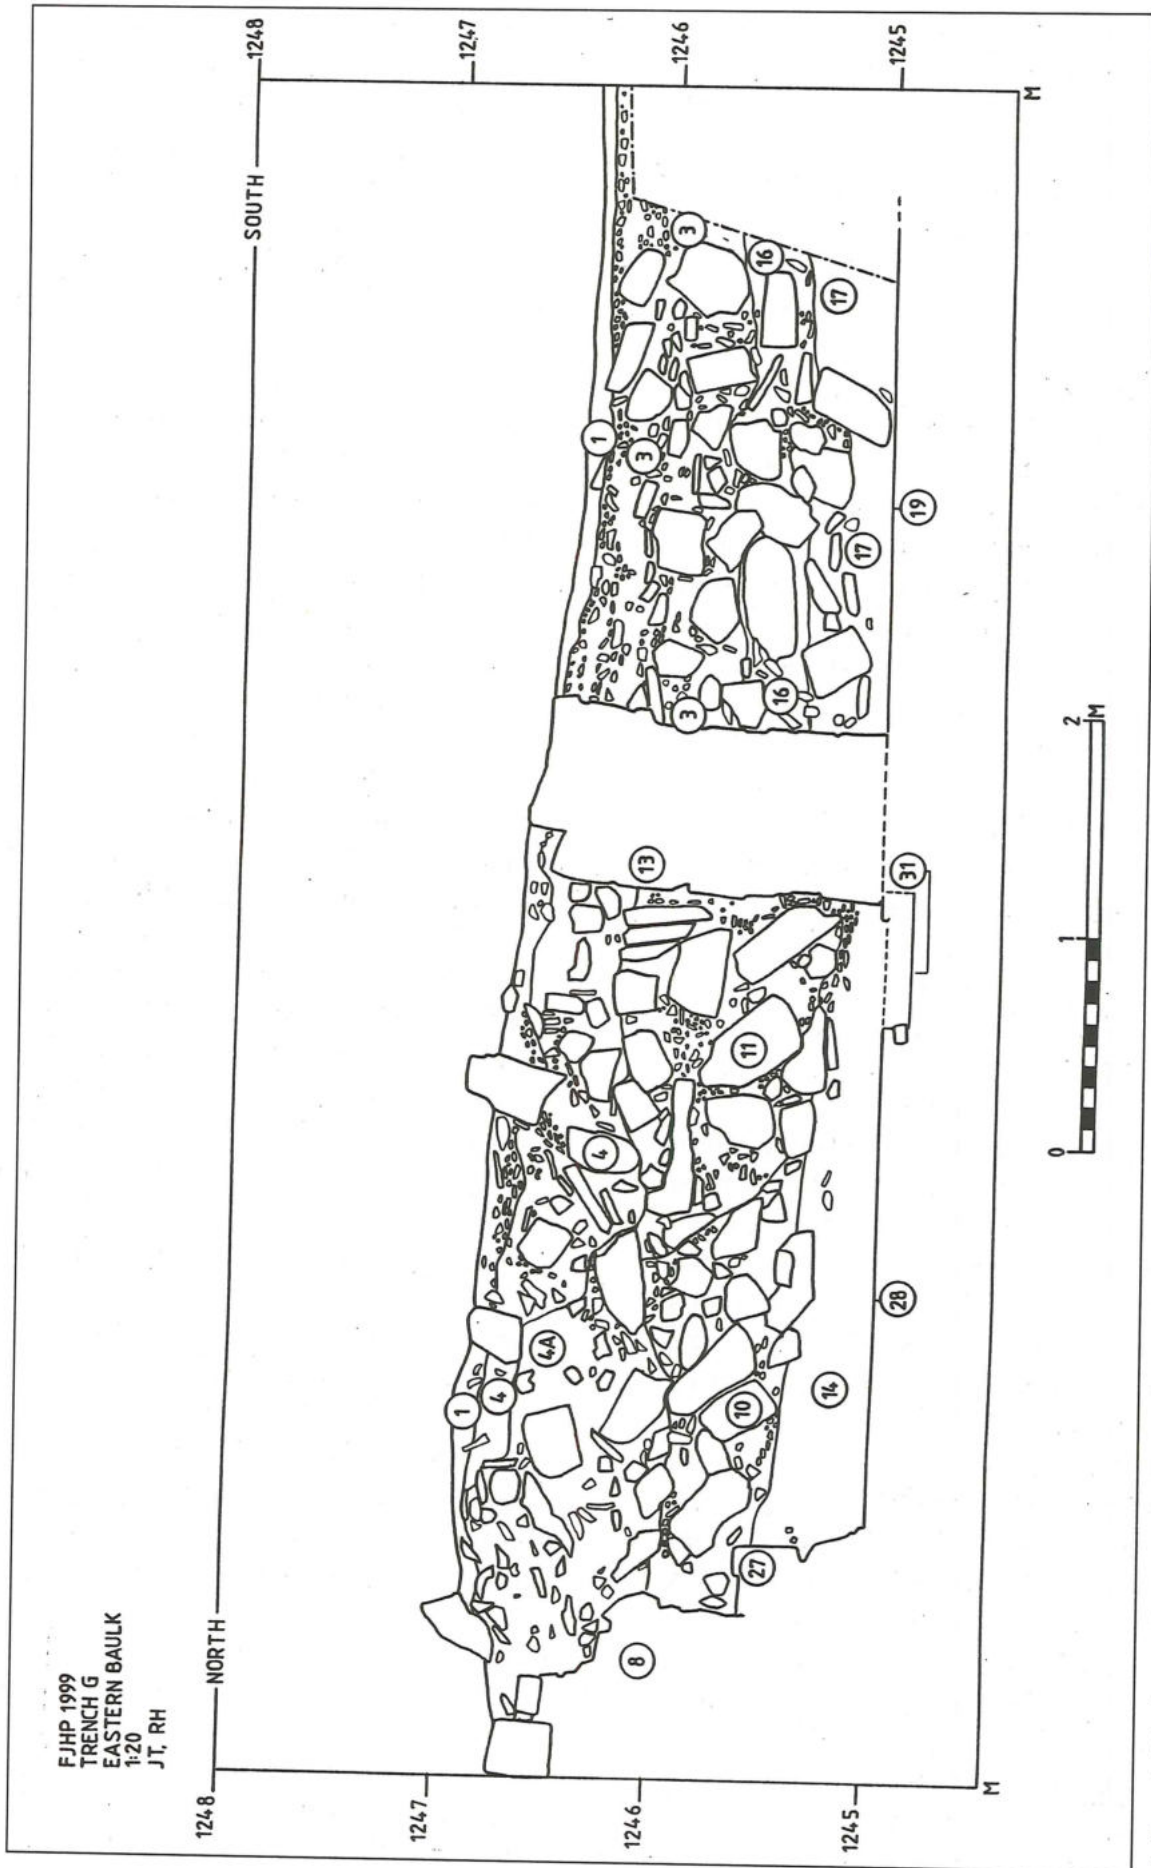
4. Trench G - the east balk (by R. Holmgren and J. Tuominen).

Trench G, situated in the central part of the northern aisle and the nave of the church, was excavated to gain information on the N-S wall which divided the church into eastern and western parts, and on the general stratigraphy in this part of the church (Fig. 4).

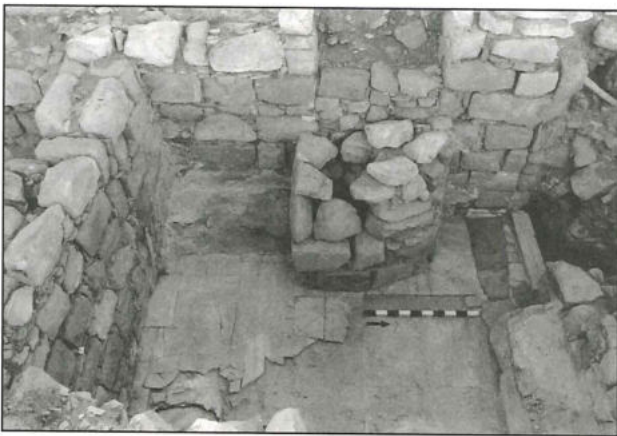
5. Trench G - the installation, locus 24 in the front, the doorway to the chapel on the right (by J. Viuhonen).

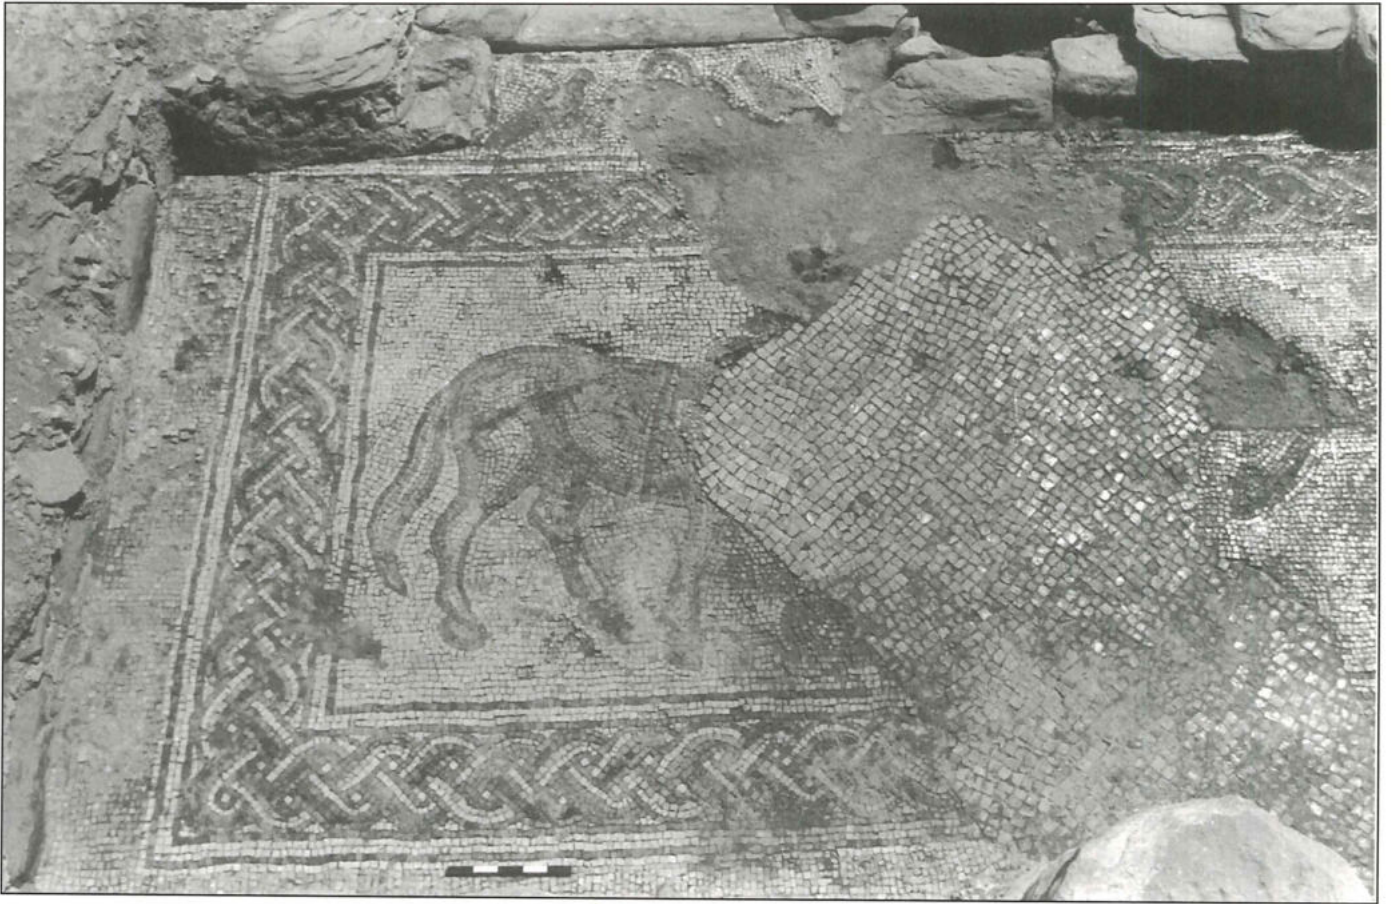
6. Trench H - the mosaic floor, westernmost section (by M. Mustonen).

*Mosaic Floor.* Originally, the mosaic featured an almost symmetrical arrangement of designs on both sides of the central door to the church proper. The northern half featured a man (or two men) standing in front of a horse, fighting a wild boar (?) with a spear (Fig. 6). Farther south was a representation of a standing lion followed by a round medallion which occupied the central position in the narthex floor, and consisted of colorful bundles and squares intertwined into intricate geometric designs. That was followed by another lion, and another hunting scene featuring a hunting dog (or panther?) attacking a gazelle which, in turn, was assaulted by another human with a spear. In the inset of the northern doorway to the church, there is a representation of two birds flanking a geometric symbol. The entire mosaic has a colorful border band of three intertwined bundles or chevrons. Except for the preserved chevron pattern, the birds, a half of a horse, small fragments of lions heads and mouths, a large part of the dog, and occasional feet, tails, hunters' spears and a shield, and the medallion, the mosaic is heavily altered by the later iconoclastic activities. The damage is evident in seven discrete areas. Tesserae which formed the images of humans and animals were either

carefully removed and equally carefully replaced by larger bluish grey tesserae filling the empty spaces, or the original colorful tesserae were removed and then reinserted into the same image but in a scrambled fashion. However, while the tesserae reinsertion was done carefully, the removal was not complete, thus the preserved details allow for an overall reconstruction.

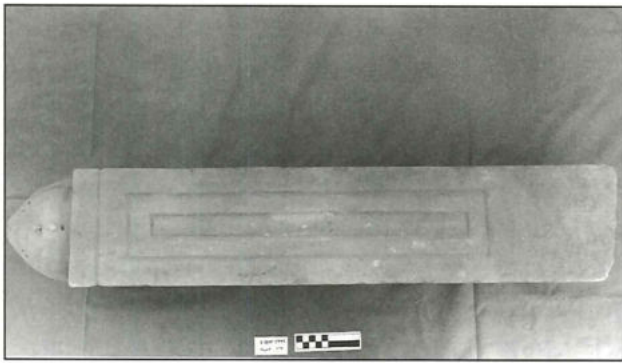
7. The marble chancel post recovered from Trench G (by M. Mustonen).

Altogether, 137 objects were registered from among the finds of the 1999 excavations. The largest group consisted of decorated marble fragments, especially from Trench G. Besides fragments of chancel screens, one almost complete chancel screen post was found (Fig. 7) and parts of other posts. All belong to a very well-known type with a bulbous, sharp-pointed finial, such as were found in the Petra church (Fiema, forthcoming). Parts of marble colonettes

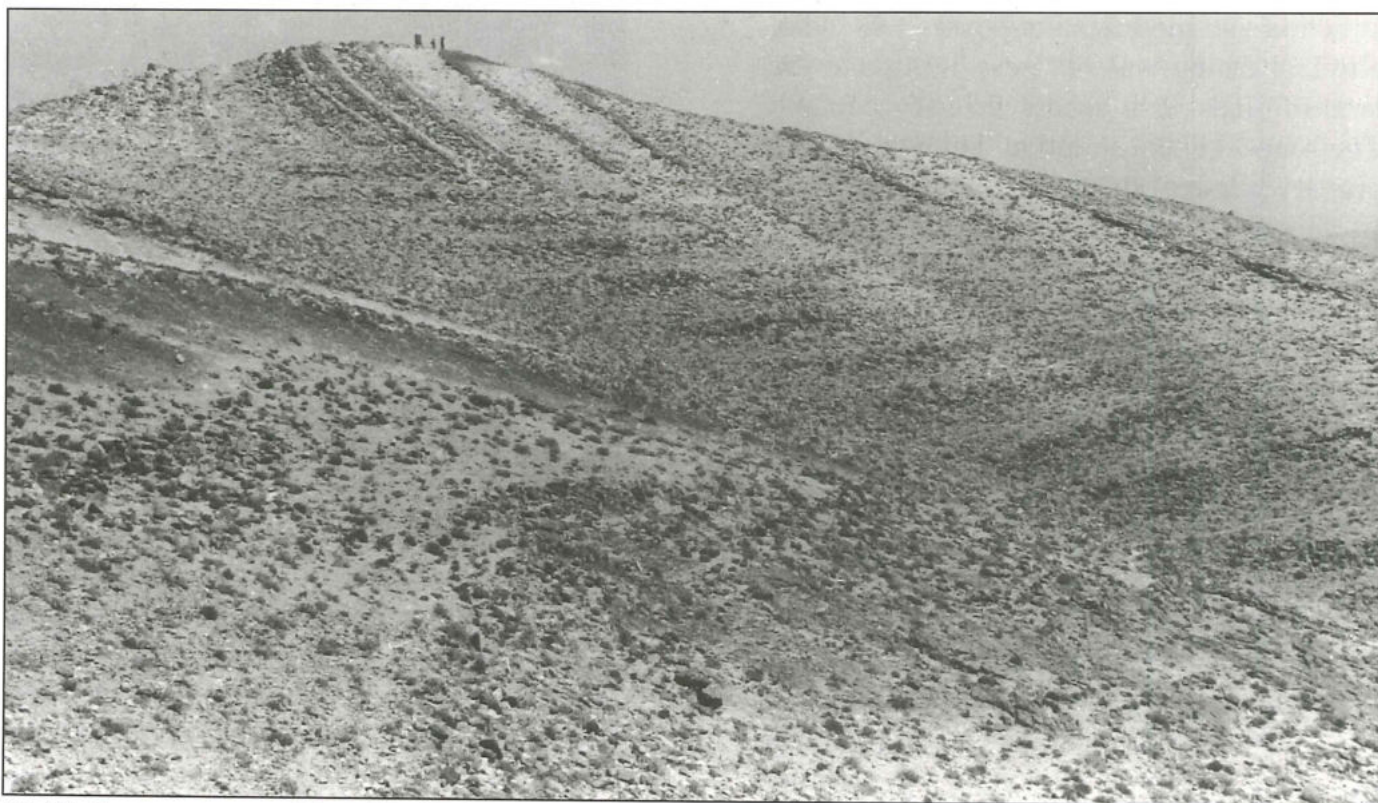
10. The barrage system of Area U -sites 67 and 68 (by H. Jansson) .

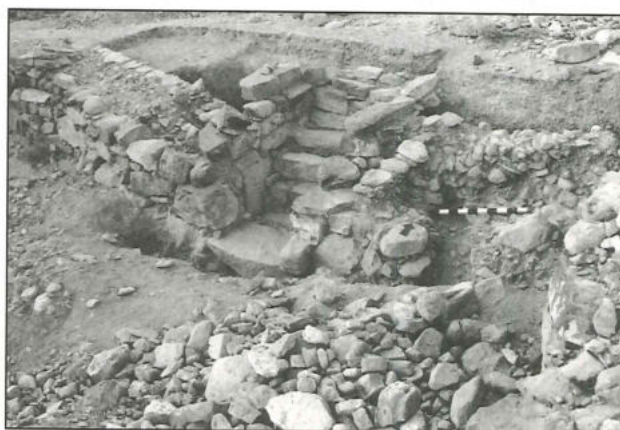
11. Site 33e, barrage 108 (by H. Jansson).

Test trenches were opened in places already investigated in 1998 (Frösén *et al.*, 1999): at a possible cultic site and at two barrages. Site 33e, barrage 108 (Fig. 11), was chosen because it contains a step-like installation running perpendicularly through the barrage. It served not only as steps for

passage, but also as a water drop structure (Evenari *et al.*, 1971: 104) that was used to irrigate cultivation terraces in a controlled way. A trench on each side of the steps was opened, and a third one at the eastern end of the barrage, a total of approximately 24 m<sup>2</sup>. The investigations concentrated on the relationship between the step-like construction and the barrage itself, the building phases of the barrage, and the relationship of this barrage to another one which runs perpendicularly to the east.

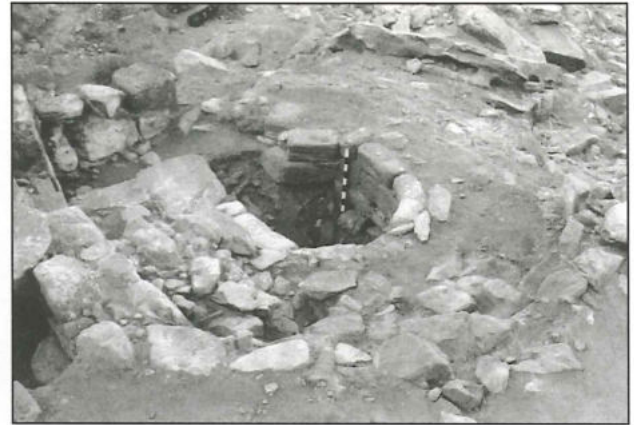
12. Site 37, the so-called “Nymphaeum” (by M. Mustonen).

Site 37, an enigmatic and unique stone structure or a “Nymphaeum” (Fig. 12) is located at the northern end of Area C, at the bottom of a tributary wadi running down the slope of Jabal Hārūn. To the south, there is a pass through which an old caravan route went from Petra to the Wādī ‘Arabah. The structure is ca. 10 m (N-S) and 6 m (E-W), with a rounded “well” in the center, and the

whole is surrounded by a semicircular wall. The “well” could not hold water, and the masonry supports did not feature waterproof mortar. Test excavation included small soundings and a general clearance. The latter, conducted between the “well” and the semicircular wall, exposed a row of steps leading to a small platform-like structure. It is also possible that there was a row of stones leaning on the semicircular wall, which could have served as seats. A floor made of sandstone slabs was found (Soundings 1 and 4) in the area between the “well” and the semicircular wall, perhaps a buildup for the seats. A water channel (ca. 0.5 m wide) was found ca. 0.7 m to the east of the southeastern part of the semicircular wall. The function of the channel remains elusive; its lower end is eroded, and the upper part buried under a thick layer of sand. Other soundings - between the water channel and the semicircular wall, and in the badly eroded southeastern part of the site - did not yield any recognizable remains. Some Nabataean pottery found might be *in situ* or re-deposited. Additionally, limestone building material (slabs and one curved ashlar) was found inside the “well” and around the structure. The exact function of the structure is unclear, but it might have been a cultic place. A “Pond Temple” recently investigated near Petra (Lindner and Gunsam 1995) resembles the “Nymphaeum” in Area C in some respect: they are both located
