THE Umayyad Mosque of the Citadel of Amman

Antonio Almagro and Pedro Jiménez

Introduction

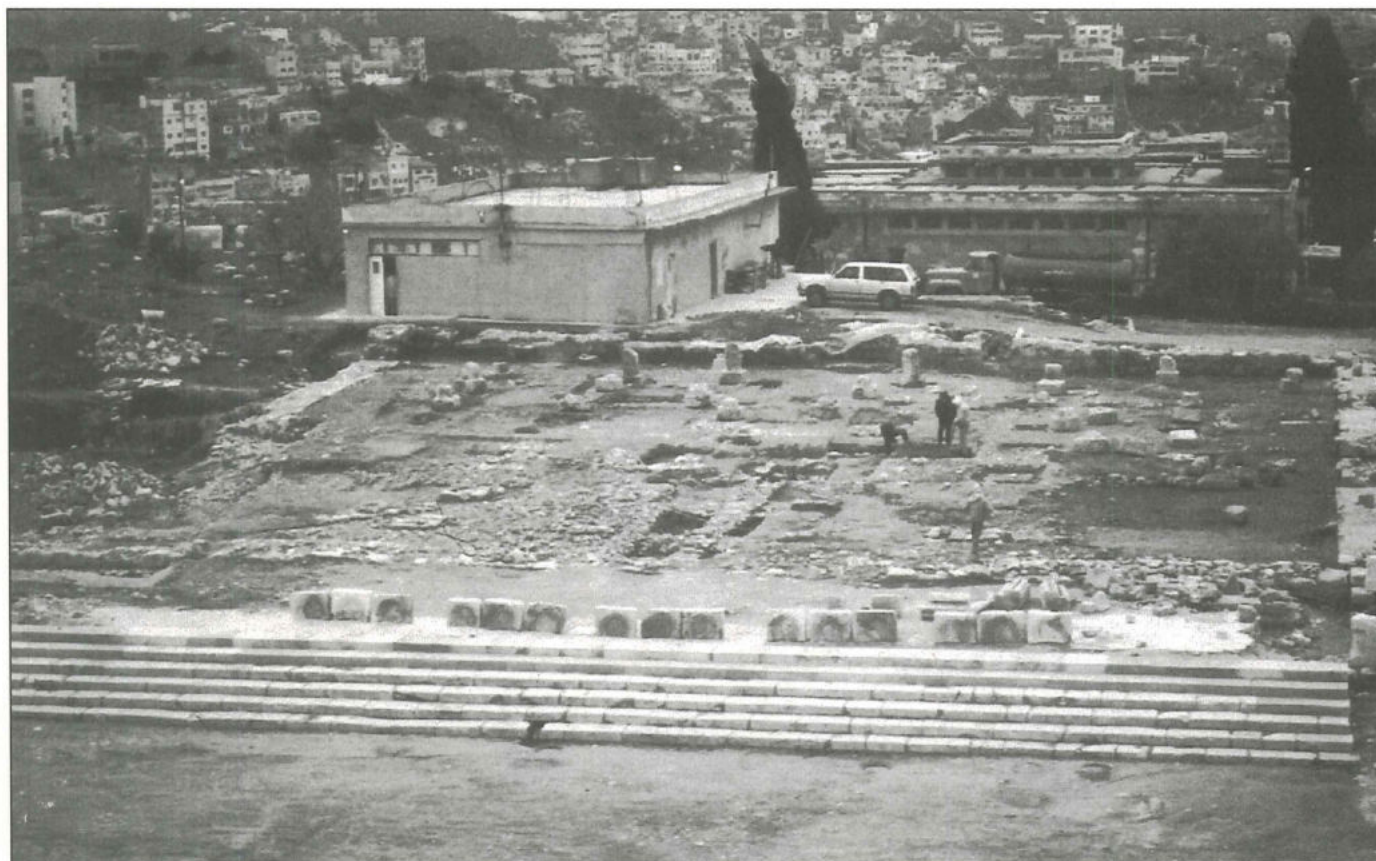
3. General view of the mosque from the upper part of the entrance hall soon after the excavation.

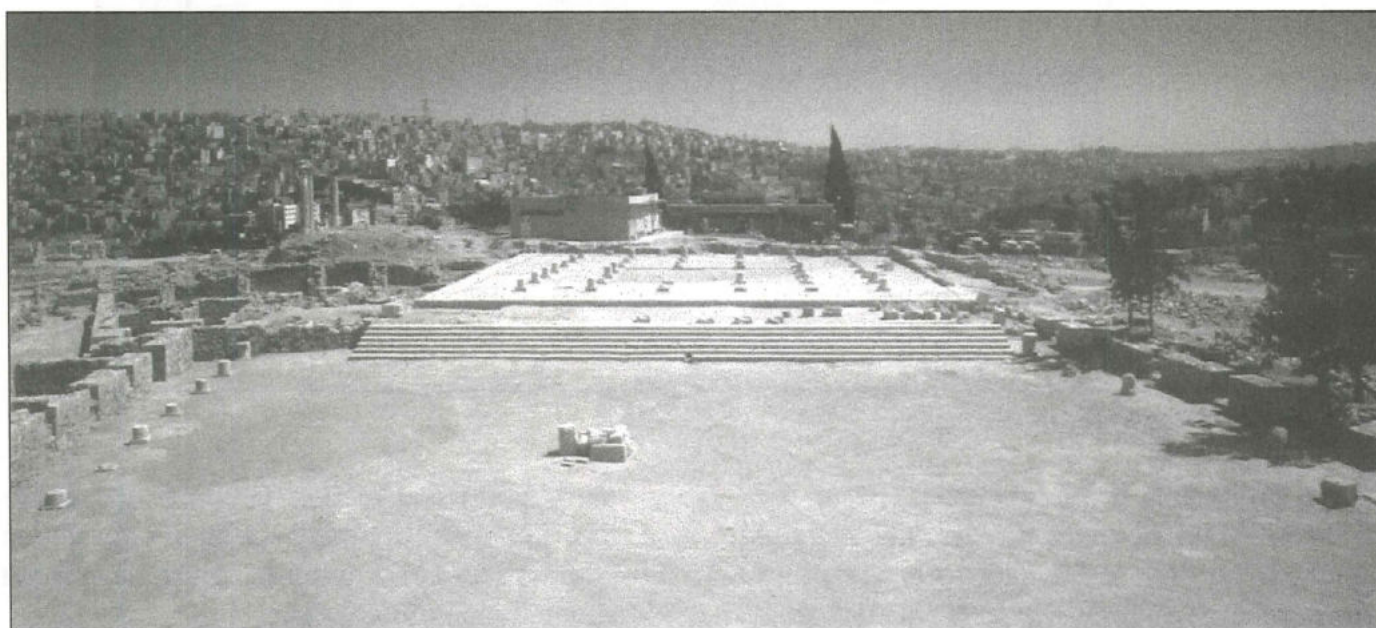
4. General view of the mosque and the square from the upper part of the entrance hall after the restoration.

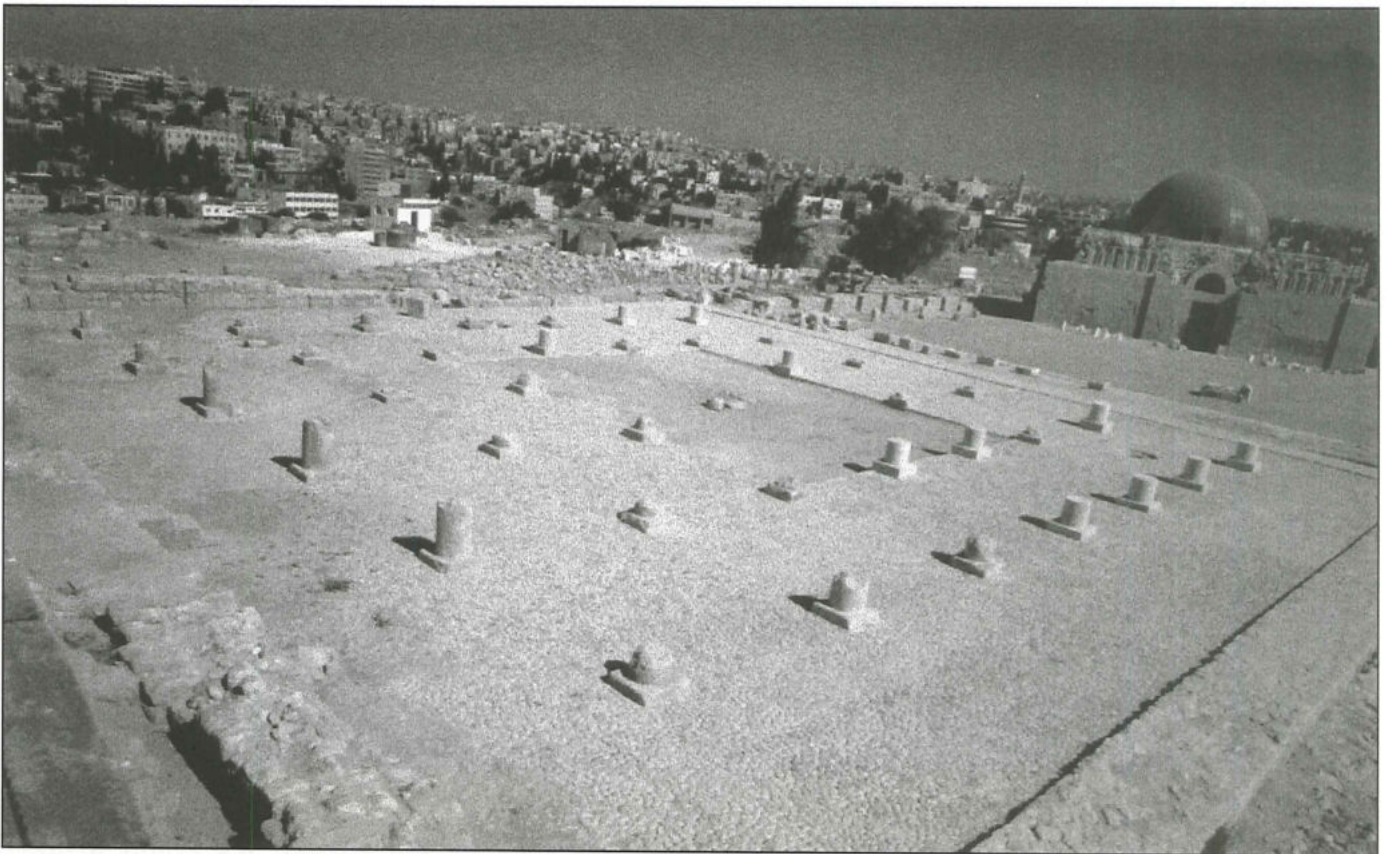
5. The mosque from the south-east corner.

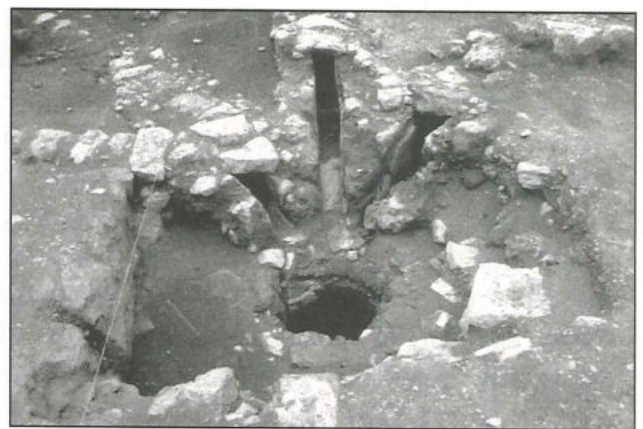
6. The central cistern of the *aş-Şahn* with the chan-

tion further to the north, there was an open courtyard or *aş-Şahn*. To do this, four columns were eliminated, two from each of the fourth and fifth rows parallel to *al-qibla*. In this way, we have a prayer-room that is three sections deep and seven wide, a courtyard of three by three sections and three *riwāqs* two sections deep. The lack of foundations of four corresponding columns proves the existence of this courtyard. In the centre of the courtyard, there is a cistern with a fairly narrow outlet (Fig. 6), similar to many others to be found in different buildings in the palace. Another cistern has been located in the western area in what may be considered as the prayer-room, and could have been a reused previous construction. In the north-eastern corner, practically in the centre of *ar-Riwāq* nearest to the courtyard, there is a small deposit excavated in the paving and well plastered, and which was undoubtedly used for ritual ablutions (Fig. 7).

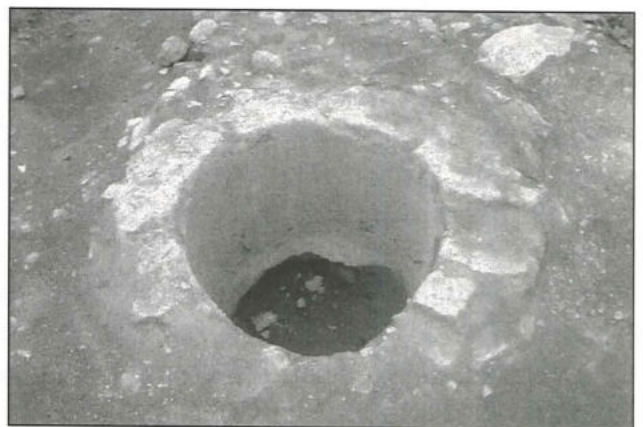
7. The basin found on the eastern *Riwāq*.

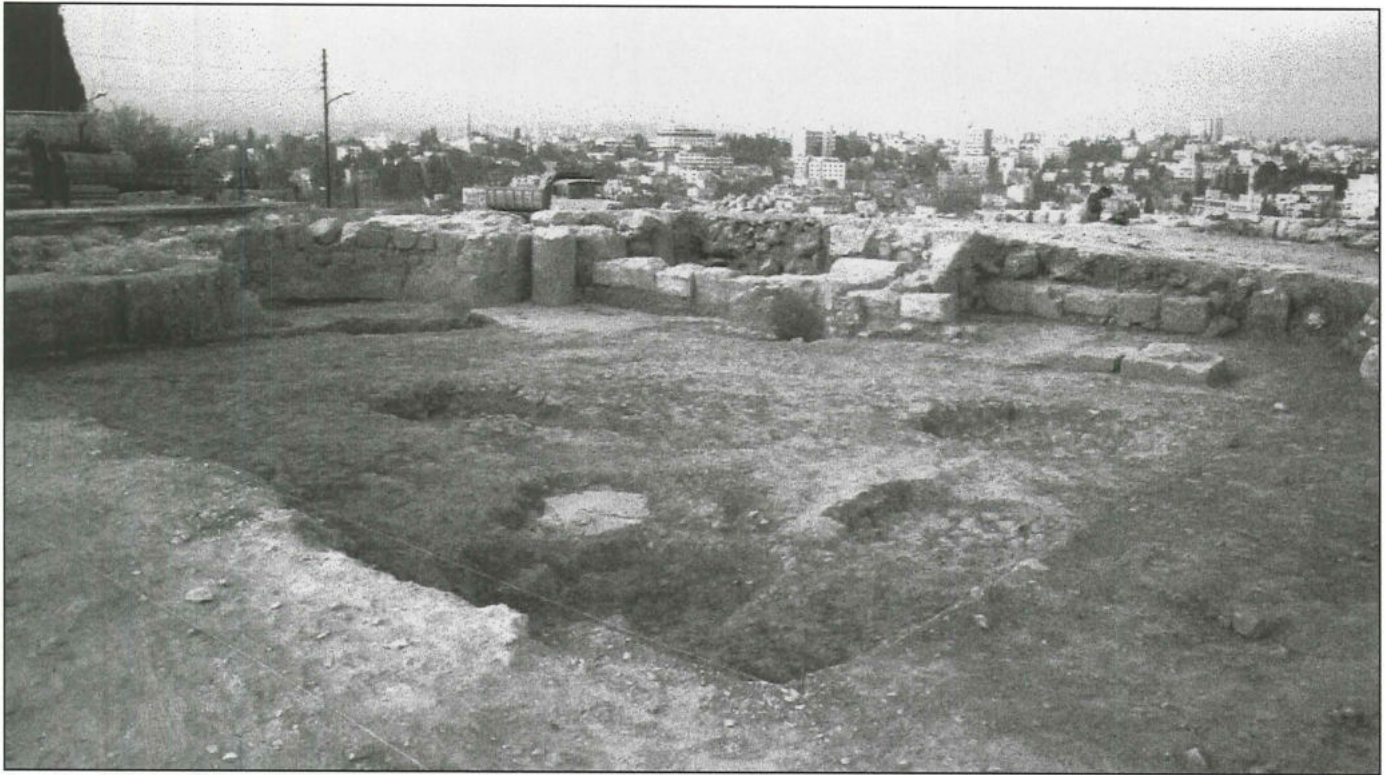
8. *Al-Mihrāb*.

In the centre of *al-qibla* wall there is a large *mihrāb* of 2.90 m wide (Fig. 8). Judg-

ing by the remains of the paving, it seems that *al-mihrāb* had a small step or ledge of no more than 5 cm which raised it higher than the rest of the hall. On the ground and aligned with this step, are traces of the presence of a decorative element in wood or marble. used as a. *Al-mihrāb* can be seen on the outside in the form of a mass of masonry projecting from the perimeter wall of the mosque, and constituting the only element which breaks the monotonous simplicity of the ground plan. It is worth mentioning the large dimensions of this *mihrāb*, which is almost the size of a small apse. The interior of the mosque has a paving composed of four layers of lime and small rubble stones.

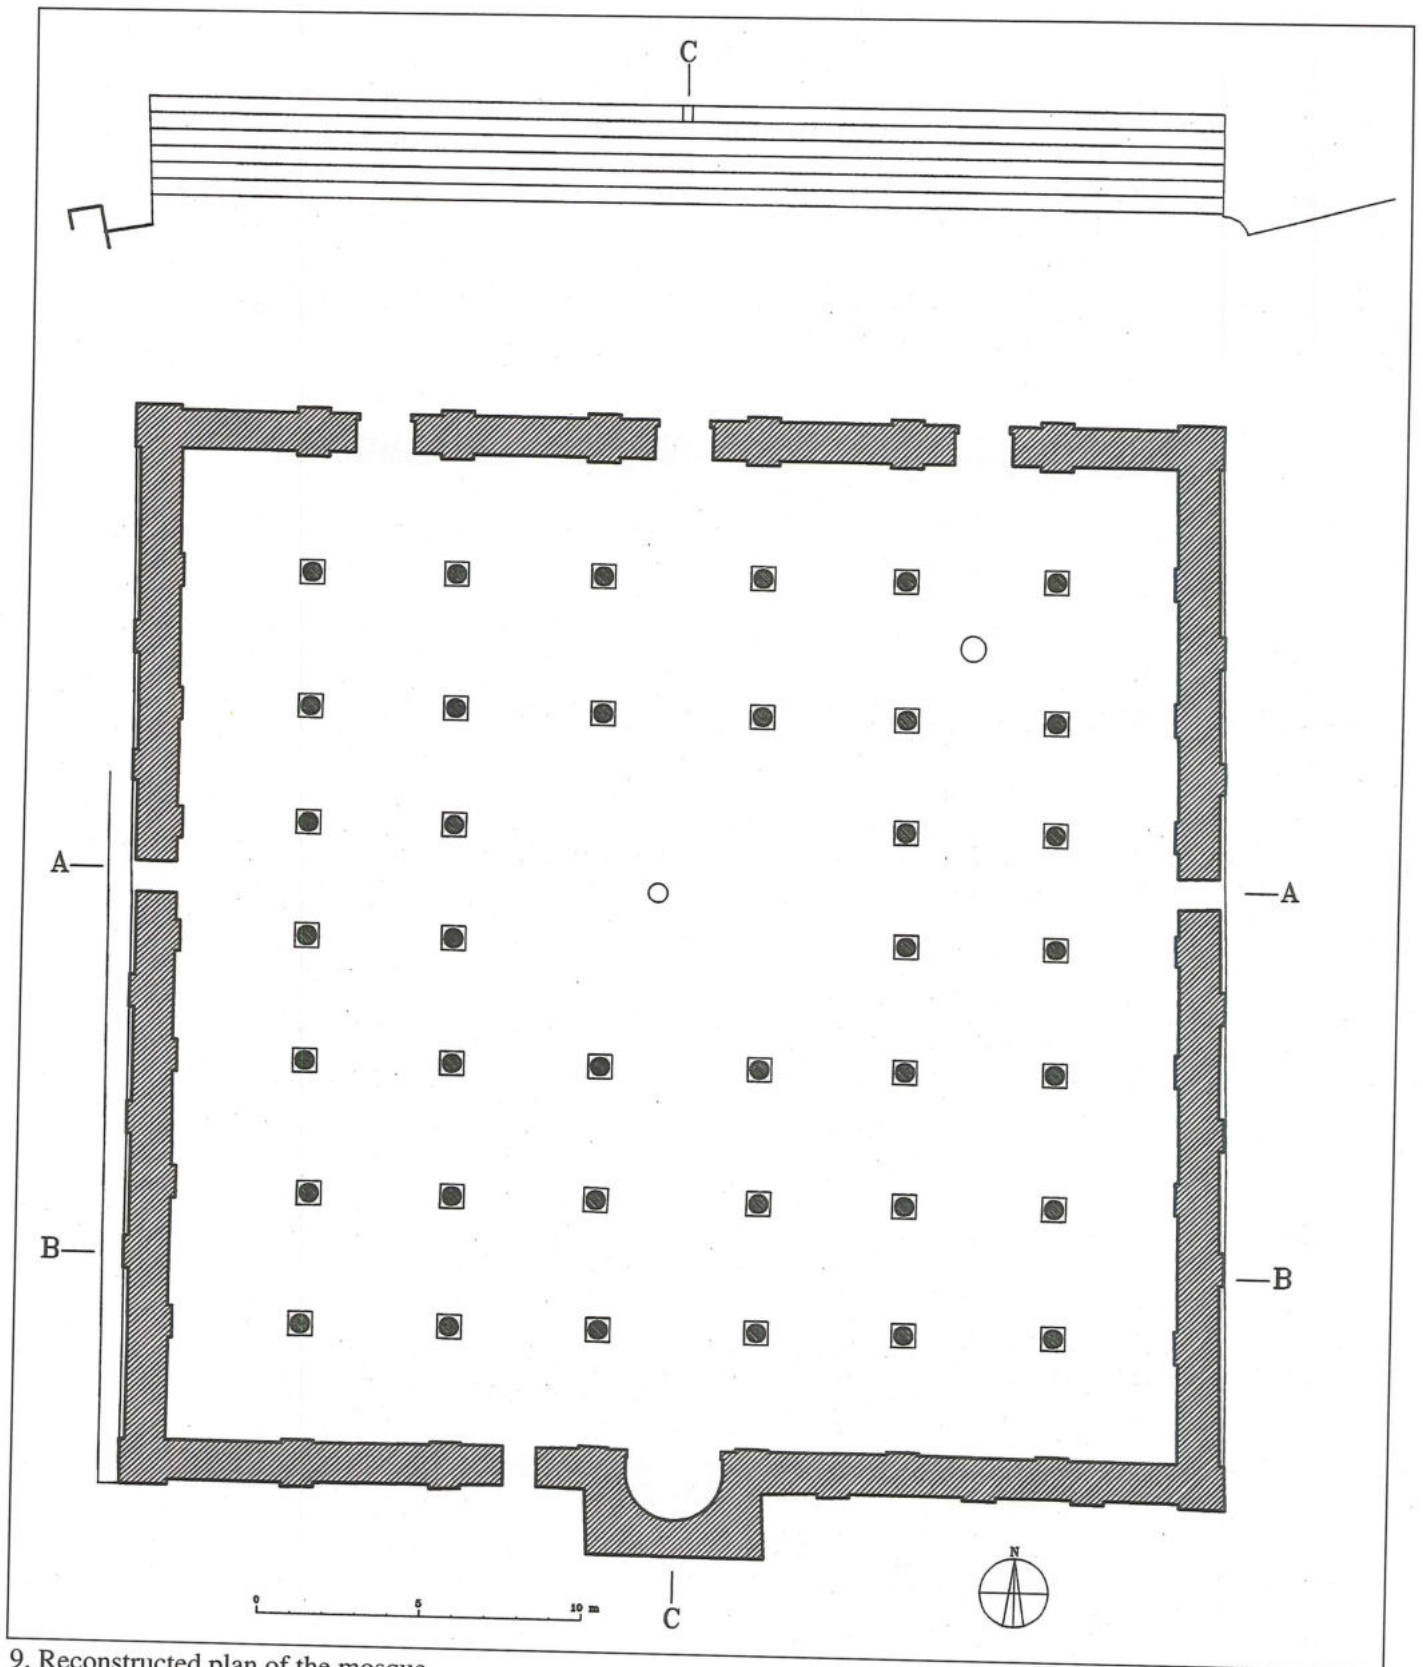
9. Reconstructed plan of the mosque.

In fact, the remains of this building which have lasted up to the present day are hardly sufficient to enable us to create a true reconstruction of it (Figs. 9-10), particularly since the site has changed considerably in both, in ancient times and more recently. This has meant the disappearance of important elements of the mosque, and even of the rubble itself, which could also have supplied us with information about the ruined parts. In spite of the lack of evidence, we believe that we should establish some hypotheses regarding the form and organisation of

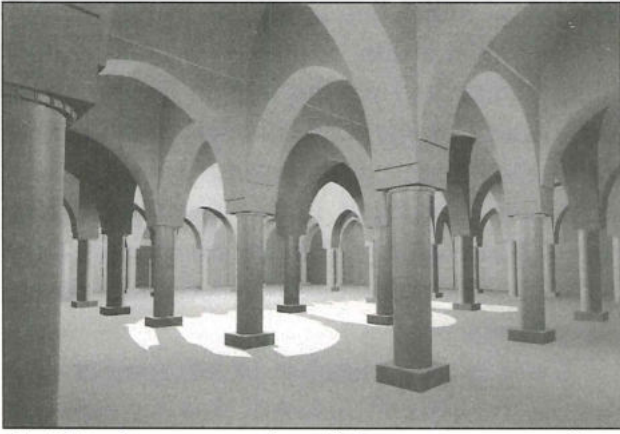
11. Virtual reconstruction of the prayer room and aş-Şahn (image made by J.A. Fernández).

It is obvious enough that we are faced with a hypostyle mosque (Fig. 11), without

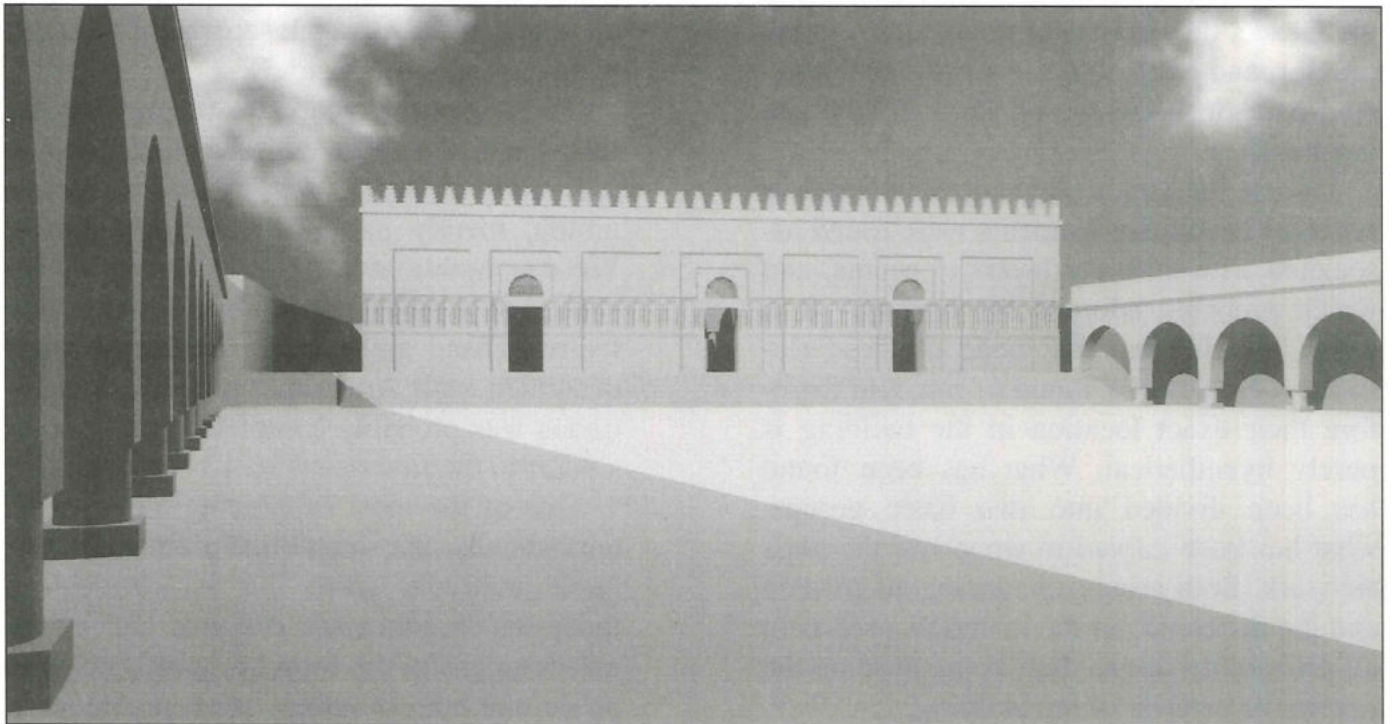
12. Virtual reconstruction of the façade of the mosque (image made by J.A. Fernández).

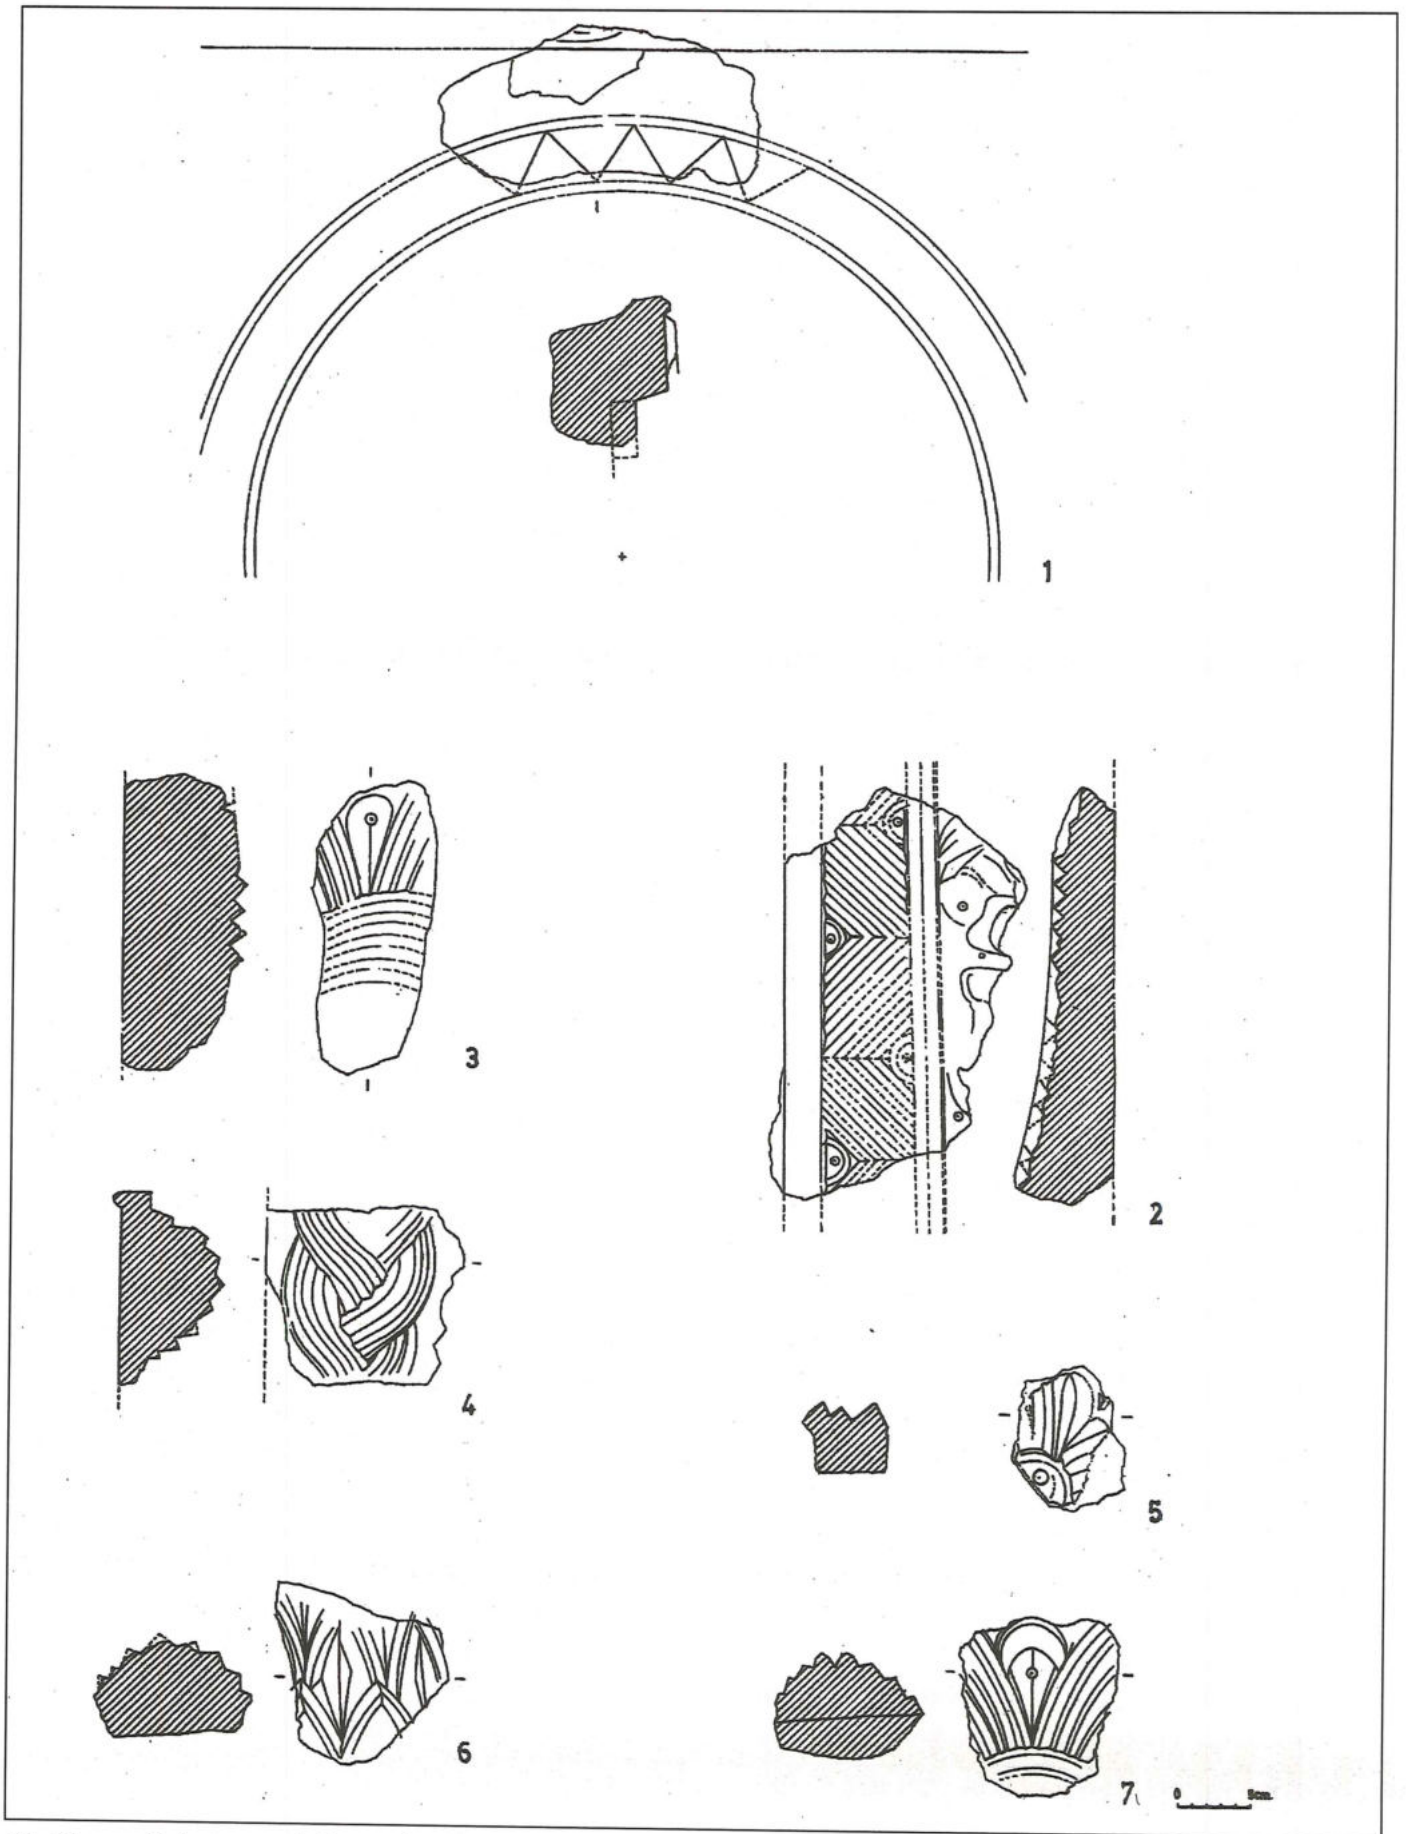
13. Pieces of plaster-work decoration found in the mosque.

There is a remarkable arch fragment with part of the smooth spandrel and the archivolt arranged in a recessed surface and decorated with triangular saw-teeth; in the same way as with pieces from the interior of the entrance hall of the palace. It is likely that the piece we are dealing with had a second concentric archivolt similarly decorated (Fig. 13.1).

One group of fragments corresponds to small half columns with decorated shafts, in some cases with a rhombus pattern, including a double plaited rope and several bands of superimposed moulding. Some of these pieces still have the carved capital consisting of one single leaf which is oval at the axis, flanked by groups of curved moulding, the crown of which is not conserved. A simple moulding with a triangular section takes the place of the astragal, separating the shaft from the capital (Fig. 13.3).

The rest of the pieces are fragmentary remains which almost entirely correspond to the bands of pearls and stylised vegetable motifs, mainly palm and acanthus leaves. We can highlight a piece of intrados consisting of a side band with a zig-zag geometrical band and part of the central band decorated with Arabesque patterns. The intrados was probably completed with a band similar to the first one (Fig. 13.2).

plaster-work that adorned it. There, we can see the *mihrāb* set between attached plaster colonettes with the shaft decorated with motifs similar to those in our piece (Fig. 13.7). The stretch decorating the wall of *al-qibla* is bordered by a geometrical moulding similar to that of the intrados in Amman, and the framed acanthus leaf which can be seen next to the small column in al-Mafraq is identical to another of the pieces of plaster-work which we have recovered.
