RESTORATION AND EXCAVATION AT AL-AZRAQ CASTLE DURING 2008

Ahmad Lash

Introduction

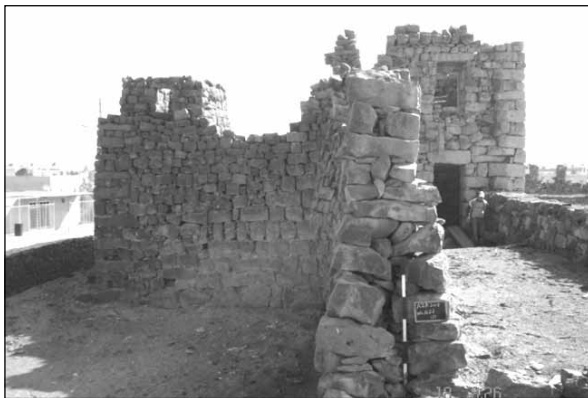
Perusal of the photographs and elevations included with this article immediately demonstrates the poor condition of Wall 22, especially in its middle portion where construction consists of largely random placements of relatively small stones. The wall was therefore in imminent danger of collapse (**Figs. 1, 2 and 3**).

2. Wall 22 before reconstruction (looking to north from the top).

It was therefore necessary to dismantle the central part of the wall, which was built at a later date, whilst maintaining the southern corner in its present condition and carrying out minor adjustments to the northern corner stones by pushing them slightly inwards, to align them with the remaining parts of the wall. Owing to its proximity to central Tower 4, which leans slightly outwards, the northern corner had adopted a slight slant to the west.

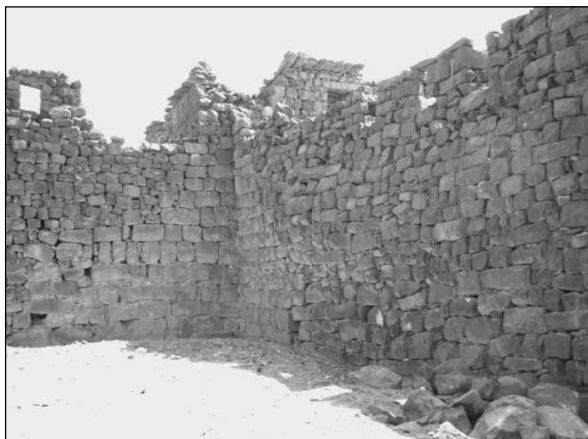
3. Wall 22 before reconstruction (looking to north).

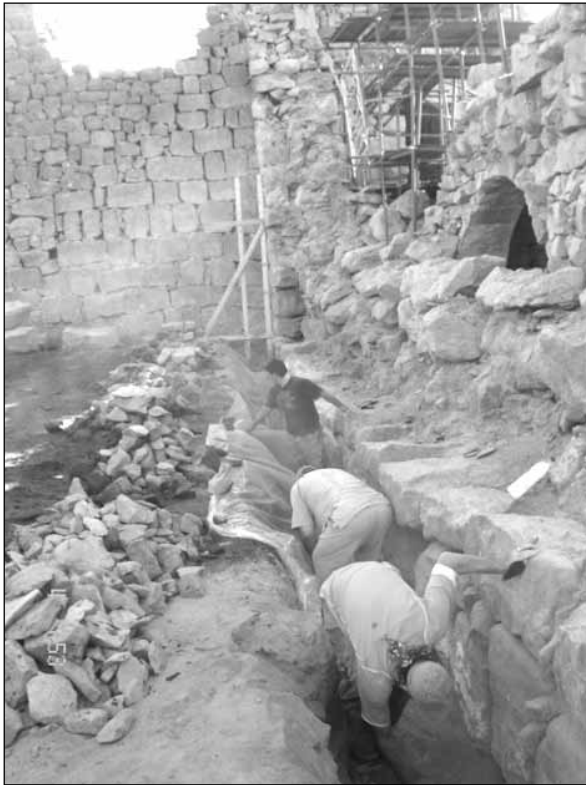
5. Wall 22 after dismantling (foundation preservation process).

After dismantling the wall, we dug a 1m wide trench along the length of the wall foundations in order to assess whether or not the foundation stones could be reused. Five stones were replaced because of their poor condition. After photographing and documenting the foundation stones, we refilled the trench by placing white mortar in its base then, in order, an earth layer, a plastic layer, a gravel layer, a blend of white mortar with earth layer and finally an earth layer, (**Fig. 5**) so as to form a barrier against moisture and salts in order to protect the wall foundations.

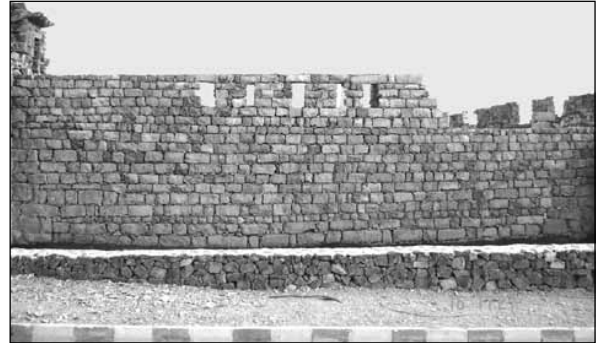
6. Wall 22 after reconstruction (looking to east).

The wall was reconstructed in the original manner, clearly visible where the stones had not been dismantled at the northern and southern corners, adjacent to corner Tower 3 and central Tower 4. Only earth available in the castle courtyard was used to bind the stones in place. Every course of stone was in turn covered with this earth; the central part of the wall was also packed with it.

It is worth noting that there is a recent entrance, built by the Druze in the 1920s, at the southern side leading into Room 12. We did not rebuild it from the outside, because it conflicts with the nature of the wall, but kept it in place on the inside to signify the utilization of the room at that time (Figs. 6, 7 and 8).

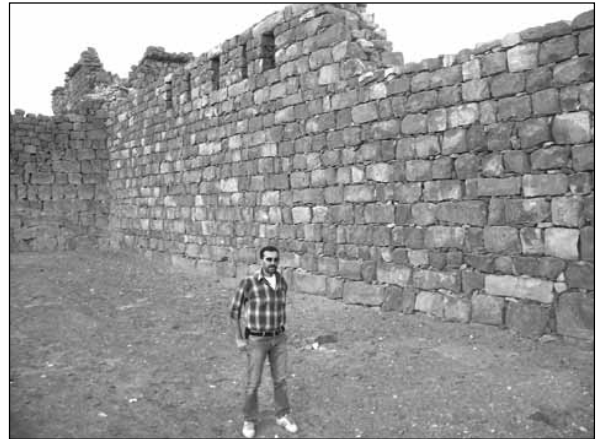
7. Wall 22 after reconstruction (looking to north).

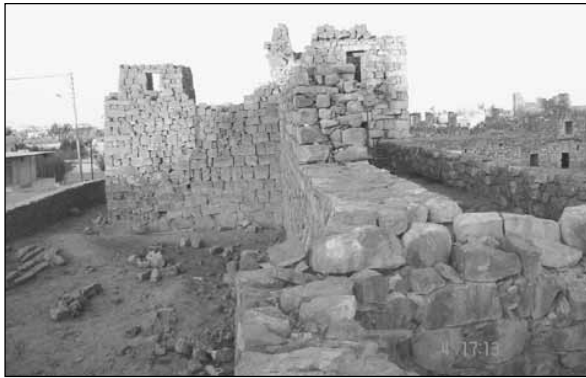
8. Wall 22 after reconstruction (looking north from the top).

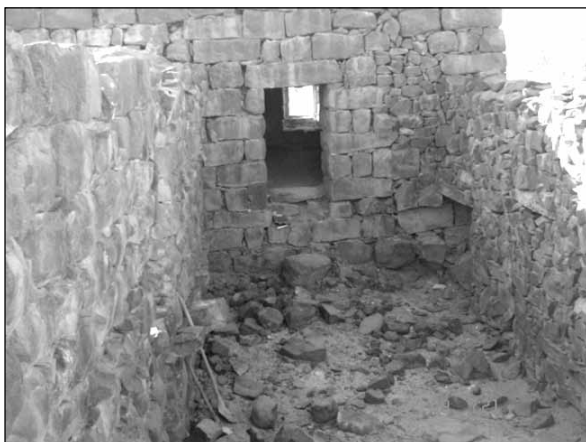
The 2008 excavations yielded interesting results, as we exposed new architectural features such as Room 45, (Fig. 9) situated at the south-eastern corner of the castle, between south-east Tower 10 and Room 46. The area of this room is 43m² it consists of Wall 81A at the southern side, Wall 82A at the northern side, Wall 83 at the western side and Wall 79C at the eastern side.

It seems that the southern wall was pulled down and a new wall built adjacent to the original foundations; two new entrances also were built for this room. During excavation, 29 layers were revealed over the foundations. Further, the original foundations of Wall 81 were discovered. These extend east-west into this room, are 11.40m long, 1.40m wide, 1.80 to 2.25m high and consists of two rows of large stones. Five or six courses of the wall survive. A north-south wall was also discovered, which divides the room into two parts; it was designated Wall 89 and is 2.42m long, ca. 0.80m thick, between 1.75 and 2.15m high, and consists of seven to eight courses and two rows of stone. An entrance was discovered at the north-western corner of the room, which leads to the castle courtyard. This

9. Room 45 before excavation (looking to east).

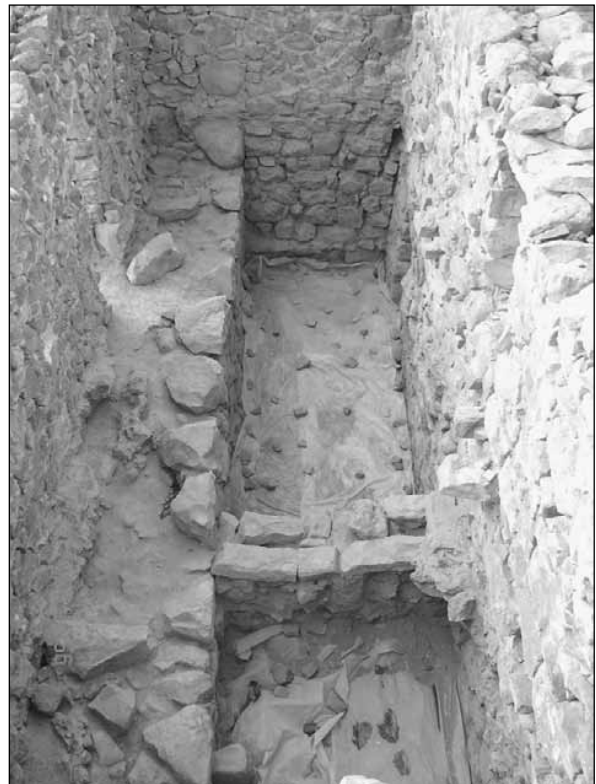
was designated Entrance 83, and was 180cm high and 110cm wide. It consists of five courses constructed over the original floor of the Castle. This room was rebuilt by Mr Qasem al-Atrash during the Druze occupation of the castle in the 1920s. Late Roman, Byzantine, Umayyad, early and late Ayyubid, and Ottoman pottery was discovered during these excavations. In Layer 4 we found part of a milestone with a four line Latin inscription; the diameter of this part of the stone was 18cm and its height is 27cm. Excavation was focused on the western part of this room, where we reached bedrock (Fig. 10).

10. Room 45 after excavation (looking to west).

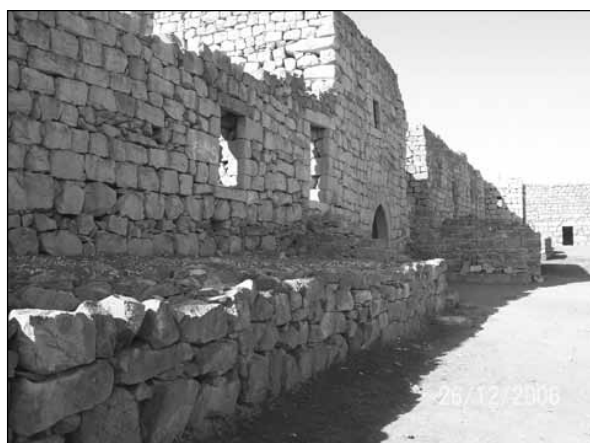
11. courtyard before excavation (looking S.W.).

ral and occupational fills. The Druze apparently changed the architectural features of the courtyard more than any other part of the castle. In the excavated trench, we found 31 occupation layers dating to recent, Ottoman, Mamluk, early and late Ayyubid, Umayyad, Byzantine and late Roman periods. A few pieces of Pottery Neolithic chipped stone were found on bedrock.

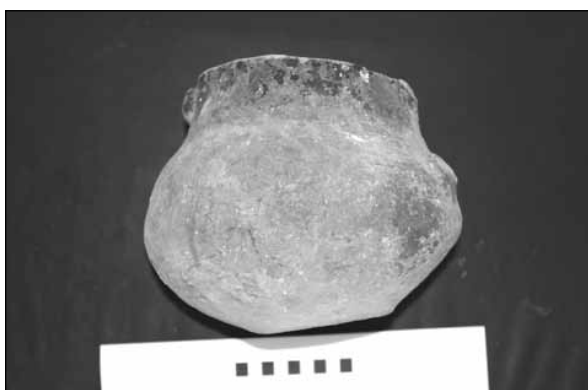
12. Ottoman pottery jar found in courtyard trench (layer 17).

Only two pieces of Nabataean pottery were found, which suggests that there was not a Nabataean settlement at the castle. We also found one piece of Fatimid pottery. In Layer 7, we found a nineteenth century handmade Ottoman jar. In Layer 20 (Fig. 12), we found a pottery bowl dating to the same period (Fig. 13). In addition, we exposed an entrance leading to Room 46. In the eastern part of the trench, we found a north-south wall, 5m long, 0.98m wide, with a height of 35 to 105cm; it was designated Wall 90 (Fig. 14).

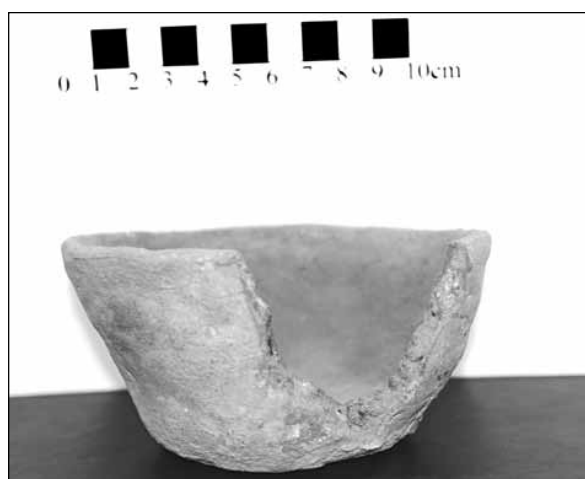
13. Ottoman pottery bowl found in courtyard trench (layer 20).

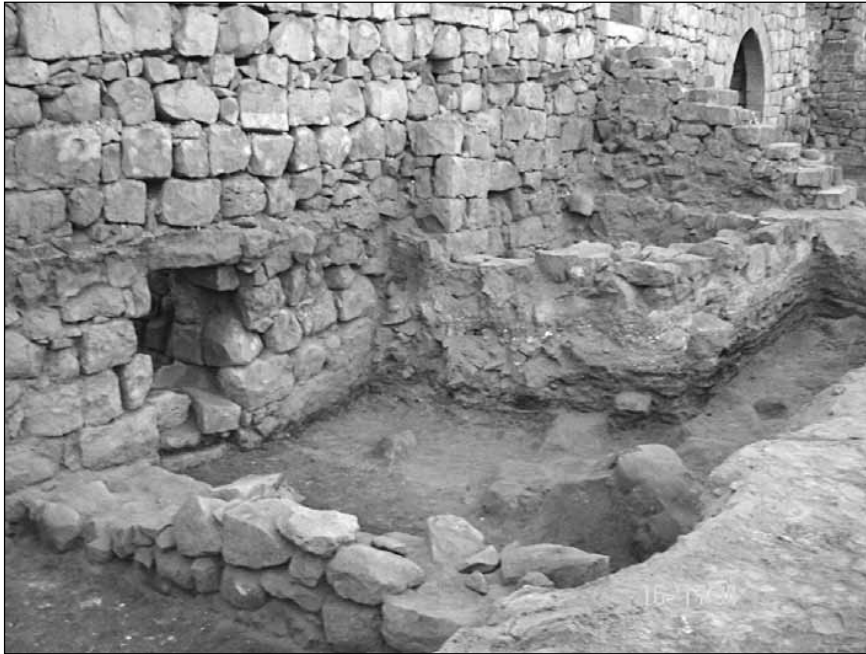
14. Courtyard trench after excavation (looking S.W.).

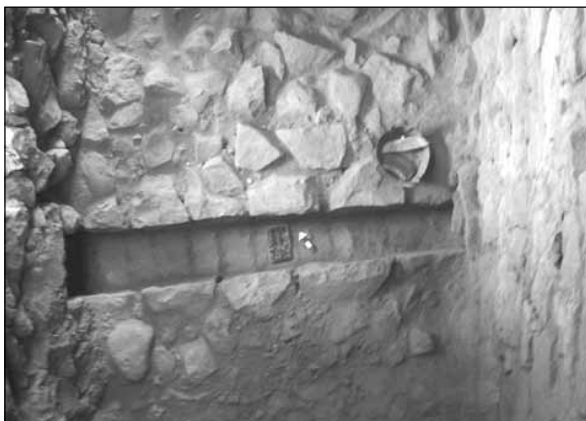
Among the important discoveries in this room was a west-east channel, built of two rows of uncovered stones with a stone-paved base. It flows from the base of western Wall 68B down to the east towards Wall 70 and has the appearance of a drainage channel leading out of the

castle courtyard, passing through Room 37. This channel is 290cm long, *ca.* 40cm deep, and 40 to 50cm wide (**Fig. 15**). This channel may be related to a not yet fully exposed architectural feature in the castle courtyard.

15. Room 37 after excavation (paved water canal).

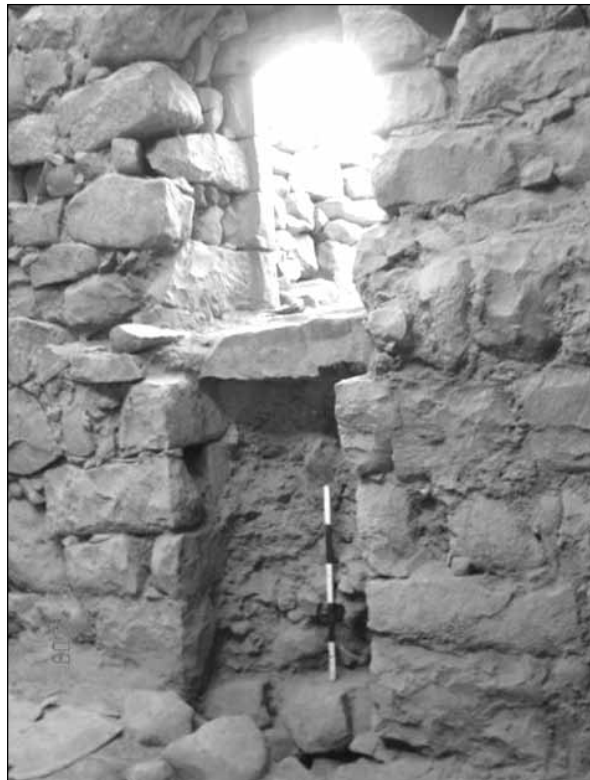
One of the important discoveries in this room was that of an earlier entrance, below the current entrance, on its western side which overlooks the courtyard of the castle. Most probably

it was the original entrance of the room before its reuse in subsequent periods. It is at the level of the original floor of the room, which we believe is the surface of the courtyard in the eastern part of the castle (Fig. 16). This entrance is 155cm high and 95cm wide; it is blocked from the west side by the fills which cover the castle courtyard. Here, the original floor is 175cm be-

16. Room 36 after excavation (modern and ancient entrances).

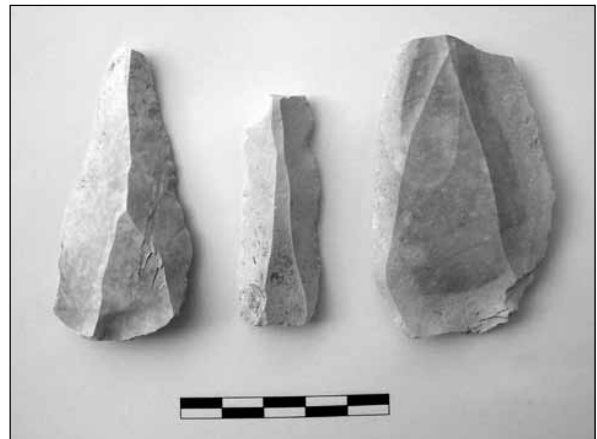
17. middle Paleolithic flints tools found in southern wall 22 corner trench.

During excavation of this trench, a number of layers were revealed, some recent and some occupation deposits containing pottery of late Roman and Byzantine date. It is clear that we reached prehistoric strata, *viz.* layers 4, 5, and 6, where we found 31 chipped stone artefacts, some dating to the Middle Palaeolithic.

As a result of the 2008 excavations, it is clear that there are traces of limited Umayyad occupation in the castle. Moreover, there is both Ottoman and prehistoric occupation (middle Paleolithic (Fig. 17), as well occupation during the late Roman, Byzantine, Ayyubid and Mamluk periods. On the other hand, there is no sign of significant Nabataean occupation. We also confirmed that the original level of the floors on the eastern side of the castle was lower than the current level of the floors (Fig. 18), because the hill on which the castle was built slopes down towards the east. Future work may reveal architectural features in areas which are still covered with layers of fill.

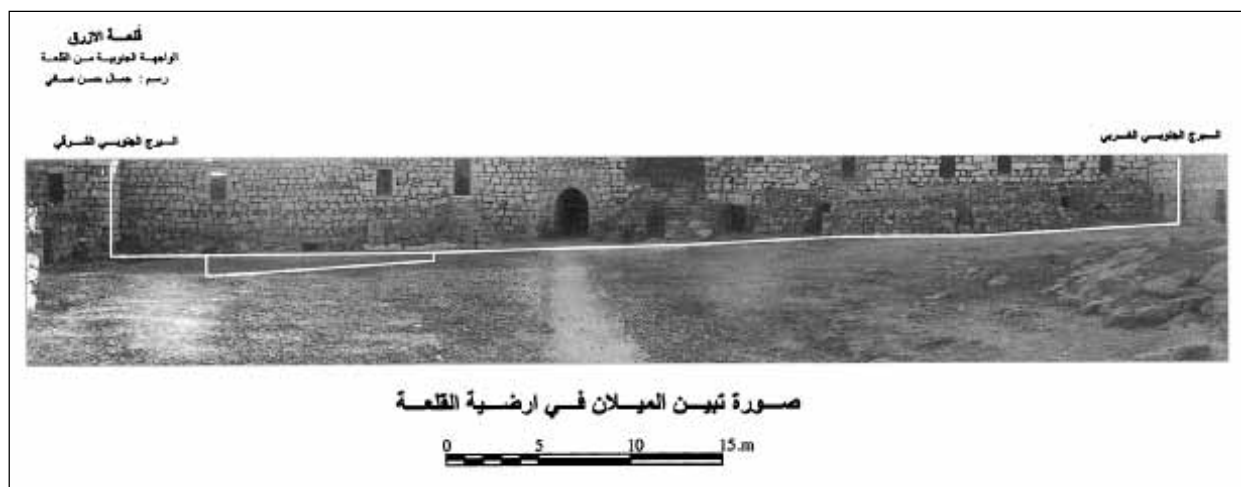
18. Courtyard ancient and modern level.
