PRELIMINARY REPORT ON EXCAVATIONS AT AL-ḤUMAYMA, ANCIENT ḤAWARA, 2004 AND 2005

J.P. Oleson, M.B. Reeves, G.S. Baker, E. de Bruijn, Y. Gerber, M. Nikolic, A.N. Sherwood

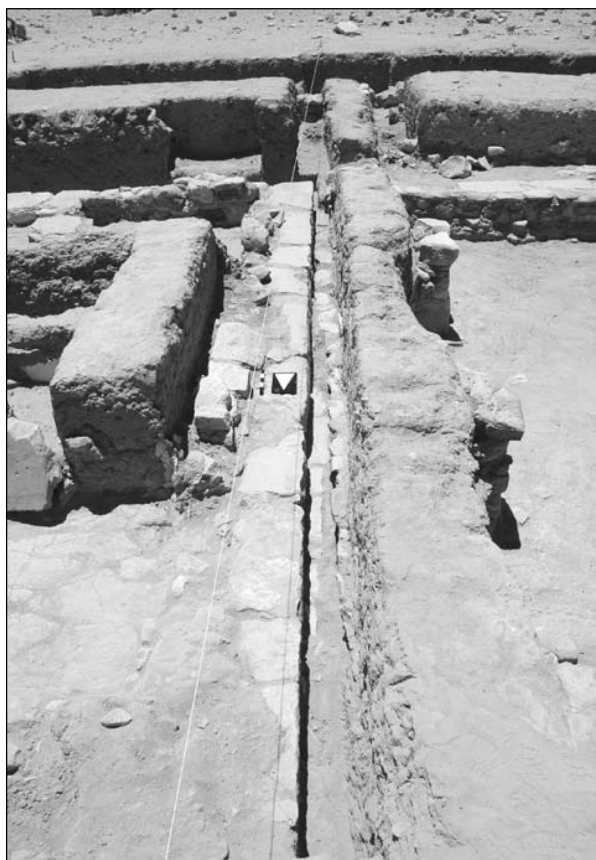
3. Abutting foundations of two Nabataean walls behind bins in Room H, E125.

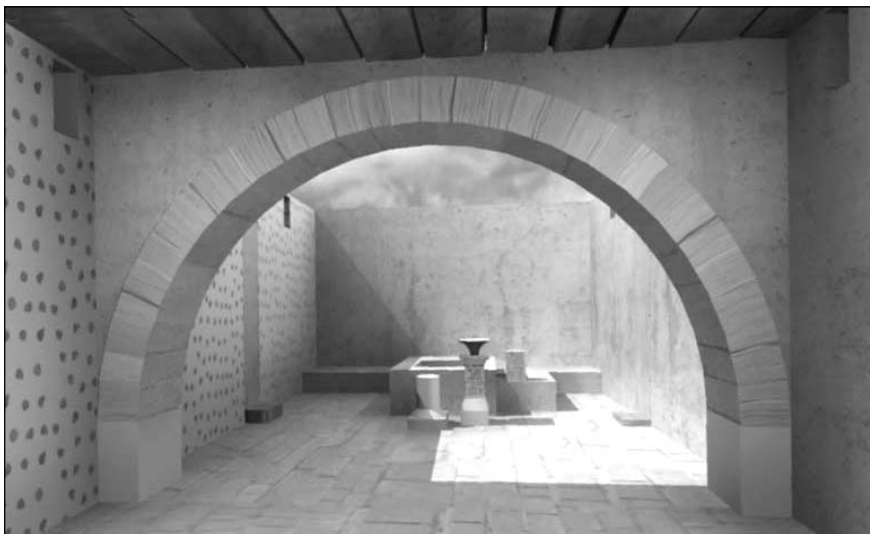
4. Roman period *naos* with betyl, legionary altar, and inscribed column fragment in place (Computer reconstruction by Chrysanthos Kanelopoulos and Platon Konstandopoulos).

Other Phase 3 alterations consisted of replacing arches with walls, lifting paving stones, and blocking or opening doorways. New walls often incorporated recycled construction materials (both stone and mudbrick) in their lower courses, whereas their upper courses reflected a new construction method (*pisé*). Sometimes (but not always) large pieces of pottery or cobbles were attached to their faces, matching the technique on the repaired walls. Where they survived the Nabataean period, the stone slab ceilings supported on arches remained in use. Other rooms were roofed with reeds and plaster. Although the buildings in this period were not as fine as those whose shells were being reused, this Roman period *insula* complex was both large and functional, containing over 30 rooms subdivided into at least three discrete structures. The extant community shrine dates to this Roman phase (Fig. 4).

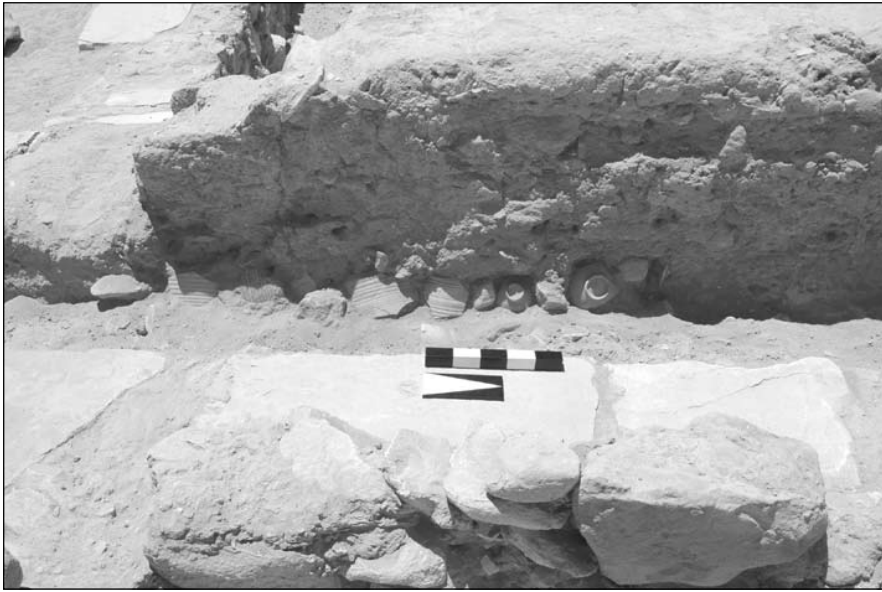
5. Roman period naos with original west wall leveled and pottery attached to face of new west wall.

In the Roman period only the eastern arch of the *naos* was still standing, and the western wall of the room was levelled off and left to serve as a votive shelf. The mudbrick wall of the separate Nabataean building to the west was now converted into the rear wall of the shrine, and at least the lowermost section of this wall was coated with large pieces of pottery (**Fig. 5**). Hundreds of fragments of polychrome fresco in a variety of designs suggest that other parts of the room were again elegantly decorated. This fresco coated the mortared cobble walls that were erected over the foundations of the ashlar walls on the south,

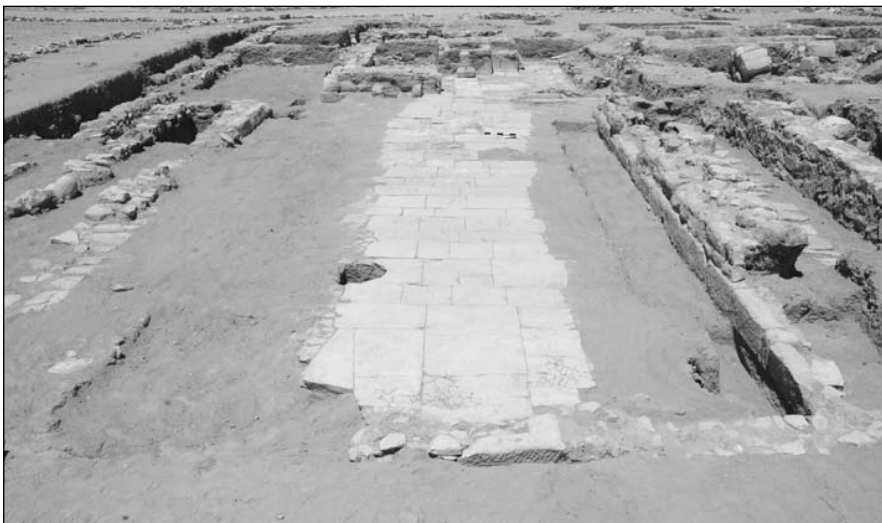
6. E125 shrine precinct, overview facing west from courtyard door.

Given the extensive recycling of building materials throughout the Roman period shrine, as well as the incorporation of walls from more than one structure, it is difficult to draw firm conclusions about the appearance of the Nabataean religious structure. In contrast, the appearance of the Roman period sanctuary is much clearer (Figs. 2, 6, 7). The Roman community shrine constituted a distinct religious precinct, organized hierarchically as a box within a box within a box. The innermost box, centred at the back of Room H, was a large bin for the stor-

age of religious paraphernalia. Centred in front of it stood the cult statue (betyl) in a position matching that of the cult statues at Khirbat at-Tannūr (McKenzie 2003: fig. 179). This central cult nucleus was then enclosed by the square walls of the *naos* (cf. Netzer 2003). The *naos*, in turn, was enclosed within a rectangular open-air walled courtyard (the *temenos*), in whose north-western corner the *naos* was situated. The main axis of the shrine ran east-west from the door of the courtyard (in Square 28), along a narrow, 20m long paved processional way, through an external built-in altar (of which only the base now survives), through the door of the *naos*, and along a line of three complete large pavers which ended at the cult statue and the large bin. This east-west axis was visually reinforced by the symmetrical arrangement of two long planters (once filled with flowers or shrubs) that flanked the northern and southern sides of the processional way. In addition, the door of the *naos* was framed by a pipe-fed water basin on its north and a bench (or bin) on its south.

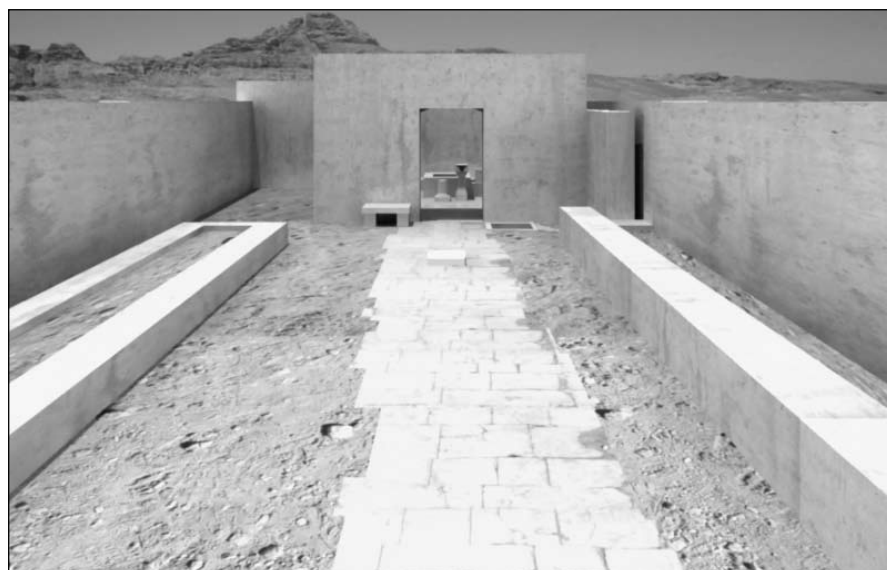
7. Roman period shrine precinct (Computer reconstruction by Chrysanthos Kanellopoulos and Platon Konstandopoulos).

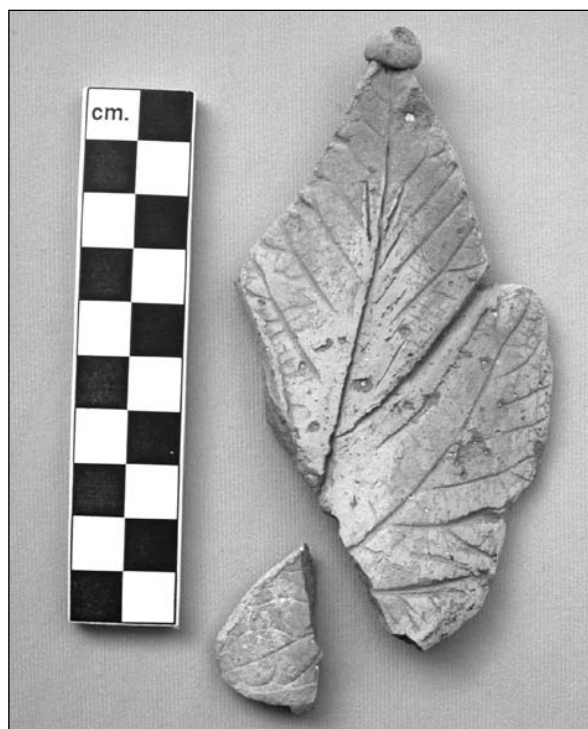
8. Terracotta leaf from votive shelf in *naos*.

terracotta grape leaf (Fig. 8), a Roman coin with a hole drilled through its centre, and some Greek *ostraka* (as yet unread).

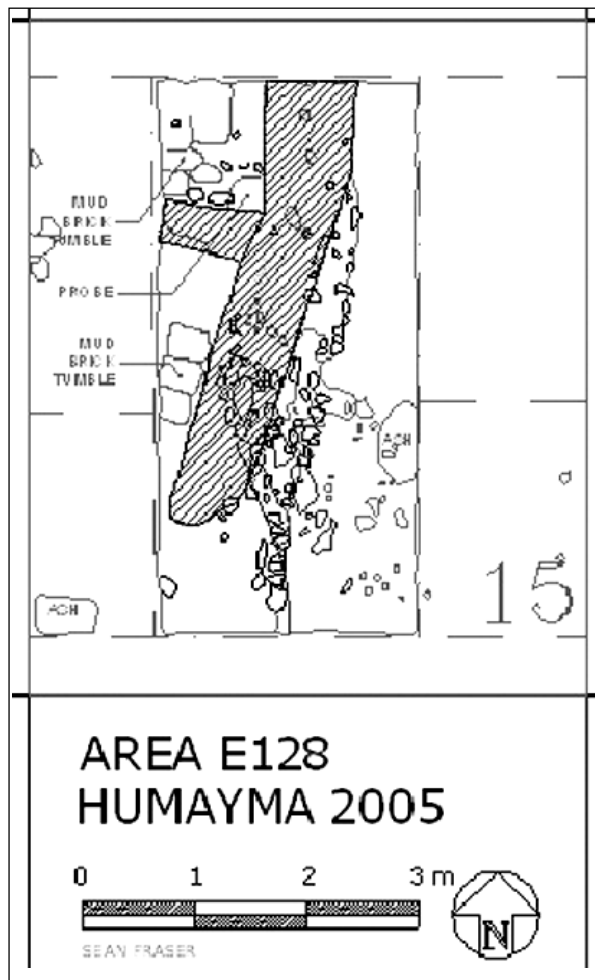
9. Mudbrick walls in Field E128, Plan.

Directly south of E125 lies a small mound. No wall lines or large stones were visible on the surface, but, given the use of earthen construction in E125 and the proximity of the mound to the Nabataean and Roman structures in Fields E125 and E122, it seemed likely that the mound contained another earthen structure. A test probe, laid out over the highest point in the mound, confirmed the presence of a mudbrick building that seems to date to the Nabataean period of the site (**Fig. 9**). Two walls of this building were exposed, each constructed similarly to the Nabataean phase walls in Field E125 with mudbricks laid on cobblestone foundations. Moreover, since the walls abut and differ in width, there is likely more than one Nabataean phase to this building. Later floor levels suggest post-Nabataean reuse as well (in several phases). Given that the walls were preserved to a height of approximately 1m,

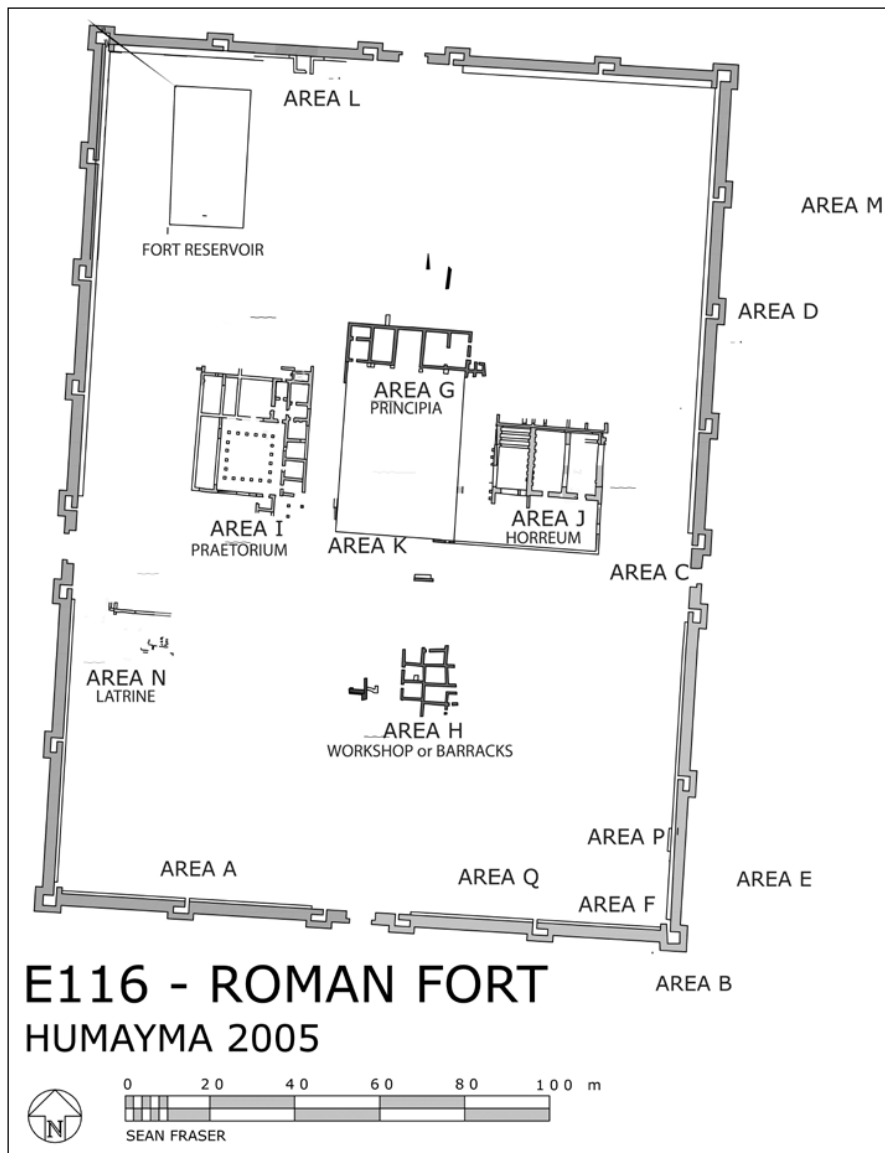
10. Roman fort, plan.

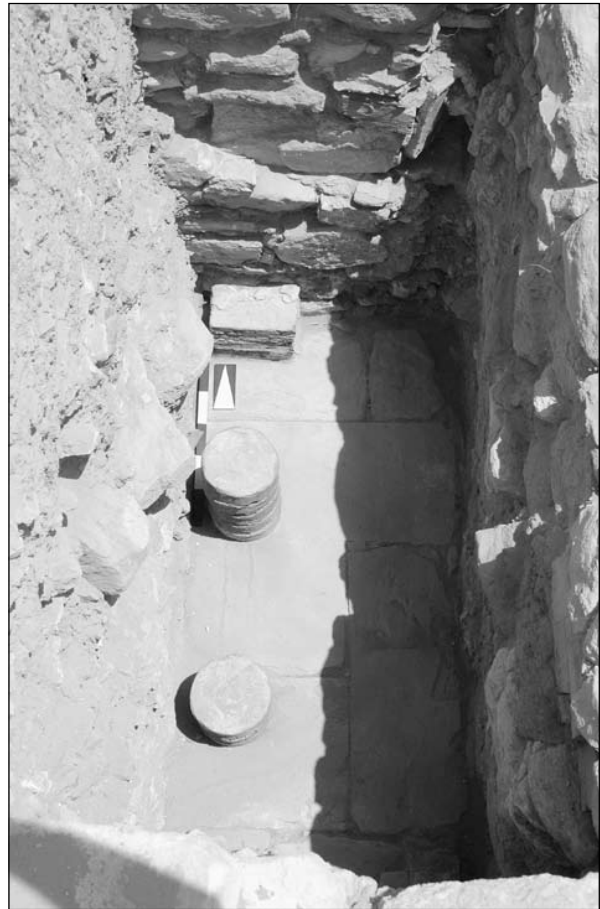
12. View of hypocaust.

The absence of a separate furnace (*hypocaustis*) and placement of the fire directly beneath the suspended floor of Room J is atypical in Roman baths. The arrangement may have been a response to a need to conserve fuel in the arid desert environment, but it also may indicate that the heated room was used for dining rather than bathing (cf. the heated *triclinium* in the *Praetorium* at South Shields; Hodgson 1993: 133). Restriction of the hypocaust to a single room might also suggest this function, but large chunks of hydraulic mortar were found in the destruction

debris. Only a small amount of ash was recovered from Room I, indicating that the hypocaust and *praefurnium* were regularly cleaned out until the heating system ceased to operate. The layered deposit of ash and clay beaten into the lowest levels of the earth floor outside the arch contained only Middle Nabataean and Roman ceramics from the first and second centuries. These ceramics, and the use of circular *pila* bricks – as seen in the early, possibly Nabataean, phase of Bath E077 adjacent to the *vicus* – connect the heated room and extension of the *Praetorium* in general to the first century of the fort's existence. Doors were built into the original north walls of Rooms C and D to provide access to the *praefurnium* room and the hot room, respectively.

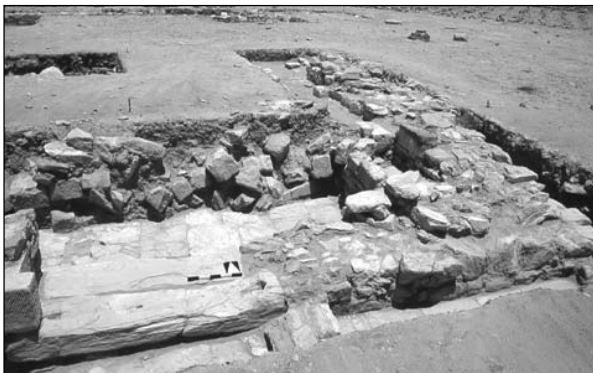
14. *Horreum*, interior.

The interior of the rooms was carefully finished (Fig. 14). The walls were faced with several layers of a hard, sandy white wall plaster, which in most areas extended over the intersection of the wall and pavement, ensuring a tight seal between walls and floors (an important consideration in a granary). Room A was paved with

large square terracotta tiles (0.30 x 0.30m sq; 1 RF), a procedure not seen elsewhere at the site, and the door (1.50m, 5 RF wide) was built into the east end rather than the centre of the south wall. Rooms B1 and B2 were paved with large, carefully laid sandstone slabs. A sturdy drain was built into the southwest corner of Room A, leading from the *Horreum* out to a north-south drain below the paved street adjacent to its west wall. The branch leading out from the *Horreum* contained a large cache of broken glassware and ceramics, mostly cups and serving wares, dating from the second and third centuries, with possibly some early fourth-century material. The special door arrangement and flooring of Room A, along with the presence of a drain, indicate that this room was intended for the storage of different goods than those in Rooms B1 and B2, possibly liquids such as olive oil and wine.

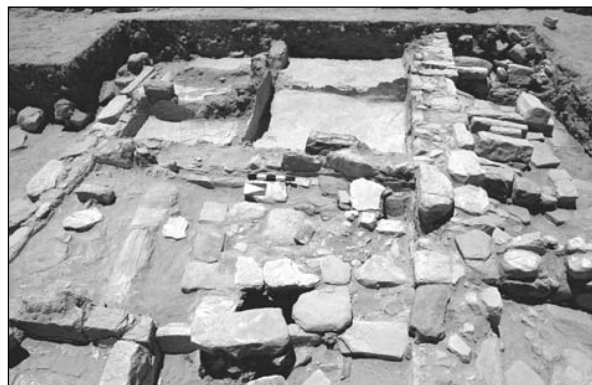
15. Latrine and bins, view.

The latrine was part of a larger structure, on the same orientation as the other structures in the fort, with thick (0.53-0.67m) walls constructed of heavy blocks and boulders facing a core of rubble set in mud packing. Many of the blocks show Nabataean trimming and clearly were salvaged from pre-Roman structures at Hawara. The wall foundations were laid on sterile soil, and the earliest deposits contain Nabataean ceramics of the early second century. Most of the walls to the west and south of the latrine and associated basins have been lost to stone robbing. What remains are two large rooms sharing a party wall but no connecting door in a structure 8.33 x 4.85m; the north wall gradually tapers to nothing 3.75m west of the core structure, the west wall disappears 2.6m to the south. To the east is a jumble of robbed walls, tumbled blocks,

The latrine occupied the northern two-thirds of a room with regular, well-finished walls (inside dimensions 4.22 x 2.00m; 14 x 6.5 RF); there are traces of a door in the east wall. When excavated, a rectangular area of sandstone paving 1m wide was found, extending 2m south of the north wall of the room (**Fig. 15**). This paved area was surrounded by a U-shaped trench *ca.* 0.50m wide, sloping gently from 0.70m below the pavement at the northwest corner of the room to 0.86m below the pavement at the northeast corner of the room, at which point there was a block-built drain through the wall. A wide, carefully formed terracotta pipe (rim D 0.077 and 0.12m) was built into the wall immediately above the trench at the northwest corner of the room, oriented downward to the south at a 45 degree angle. Narrow offsets on the inside faces of the east and west walls of the room supported four slabs that bridged the trench near the north end and at the south end of the paving. A row of blocks marked off an earth platform, at the same level as the paving that occupied the southernmost 1.25m of the room.

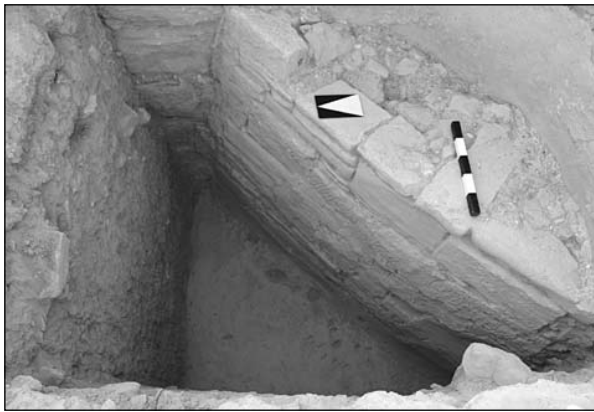
17. Reservoir, view of southeast corner.

Probe 9 (W 2m, L 1.5m) was excavated at the centre of the inside face of the southern reservoir wall where it was hypothesized that an outflow drain through the wall might have delivered water under pressure to other parts of the fort. The probe, cut through extremely hard, compact silt, found no outflow pipe or other water delivery system, but revealed unexpected features of the reservoir floor. From a point 2.40m below the top of the wall, the hard cement wall slopes outward, meeting the flat reservoir floor at an angle of 24 degrees and a depth of 2.76m. A probe in the southeast corner of the reservoir revealed the same arrangement: vertical walls, then a downward slope on both the east and south to the level floor at 959.74m. At some point after the reservoir had been lined with its tough hydraulic plaster, the southeast corner was filled in with a solidly constructed masonry platform, triangular in plan, extending 2.5m out from the corner to north and west, its level upper surface at 1.95m above the lowest reservoir floor (**Fig. 17**). A similar platform, badly damaged, was subsequently discovered in the southwest corner of the reservoir at the same level (Probe 14),

but none existed at the northeast corner (Probe 19). The purpose of these platforms is unclear. Since none was built at the northwest corner, where water flowed into the reservoir, or at the northeast corner, which is far from the water-consuming areas of the fort, they may have had something to do with removal of water. They may have functioned as platforms for individuals working *shadufs* (counter-weighted tip beams with buckets) that lifted water to troughs on the reservoir wall. The corners may have been chosen because they help brace the installation, but it is possible that other platforms exist along the walls of the reservoir. Since the reservoir floor is horizontal at the northwest corner and meets the vertical walls with a simple quarter-round moulding, the slope seen in Probes 9 and 11 may indicate the presence of a sump for sediment along the south wall.

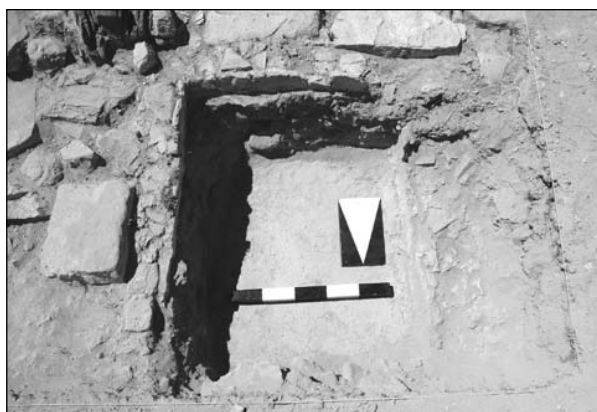
18. Basin, view.

One goal of the 2005 excavation season was to establish the location of the fort's stables. The southeast quadrant seemed a likely location because it is downhill and usually downwind from the rest of the fort. A probe was excavated around two perpendicular lines of hydraulic plaster projecting through the surface in this area (Area Q). Excavation revealed a small basin (interior *ca.* 0.67 x 1.02m) built of mortared rubble walls (Th 0.15m) and lined with a plaster heavily tempered with pebbles and crushed ceramics (**Fig. 18**). The angle between the floor (at 960.405m asl) and walls of the basin was reinforced with a quarter-round plaster seam, typical of Roman hydraulic installations. The walls survive to a maximum height of 0.37m, but given their thickness, the walls could not have been much taller than 0.40m. There was no sign of an intake for water, but a drain had been built into the northwest corner to empty the contents on a pavement of large sandstone slabs. The basin was built into the southeast corner of a substantial structure with solid stone walls 0.88m (3 RF) thick, which can be traced on the surface

for several metres to the west and north. Given the 2.5m drop from the reservoir, this area could easily have been serviced by a pipeline.

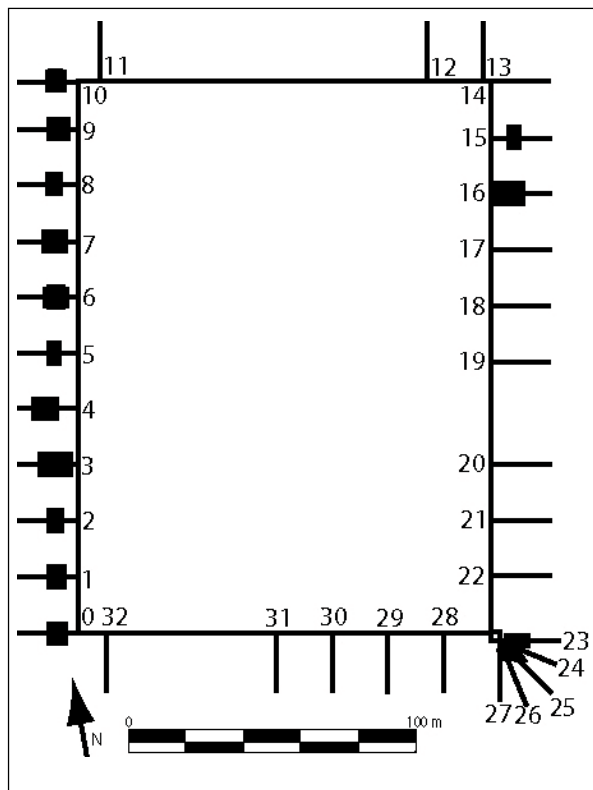
19. Schematic drawing of ditch locations outside of the fort walls as predicted by GPR. The width of the line indicates the approximate width of the ditch at that location.

Within the Roman fort geophysical data were collected to search for suspected pipelines, to look for the continuations of known buildings, and to search for possible deep pre-Roman structures. These investigations met with mixed results. As discussed above, pre-Roman structures posited by the geophysics to lie beneath the *Via principalis dextra* were not found. In contrast, the GPR survey conducted around the fort walls produced excellent documentation of an external ditch system. Thirty-two profiles were taken around the perimeter of the fort to determine the location and geometry of the ditch, including five profiles radiating out from the southeast corner of the fort. After analyzing all of the profile lines collected, it was observed that the majority of detectable ditches were on the west side of the fort while the remaining sides of the fort showed little evidence of the ditch. No evidence was seen on the profiles from the north and south walls, and only two profiles showed the ditch on the east side of the fort. Of the five profiles collected on the southeast corner, three showed evidence of the ditch system. Figure 19 shows the location of detected ditch sections, with the approximate width of the ditch indicated by the thickness of the line.

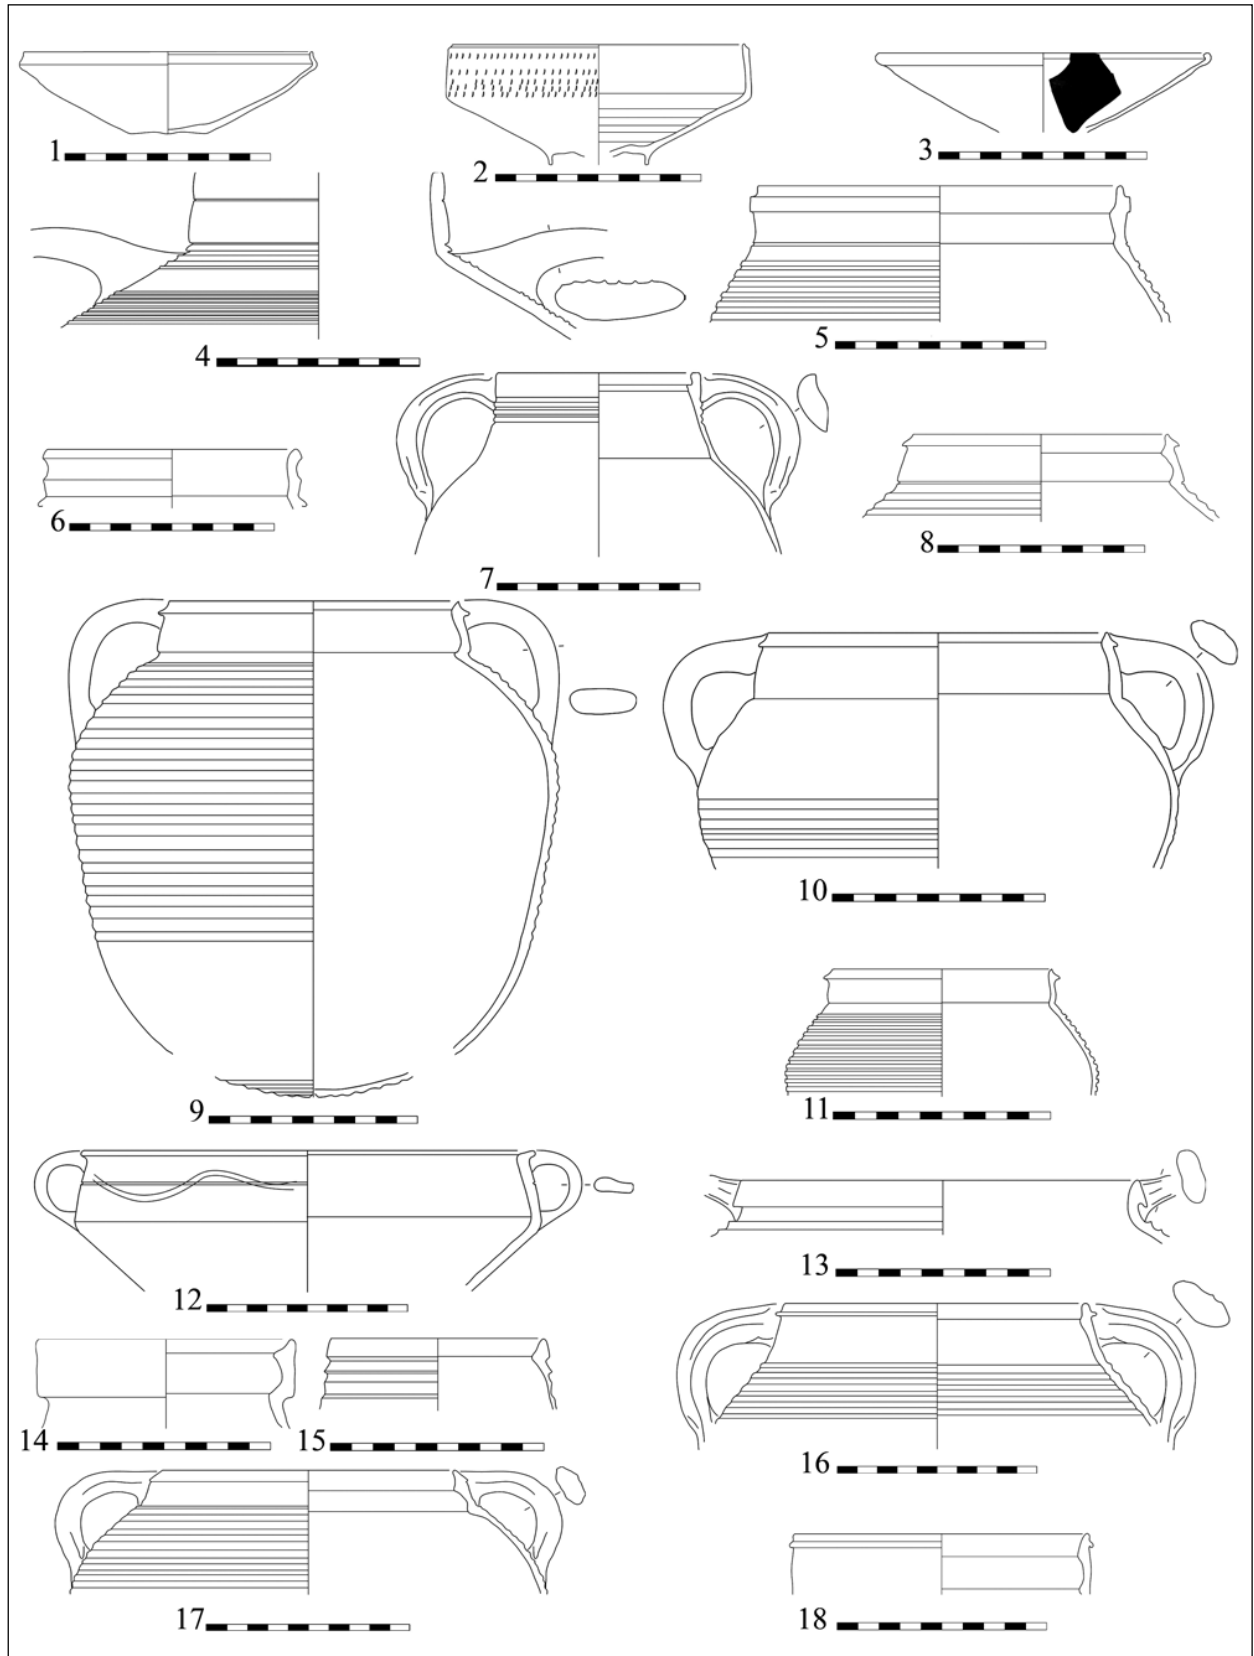
22. Ceramic vessels nos. 1-18.

Some al-Ḥumayma vessels similar to nos. 13-18 may differ somewhat in fabric from Petra parallels in late first-early second century contexts. The different fabric does not call into question the Petra provenance; early types associated with greyish fabric simply are not usual in the known Petra assemblages. Could this indicate a later date for al-Ḥumayma specimens? Conceivably, rim types of the early second century may have remained common for quite a while, while the well-fired, light-red, barely tempered, thin-walled specimens may gradually have been replaced by items with the same rim forms but with greyish or light-grey fabric. This kind of “intermediate” phase of pottery development seems to be missing in Petra due to the absence of well-stratified second or third century contexts. One of the rare Late Roman contexts is represented by structures in the northeast section of the “Lower Terrace” on az-Zanṭūr (EZ III). That pottery dates very roughly to the second or third century, pending a more detailed study (Gerber 2001, 2005). At al-Ḥumayma, until the pottery has been studied and published in its full stratigraphic context, the matter must

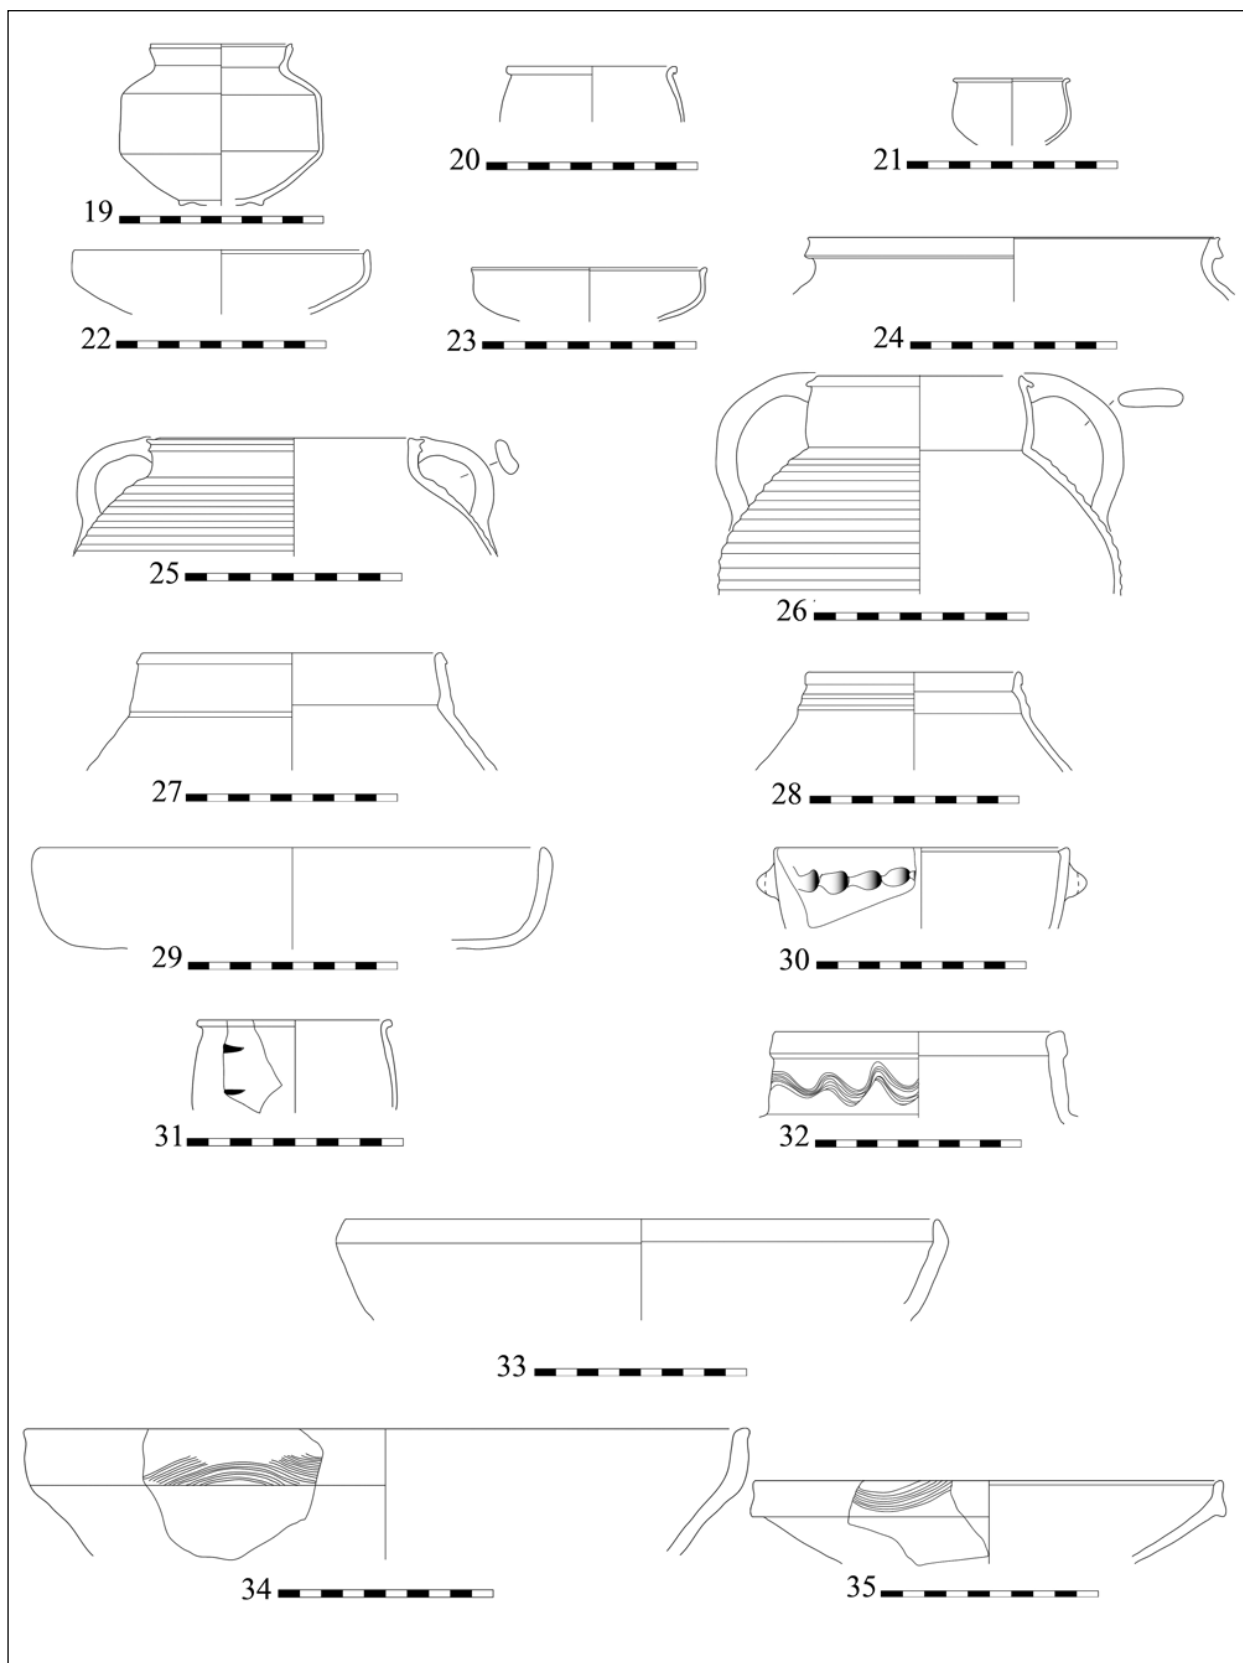
23. Ceramic vessels nos. 19-35.

Generally the second to third-century al-Ḥumayma pottery (**Fig. 23, nos. 24-30**), especially from the Area E125, but likewise from the earlier layers from the fort (E116), shows a wider variety of forms and fabrics than attested in Petra. A small bowl with simple painting on its exterior (no. 31) recalls the shape of no. 20, but its light-red fabric is coarser. Many comparable samples, painted and unpainted, are known from Petra. On az-Zanṭūr this specific painting pattern on vessels of the very same form, and indeed of others, is known from mainly later second-third century contexts. The same kind of pattern is known from other sites in Petra, e.g. Area I Household excavation (excavated by K. Russell) and az-Zurraba (excavated by K. ‘Amr) — neither pottery assemblage has yet been published. Their suggested dates are both much later than second-third century. No precise chronological framework for the pottery of
