VILLAGE LIFE IN MAMLUK AND OTTOMAN ḤUBRĀŞ AND SAḤAM: NORTHERN JORDAN PROJECT, REPORT ON THE 2006 SEASON

*Bethany J. Walker, Ellen Kenney, Laura Holzweg, Lynda Carroll
Stéphanie Boulogne, and Bernhard Lucke*

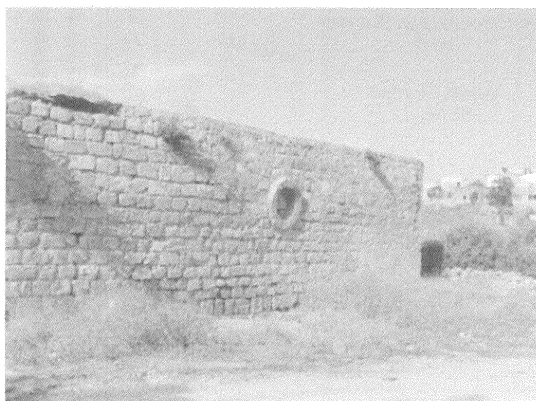
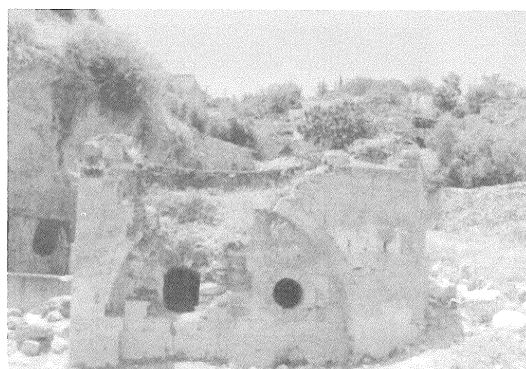
3. Bull's eye windows of Saḥam mosque and sabīl compared.

Old Saḥam mosque

Old Saḥam sabīl

The bull’s-eye window is another feature quite characteristic of late Ottoman buildings in the area (Fig. 3). Comparanda can be found at Umm Qays and in late nineteenth-century domestic architecture, the so-called “throne villages”, of Palestine (Amiry 2000: 46, fig. 1 — the house of Abu Qutaysh). In some cases, such windows are open and in others they are “blind”. At Saḥam, the question remains whether the bull’s-eye window was ever open to illuminate the interior. As the floor-plan drawing demonstrates (Fig. 5), its placement aligns only approximately with that of the *miḥrāb* on the interior, but this does not rule out the possibility that it served as

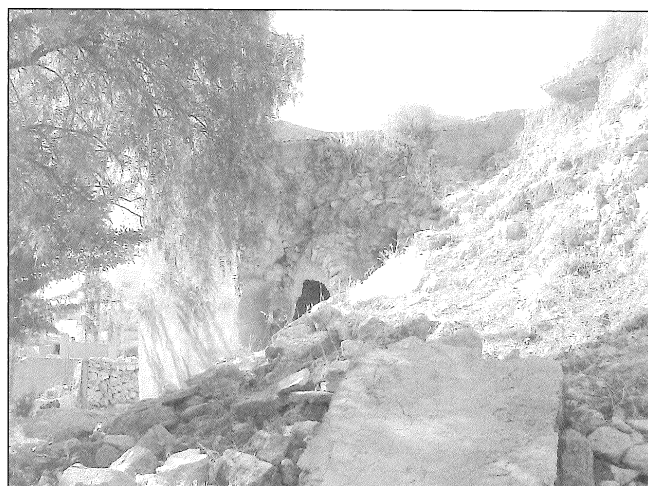
4. Saḥam mosque — collapse of northern façade.

Likely built in the 1880s, it served the village until 1976, when the building was no longer structurally sound and the local *Awqāf* office decided to close it. A road was constructed that destroyed the complex to the west of the mosque; three new mosques were eventually built to replace the old one. The village protested at the closing of the old mosque and asked repeatedly for monies for its reconstruction.⁵ In 1984 the Ministry replastered the interior, and then closed the mosque for good, citing structural weaknesses. Heavy winter rains in 2005 caused the collapse of the northwestern corner of the structure (Fig. 4).

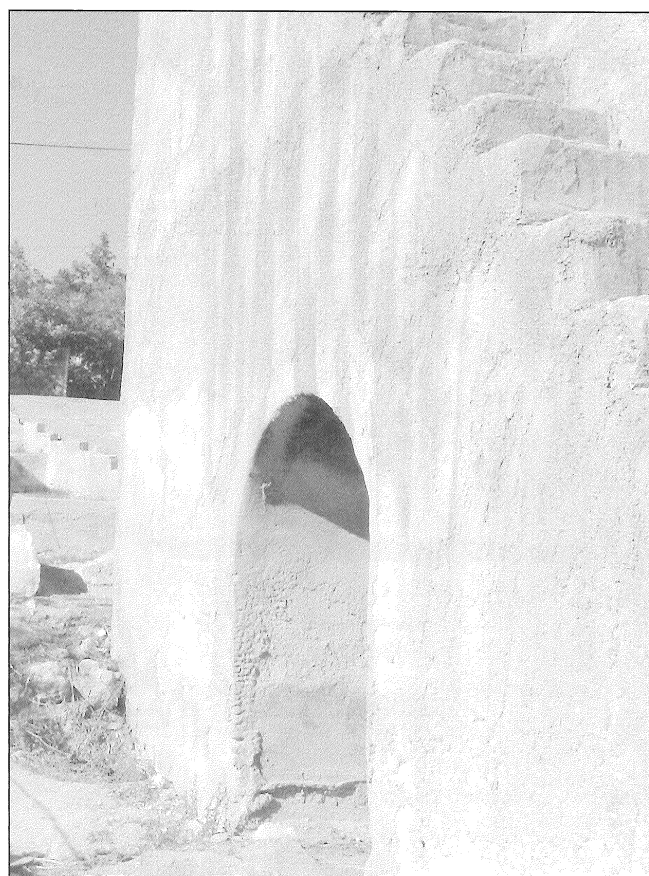
6. Saḥam mosque staircase.

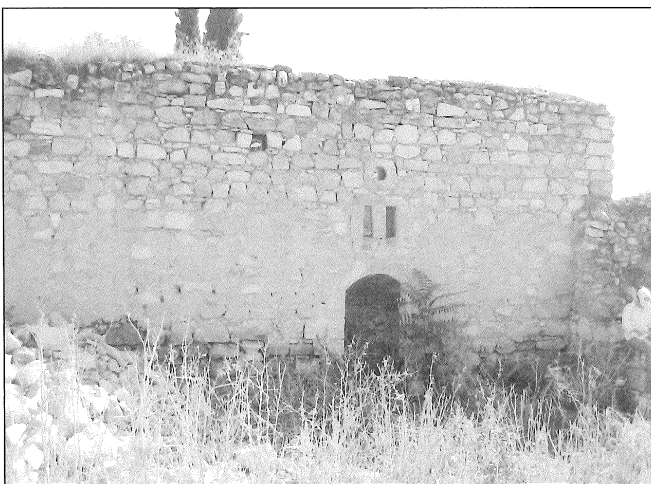
8. Façade of Zaytūna's farmhouse.

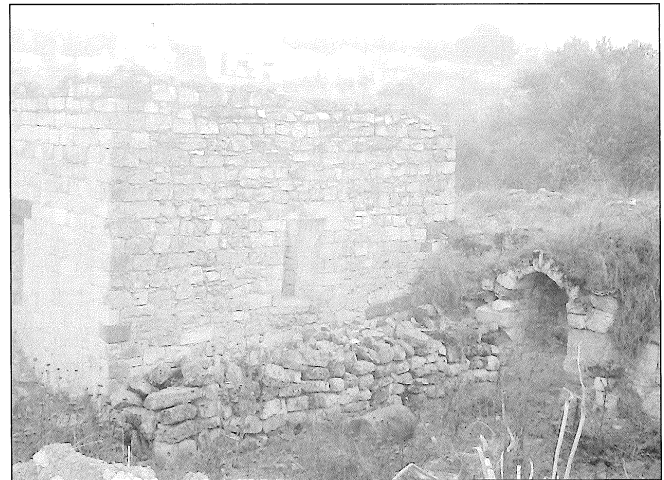
10. Embedded mosques of Ḥubrāṣ, facing southeast “The western wall of the Mandate-period mosque is visible to the left of the original mihrāb of the Early Islamic sanctuary. The Mamluk pavement is visible in the foreground.”

of that village still stand today, surrounding two historical mosques, one built in the prayer hall of the other (Fig. 10 — see Walker 2005: 11, fig. 5 for floor plan).

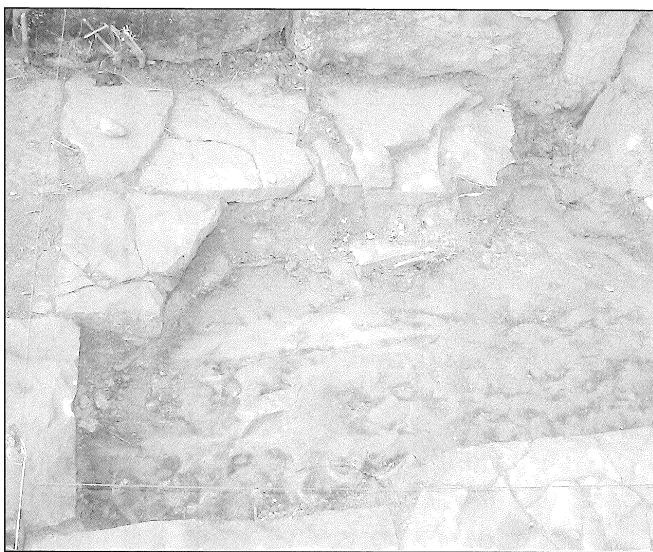
11. Square A1 – final morning photo “The Mamluk pavement, damaged by collapse, is laid directly on bedrock, its surface possibly pocked to receive a mosaic bedding”.

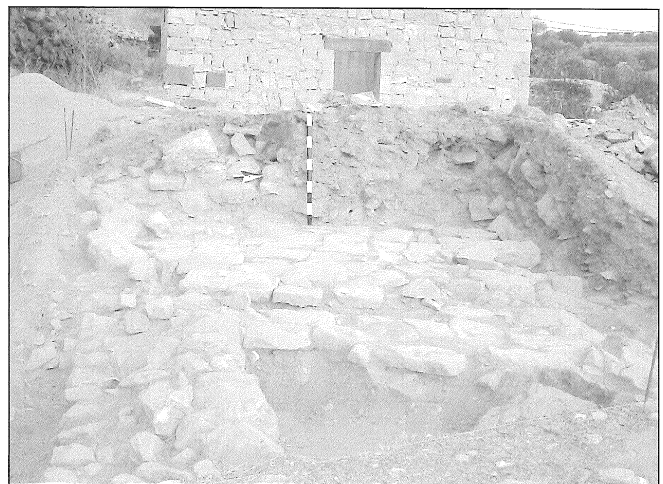
12. Square A3 – end-of-season photo “View west of the ‘eastern building’ adjacent to the medieval mosque”.

There are a number of other loci that did not fit so easily into the above sequence. Loci 10A and 3B constitute what appears to be a field wall (visible to the left in Fig. 12). Locus 10A, the

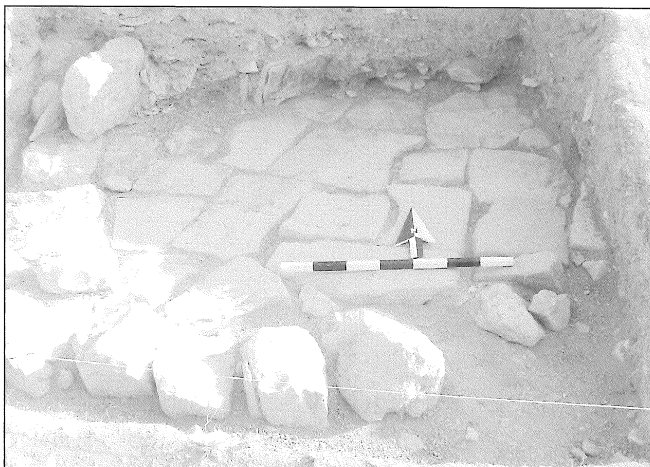
13. Detail of reused flagstones in A03.9A. "Note the two flagstones with rounded profiles, above the North Arrow".

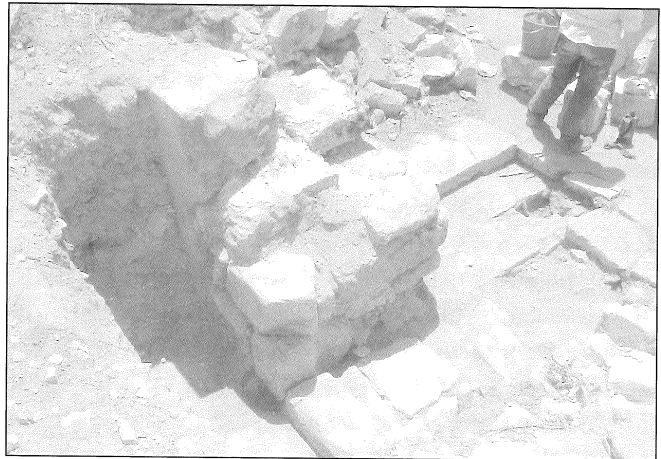
14. Square A6 doorway, end-of-season photo “Threshold and interior and exterior pavements are visible”.

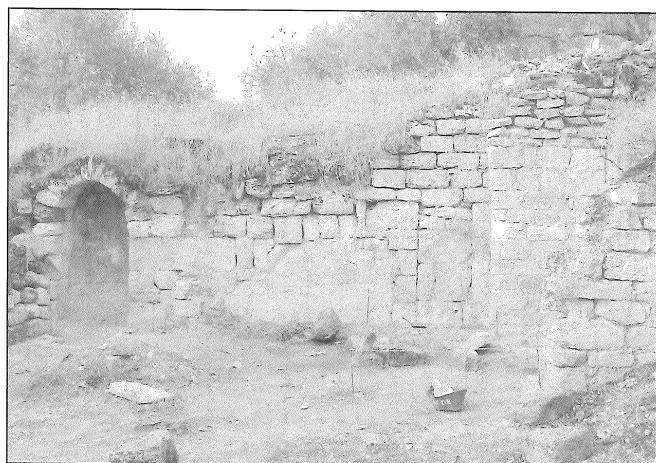
15. Remnants of Umayyad mosque at Ḥubrāṣ, view to southwest “Note the bedrock in the corner. The piers and flagstone are later, Mamluk additions”.

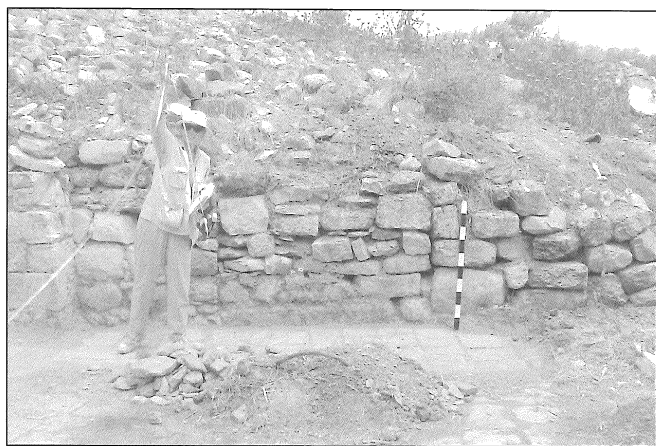
16. Original doorway to Early Islamic mosque, north wall.

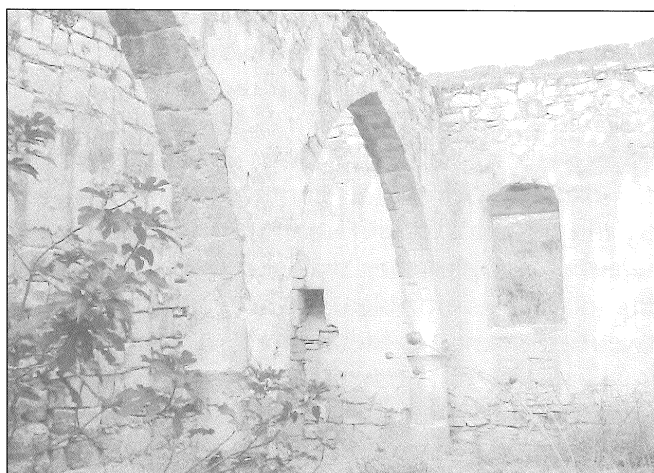
17. Interior of Mandate-period mosque at Ḥubrāṣ in 2003, view to southwest.

sanctuary (see Fig. 10 for floor plan). It was a small, nearly square, closed mosque (6x10m), with a single *mihrāb* (1.5 meters deep, 1.85 meters high, and 1.5 meters wide — Fig. 17) and covered by a dirt, cane, and thatch roof. Its walls were built on top of the medieval flagstone pavement. The structure of the interior supporting arches (running parallel to the *qibla* wall) and the exterior staircase (Fig. 18), built into the repaired *qibla* wall, are part of an architectural tradition that is common to the Mandate period in northern Jordan. The remaining space of the medieval sanctuary was put to use as a *kut-tāb* until 1965, when a new village school was built. The smaller sanctuary was used for Friday prayer until 1969, when the minaret collapsed and made the building unsafe. At that point the village asked, through official channels, that a committee be formed to raise money for its res-

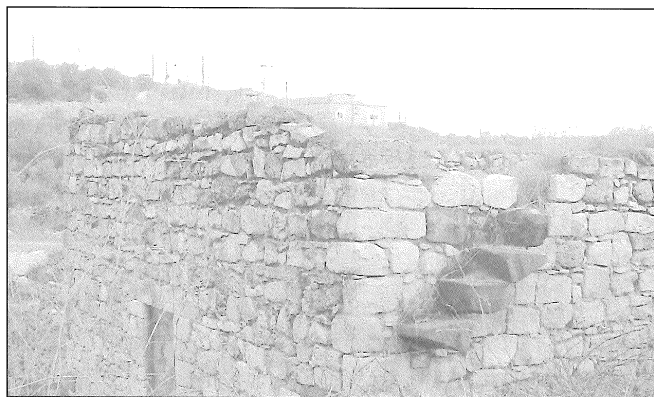
18. Staircase of Mandate-period mosque at Ḥubrāṣ, built into the outer face of the *qibla* wall, rebuilt in 1931 "Prayers were done from the roof."

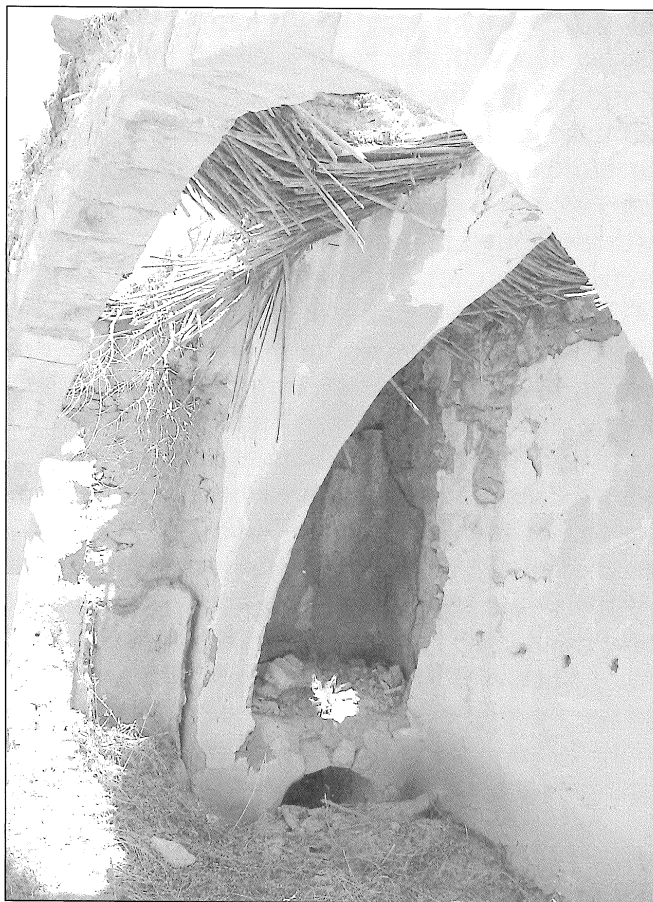
20. Interior of 'Obeidat farmhouse, illustrating transverse arch forms of construction.

The core of the rectangular residential building is the central room, which clearly predates the spaces that flank it. A classic example of a single-spaced, transverse-arched village housing unit (Fig. 20), this room was roofed over with cane and mud plaster, remnants of which remain *in situ*. The walls are constructed of irregular courses of unevenly formed blocks and chink fill. Access to the room is through a single door, rectangular in profile from the exterior (with a monolithic lintel) and arched in profile from the interior (with a low, segmental arch),
