# THE BROWN UNIVERSITY 2001 PETRA GREAT TEMPLE EXCAVATIONS OFFER MORE SURPRISES

*Martha Sharp Joukowsky*

The ninth 10-week season of excavation by Brown University archaeologists at the Petra Great Temple took place from June until August 2001, and helped us clarify the architecture of the precinct. Eight trenches and two special projects were excavated with startling results. A revised site plan with the 2001 trenches is shown in **Fig. 1**, and an aerial photograph of the site at the conclusion of the 2001 season is shown in **Fig. 2**.<sup>1</sup>

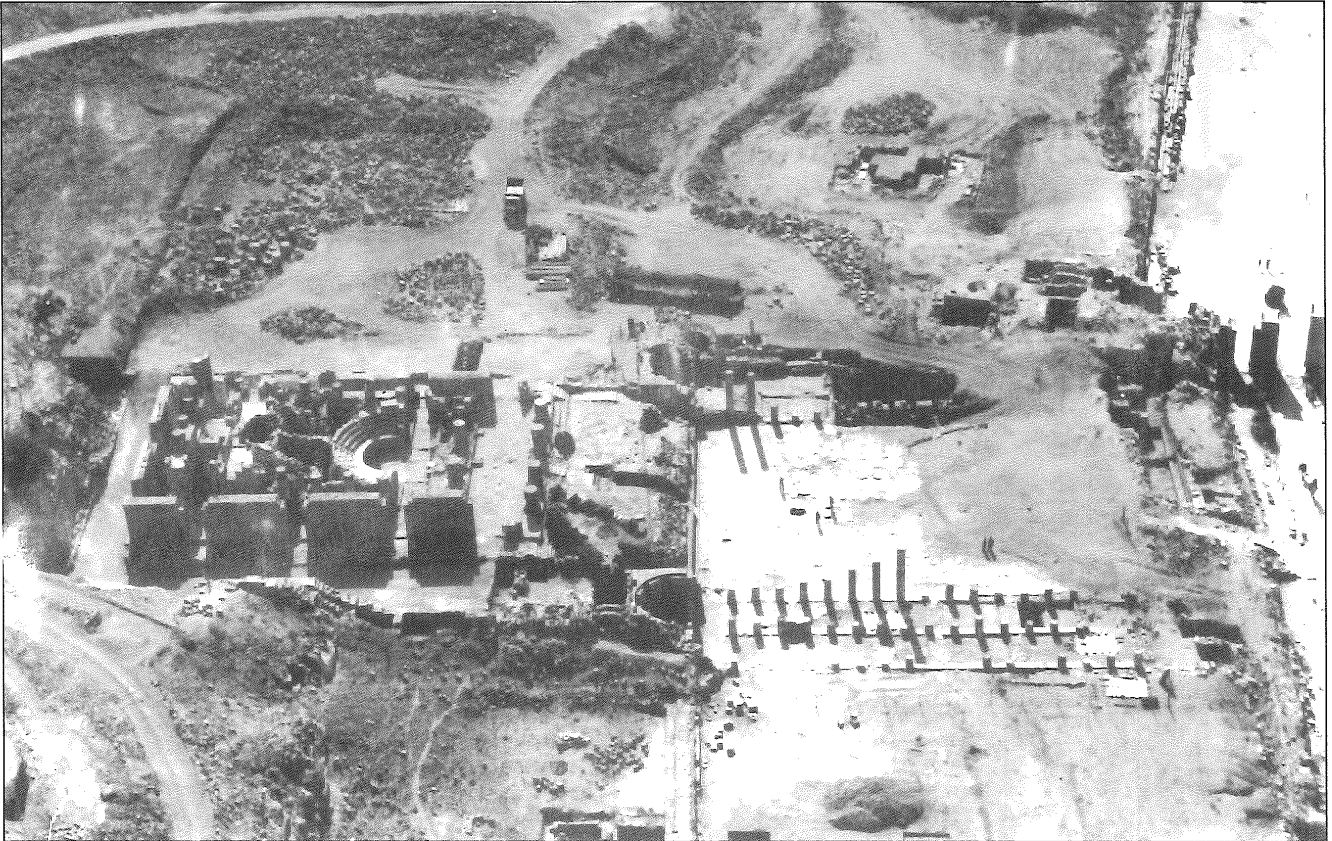
2. Aerial photograph of the Petra Great Temple looking west (photograph by A.W. Joukowsky).

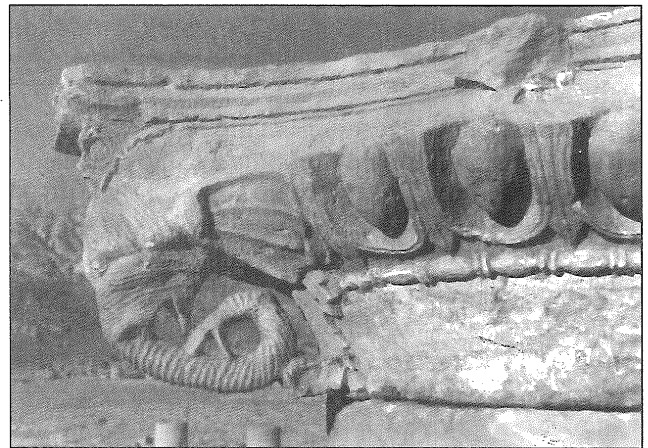
3. Complete elephant-headed capital excavated in 2001 (photograph by A.W. Joukowsky).

wall, had brought forth elephant headed capitals from the Propylaeum-Lower Temenos Triple Colonnade. During the 2001 season yet another, the best preserved of all was recovered — one side of an elephant headed engaged capital was completely preserved (*mirabile dictu*), which is shown in Fig. 3.

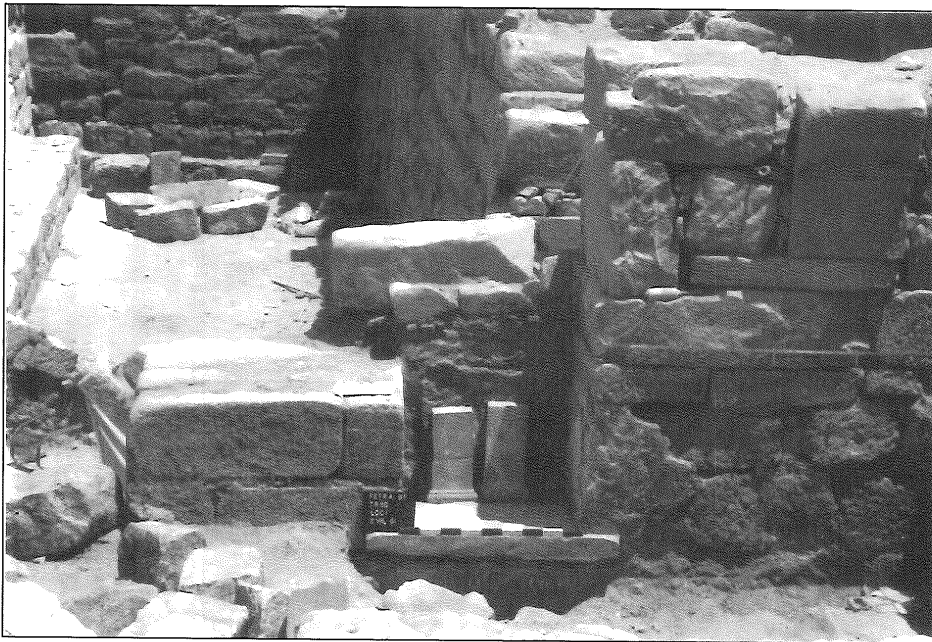
4. *Propylaeum west, betyls in situ*  
(photograph by A.W. Joukowsky).

Continuing excavations under the supervision of Darryl B. Sneag in Trench 80 of the West Propylaeum also revealed unprecedented double limestone betyls attached into a niche with plaster. The niche measured 0.97m in width and is inset 0.69m. Shown *in situ* in Fig. 4 and by drawing in Fig. 5,

these sacred aniconic representations of Nabataean deities are in remarkably pristine condition, measuring approximately 0.50m in height x 0.21m in width — their tops are approximately 0.09m in thickness.<sup>3</sup>

3. The betyls are in remarkably good condition considering the huge collapse/destruction that ransacked the rest of the Great Temple; however, the north betyl, Cat. No. 01.S.38, is fragmented into two pieces and the back left edge of the south betyl, Cat. No. 01.S.39, has a small chip. Unlike those

found throughout as-Siq, most of which are carved out of the sandstone bedrock and are badly weathered, these free standing betyls are carved out of a high-grade limestone, their edges remain well-articulated, and their faces are flush.

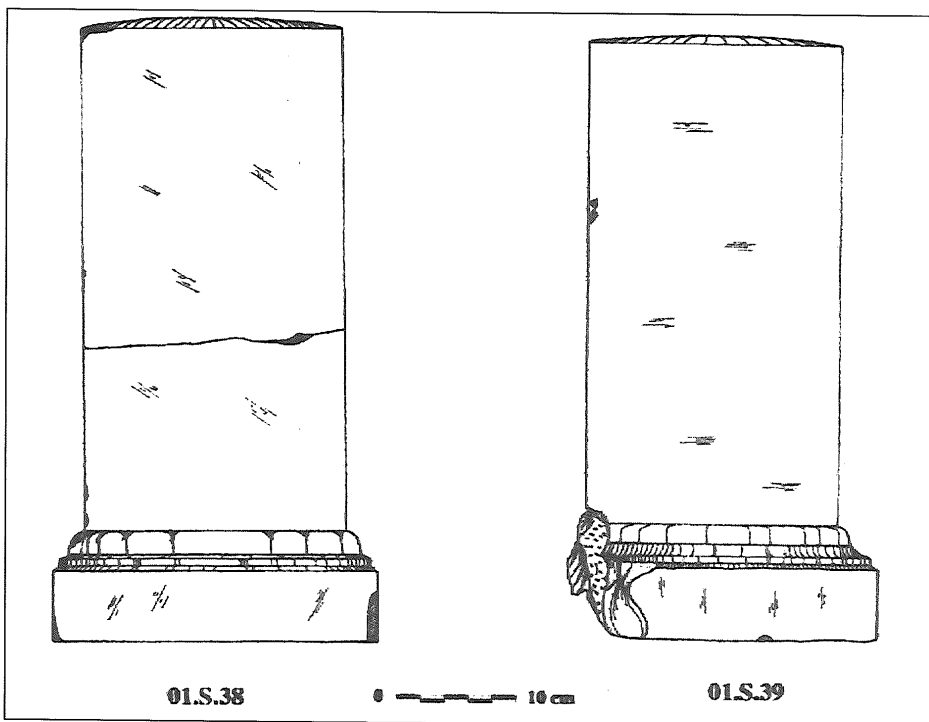
5. *Drawing of Propylaeum betyls*  
(drawing by Emily C. Egan).

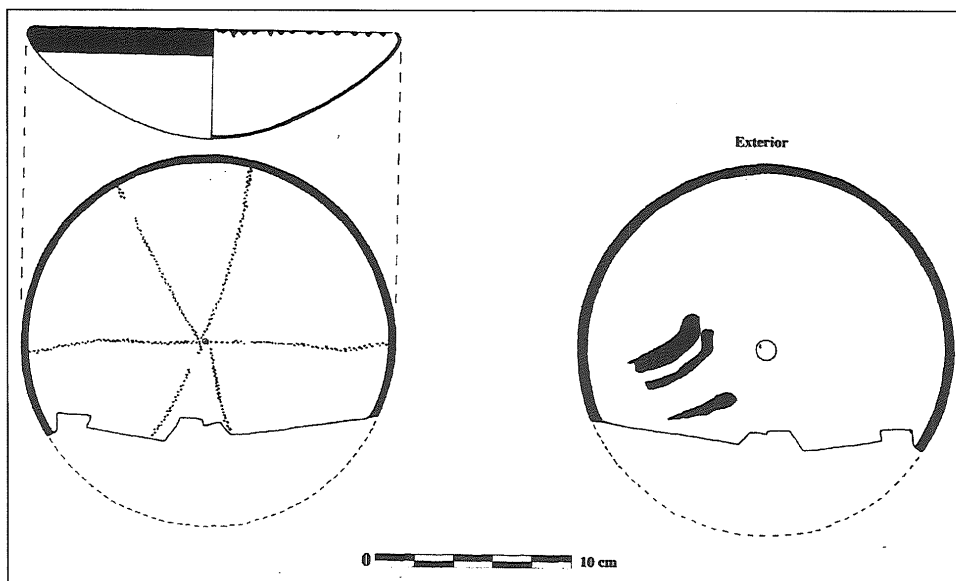
6. West Propylaeum bowl (drawing by Emily C. Egan).

5. The bowl has an even core and is of a light red (Munsell 10R 7/6) ware with a self-same slip. The interior design consists of six evenly spaced lines of small, dark red (Mun-

sell 2.5YR 4/8) dots. These lines extend from the incurved rim, which is decorated with small, dark red (Munsell 2.5YR 4/8) triangles, and intersect at the base. The exterior is undecorated except for three streaks of the same hue of dark red paint as the interior decoration, possibly from the fingers of the potter. The exterior of the rim is painted with the same hue of dark red paint described above. Although there are no exact parallels in Schmidt's typology, the incurved rim and the design of relatively small, closely spaced triangles on the interior of the rim, and open, largely undecorated spaces on the bowl suggest an early date for its manufacture.

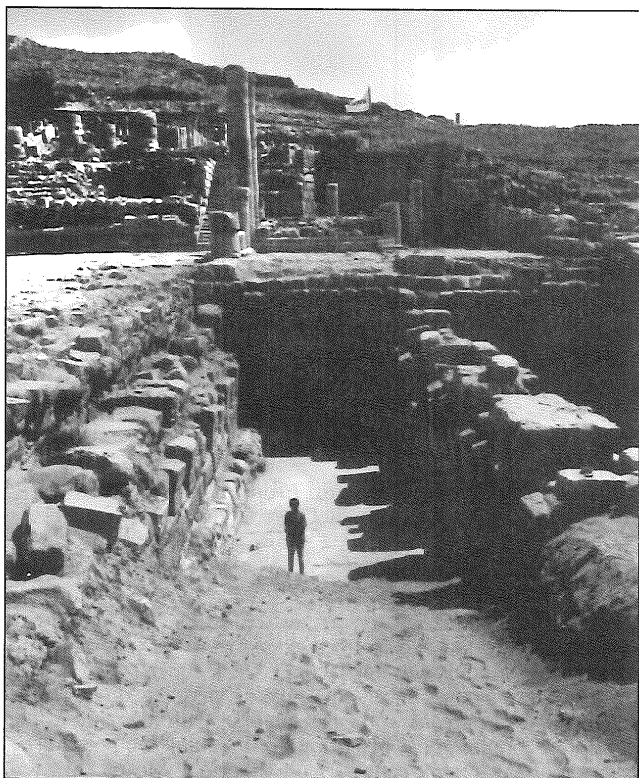
7. West Cryptoporticus looking south (photograph by A.W. Joukowsky).

Now with the all but complete excavations of a 13.00m north-south x 12.50m east-west portion the West Cryptoporticus can we begin to interpret its plan on surer grounds. There must have been an entry (not as yet found, but possibly in the Propylaeum) leading into two long subterranean arched galleries. Oriented to the north these two galleries were constructed of well-cut masonry joined with mortar and covered with plaster, some of which is colorfully painted with elegant designs.

During the early excavation stages the west wall architecture in the west sector of the West Cryptoporticus was uncovered, the middle pier wall (Piers 1-6), and the east sector of the West Cryptoporticus wall. All three walls were constructed with arch springers extending from them. As the excavation moved deeper in depth it was found that under the piers in the Middle Wall, a large ashlar wall supported the piers, and a now disintegrated wooden beam was found in the lower courses of the west wall. The close of the excavation in this area was triumphed with the discovery of an excellently-preserved limestone flooring found in both cryptoporticus sectors. Uncovered in a superb state of preservation at a depth of 4.77m below the building level of the West Triple Colonnade, approximately 6.00m north-south x 3.73m east-west flooring was cleared in the east sector, whereas 1.50m north-south x 4.18m was excavated in the west sector. Excavations also brought to light benches built against the east-west retaining wall in the east sector of the West Cryptoporticus, and one abutting the east wall of the West Cryptoporticus east. More excavation needs to be undertaken to better define these floors and their associated benches.

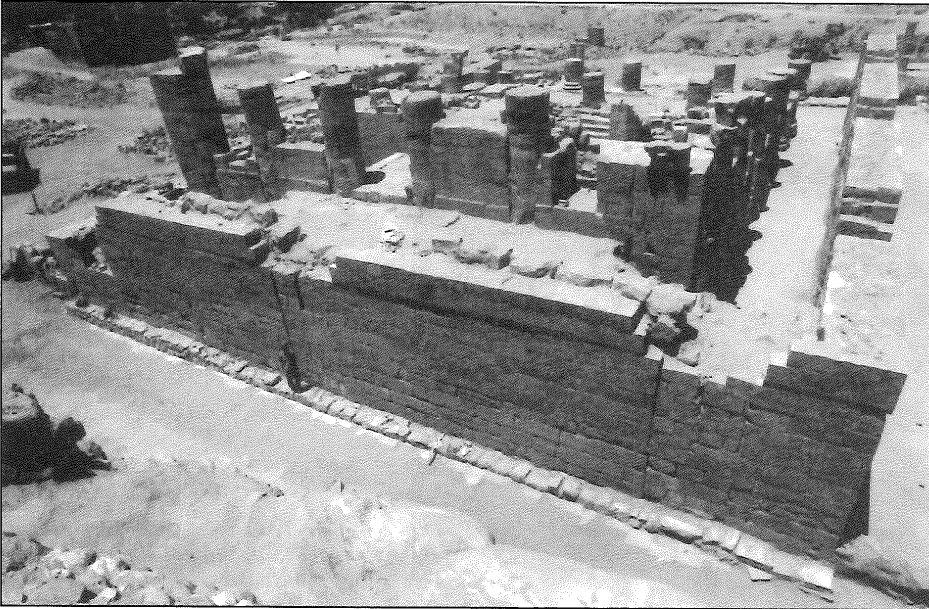
8. Upper Temenos South passageway  
(photograph by A.W. Joukowsky).

Trench 83 is located in the extreme south of the Upper Temenos and stretches 31.20m in east-west length x 6.45m in width in the east, and 12.21m in width in the west. The substantial clearance of the south passageway, excavated by Emma S. Libonati, began with the cleaning and removal of debris in the southwest. Fig. 8 shows the South Corridor freed from debris.

The south retaining wall of the passageway is in poor condition — only small sections of the original facade wall remain intact, usually only two or three courses in height. In the east central section of the trench, six courses remain intact but dramatically slump into the passageway in a northwesterly direction at a precipitous angle of approximately 30 degrees. This remaining section of the facade wall shows the violent force and pressure of the weight of the terraces behind. In antiquity, this wall would have been constructed at least to the 12.00m height of the surrounding bedrock escarpments. It would have made a dramatic statement for the Upper Temenos south.

Portions of the original south passageway pavement were recovered in fairly good condition, stretching from the east to the west in an uninter-

rupted line for 23.80m, and extending north-south at its widest point to 1.73m (the average length for a paver is 1.07m while the average width is 0.52m). In the east, most of the pavement was robbed, and in the west, a major portion of the pavement was also missing. The south passageway has slab covered water passage system abutting the south and southeast Perimeter Walls — the conduit is 0.30m wide x 0.73m depth and the channel is lined with hydraulic cement. At some later point in time, additional water channels cut into the south pavement bedrock provided supplementary water. This indicates that the pre-existing water systems were for some reason inadequate and additional surface canalization needed to be added to bring or receive water to or from the west. Certainly, this system and its relationship with the Upper Temenos systems in the east plaza need to be more carefully examined.

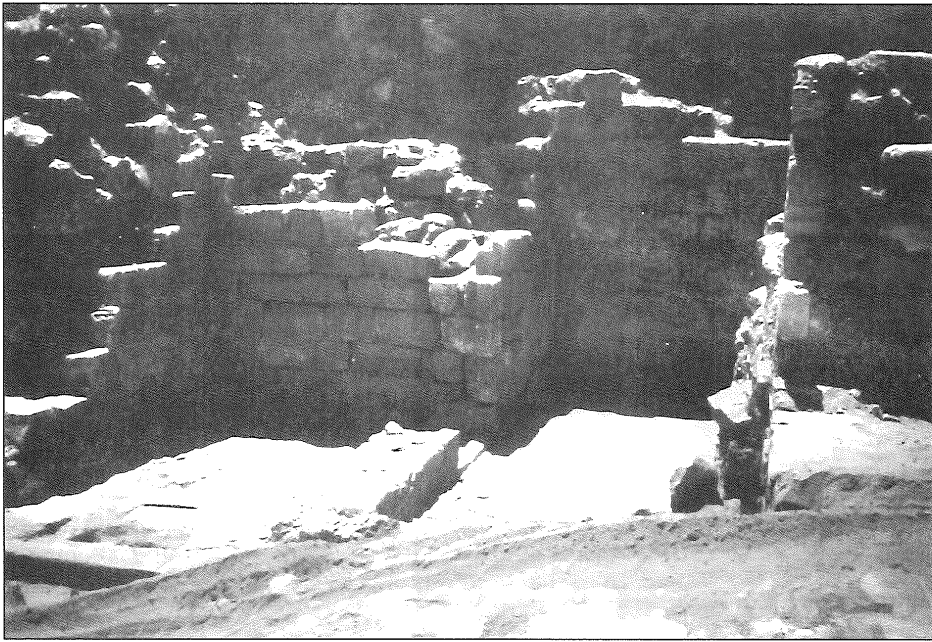
9. Upper Temenos South passageway chapel and anteroom (photograph by A.W. Joukowsky).

In the removal of dangerous fallen blocks from the southwest terraces, we recovered the remains of an anteroom and chapel with frescoed walls, a hexagonal pavement and an empty cult niche. Shown in Fig. 9, this enigmatic chapel measured 2.07m north-south and its partially excavated east-west south wall was 3.02m in length. The original construction of the north wall is seen only in its foundation, and the west wall remains under the west balk. The chapel walls are comprised of well-hewn diagonally dressed ashlar — the east wall is composed of five to eight ashlar courses measuring 3.22m in height whereas the east-west south wall is composed of ten courses and measures 4.00m in height. *In situ* decorative plaster in the southeast corner of the chapel adheres to the wall to a 2.09m height. This decoration consists of a purple border

In the chapel south wall, 1.32m above the floor level, was a niche with a preserved height of 1.02m. Both the east and west niche walls were comprised of one large ashlar block, 0.38-0.44m in height, carved at the top in an arc with two courses of ashlar below. A 0.31-0.34m recessed platform was carved to provide a prepared surface for a sacred object, most likely, a statue or a betyl. A slight oval depression has been hollowed out in its center and several dowel impressions indicate that there was a purposeful method employed for affixing what was placed there.

The flooring of the chapel is comprised of wet-laid small limestone hexagonal pavers that mirror those found in the forecourt of the Upper Temenos. The pavers average 0.35m diameter (from point to point) and remain in excellent condition. Near the walls the pavement does not retain its hexagonal shape but is cut flush to abut the bottom of the room's walls disregarding the aesthetic schema in favor of practicality. The extreme care and effort taken to set and place this floor in an area not only with the possibility of being sealed off from the public at large further suggests that it had a ceremonial or special purpose. We are undertaking the consolidation of the frescoed walls and will continue the chapel's excavation to the west so that its overall dimensions and other features might be determined.

Leading into the chapel is an anteroom measuring 3.44m north-south x 3.20m east-west. A large

regularly carved ashlar serves as the threshold, 1.08m x 0.41m, between the anteroom and the South Passageway. The east wall of the anteroom is composed of seven courses of scavenged building material — some of the blocks contain marginal drafts, however others are small snecking stones set between irregular blocks.<sup>8</sup> The preserved height of the wall is 3.12m. The northern blocks of the facade wall and the eastern wall have been removed to the foundation course making it impossible to determine if these features bond. The floor of the anteroom has been left relatively unexcavated to show the *in situ* position of roof tiles that fell flat onto the surface. Portions of the excavated floor indicate it to have been of rough plaster and mortar — its pavement probably was robbed in antiquity. At a later point in time, and we presume this to be *before* the Great Temple was transformed by the addition of the *theatron*, there was a blockage of the doorway accessing the chapel. This blockage was composed of tightly laid, approximately 0.21m square, diagonally dressed limestone blocks. Great care was exercised to lay these blocks flush to the doorway and the high quality of the material indicated this area was intentionally blocked off. The blockage height was preserved to only 0.48m, suggesting that salvageable blocks in this area were removed in antiquity to be used elsewhere. This blockage suggests the chapel was blocked off and no longer in use while its anteroom may still have remained in use.

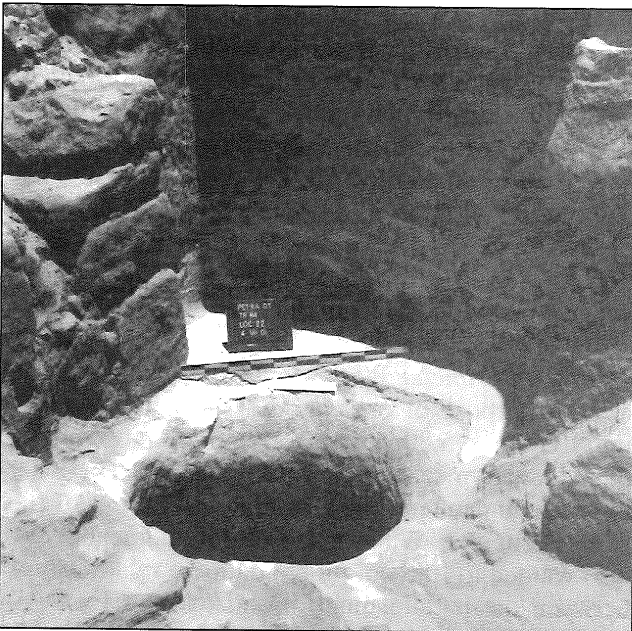
10. Upper Temenos east cistern opening (photograph by A.W. Joukowsky).

Shown in Fig. 10 in the Upper Temenos southeast, was the astonishing discovery of a subterranean cistern, which extended under the southeast plaza bedrock floor. This cistern was part of the overall planned scheme of the Great Temple water management with various canalization systems

within the precinct evidently varying in function. Known as Special Project 85 excavated by Christian F. Cloke, this feature was discovered below a round opening along the southeast escarpment. A test trench in the interior, 2.50m north-south x 1.50m east-west, helped us recover its original bedrock floor. While it is likely that the floor is uneven throughout the cistern, perhaps deeper in the center, we were able to get a rough metric estimation of its water-holding capacity. Estimating by the measurements of the cistern room itself (excluding the shaft, and assuming that the cistern was filled to capacity), we arrive at a figure of almost 390 cubic meters, for the structure measures 8.50m in north-south length x 7.80m in east-west width x 5.88m in depth. Although this is hardly an exact computation (as it does not make allowances for the diminishment of the area by columns and other features), it gives us a rough idea of the storage capabilities of this massive structure. In its interior were the remains of two built arches spanning the east and a centrally located massive support column carved out of bedrock.<sup>10</sup>

As for the architectural components of the cistern and their sequencing, while not wholly apparent at this point, as the entire extent of most features cannot be seen, some preliminary hypotheses can be made. It appears that the initial building phase involved the cutting of cistern shaft, followed by the quarrying of the cistern in its original form, which was probably a simple rectangular room furnished with an east bedrock column and a short support wall to the southwest of cistern shaft. These features appear to be the most thoroughly incorporated into the cistern's fabric, and the most sturdily and carefully constructed, so they have been assigned to this early building phase. Following initial building the entirety of the cistern was sealed with a coat of waterproof plaster.

Constructed also at this time was the canalization on the west of the Upper Temenos East Plaza, which fed the cistern via an opening in the cistern's southwest ceiling. The shaft and this opening in the southwest were presumably the two main original sources of cistern water. The small channel piping water into the shaft would have sent the water flowing in a cascade against the northeast side of the shaft walls where it would have landed on the ledge transecting the shaft. After there it would have then streamed more slowly into the cistern, so as not to unnecessarily stir up any impurities. These two large systems would have provided a

The following phase of the cistern's building seems to have taken place not long after this initial phase of construction. The ceiling of the cistern's southwest corner is noticeably and significantly lacking in strength and higher than the bedrock in the other parts of the cistern. This weakness must have occurred during or shortly after the cistern's construction, necessitating the addition of support elements to this room area. There was then the addition of a small north-south wall plus the cistern's south wall with its incorporated arches which lent support to the cistern south. These elements were also heavily plastered to prevent extensive water seepage and possible structural weakening.

Even these elements, however, were apparently deemed insufficient for the support of this area, and another southwest pillar then was added. This stone pillar is somewhat shoddy in construction, and appears to have been a final attempt at stabilizing the ceiling in this critical area. This has been deemed the latest addition because of the poor aesthetics of its orientation and the fact that its position would have left little space for the construction of the south arched wall.

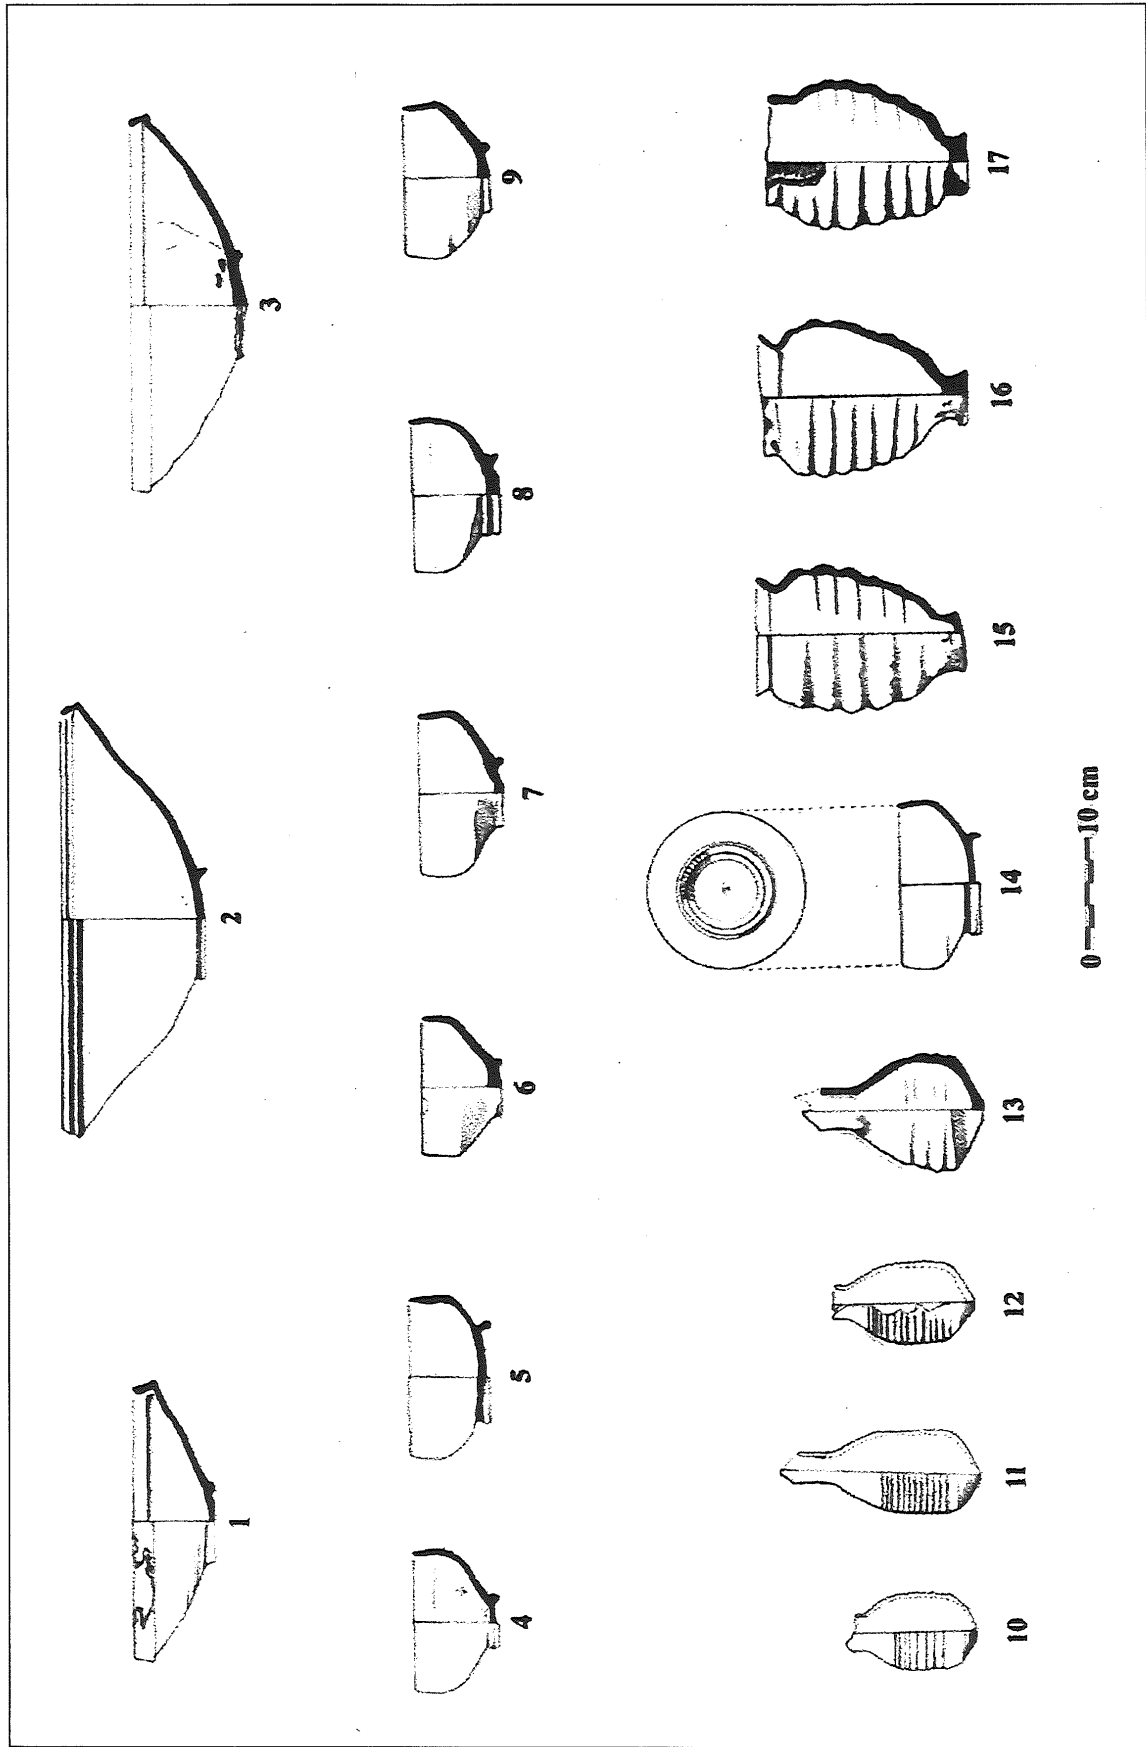
11. Pottery from the rock-cut room over the Cistern (drawing by Christian Cloke).

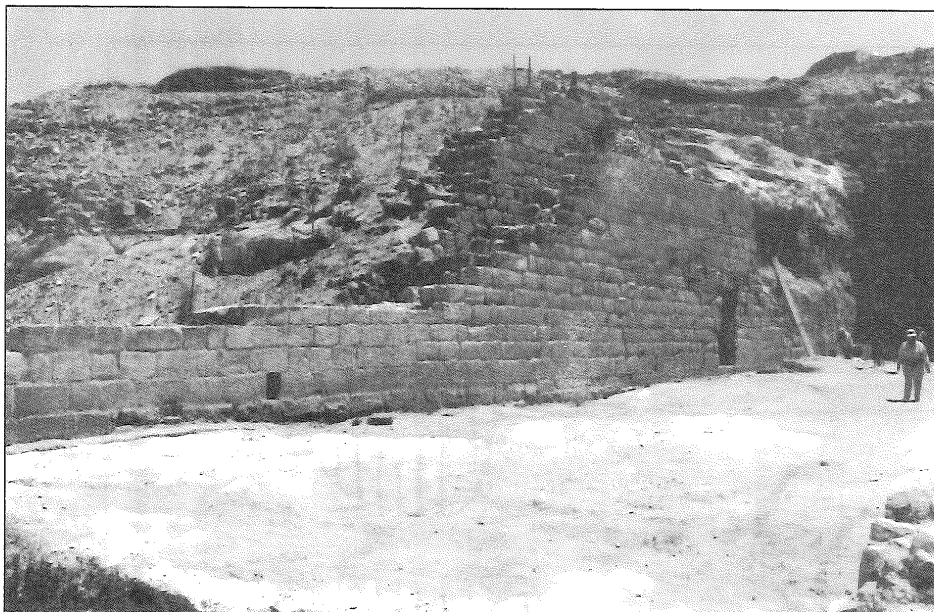
12. Upper Temenos East Perimeter Walls with doorway (photograph by A.W. Joukowsky).

Fusté, who first targeted the area inside the flat lintel doorway, discovered in 1999, of the interior East Perimeter Wall. Here was a small square room, Room A, with high arched niches, and the later installation of an oven and a trough shown in Fig. 13. Also excavated was a north-south long, narrow rectilinear room, Room B, to the south of the water reservoir discovered in the 1999 excavations.

After the bedrock was prepared there was the creation of the East Perimeter Wall with its exterior vaulted arch, extant to a 9.29m height, surmounting the most eastern section of the East Perimeter Wall and extending over the west section of the wall. In the building of the west section of the East Perimeter Wall, Room A, measuring approximately 2.50m square was constructed behind

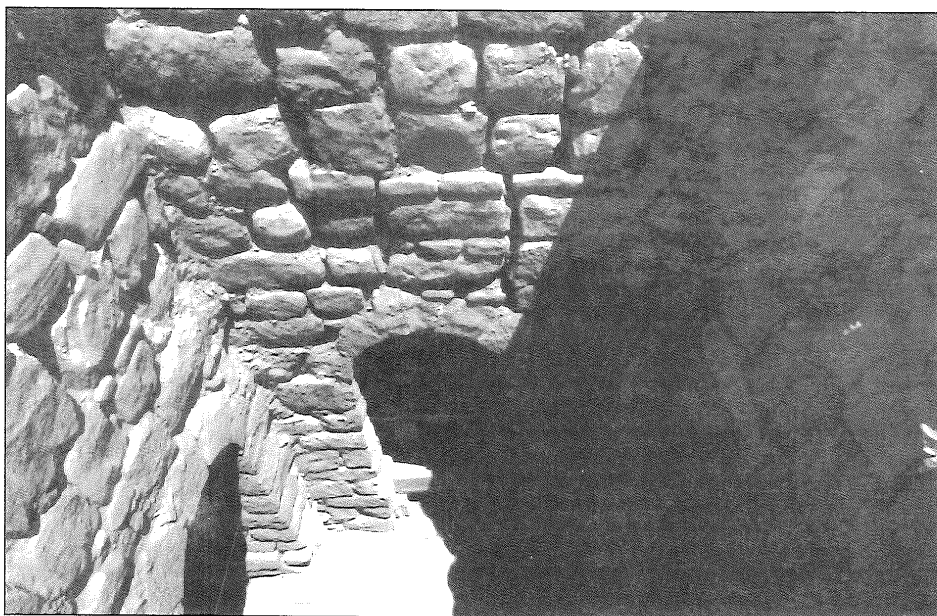
13. Upper Temenos East Perimeter Wall Room A interior (photograph by A.W. Joukowsky).

the west wall between the interior and exterior East Perimeter Wall, facing the East Plaza. Room A walls stand to a 7.71m height — and the north and east walls are embellished with very high, 3.40m in height finely crafted niches surmounted by arches. Based on the stratigraphy and the ceramics, it is posited that these two beautifully arched niches ceased to serve their primary function during the first century BC. A later phase saw the removal of deteriorated stucco on the walls and the construction of a plastered water basin set into the east arch niche. A hearth surrounded by rocks was also installed inside of the north arch niche, which left soot-marks on the arch niche, as well as on the bed-rock floor and the fill directly above it. Thus at this point in time, Room A functioned as a kitchen with large amounts of cooking pots and a hearth. After enough dirt mixed with ash accumulated, the hearth fell out of use and an oven (*tābūn*) was dug into the floor in the southeast corner. This furthers the point supported by other evidence found in the Great Temple indicating that at some time in the building's existence its layout and purpose changed.

In a later phase the doorway from the East Plaza leading into Room A was partially blocked directly above the threshold. There was also the addition of a thick floor packing layer on top of the occupational debris, but the water basin in east arch niche continued in use. During this phase, however, the *tābūn* fell into disuse and was instead converted into a storage pit for fine Nabataean pottery, including fine rouletted cups, red slipped jugs with twisted handles and a Nabataean pilgrim bottle (Fig. 14). There was also the addition of a stone shelf over the *tābūn* of reused floor-pavers. At some later point in this phase or perhaps in a later phase, the water basin inside the east niche was reused as a trough. Three tethering holes were bored into several ashlar, which is an indicator that at this time the room served to keep animals. It is difficult to establish the chronology for this room in its later phases, for these deposits represent the most recent surviving events before the destruction debris accumulated.

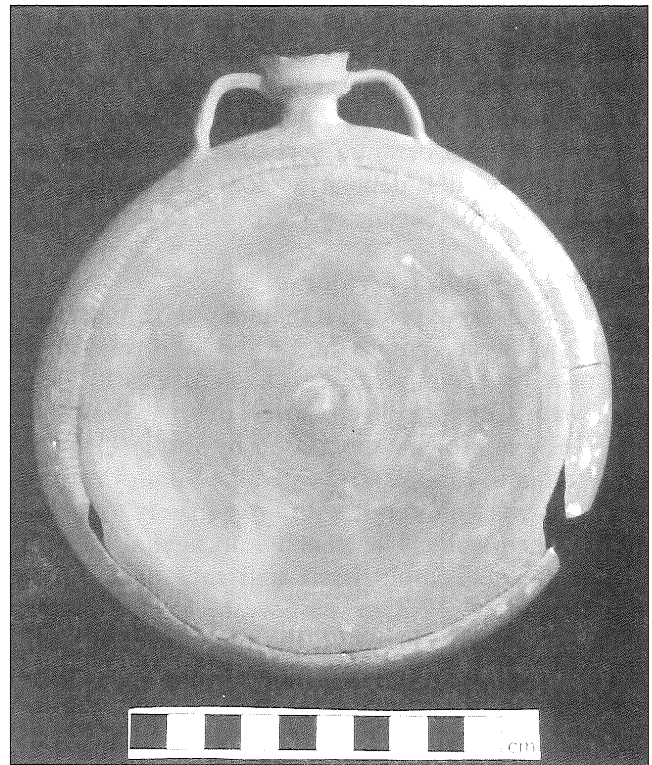
14. Nabataean pilgrim bottle found in the Room A deposit (photograph by A.W. Joukowsky).

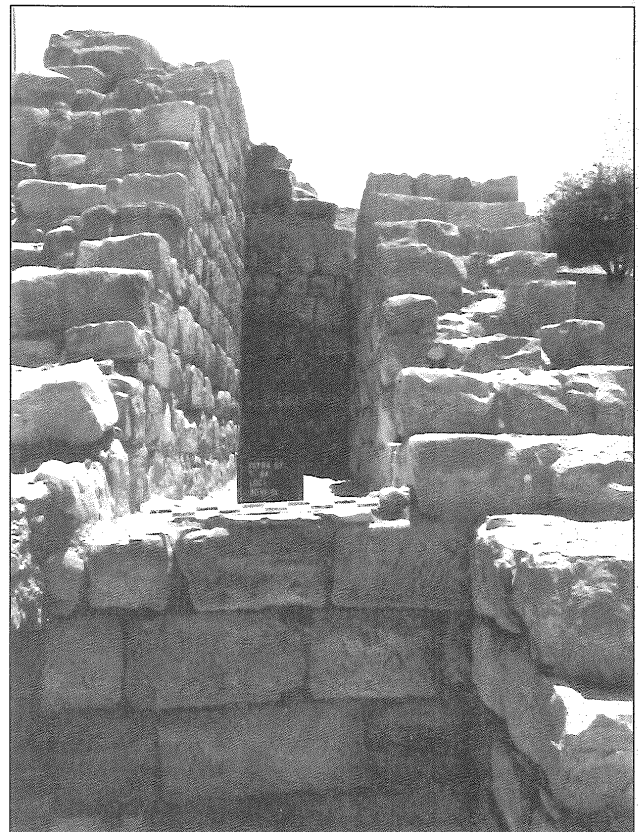
15. Upper Temenos East Perimeter Wall Room B (photograph by A.W. Joukowsky).

The excavation of Room B (Fig. 15) allowed us to be certain that the interior East Perimeter Wall bonds with the most east exterior Perimeter Wall lying parallel to it. Therefore, it was confirmed that these double walls were constructed at the same time. In Room B two small niches were installed on both the east and west interior walls of this long rectangular room. Additionally there was the filling of the room with a raised floor bedding on top of accumulated fill, and the creation of a low retention wall to retain the fill and support the new floor bedding. There was also the construction of the water

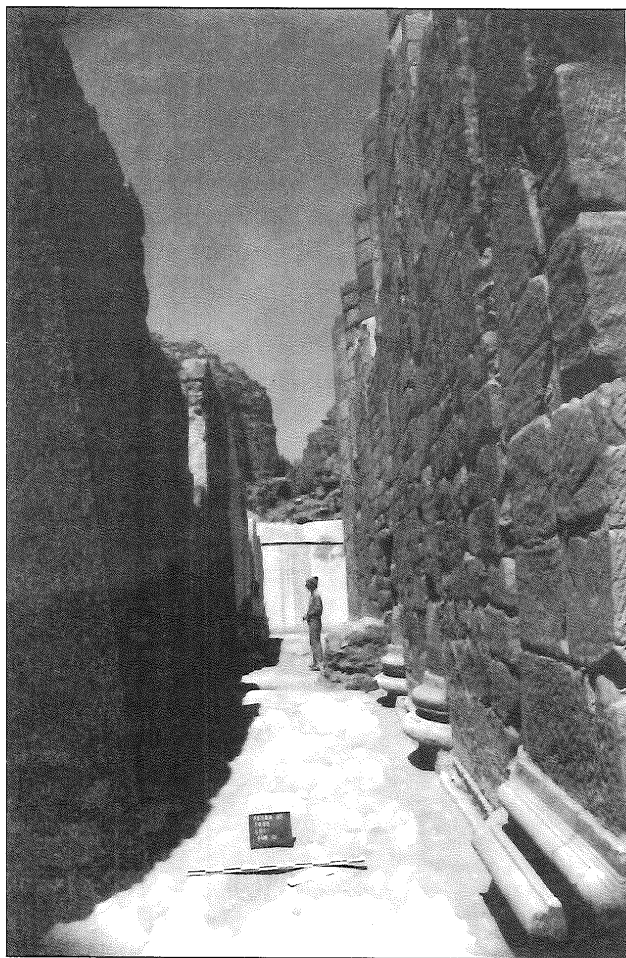
16. Temple South Corridor (photograph by A.W. Joukowsky).

The only large project remaining to be undertaken in the Great Temple during the 2001 season (it has now been completely excavated) was to clear the South Corridor of collapsed debris. Shown in Fig. 16, this project, supervised by Emily C. Egan and Emma S. Libonati, revealed the South Corridor wall in its entirety with exquisitely stucco-embellished walls. The trench is located at the rear of the Great Temple itself and measures 2.73m north-south x 17.27m east-west. In the north, Trench 85 is bounded by the temple's southernmost east-west colonnade and its inter-columnar wall system. Between the six rear columns, the inter-columnar wall (2.39m in width) now stands to an average 6.43m height — with some 24 courses of diagonally chiseled ashlar set between the col-

umns. The southern boundary of the trench is the south wall of the Great Temple, and the eastern boundary is the Great Temple East Corridor. In the west, a portion of the South Corridor had been excavated in conjunction with the southern half of the West Corridor (Trench 59) in 1998. Between the south wall segments are three doorways leading into the structure from the South Passageway, which had been blocked with ashlar in antiquity. There are also interior passageways leading into the east and west corridors, and an additional narrow central doorway (2.04m in height x 0.67m) accessing the Great Temple's Central Arch. The canalization system under the Great Temple was also found to continue under the flooring of the South Corridor, but does not as yet seem to connect with the canalization found in the Central Arch.

As for the phasing of this trench from earliest to latest deposits, the earliest phase included the quarrying of bedrock, construction of builders' trenches, and installation of the water channel system. The second phase saw major construction with the building of the southernmost east-west colonnade, the south wall (with open doorways), the east wall, and the decorative plastering of the columns and the north face of the south wall. In the third phase was the redesign of the Great Temple with large scale architectural modifications, including the building of the inter-columnar walls and the south doorway to Central Arch between the columns of the southern east-west colonnade, and the blocking of the central doorway in the south wall. A later phase is represented by the restriction of access and/or fortification with the ashlar blocking of the doorways in the south wall. The penultimate phase is represented with a deposit of fluvial material and a brief domestic occupation, and the latest phase is represented with the debris from the major AD 363 collapse and destruction.

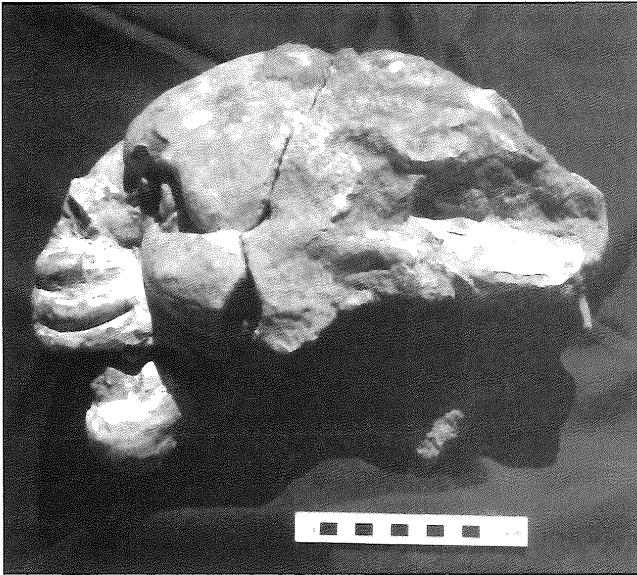
17. Lion from the Great Temple South Corridor (photograph by A.W. Joukowsky).

Well-preserved painted plaster with extraordinarily fine molded cornices was found along the north face of the south wall to the east and west of the central doorway. The excellent preservation of this plaster can be largely attributed to the blocking of the doorway, protecting the plaster from falling debris at the time of the Great Temple's collapse. Most surprising here was the recovery in the collapse of two massive sculpted stucco lions which must have been positioned opposite each other above the central doorway leading into the South Corridor. Additionally these sculptures can be associated with the doorway in this wall. One lion, thought to be a male, faced westward and appears to be snarling. The second lion, the female, shown in Fig. 17, faced eastward and looks to be smiling. Both lions have open mouths with exposed teeth

and a red painted tongue is visible on the lower jaw of the eastward facing lion. Due to their location and massive size, it is thought that the two lions flanked the upper part of the doorway. Further detailed analyses of this decoration has been undertaken by Emily C. Egan, who will report on the excavation and design of these walls, their sculptures and the attendant wall paintings in a separate study.
