THE ECCLESIASTICAL COMPLEX OF SAINT PAUL AT UMM AR-RAŞAŞ - KASTRON MEFAA

Michele Piccirillo

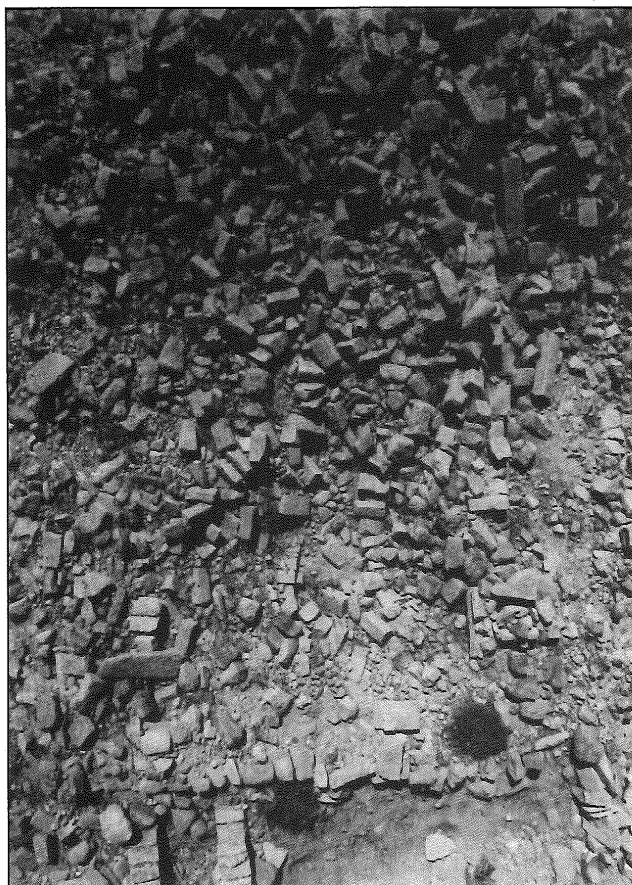
2. Umm ar-Raṣāṣ - Kastron Mefaa. The Church of Saint Paul prior to excavation (view from the west).

The area, which was difficult to reach, had not been affected by the modern re-occupation by the families of the Salayṭa tribe, who might have limited themselves to raising, in dry stone courses, the north wall of the courtyard that is a continuation of the sacred edifice to the east (Fig. 2).

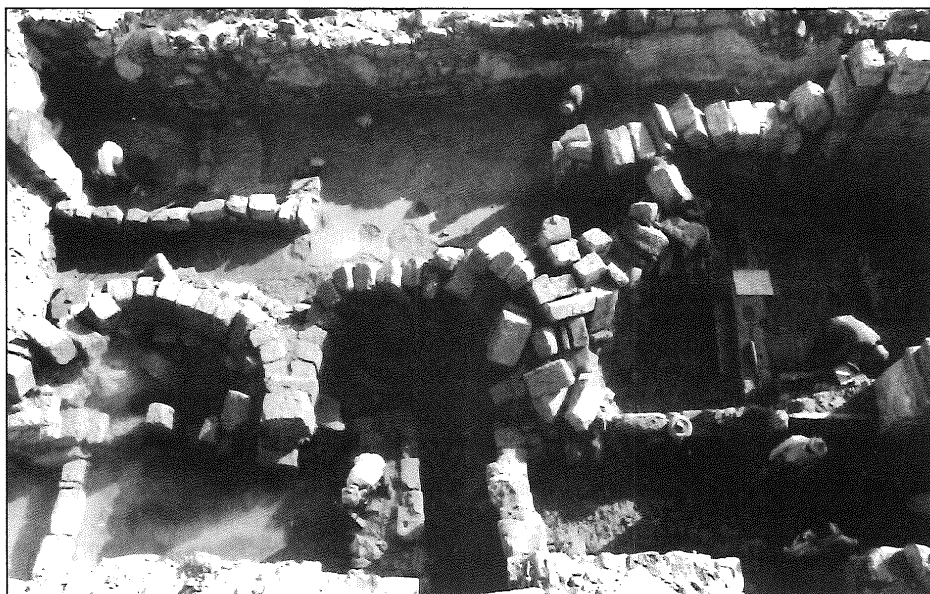
3. Church of Saint Paul after excavation, prior to the removal of the fallen arches.

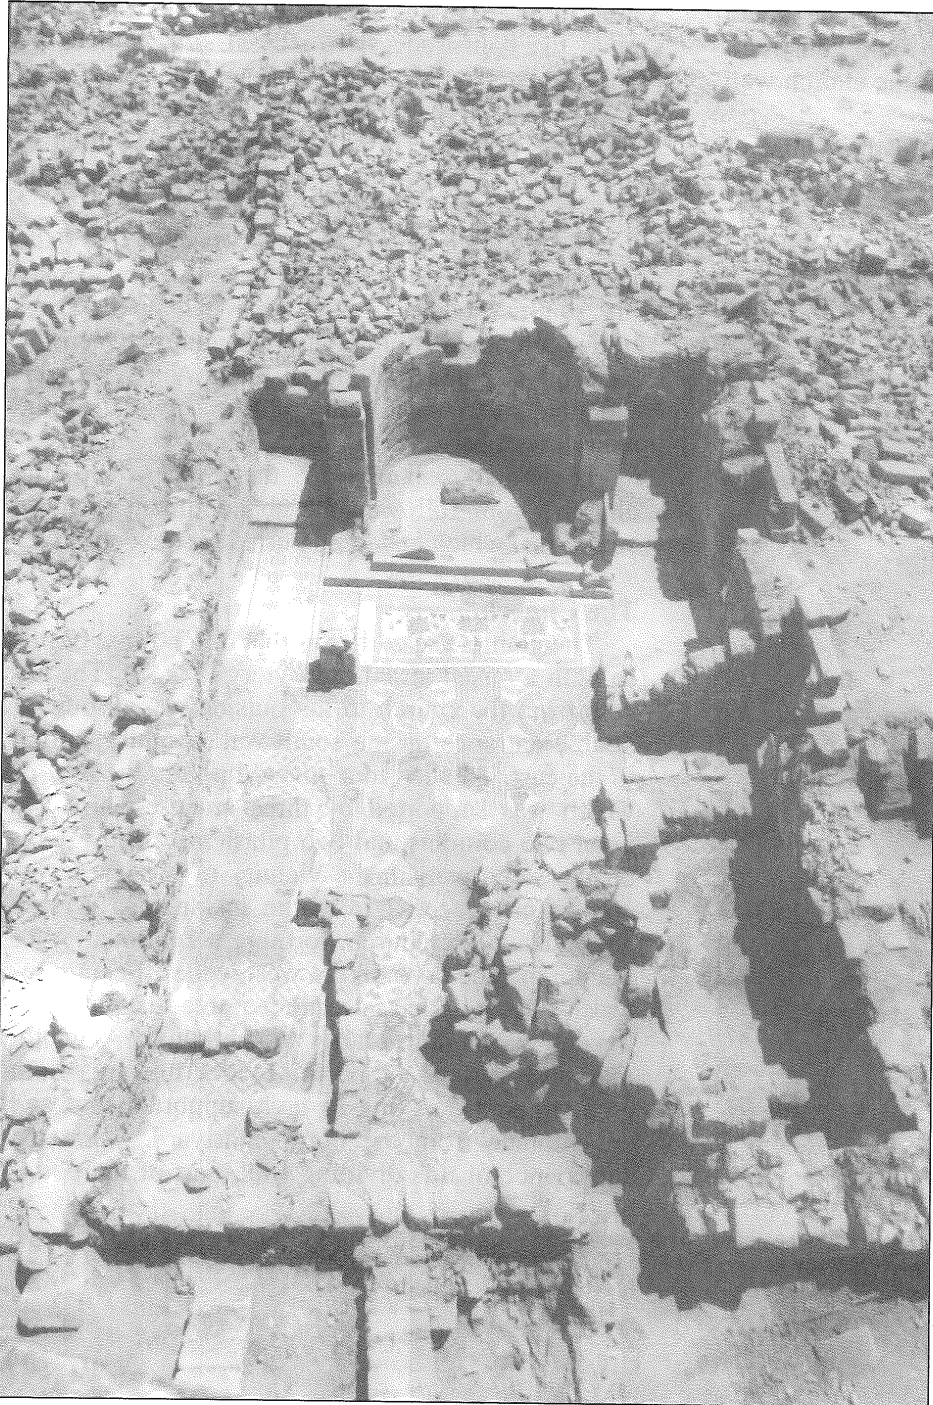
4. Church of Saint Paul after the removal of the fallen arches.

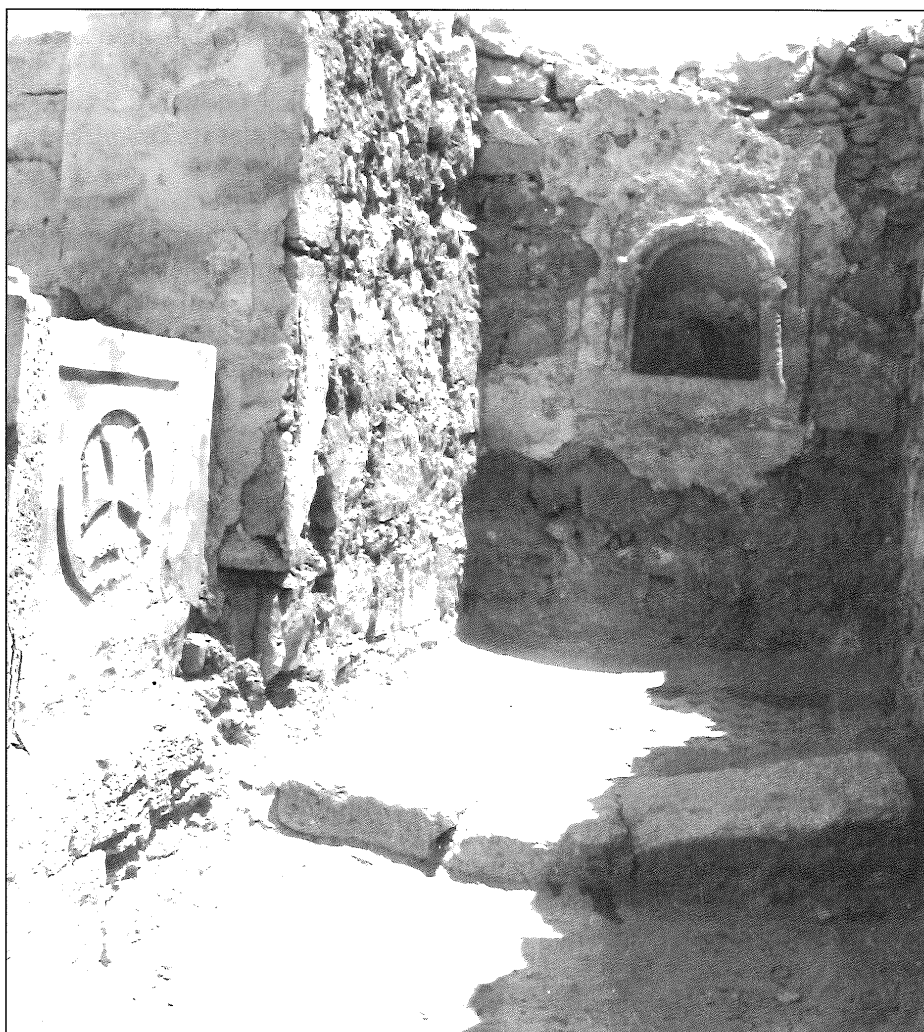
7. The east head of the south aisle with the edicule on the east wall and the still standing chancel screen with a cross in relief.

On the east head of the side naves, a step created a small reserved raised area characterized by a niche with jutting stone or plaster moulding set in the eastern wall. Most probably a barrel-vault or calotte covered both areas. Some ashlar of the roofing are still *in situ* in the south nave while those of the north nave were found among the debris. The niche in the south nave is still well pre-

served with its jutting stone moulding which imitates an arch supported by two small columns with capitals. The internal calotte had a double layer of lime mortar, the lower showed traces of paint while the upper stratum had sherds inserted in it. Only the lower part of the north niche survived.

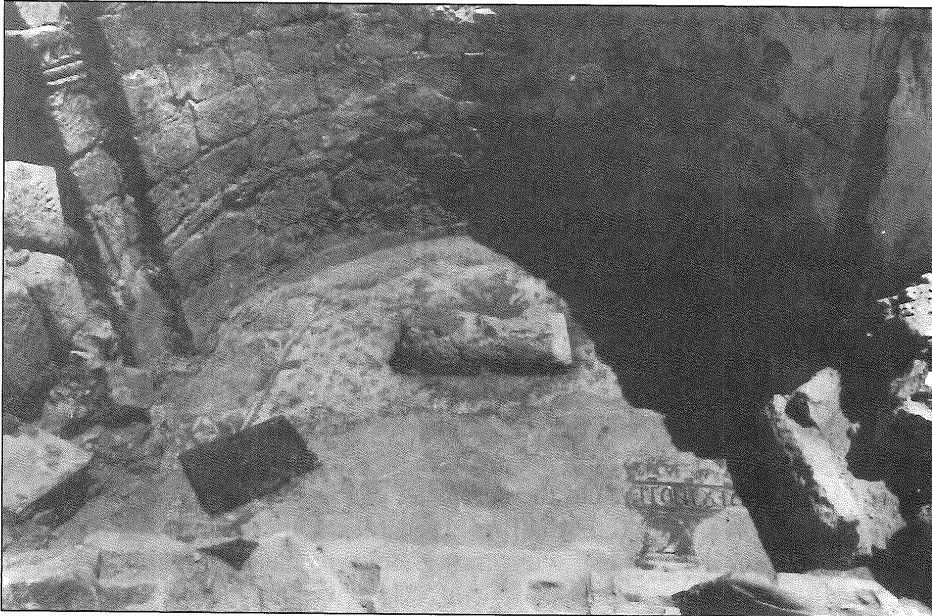
8. *The presbytery with the altar and the offerings table, during excavation.*

Two steps raised the presbytery that juts slightly out into the nave (Fig. 8). Four bituminous schist chancel slabs closed off the jutting part. At the time of excavation, the south slab was still *in situ*, inserted between the apse pilaster and the corner columnette, which had a simple moulding on the frontal view face. The chancel slab was decorated with an encircled cross in relief, set in a sunken panel. Fragments from at least two chancel slabs were recovered during excavation: one had an inscription incised on its base, another was decorated with a small column in relief of which there remained part of the fust and the small foliated capital.

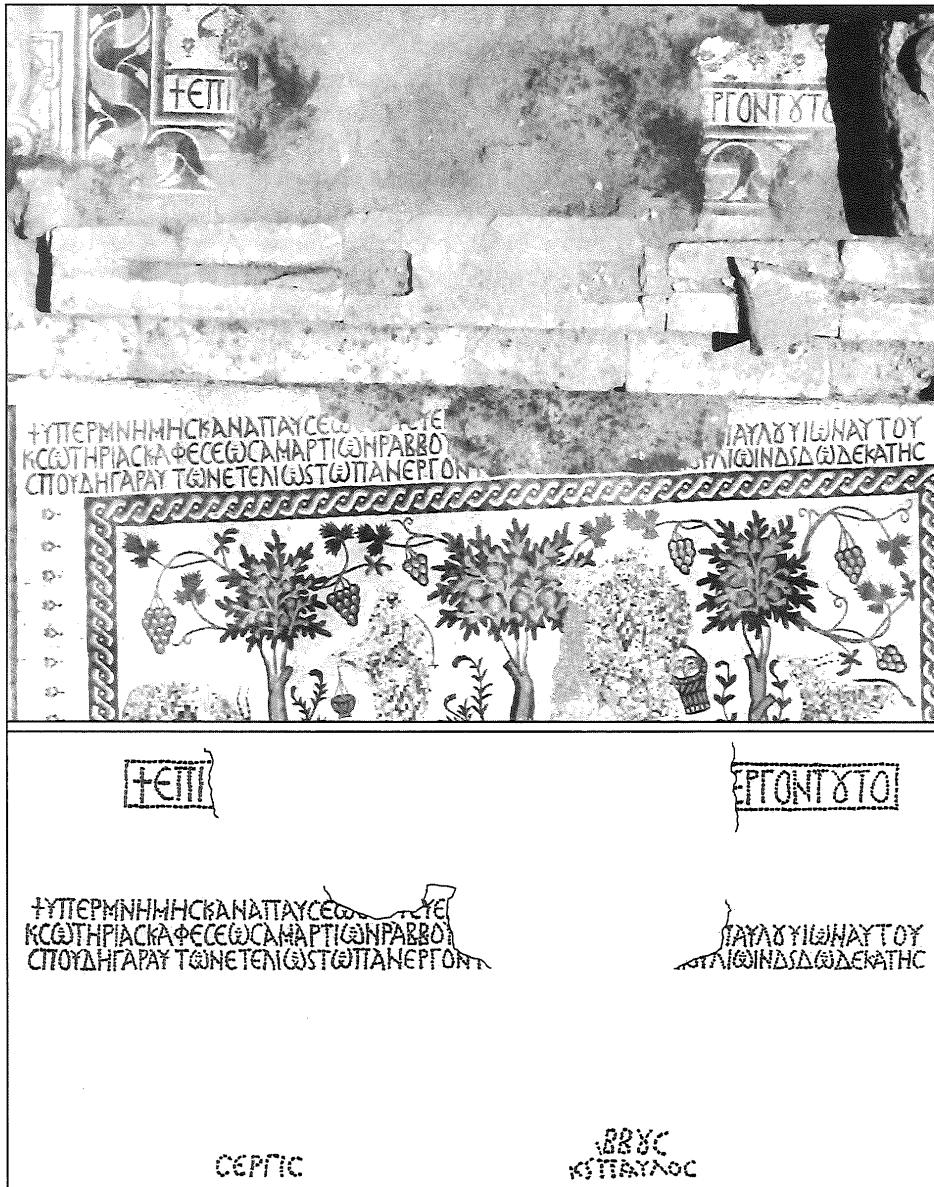
10. The two inscriptions in the presbytery and the nave of the Church of Saint Paul.

Four inscriptions in Greek were recovered during the excavations of the church. Two were found in the floor mosaic, one incised on a roof tile, and the fourth on a chancel slab.

+ Ὑπὲρ μνήμης κ(αὶ) ἀναπαύσεωςΥΕΙ
 Παύλου..... υἱῶν αὐτοῦ
 κ(αὶ) σωτηρίας κ(αὶ) ἀφέσεως ἁμαρτιῶν
 Ραββου.....
 σπουδῆ γὰρ αὐτῶν ἐτελιώ(θη) τω πᾶν
 ἔργον τ[οῦτο....μην] Ἰουλίῳ ἰνδ(ικτιό-
 νος) δωδεκάτης

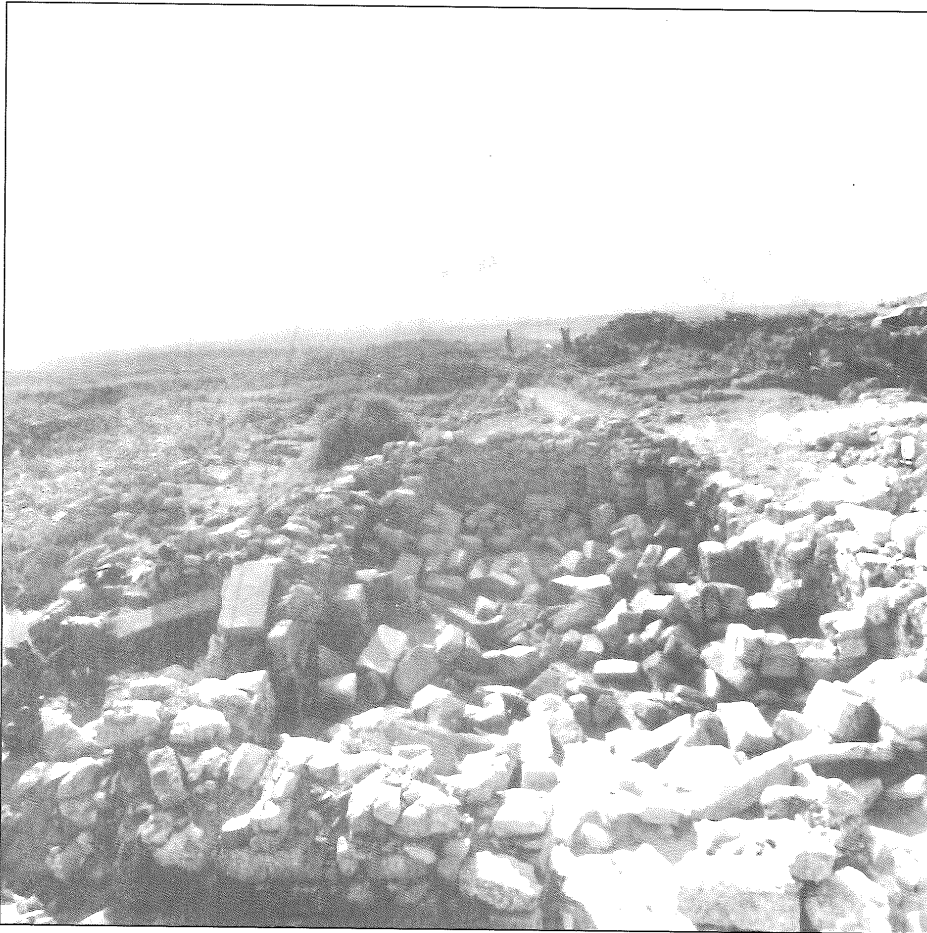
16. *The Chapel of the Peacocks with the northern service room.*

The main motif in the area of the bema was a semicircular composition, extending from the apse to the step, divided into two panels with a field of florets in the eastern panel, and two peacocks facing each other depicted in the western panel (which give the chapel its name). The two birds had already suffered the iconophobic mutilation before being partly destroyed. Of them only the two tails with the characteristic feathers and one leg of the northern peacock survived. On the north and south extremities, the mosaicists added two polychrome geometrical motifs.

The nave was wholly decorated with a single motif and surrounded by a band with a swastika meander alternated with squares knotted with the inner composition of superimposed polylobed squares. Of the dedicatory inscription inserted in a *tabula ansata*, only half a letter has been recovered. The resultant square spaces of the enclosing band as well as the resulting spaces within the main composition were filled with flowers, birds facing flowers, and geometric motifs. One polylobed square, set in the northwest corner of the main carpet, contained a large braided cross. The intercolumnar spaces on the sides, mostly preserved, were decorated with geometric knotted motifs.

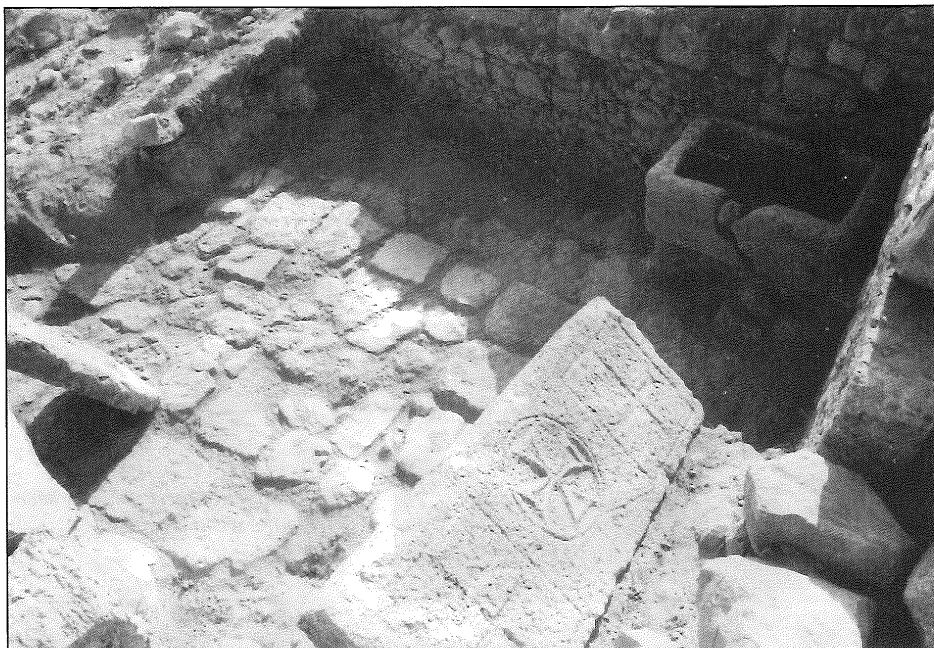
17. The lintel of the northern door in the northern paved courtyard.

ternal courtyard was decorated with two crosses incised in a square panel on either side of a third Greek cross in circle in relief (Fig. 17). Another room, with its roof supported by two arches, was added on — externally to — the service room and set against its northern wall. This last room did not serve the chapel in any way but is to be placed in relation with the internal courtyard of the complex.

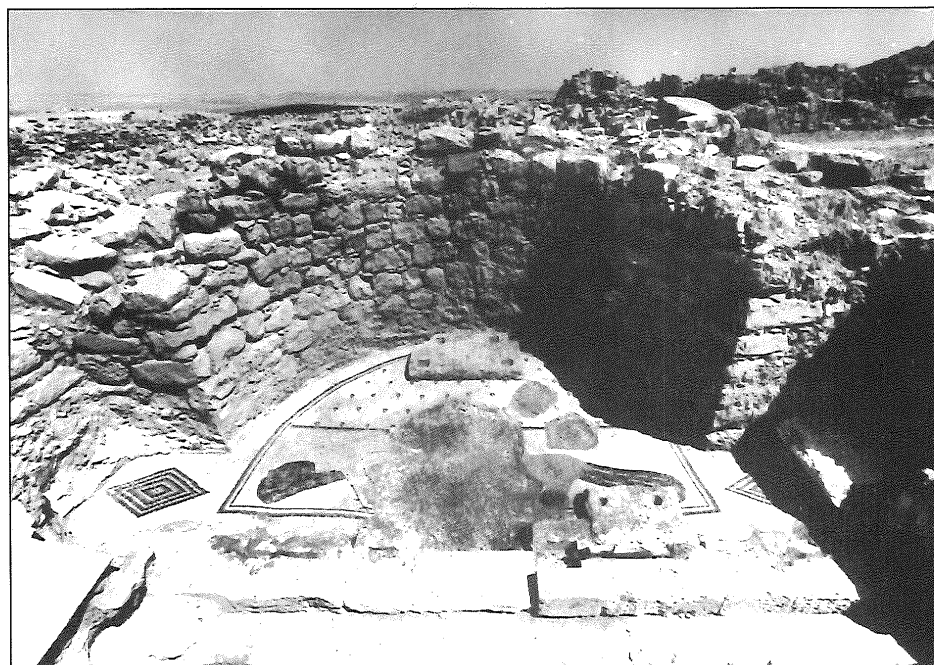
18. The presbytery of the Chapel of the Peacocks.

A chancel screen made of bituminous schist protected the raised sanctuary of the chapel (only 20cm high). In the apsed area there were two liturgical furnishings still preserved (Fig. 18). The base of the altar was found against the splay of the apse while the base of the offering table was recovered near the chancel screen, on the south side of the entrance to the sanctuary. A third element that can be related to the liturgy celebrated in the chapel is the small walled-in cupboard. This was found on the south wall of the apse, one meter from the floor.

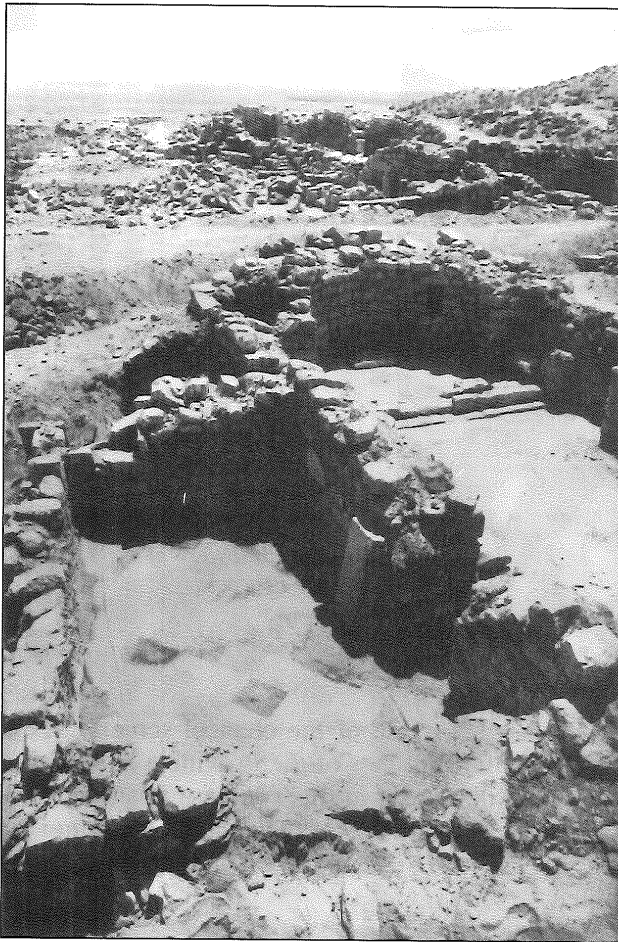
20. *The Chapel of the Peacocks seen from the northwest.*

the damages of the iconophobic crisis and their repairs, the despoiling suffered by the mosaic floor in the centre of the chapel, and the re-use of the chapel as a dwelling attested by the oven in the south-west corner. Moreover, we recovered a cooking pot
