THE 2002 FINNISH JABAL HĀRŪN PROJECT: PRELIMINARY REPORT

Jaakko Frösén, Zbigniew T. Fiema, Mika Lavento, Christina Danielli, Richard Holmgren, Jaakko Latikka, Anu Rajala, Nina Heiska and Antti Lahelma

CARTOGRAPHIC REPORT (J. Latikka and J. Jarvinen)

EXCAVATION REPORT

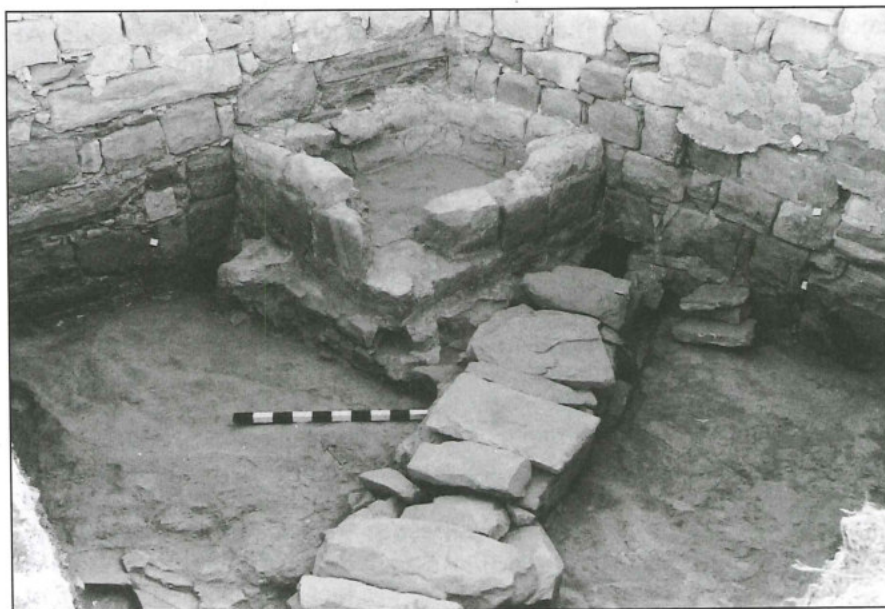
3. Basin and water channel in Trench R (by J. Vihonen).

Sub-phase Ic marks the erection of the eastern wall (YY, locus 3), immediately followed by the construction of a platform (locus 24) supporting a basin (locus 11) built in the corner of Walls XX and YY (Fig. 3). At the same time the eastern part of the rock-cut channel was modified by adding capstones and internal lining slabs (locus 19). The

eastern, modified part of the channel and the platform were abutting each other in a manner indicating their contemporaneity. The platform, a limestone and mud mortar construction, supports a basin ca.1.6 x 1.82m. The latter has a small, piped outlet in the central bottom of its western wall to empty the contents through its western side. The interior of its rather thick walls is covered with remains of watertight plaster, and the quite sturdy construction suggests some kind of industrial use. South of this installation are traces of plaster on the ashlar of Wall YY. The plaster seems to have lipped out onto a feature that was once located here but is now missing. Since there are indications that Wall YY forms the western frame of a major access to the site, further excavations towards the west and east are needed to verify the relative construction chronology of Phases Ia, b, and c.

the channel — probably outside of the main walls of the monastery — is also indicative. Such a location would support an industrial function of the basin. Similar locations and installations were noted at the Monastery of the Shepherds (Khirbat Siyar al-Ghanam) in Palestine. There is a basin or vat (No. 41) is located outside — but directly against — the main wall of the monastery. Nearby is a channel (No. 55) interpreted by the excavators as a drainage conduit (Corbo 1955: 39, 54). Although neither the function nor the specifics of these installations are provided, that monastery also possessed presses and vats for producing oil or wine.

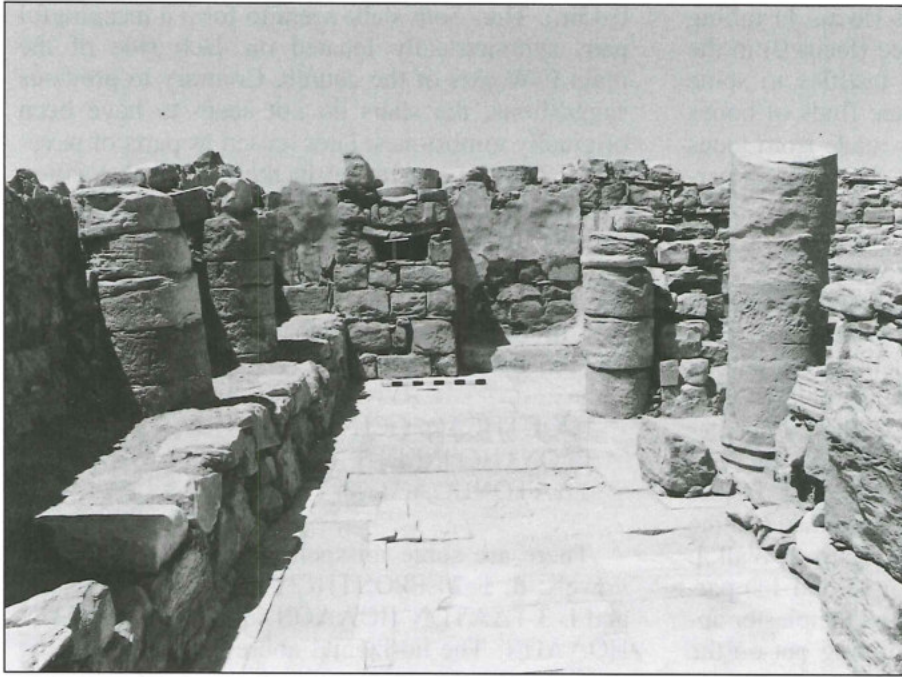
5. Trench T-the southern aisle of the church, view from E (by J. Vihonen).

Possibly associated with Phase III is the buttress or revetment (locus 31) built against the exterior of the southern wall of the church. It could be related

to seemingly similar buttresses in the area of the church: a buttress built against the dividing wall of the church and a revetment built against the northern wall of the chapel. It may, therefore, be a part of an anti-earthquake support system. It appears that Phase III ended with a partial destruction of the building. The damage was not extensive, for at least the arches of the southern aisle were left standing and the floor here was not much damaged. However, the arches that spanned the nave do seem to have collapsed directly onto the marble floor.

15. Fallen column in Trench T before the restoration (by Ch. Danielli). The same column, after the restoration can be seen on Fig. 5, center.

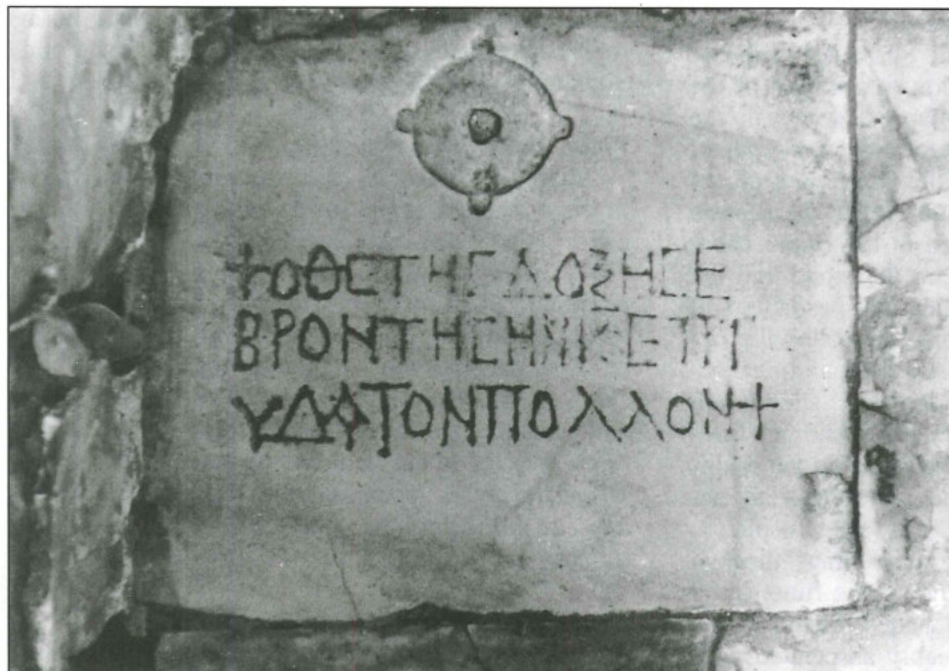
6. Inscription from Trench T (by J. Vihonen).

An inscribed marble slab was found *in situ* integrated with the floor of the nave in Trench T (Fig. 6). Its location implies that the slab should belong to the original flooring of the nave, associated with Phase I. Specifically, the slab is in the corner between the pilaster (locus 12, Phase IIa), its later extension (locus 11, Phase IIb) continuing farther westward as Wall FFF (locus 4, Phase IIIa), and the bench (locus 25, Phase IIa) built against Wall I. The pilaster and its extension (loci 12 and 11) partially stand on the inscribed slab, and the plaster applied to the side of the bench is lipping out on the surface of the slab.

The location of this slab is mirrored by the location of another inscribed slab found in Trench G in 1999 (Frösén *et al.* 2000: 411). Both slabs feature a circular depression on the surface, associated with small semicircular extensions at each of the four cardinal points. The depression was probably carved for facilitating the attachment of a metal object, a cross or a bowl (*infra*), rather than to attach a lifting ring to the slab. The slab in Trench G is also only partially visible (obscured by later, secondary walls) and of approx the same size (ca.0.5 x

The function of the incised slabs from Trenches G and T is enigmatic. However, the reference to water and the possibility that there might have been vessels set in the depressions in these slabs are significant. An intriguing parallel is provided by the marble crater with panther handles found in the Petra church (Fiema 2001: 89-90; Herrmann 2001: 337-9). This vessel was found broken, apparently *in situ*, in the fourth intercolumnar space, i.e., almost in the same location as the inscription in Trench T. It is impossible to decide whether or not it was its original location; at any rate, the crater stood there before the fire, which destroyed the Petra church. Although such vessels in the early Christian

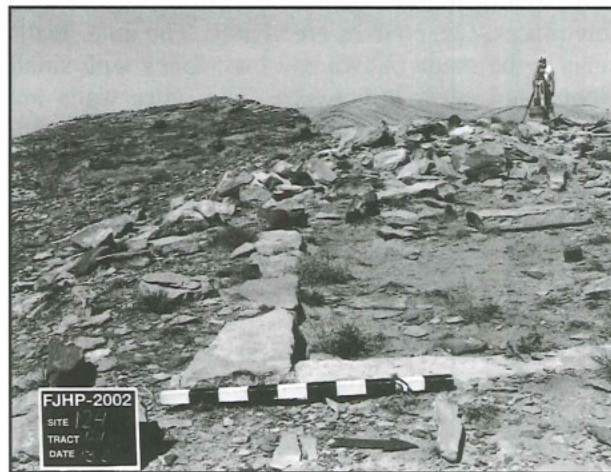
8. Site 124-the possible watchtower on the top of Jabal al-Farāsha (by P. Kouki).

worked stones. The walls are ca. 2m thick, built in a double-wall manner of large boulders with sandy rubble between the wall lines. Nabataean diagonal dressing is still visible on some stones. Surface pottery was mainly Nabataean-Roman ware with some slightly later sherds. Four small soundings in the interior and the wall fill of the building yielded the same types of pottery. The building was most likely constructed in Nabataean times and occasionally used later. No cistern or other water storage installation was found (although rainwater may have been collected in a rooftop cistern). The mountaintop location seems impractical for a dwelling but ideal for a watchtower, although the building might also have had some cultic function. The visibility is excellent in all directions. From west to north, the ancient road to Wādī ‘Arabah, the watchtower in Area T, and the Nabataean building near it can be clearly seen (see Frösén *et al.* 2000: 418; 2001: 389-391). To the north, the *weli* on top of Jabal Hārūn is clearly visible, and farther to the east are the Snake Monument and the outskirts of Petra. Visibility to the south, the direction of Ṣabrā (صبرا), is also good.

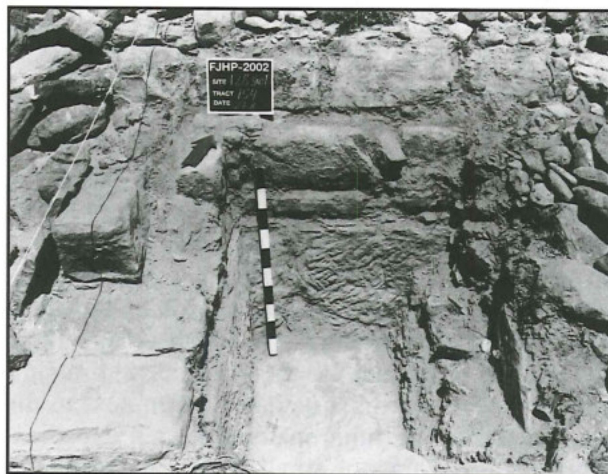
9. Site 128-the "village" Sounding in the corner of one of the houses (by P. Kouki).

Muqāblayn, which crosses the gently sloping eastern foothills of Jabal al-Farāsha. The size of the site is ca.50 x 75m. The building remains are poorly preserved, mostly forming large stone heaps, but 14 more or less clear wall lines could be discerned and mapped. The site could have been one large household complex or a hamlet of several independent smaller buildings. Some building stones are diagonally dressed and the majority of the pottery collected was Nabataean. Two soundings near the inside corners of buildings (**Fig. 9**) revealed that the

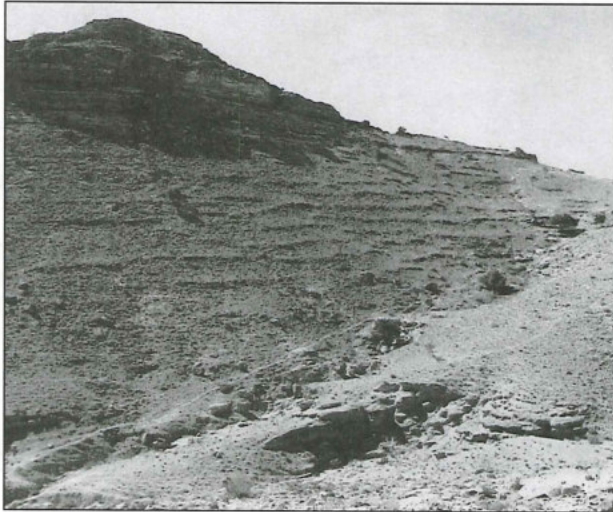
Specific photographs have been taken to test the photogrammetric application in the survey area (Figs. 11, 12). These were used for the doc-

11. The view of the area documented by photogrammetry in 2002-the terraces (by H. Haggren).

12. Map of the sites and structures documented by photogrammetry in 2002 (by H. Haggren).

umentation of field survey sites in Areas F, G and O, and for the documentation of the “village” (Site 128) in Area P and the watchtower (Site 124) in Area N, both at Jabal al-Farāsha. Additionally, a site within Area W was recorded to complete the documentation of the 2000 fieldwork. Photos were taken with an Olympus CL-1400 camera having an image resolution of 1280 x 1024 pixels. The approximate locations of all shots were recorded with GPS. Additionally, four new geodetic ground control points were established and measured (0201-0204).

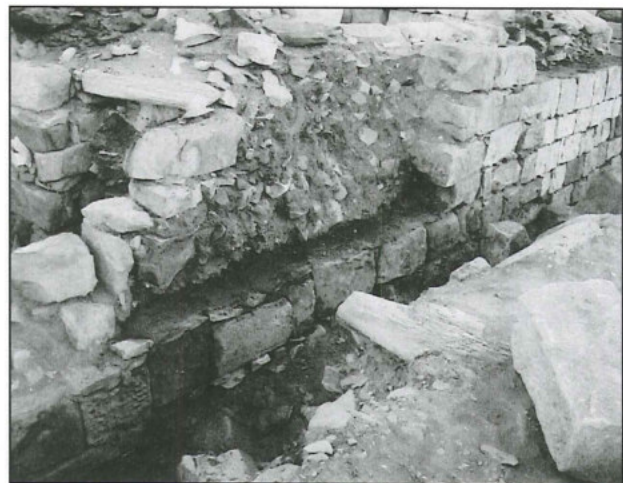
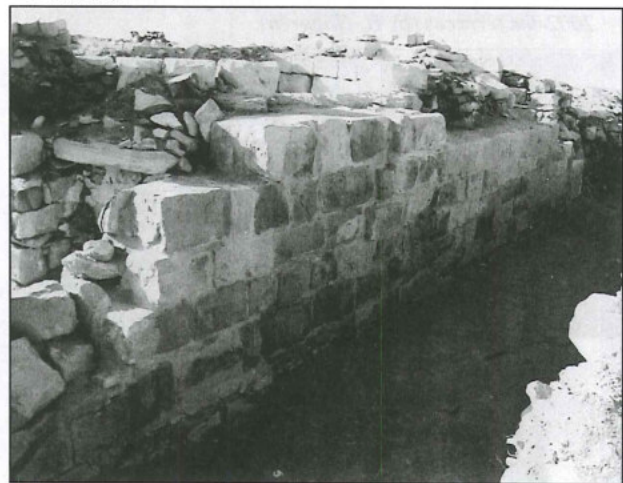
Some of the structural elements excavated during the 2002 season were in such precarious condition that careful dismantling and reconstruction was necessary in order to preserve them from imminent collapse. The most significant of these interventions pertain to the perimeter walls of the complex, specifically the areas of the NE corner and the eastern section behind the apse (Figs. 13, 14). In both cases, the walls had partially collapsed and were unable to buttress the interior walls, which were gradually leaning outwards. In these areas, the wall was dismantled and rebuilt: original blocks were re-inserted in their places with the help of digital photos taken before the dismantling of the walls. Eroded or powdering blocks, which had to be discarded were replaced by stones of similar shape taken from the *lapidaria*. The walls were ce-

13. Wall supporting the apse, before the restoration (by Ch. Danielli).

14. Wall supporting the apse, after the restoration (by Ch. Danielli).

mented using mud mortar. A finishing layer of lime mortar was applied between the joints and the upper surface to avoid water infiltration.
