THE 2002 SEASON AT QAŞR AL-ḤALLĀBĀT: A PRELIMINARY REPORT

Romel Ghrayib

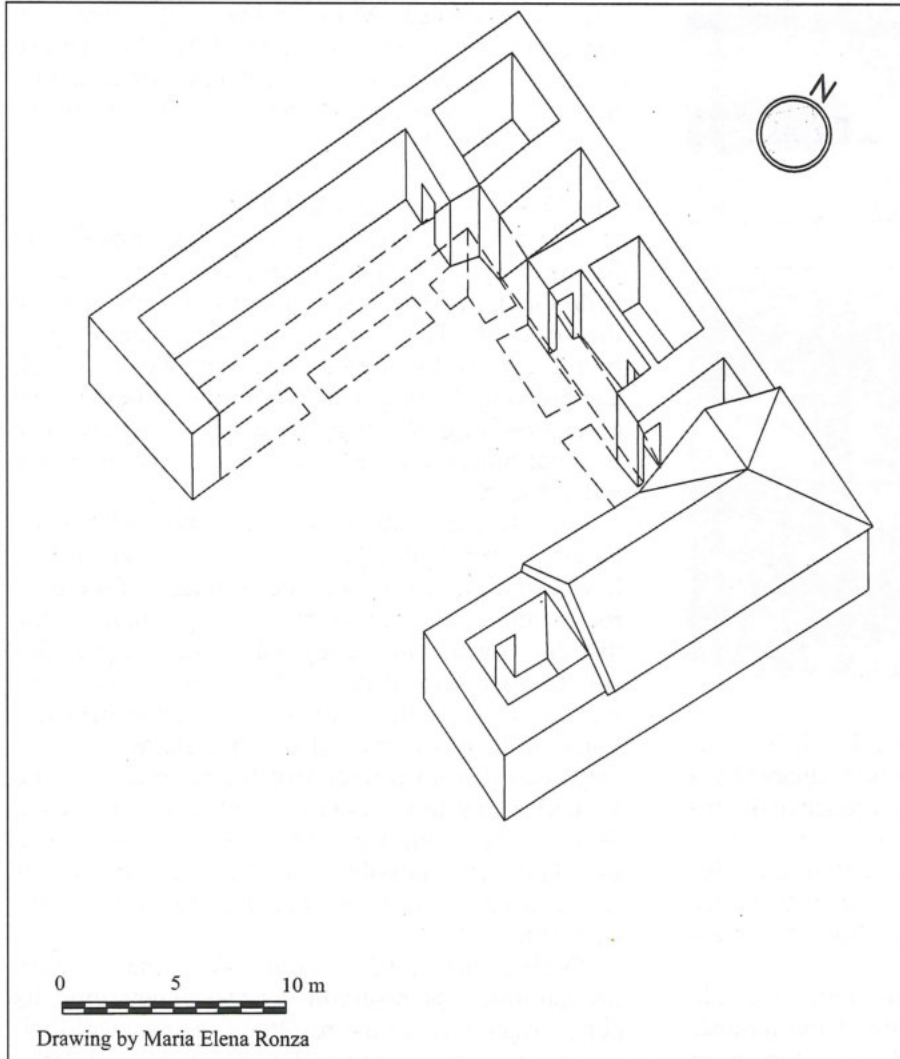
2. Typological reconstruction of house no. 19.

House no. 19 is located on the northwest side of the *qaṣr*, at the opposite side of the mound, at the entrance of the site. The structure is in

good condition and features rubble core walls made of dressed and undressed blocks, with a wall thickness of about 90cm. Two plastered floor surfaces have been uncovered. The house was probably roof tiled, since roof tiles have been found all around and inside the structure. An open courtyard surrounded by several rooms, with two lateral wings which characterize the plan of the building. The heart of the house with the fireplace and the daily functions represents the central part, facing southwest and consisting of four rooms. The wings seem to be connected to the courtyard rather than directly to the heart of the house. The southeast wing features a huge room without any evidence of internal partition that might have been used as a storage room or as a recovery for animals.

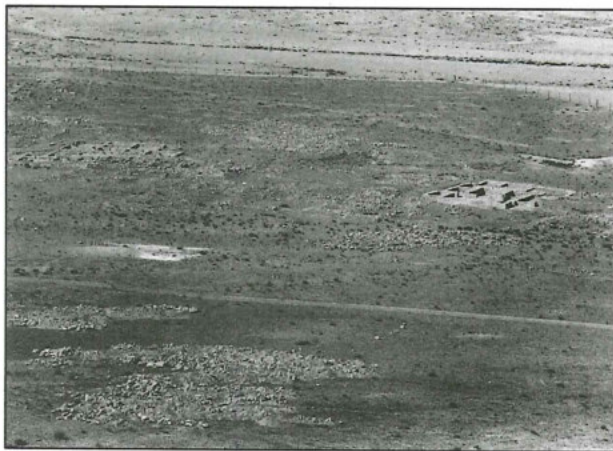
3. General view of houses no. 1 and no. 3.

- a) Residential complexes, such as no.1 and no. 3. These are featured by several houses, with each residential unit consisting of several rooms around a central hall (Fig. 3).
- b) Isolated houses, such as no.6, no.8 and no.19. House no. 6 (Fig. 4) is the only one among the twenty-six identified houses that was different

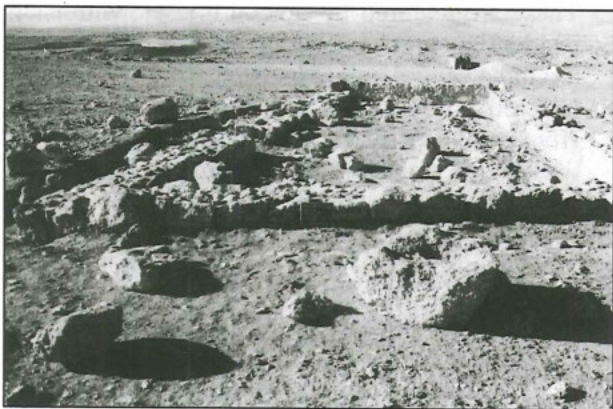
4. House no. 6 during restoration.

in form and was the smallest in size. It is a rectangular structure divided into two squares by a wall in the middle. It has one entrance and a total area of 60m². House no. 8 is in a bad condition as many of the walls have collapsed (Fig. 5). It consists of eight rooms, four of them are rectangular and large in size, while the others are smaller and square shaped.

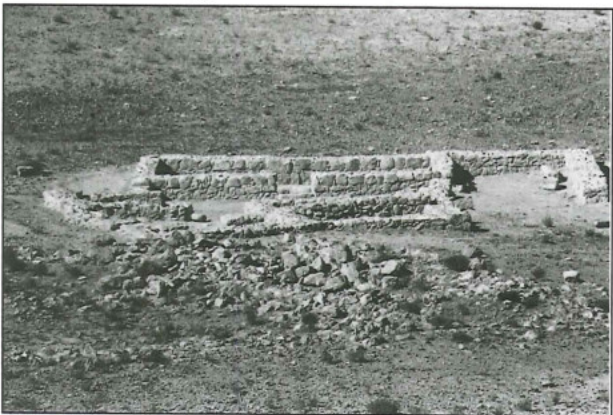
5. House no. 8 after the restoration.

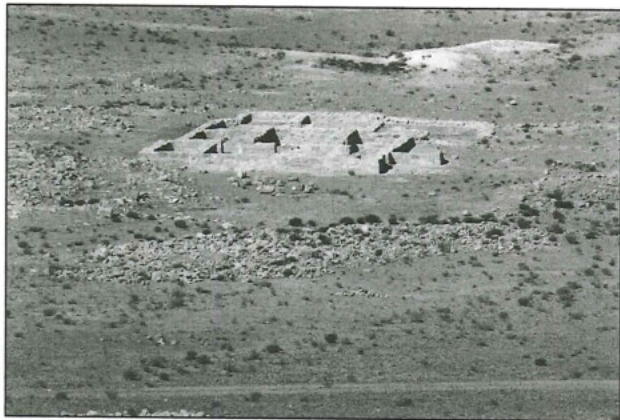
7. House no. 3 after the restoration.

Excavation and consolidation took place during the same season in order to preserve the houses. Once the excavation was completed, all the structures, which were in a bad state of preservation, have been consolidated. Most of the walls were preserved to the second or the third building course without any additions. The technique of construction and the type of building material were maintained (Figs. 6, 7).

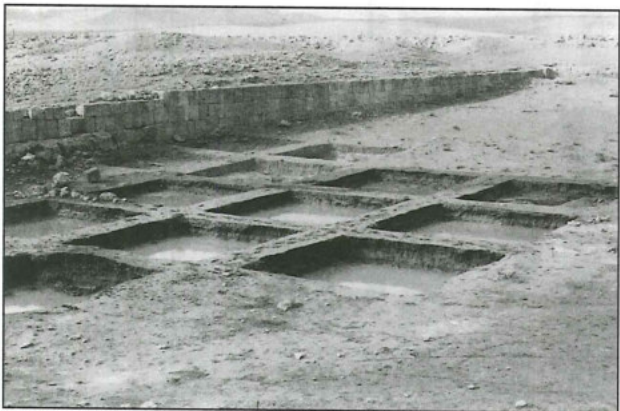
8. The west wall of the reservoir.

The reservoir has an area of 2059.905m² and has an irregular shape. It was partly carved out of bedrock. Different types of masonry characterize the structure. The structure is mainly made up of rubble core walls of local limestone blocks, which has probably been quarried from the same site; the core consisting of small stones and concrete. The external blocks are well dressed and have different sizes (Fig. 8).

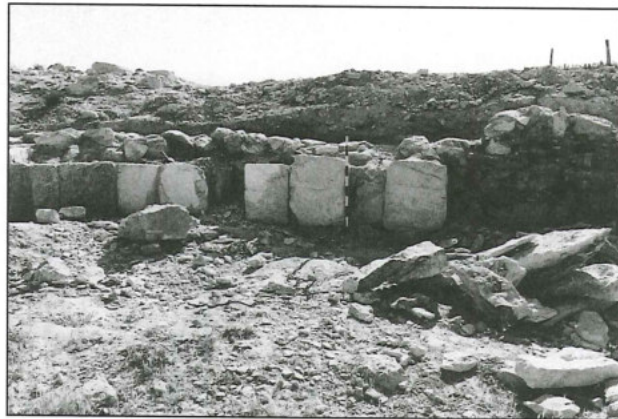
9. The eastern wall of the reservoir during the restoration.

of water, which the reservoir could store. Assuming that the medium height of the reservoir is 2.50m, the quantity of water that can be stored is 8107m³, which represents a medium sized reservoir (Kennedy 2000). The supply of water was irregular and during the rainy season there was abundant water flow. Hence, two wells were carved on the northeast side of the reservoir in order to collect the surplus water, which could damage the structure of the reservoir. For the same purpose, the perimeter of the reservoir was bound by earth all around. The eastern wall is partially collapsed due to the water flow. Thus, consolidation and anastylosis was carried out during the 2002 season (Fig. 9).

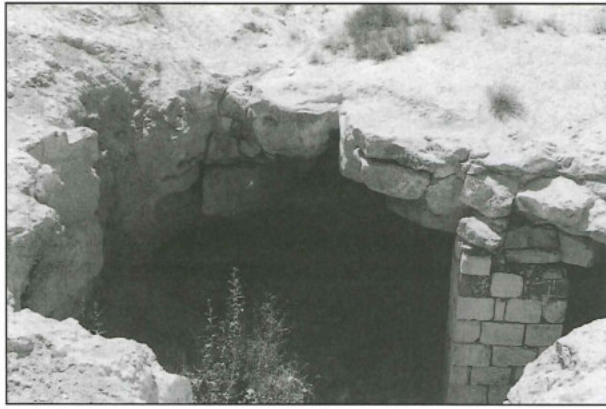
11. The underground quarry northwest of the qaşr.

Evidence of quarrying activities feature the entire area of Qaşr al-Ḥallābāt. Four underground quarries have been identified around the hill and evidence of surface quarrying are also present on the top, just beyond the *qaşr*. Two of the underground quarries are located on the northwestern side of the *qaşr* and in one of them a standing pilaster supports the ceiling. The pilaster measures about 1 x 1m and is built of roughly dressed basalt and limestone blocks (Fig. 11). It was probably a cistern reused as quarry in a later period, as proved by the remains of a deep completely plastered basin in a corner.

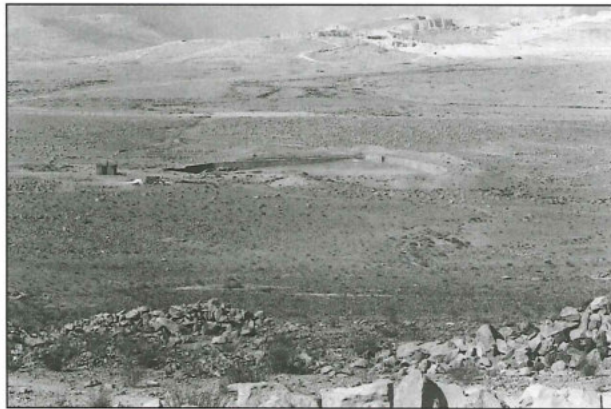
12. The quarried blocks around the reservoir.

The other two identified quarries are situated on the western slope. The southernmost one presents evidence of channelling; the northernmost quarry has been closed by the collapse of the ceiling and so it is inaccessible. The reservoir itself probably served as a quarry with its walls built with stones originally from it. The most important feature of the site (concerning the quarrying activity) is the big number of quarried blocks spread all over the area around the reservoir (Fig. 12).
