JOHN THE BAPTIST CHURCH AREA: ARCHITECTURAL EVIDENCE

Rustom Mkhjian and Chrysanthos Kanellopoulos

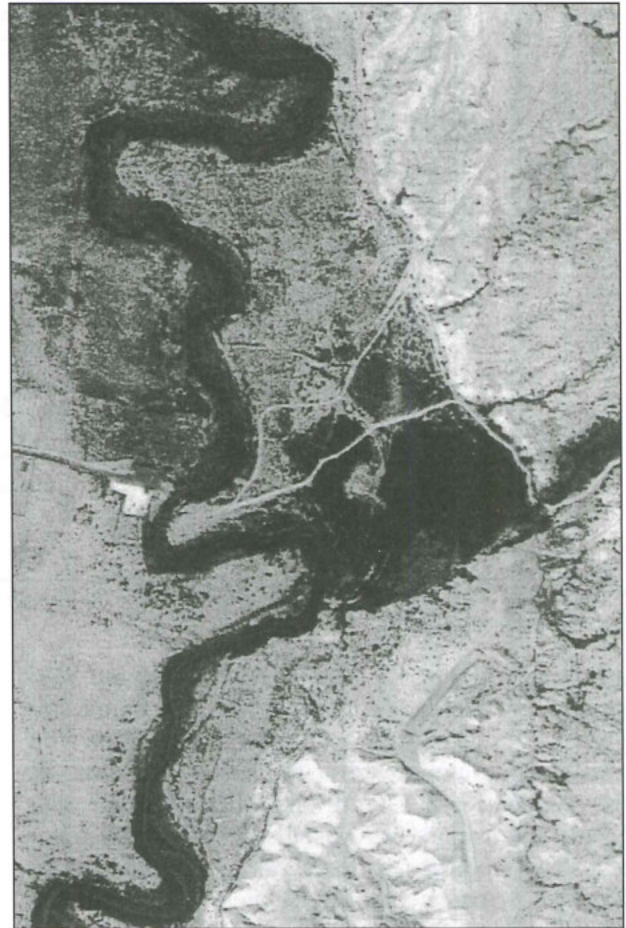
1. Aerial photograph of the area of the John the Baptist Church (center of picture) and the meandering river (Photo produced by the Royal Geographic Centre).

The present study focuses on the memorial churches 300 meters east of and 70 meters north of the present course of the river (Fig. 1). The site is called the “John the Baptist Church Area” (Fig. 2) and includes the following structures (the descriptions in parentheses are those used by M. Waheeb [2001]): Pillared Hall (the first church); Lower Basilica (the second church); Basilica (the third church); Room South of the Basilica (Mosaic Pavement); Staircase; four piers; Chapel (the fourth church); and Later Structures (Late Islamic Structures).

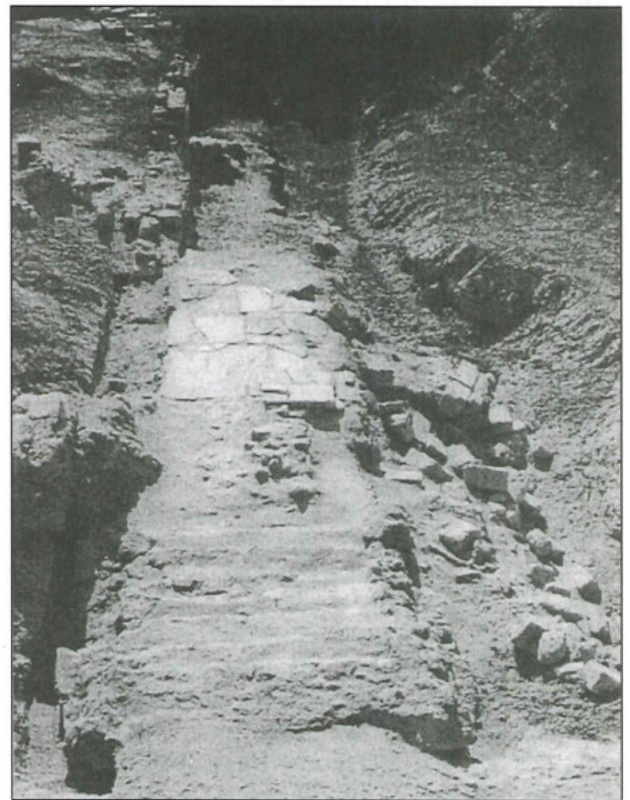
9. The western part of the staircase from the west (photo by Rustom Mkhjian).

The south wall of the staircase has totally collapsed southward to a depth lower than the staircase itself. This indicates that the natural level south of that south wall was of a lower level than the steps at this point along the descent (Figs. 9, 10). Therefore, water may have raised that high at some point in time, thereby undermining the foundations.

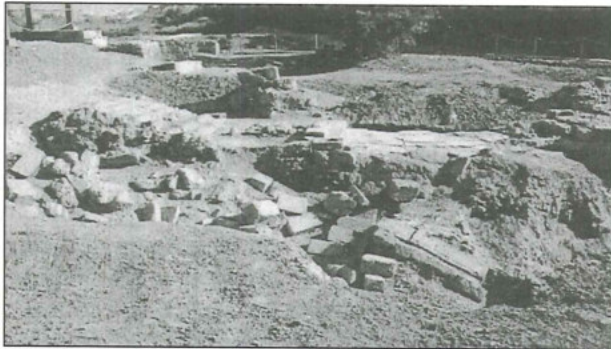
10. Western part of staircase from the south with the western wall collapsed to a lower depth (photo by Rustom Mkhjian).

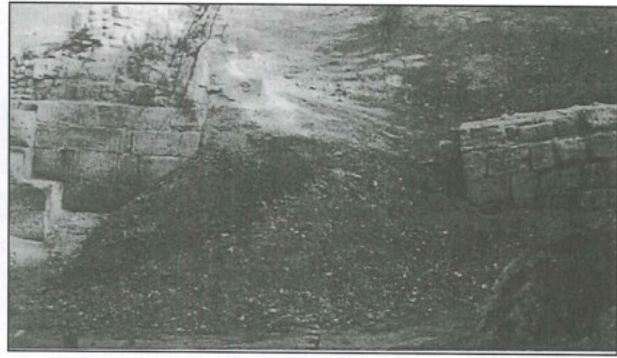
11. The remains of the four piers from the south (photo by Rustom Mkhjian).

The remains of three massive, well built piers are at the lowermost end of the staircase (Figs. 2, 11). Two of them stand to a height of 3m and there are the poor remains of a third pier to the SW. It appears that these belong to an original arrangement that consisted of four piers. The fourth (SE) pier has almost totally vanished, but can be assumed by symmetry, and excavations carried out in the summer of 2002 uncovered a few ashlar and fieldstones scattered in the presumed location of the SE pier.

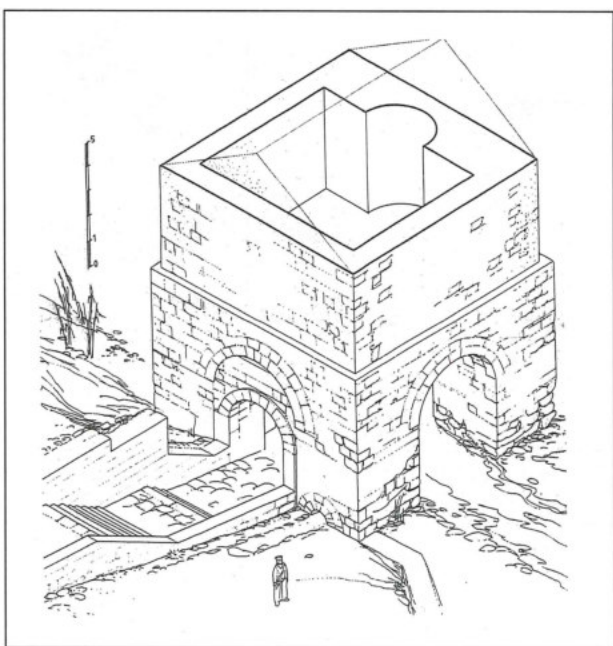
13. Hypothetical reconstruction of the piers carrying a Chapel (drawing by Chrysanthos Kanellopoulos).

A study of the arch stones found in the center of the four piers indicated that they belonged to arches of about 1.8m in radius. Knowing that the distance between the piers is about 3.50 — 3.60m, we could conclude that they belonged to arches and vaults on top of the piers (Figs. 12, 13).

Waheeb (2001: 425) associated this description with his third or fourth churches. However, it is more likely, given Arculfus's description of the church being “on four stone vaults”, that what he saw was a structure carried on the four piers (Fig. 13 or, much less likely, Fig. 14). Arculfus' description of a slope might fit well with the staircase. His mention of a stone bridge, however, is more difficult unless there was once such a bridge out to the place where the cross was and there is now no trace of that structure.
