THE BUILDINGS UNDER THE "CATHEDRAL" OF GERASA THE SECOND INTERIM REPORT ON THE JARASH CATHEDRAL PROJECT*

Beat Brenk, Carola Jäggi and Hans-Rudolf Meier

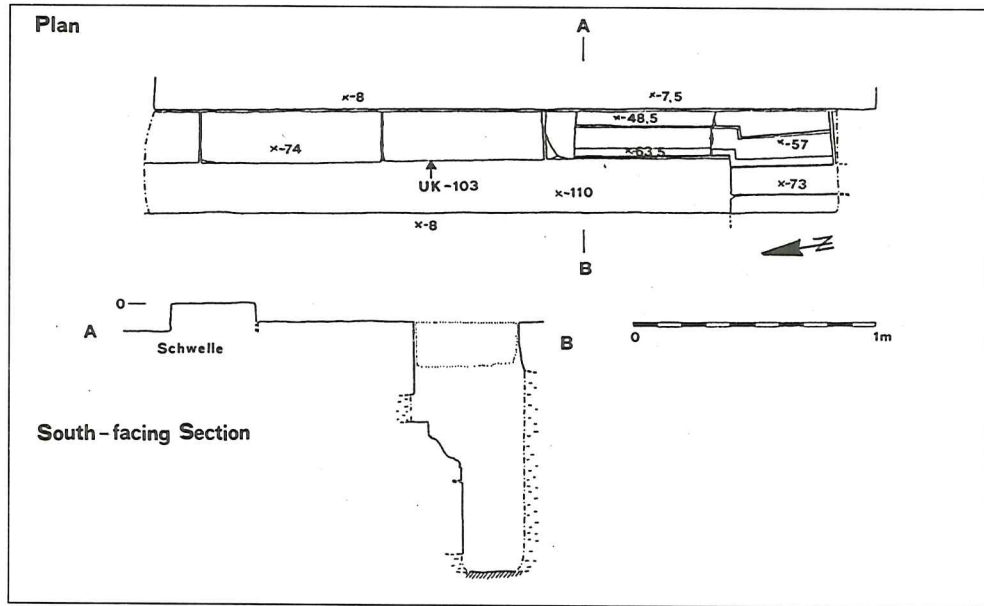
The Situation in the Eastern Walk of the Atrium (Fig. 2)

2. Jarash Cathedral. Plan and section of the trench in the eastern walk of the atrium.

To the west of the threshold of the central portal of the Cathedral there is a noticeable irregularity in the pavement of the atrium. Instead of the octagonal slabs with which the rest of the eastern walk is paved, here three large slabs abut the threshold, forming a kind of ante-threshold. Seemingly puzzled by this irregularity, the Americans removed these three flag stones and

found underneath the remains of the above mentioned earlier structure. In order to evaluate this feature, we lifted the slabs once again and removed the modern fill beneath them. The uppermost course of stone of the structure we were looking for was found circa 40 cm below the present level of the pavement in the southern half of the trench. The complete removal of the fill revealed a row of blocks, 65-75 cm long and about 30 cm high, which formed the base

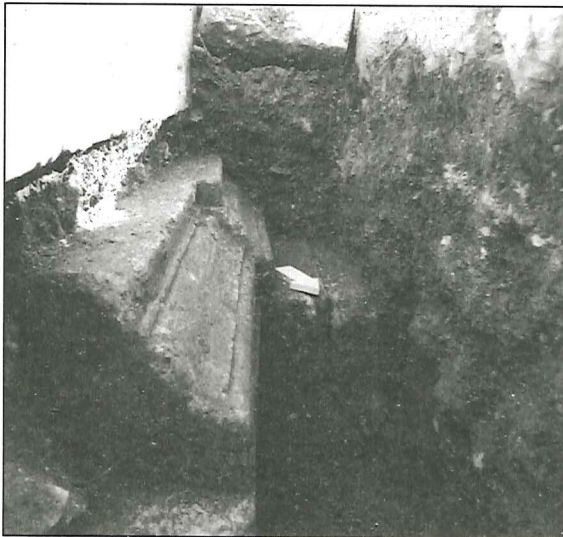
3. Jarash, Cathedral. moulding under the eastern walk of the atrium.

course of a wall (Fig. 3). This was not built directly onto the natural rock, but was separated from this by a loamy layer of earth a few centimeters thick. This row of blocks, the western edge of which projects a good 20 cm in front of the edge of the three large stone plaques of the ante-threshold, survived *in situ* for the whole length of the trench. At the southern extremity of the excavation these blocks turned at right angles and continued to the south beyond the extremity of the trench. A second course of blocks, in this case finely profiled, lay on top of the base course. Only one block from this course remained in place, broken in two halves in the southern half of the trench. But the continuing line of this wall, running southwards, could be seen in the section of the trench. Where the base course turned at right angles, the upper profile broke into a shallow rectangular projection, which indicated the presence of a pilaster. A conspicuous feature of this profiled block is its seemingly imperfect execution. It is imprecisely cut and is slightly off-axis. This contrasts strangely with the otherwise extremely exact cutting of the moulding.

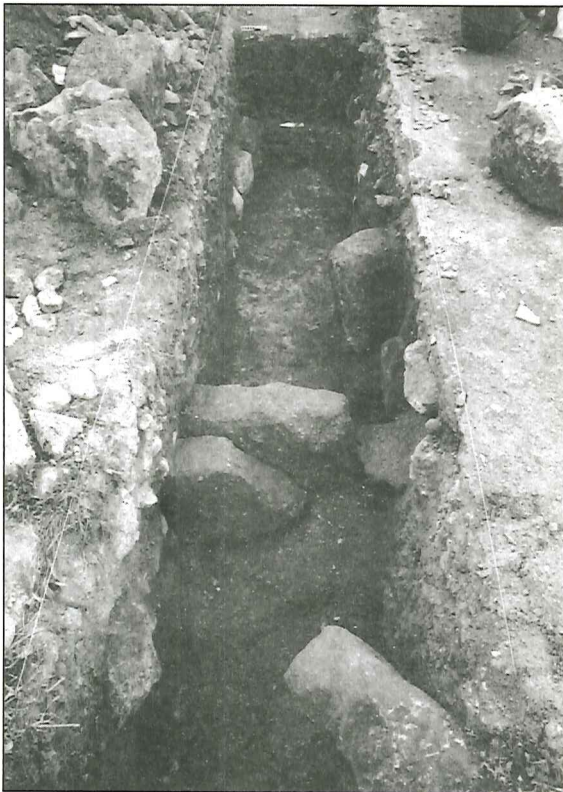
5. General view looking eastward of the trench in the nave. In the middle the tow remaining stones of the wall 44, in the background wall 4, in between the mortar floor 41.

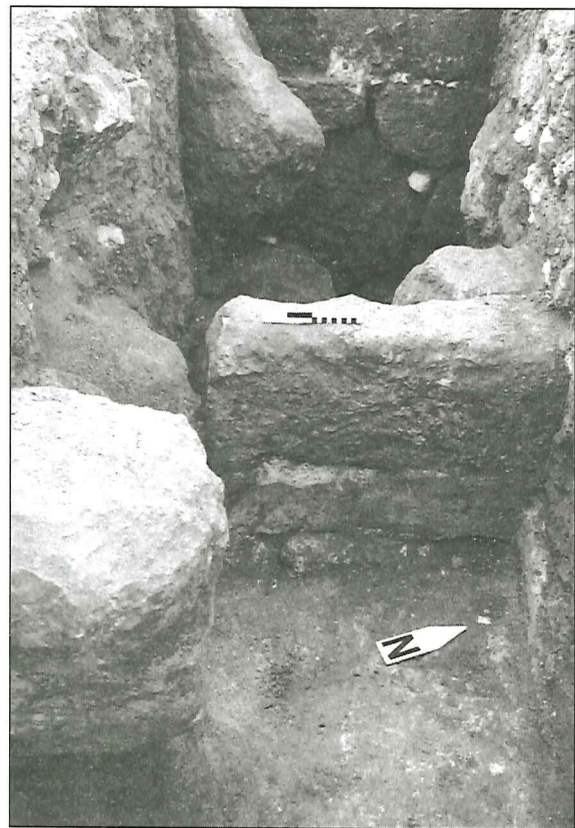
6. On the left of the eastern-face of the wall 4 with the original wall-plaster, in the foreground the affiliated mortar floor 44. In the background the foundations of the Cathedral-west-wall with their section.

clear from the configuration of the original wall-plaster which still adheres to its eastern face (Fig.6). The vertical surface of this plaster curves out at the bottom of the block to run into the horizontal mortar-surface of the floor, which is still preserved further to the east. This white two-layered covering of plaster consists of a 2 cm thick friable *arriccio* over which there is a thinner skin of fine plaster, 2-5 mm thick, with a smooth surface. The adjacent block to the west, which was also set upright, appears to have been slightly disturbed, since it is no longer mortared to the first block nor does it show signs of a continuation to the north where the stratigraphy is still intact. Here, too, it is unclear how wide the wall was originally. To the west the underlying bedrock has a markedly straight edge, which suggests that the rock may have been cut back when wall

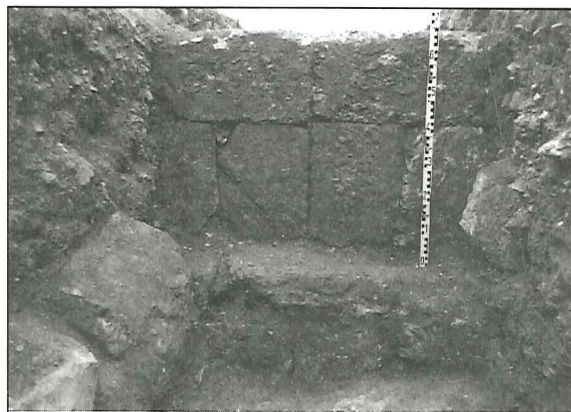
7. View from west on the late antique wall 4.

A thick wall beneath the north-south wall 4 (Fig.7) also must have formed part of the earliest building on the site of the later Ca-

thedral. The principal evidence for this was found on the east side of this structure. The mortar surface 37 which belongs to building phase I overlaps both the projecting foundation 39 and the lowest course of the set-back wall. Furthermore, the construction-trench for this wall, both sides of which are clearly visible at this point, falls from 4 to a level of -1.12 m,⁹ and this corresponds precisely with the upper surface of the first course of stone blocks. On the opposite, western, side of this wall, the corresponding horizontal building-break runs between the projecting edge of the foundation (40) and the first course of stone blocks above.¹⁰ The presence of a thin layer of soil in the narrow space between the foundation and the course of blocks above shows that there was a horizontal break in construction at this point. Here it is clear that the cross-wall 40 is later than the structure 38 which runs parallel to the nave of the later Cathedral. The fact that 40 also cuts through the floor surface 41 shows that the construction of this wall 40 is the latest change which can be associated with phase I. It is not yet possible to tell whether parts of the earlier wall were demolished and the floor surface was raised to the west when wall 40 was constructed.
