1994 ARCHAEOLOGICAL EXCAVATIONS AND SURVEY OF THE SOUTHERN TEMPLE AT PETRA, JORDAN

by
Martha Sharp Joukowsky and Erika Schluntz

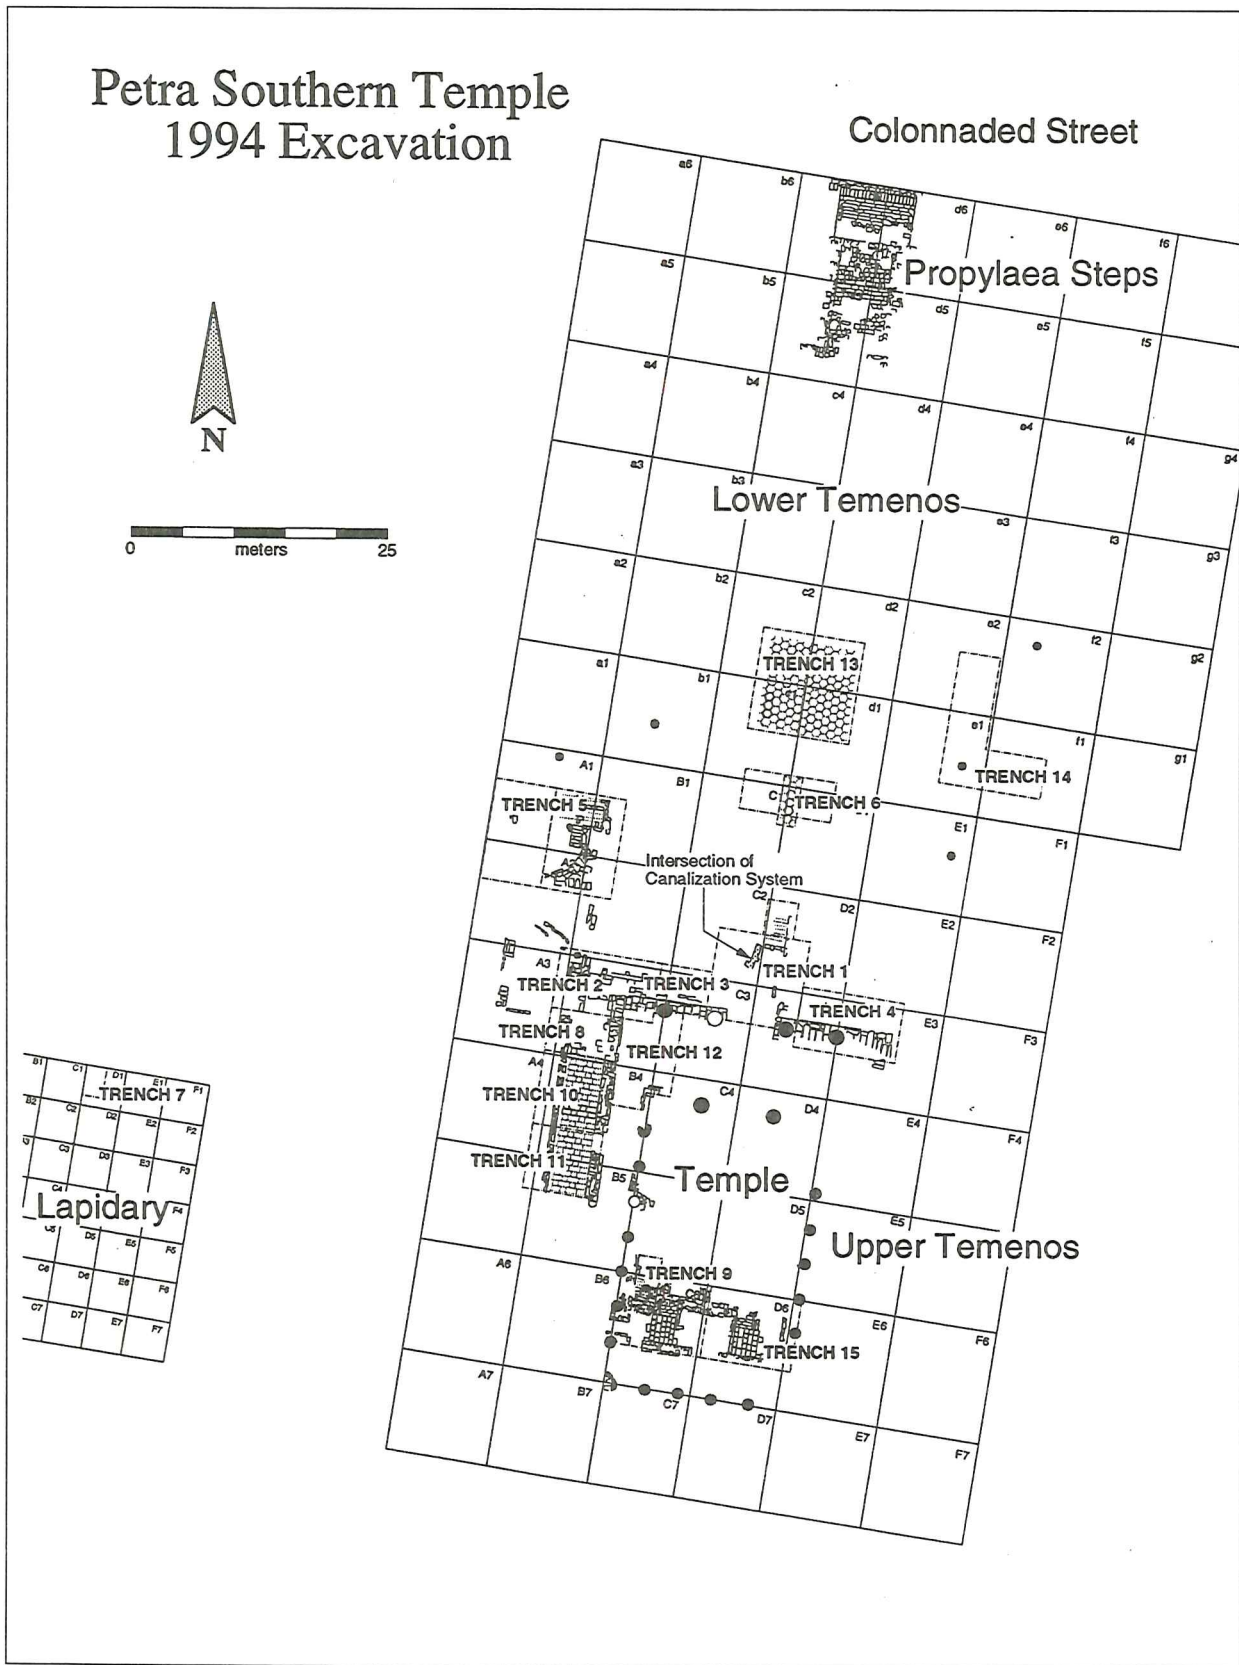
2. Petra Southern Temple Excavation Grid and Layout of Trenches 1994.

tablished across the Upper Temenos in 1993, but this year we were able to extend it to the Lower Temenos, the West Lapidary and the Propylaea Steps (Fig. 2). Excavations were conducted in accordance with the grid using computer-generated maps with scales of 1:100 and 1:50. Detailed archaeological site plans were compiled to include all visible features such as fallen columns and walls. This plan now encompasses the temple and its entire precinct, which covers some 7000 square meters. The Temple area alone measures 113 m north-south x 55.68 m east-west. To the five main areas established in 1993 — 1) the Propylaea Steps, 2) the Lower Temenos, 3) the Grand Stairway, and 4) the Upper Temenos with 5) the Southern Tem-

with the Temple as can be seen in the site plan (Fig. 2).⁵

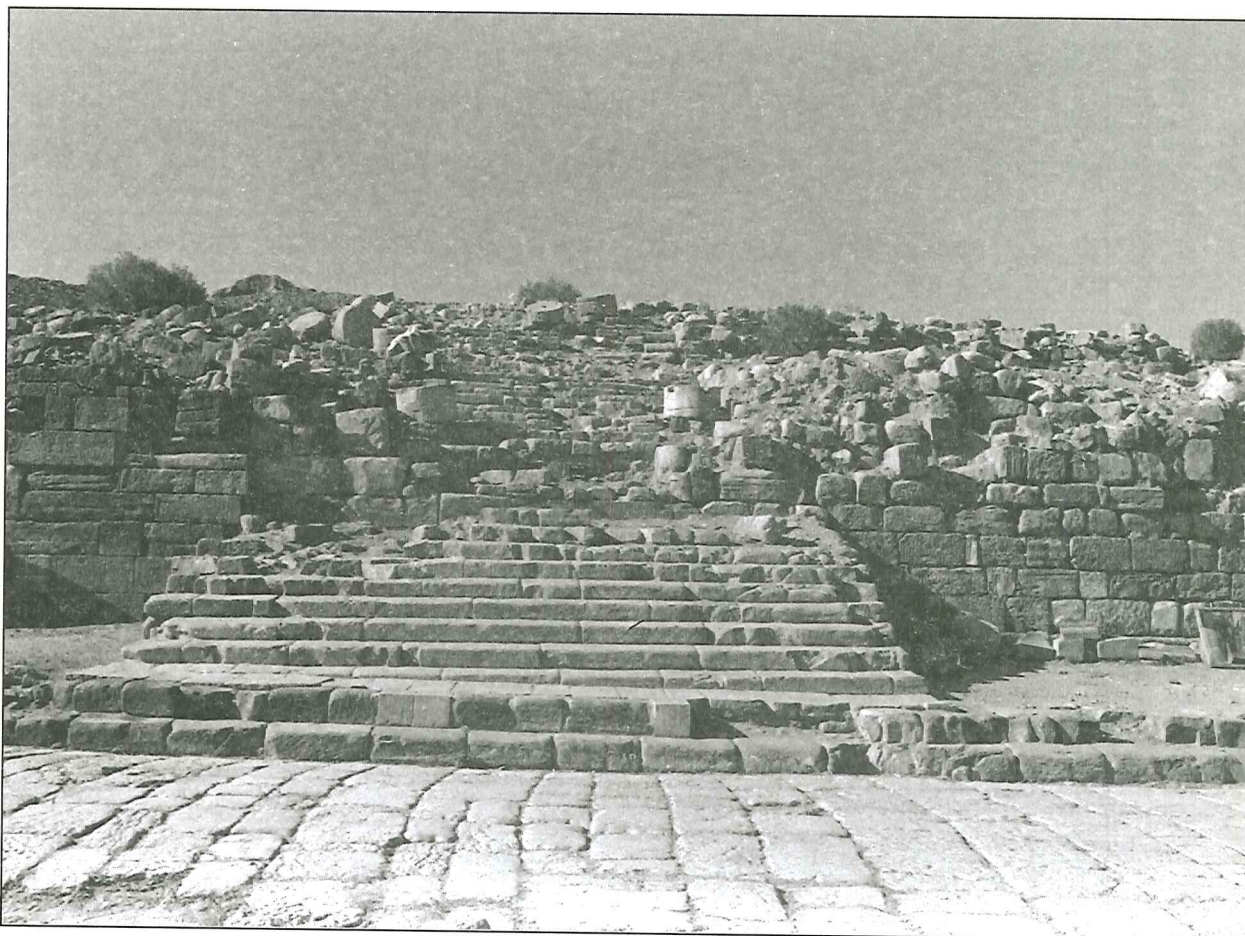
3. Petra Southern Temple Propylaea Steps, general view facing south.

The Propylaea Steps had been partially documented in 1993. In 1994, however, the side walls and each block were surveyed (block-by-block — over 350 individual blocks), and further consolidation of the steps was undertaken (Fig. 3). It was clearly established that this entrance from the Colonnaded Street was in direct alignment

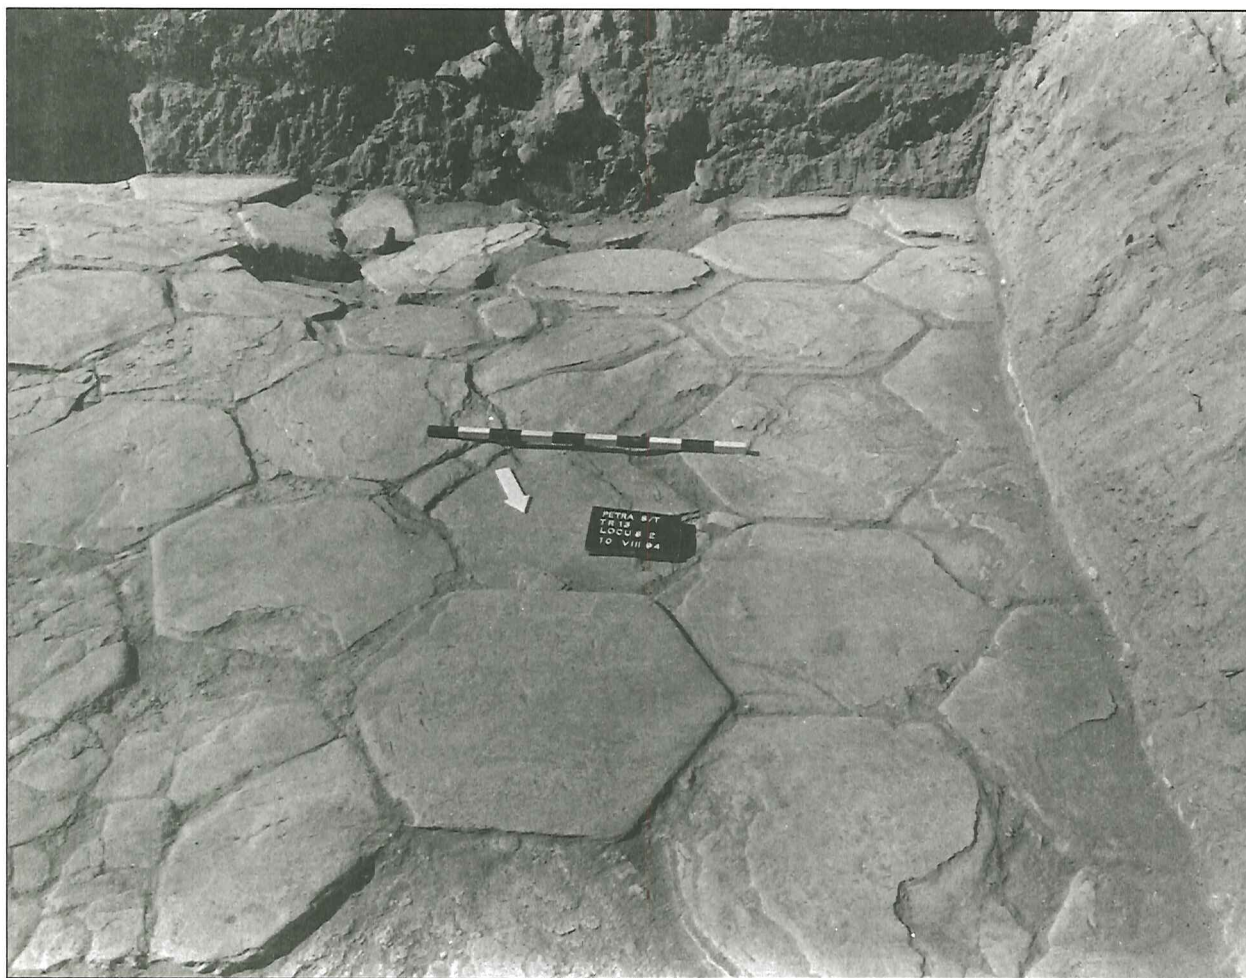
4. Petra Southern Temple Lower Temenos, hexagonal pavement, facing south.

A limestone hexagonal pavement (composed of the largest Nabataean pavers known to date in Jordan) was found under a

ca 1.50 m deposit of fill. This pavement is reminiscent of the white limestone hexagonal pavement present in the Upper Temenos forecourt, but on a larger scale — the Lower Temenos pavers are 0.77 m in width, compared with the 0.36 m pavers above. Clearly these corresponding pavements reflect a concern for a coherent decorative program for the entire precinct area.

After the discovery of the Lower Temenos pavement, a larger 10 x 10 m trench (Trench 13, Fig. 4) was excavated four meters to the north of Trench 6, to ascertain the extent and state of preservation of the pavement. Generally, the limestone pavers uncovered were still *in situ*, under a ca. one meter depth of sandy fill, but some were

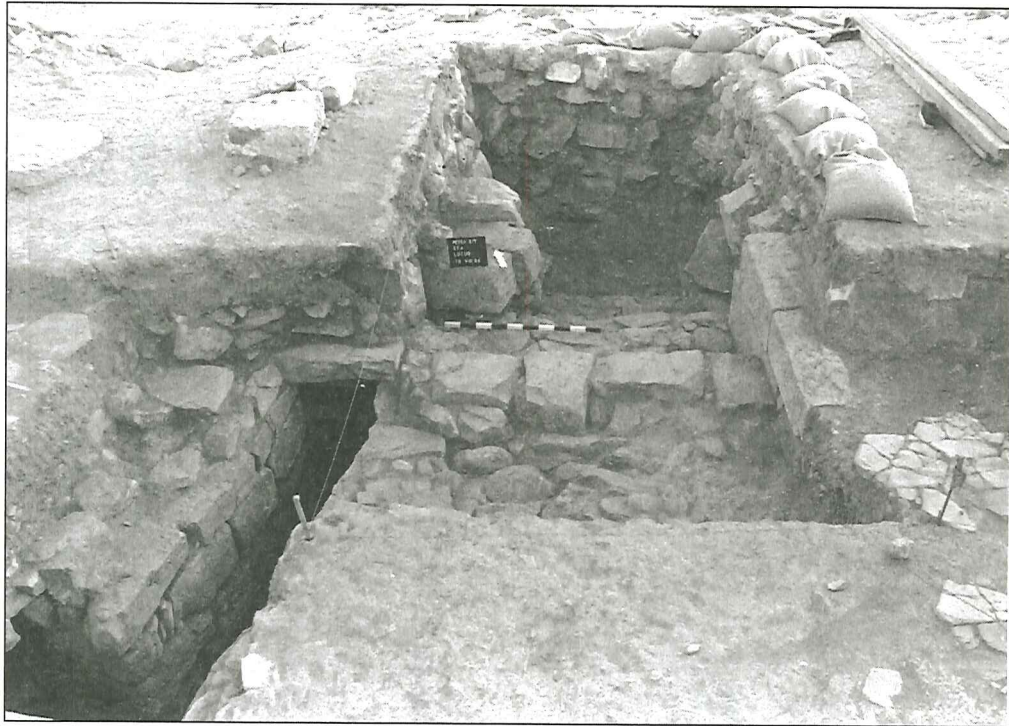
5. Petra Southern Temple, Canalization System, north channel, east wall.

On the final day of excavation during the 1993 field season, a small circular patch of loose soil located in the center of the Southern Temple forecourt was cleared to reveal the main junction area of four subterranean

water channels, leading to the north, south, east, and west (Fig. 5). Due to the potential risk of collapse, and because they were discovered at the close of the season, these passageways were only cursorily investigated, and then covered and sealed for the 1994 season's investigation.

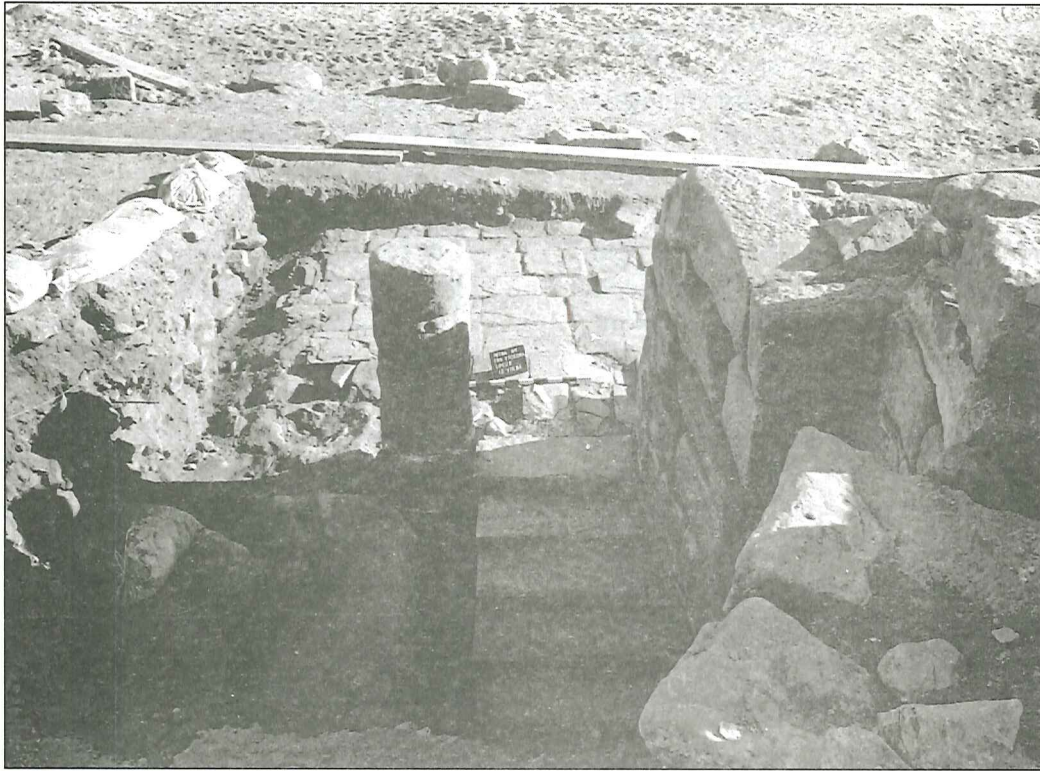
7. Petra Southern Temple, Trench 5, West Exedra, facing north.

Yet another investigatory probe in the Lower Temenos was the excavation of one-half of the West Exedra (Trench 5, Fig. 7), which lies directly west of the Grand Stairway. This limited study enabled us to compare the orientation and axis of the Exedra

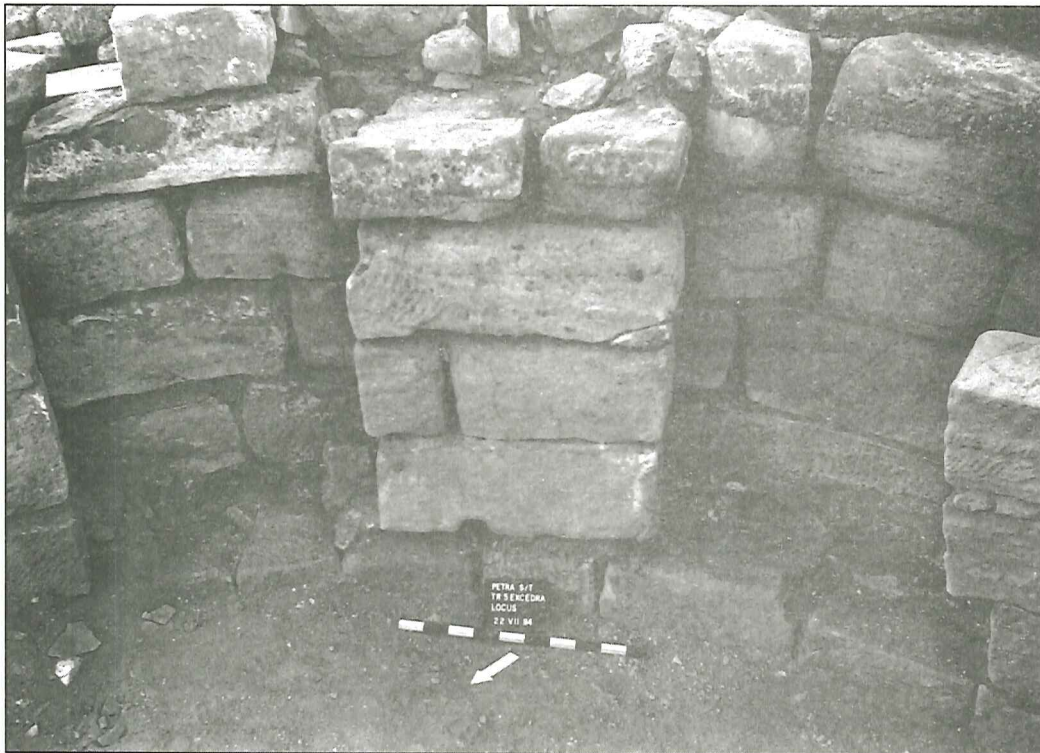
8. Petra Southern Temple, Trench 5, West Exedra, wall niches, facing south.

Excavation revealed that the original Exedra structure consists of a semi-circular wall, containing four¹¹ recessed niches (each 1.1 m in width) evenly-spaced within the interior face (Fig. 8). The north-facing entry measures 6.38 m in width. Composed of hewn sandstone blocks of variable dimensions, the Exedra wall is currently exposed to a height of 3.72 m, although excavation was halted before its founding level was reached. Apparently the blocks were dry-laid, though small patches of architectural stucco on the face of the wall suggest that its surface was at one time plastered.

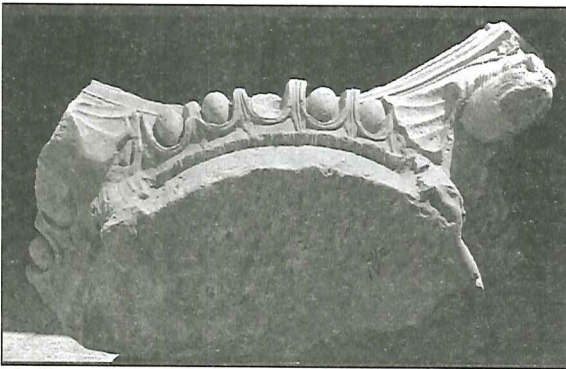
10. Petra Southern Temple, Trench 5, West Exedra, Capital with elephant-headed volute.

In a debris level filled with carved architectural fragments, a limestone capital with elephant-headed volutes (Figs. 10 and 11) was found.¹² Most likely the capital originally adorned the Exedra structure, its 0.86 m width corresponding well with the engaged column's measurements. Several other carved limestone fragments including elephant ears, cheek-pieces, and trunks have also been identified and registered as having come from this area, which strongly suggests that this was the place of this decorative capital's origin.

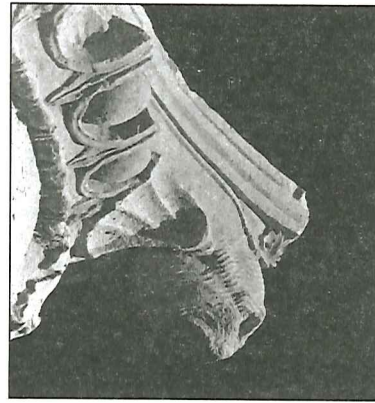
11. Petra Southern Temple, Trench 5, West Exedra, Capital with elephant-headed volute, detail.

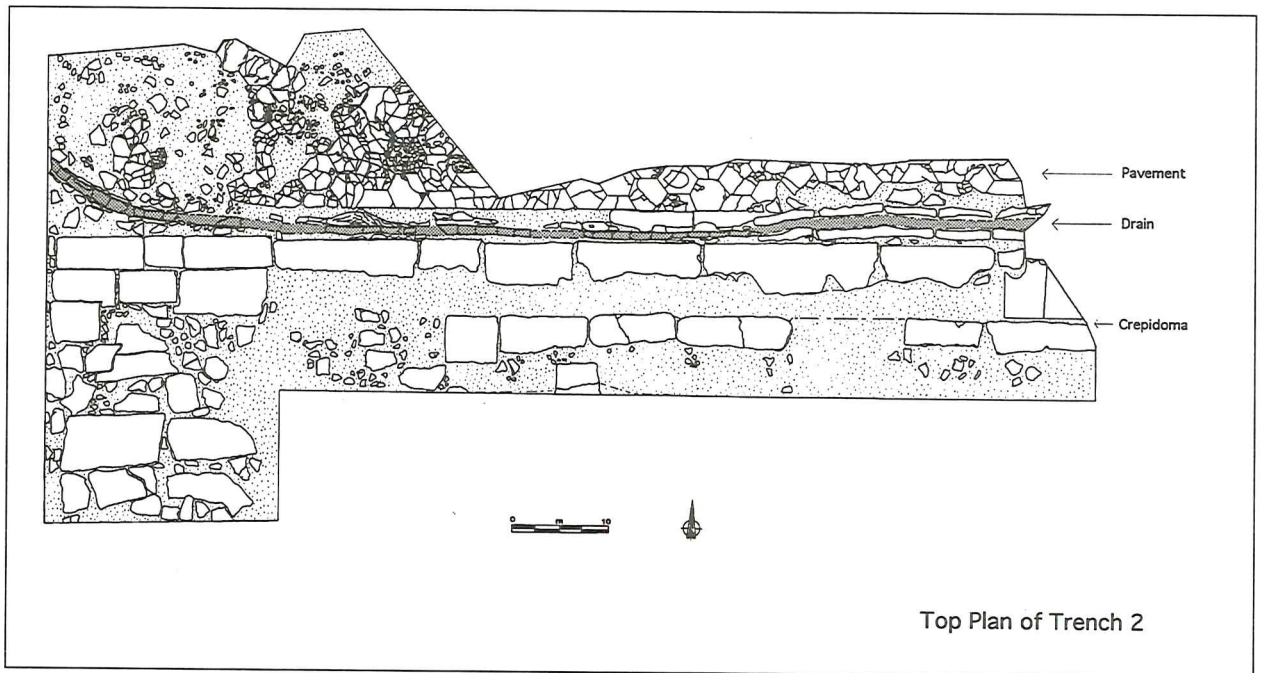
12. Petra Southern Temple, Trench 2, Plan.

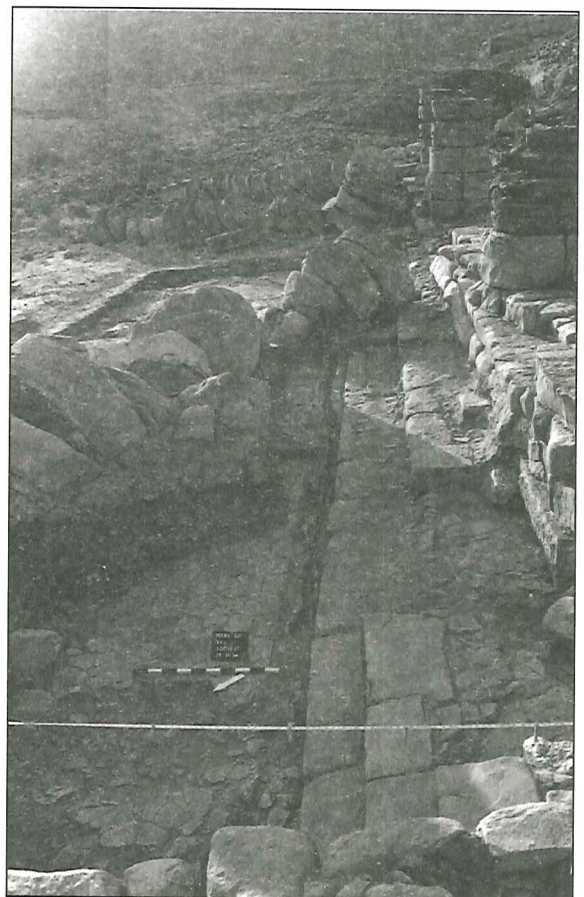
13. Petra Southern Temple, Trench 2, Temple stylobate and crepidoma, facing east.

of the temple. Each course was constructed of two layers of large limestone ashlars (Fig. 13). The top layer ashlars appeared to have been mostly robbed away. The lower ashlars, ranging anywhere from 0.40 m to 1.3 m in length, averaging 0.43 m in depth and 0.20 m in thickness, had what appeared to be a mix of sandy mortar and thin leveling stones on their surface; apparently this served to hold and support the (now missing) top ashlars in place. The crepidoma continued 1.25 m west beyond the northwest corner of the temple, and may have originally ringed the entire building. At some later period of the temple's use, however, the west side of the temple was provided with a broad north-south walkway (see below).

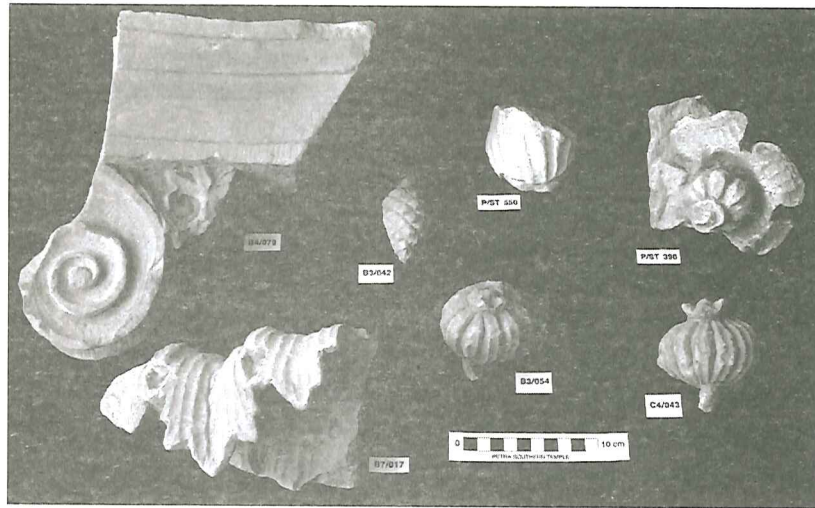
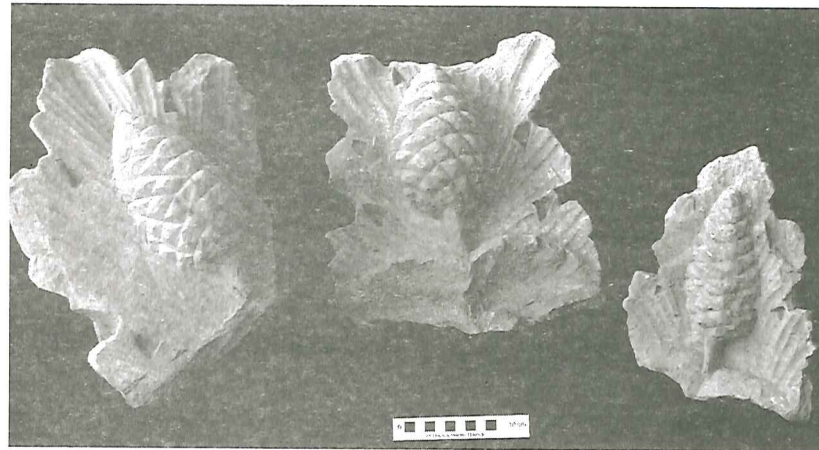
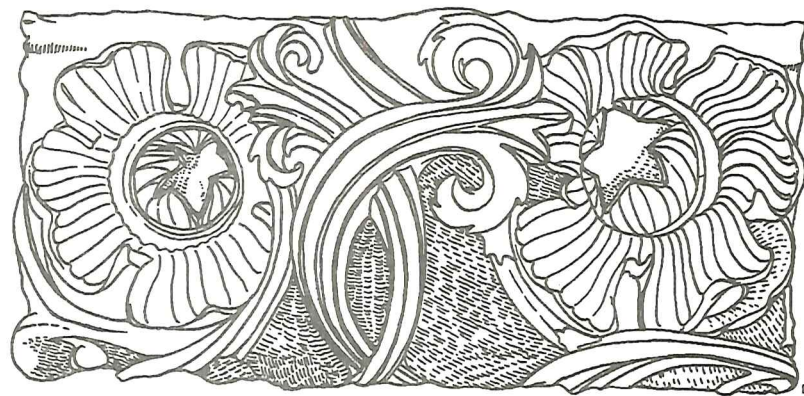
14, 15, and 16. Petra Southern Temple, Trench 2. Carved architectural fragments.

Also belonging to the temple was the abundance of carved limestone architectural fragments recovered from the destruction levels to the northwest (Figs. 14-16). These hundreds of artifacts will aid in the understanding of the decorative program of the temple façade. These elaborate floral and vegetal elements — thick curving vines

ending in flowers bursting forth with pomgranates, pine cones, and bushy acanthus leaves — indicate an early first century date. Significant also was the large number of stucco architectural fragments which turned up in the destruction debris. The bulk of the fragments were flat, but a number were molded, either as very shallow curved elements, or as raised flat bands. These decorative elements probably served as string courses on the temple's entablature, and for covering the columns along the stylobate. Similar patches of vertical curving stucco with raised bands remained *in situ* on a few of the partially exposed columns of the interior cella colonnade. Of over 300 stucco fragments recovered in the forecourt area this season, only a few small flat pieces had paint preserved on their surface, which suggests that the temple exterior was predominantly white and unpainted.

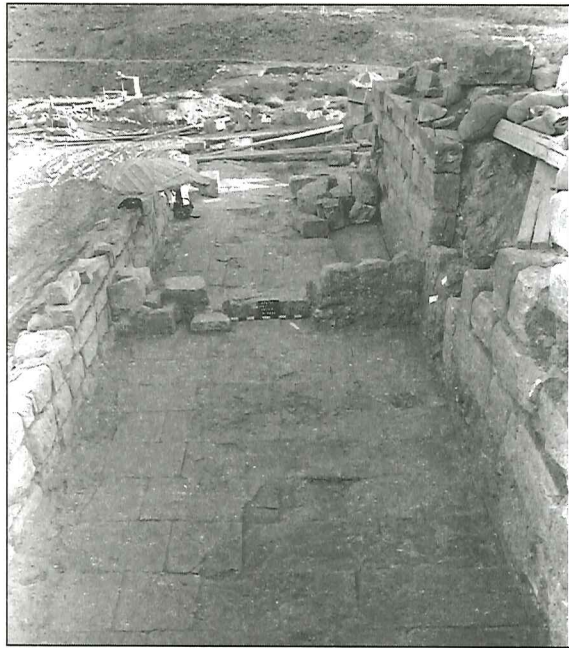
17. Petra Southern Temple Trenches 8,10,11 West Walkway, facing south.

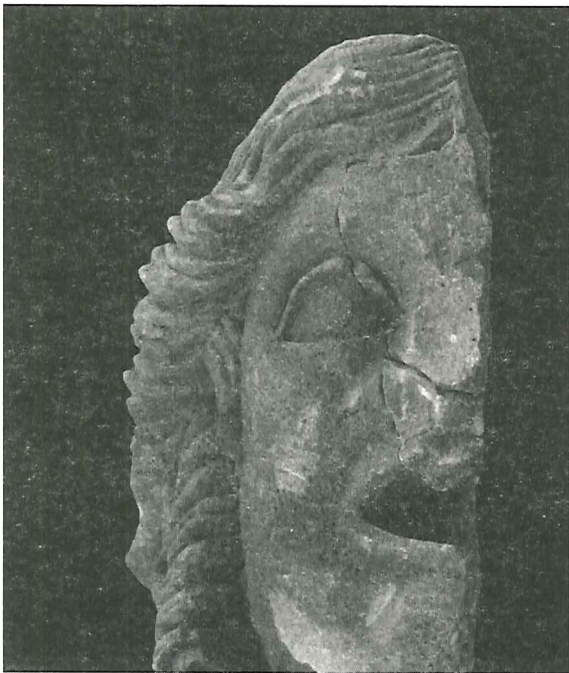
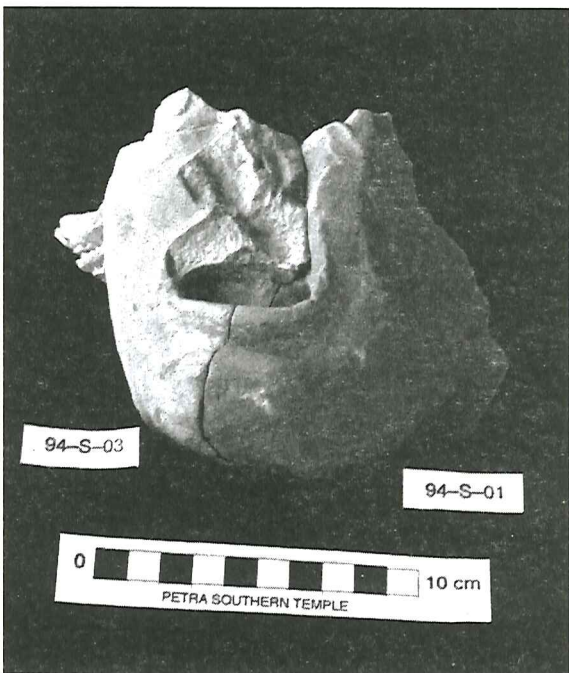
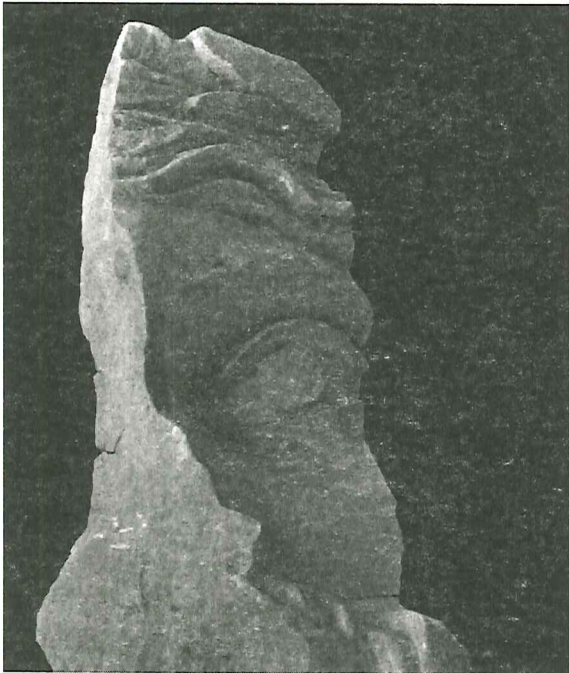
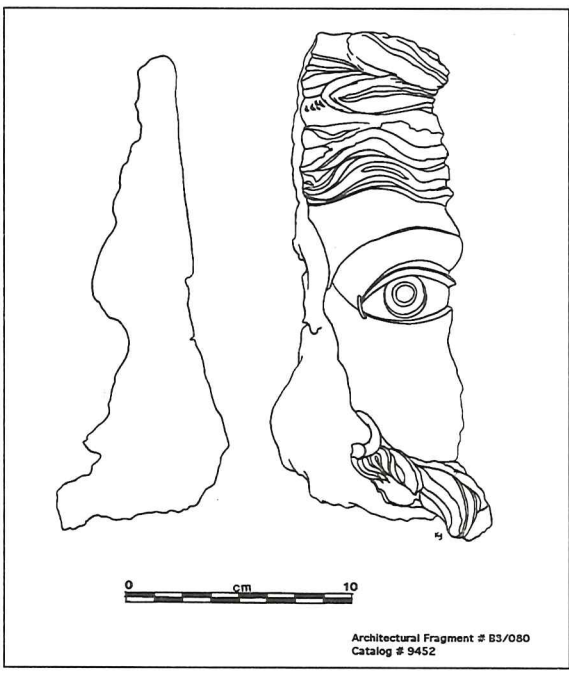
19 - 22. Petra Southern Temple, Trench 12, Carved facial architectural fragments.

Collapsed construction materials and destruction debris surrounding the doorway leading from the walkway into the pronaos contained a great many carved architectural fragments, of the type and style unearthed in the temple forecourt area. Here were found a series of carved limestone faces, two-thirds to slightly over life-size (Figs.

19-22). These finely-carved faces are mask-like in appearance, with open mouths and staring eyes. The outlined irises of these eyes curiously protrude, a sculptural technique peculiar to earlier Nabataean art.¹⁶ In style and quality they most resemble the assemblage of architectural sculpture known as the "1967 Group of Sculptures".¹⁷ No paint was preserved on these or any other carved fragments.

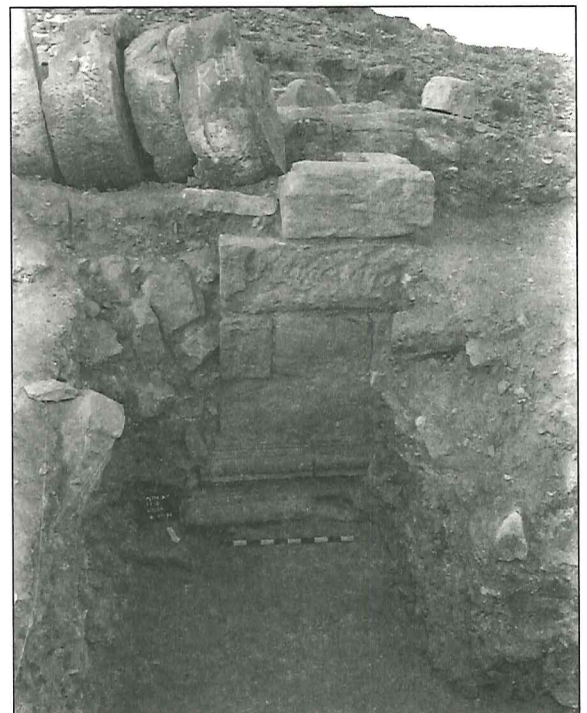
23. Petra Southern Temple, Trench 12, Temple Interior, Attic based Anta, facing south.

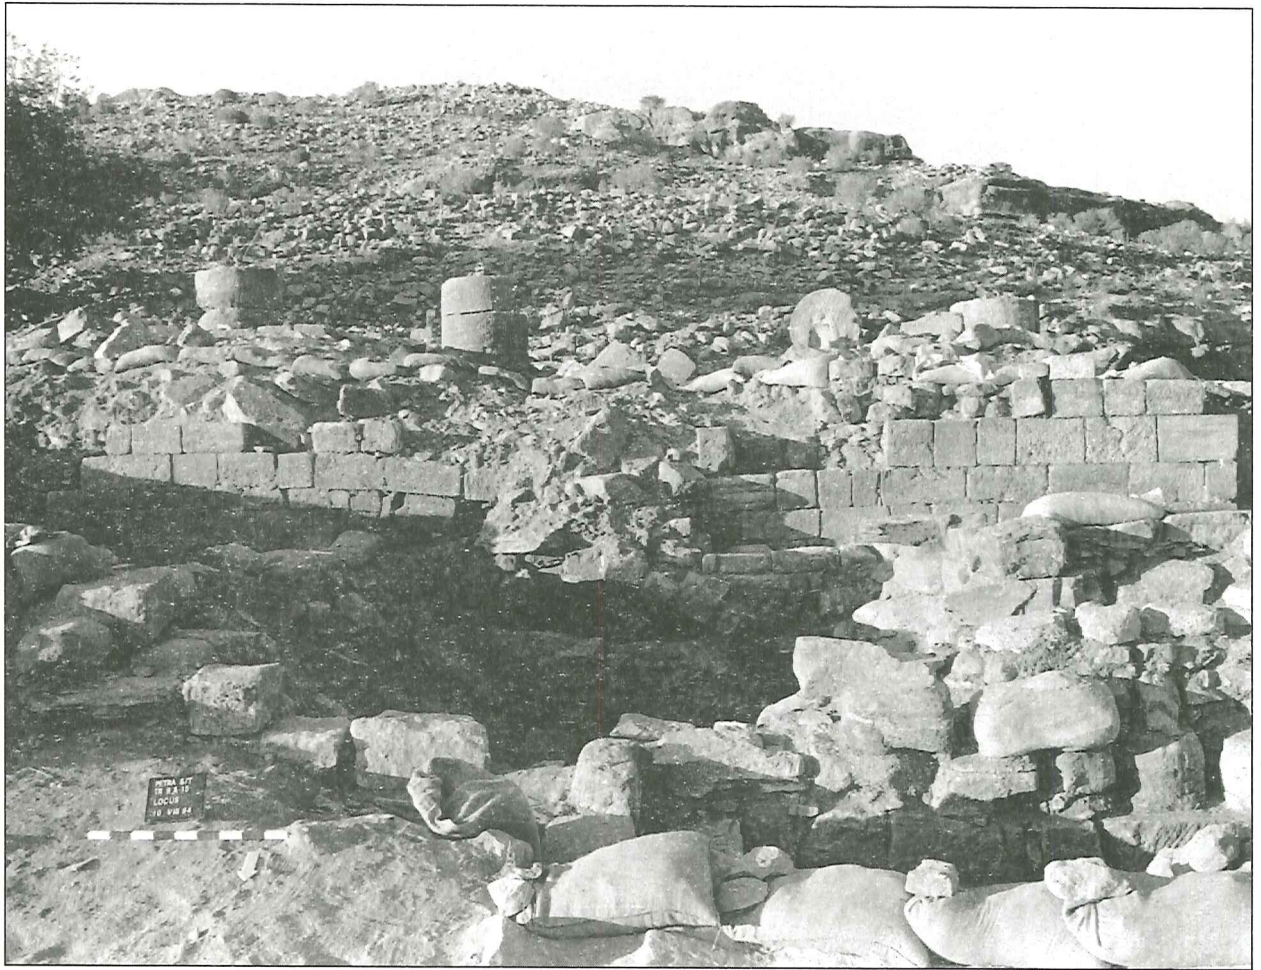
24. Petra Southern Temple, Adyton, central vaulted structure with Trench 15 (left), and Trench 9 (right), facing south.

three roughly equal sections. This subdivision was achieved by two north-south walls, which helped to bear the central Vaulted Structure. Both to the east and west of the Vaulted Structure, it appears that stairways rose to what we have called the "Mezzanine" level (Fig. 25). This tripartite adyton plan is also found in the Southern Temple's neighbor, the Qaṣr al Bint, as well as other Nabataean temples, such as the "early" temple in Wādī Rumm. The Qaṣr al-Bint also clearly shows evidence of both a tripartite subdivision of its main level, and a mezzanine level above. In the Southern Temple, the Mezzanine level is also divided into three areas: two landings

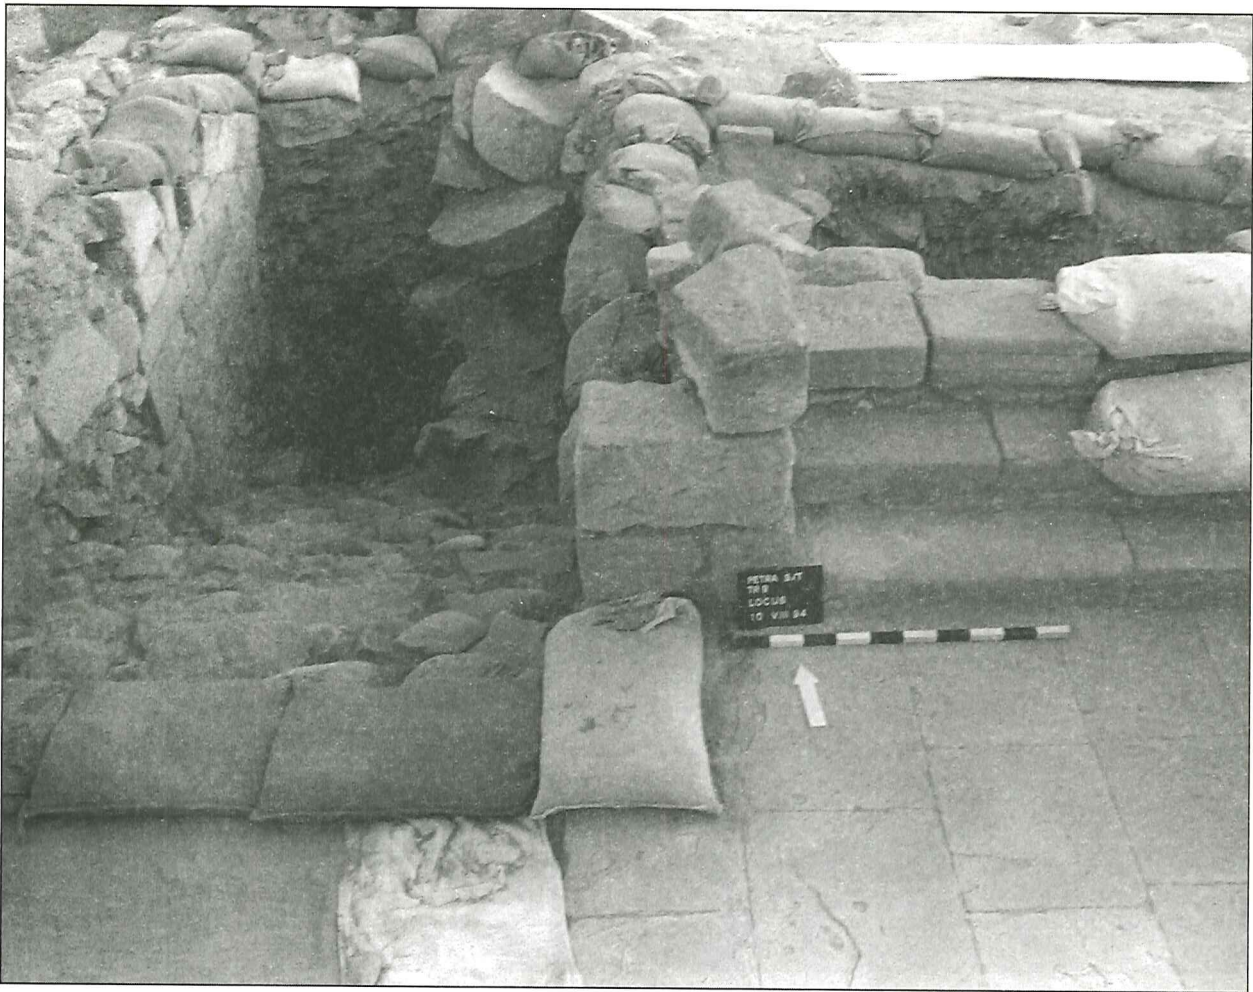
25. Petra Southern Temple, Trench 9, Adyton, Mezzanine landing and stairways.

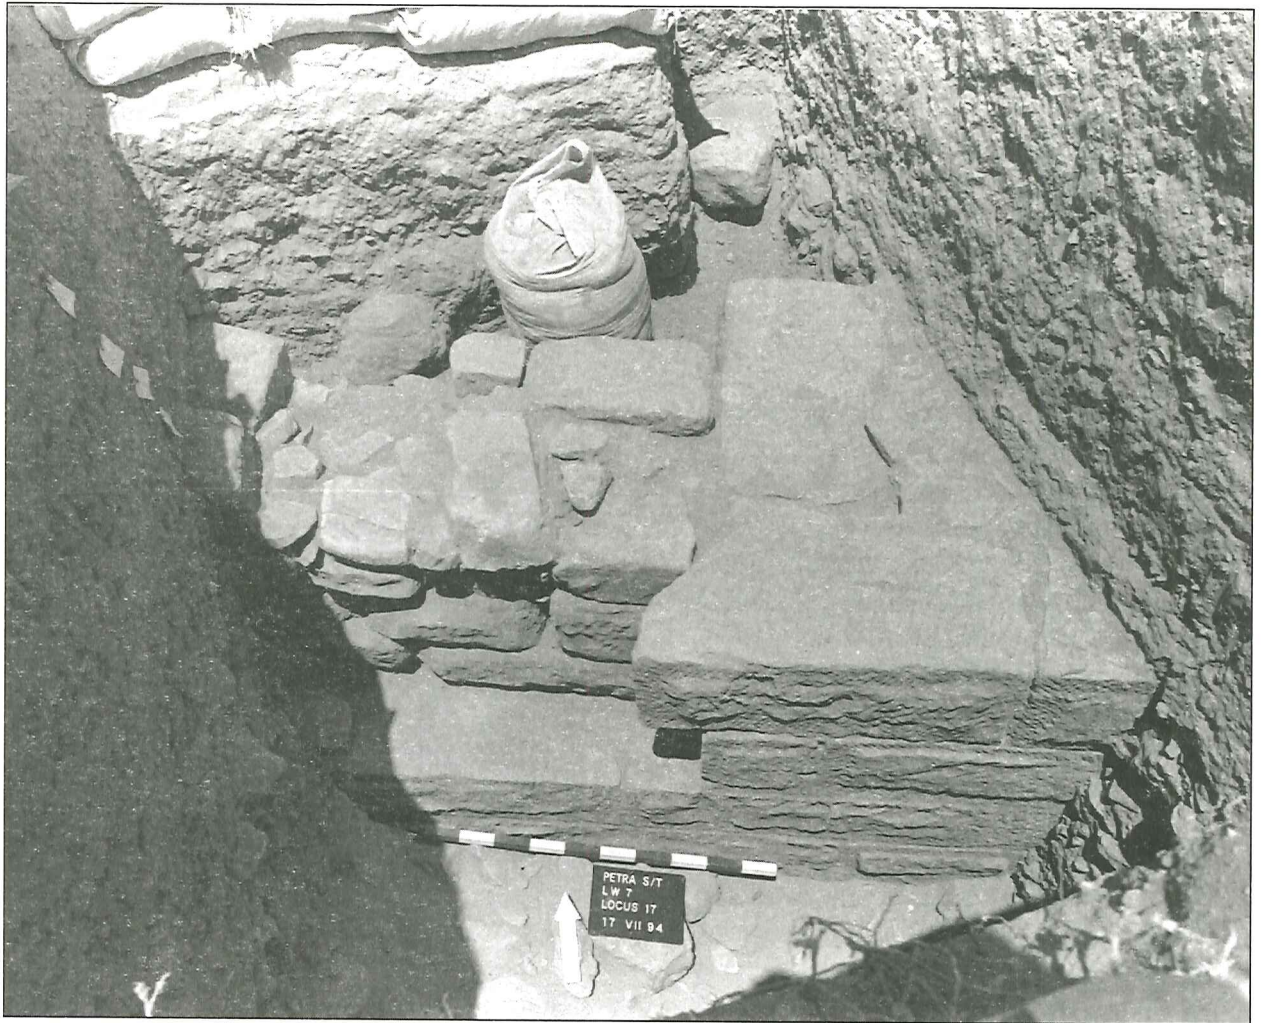
27. Petra Southern Temple, Trench 7, Lapidary West, Nabataean walls, facing south.

This wall, composed of limestone headers and stretchers, runs obliquely east-west, toward the area to the rear of the Southern Temple. Over 100 of the pottery fragments from this area were drawn and described, and samples have been sent for petrographic and neutron activation testing to the Applied Science Center of the University of Pennsylvania Museum.
