# 1995 ARCHAEOLOGICAL EXCAVATION OF THE SOUTHERN TEMPLE AT PETRA, JORDAN<sup>1</sup>

Martha Sharp Joukowsky

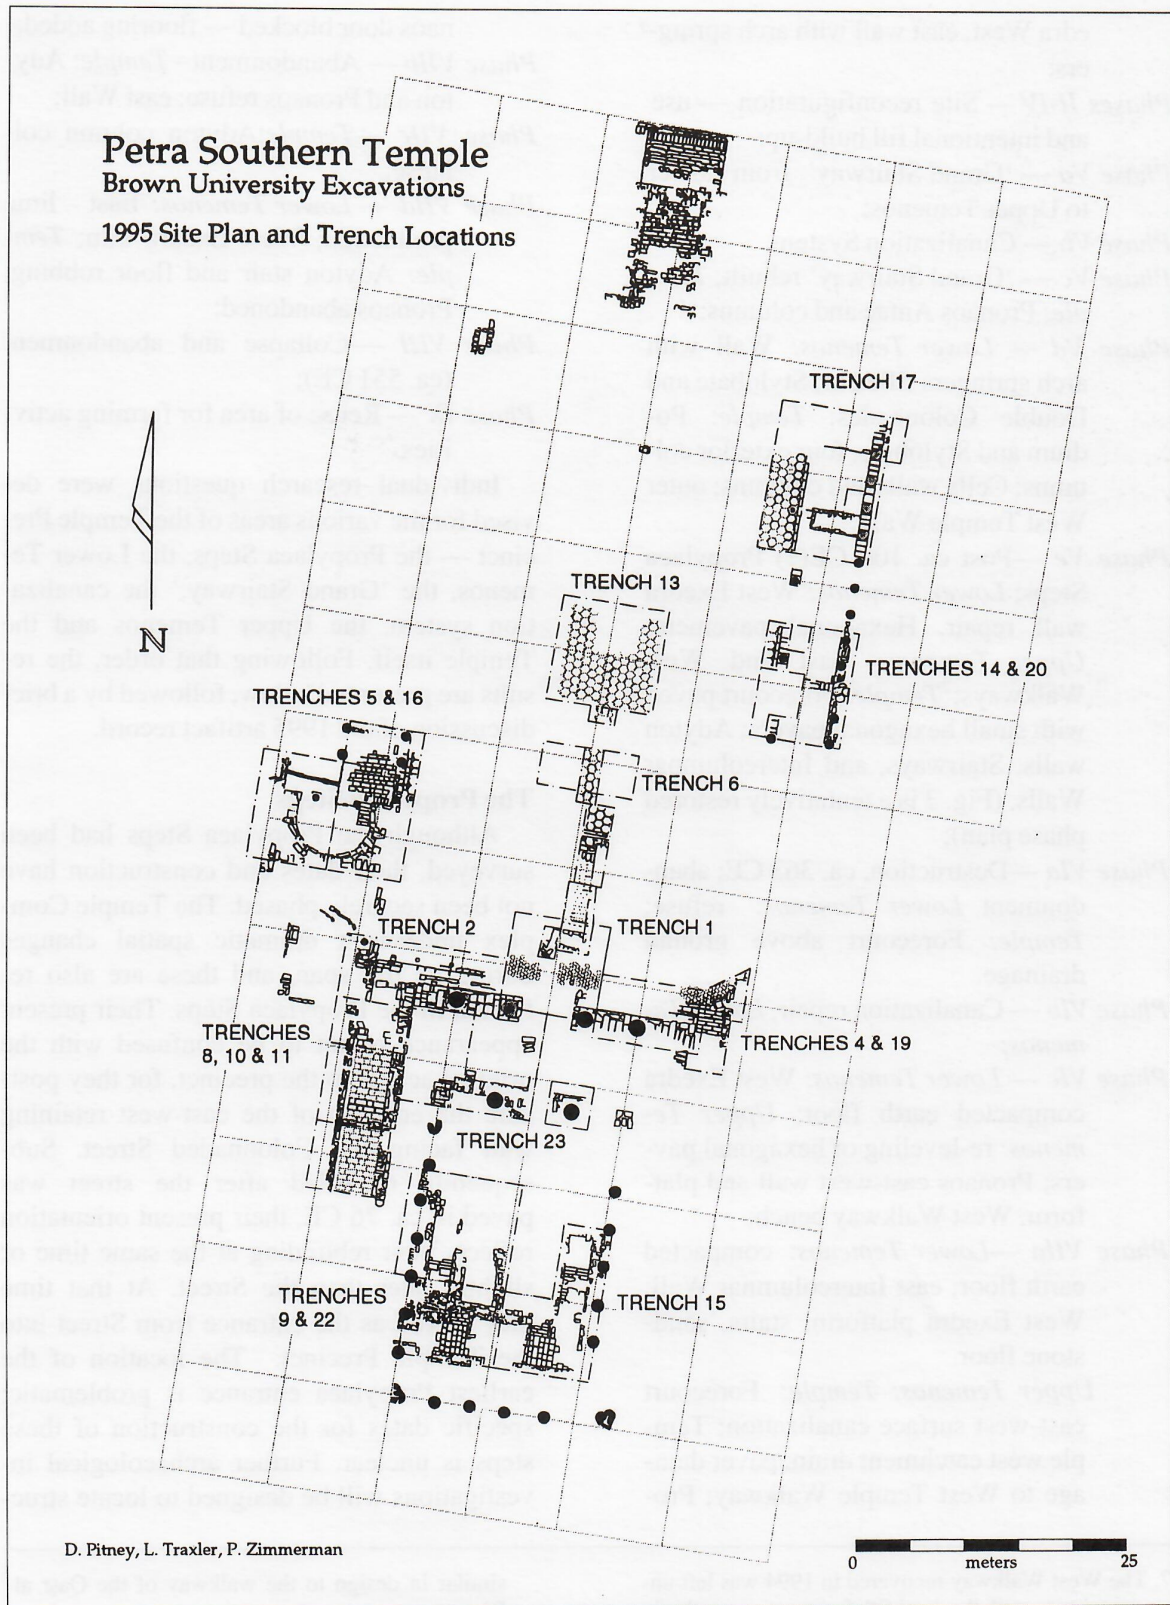
2. 1995 Site plan with trenches. (D. Pitney, L. Traxler, P. Zimmerman).

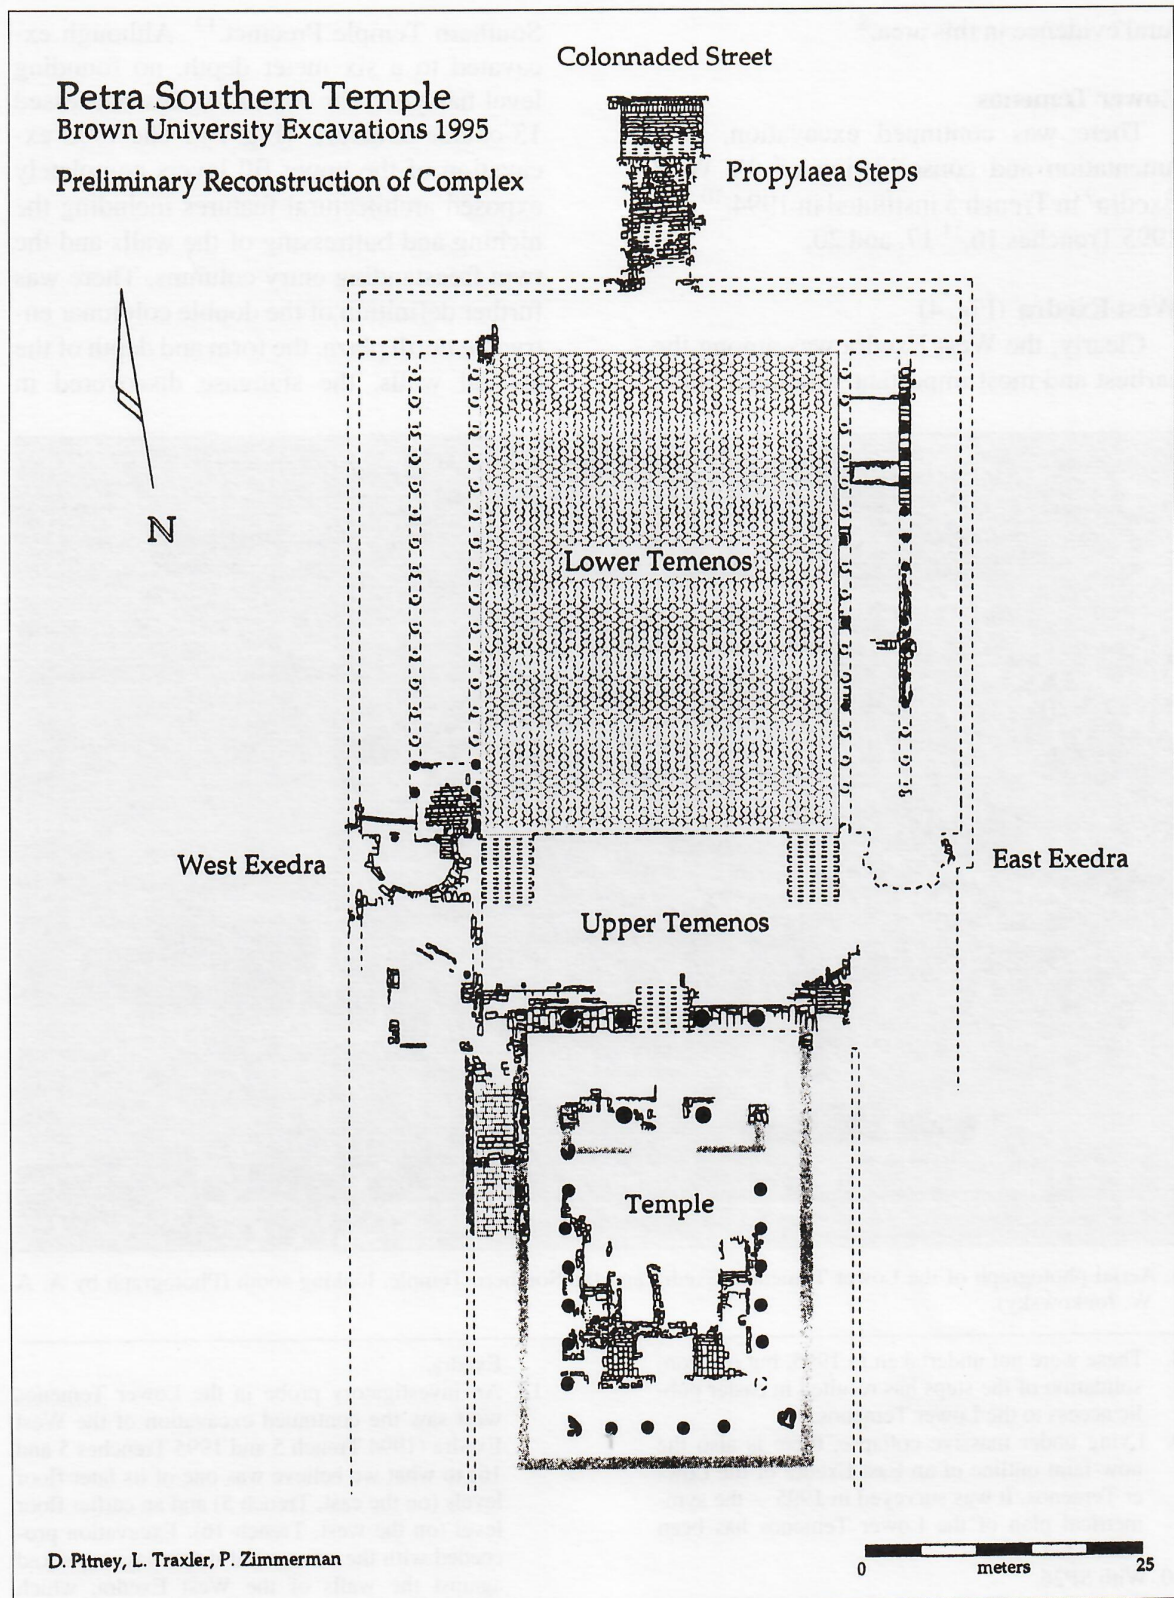
3. Reconstruction of the Late Nabataean reconstruction phase (D. Pitney, L. Traxler, P. Zimmerman).

- Phase Ve* — Post ca. 106 CE(?) Propylaea Steps; *Lower Temenos*: West Exedra wall repair. Hexagonal pavement. *Upper Temenos*: East and West Walkways;<sup>7</sup> *Temple*: Forecourt paved with small hexagonal pavers; Adyton walls, Stairways, and Intercolumnar Walls. (Fig. 3 is a tentatively restored phase plan);

Another two subphases included the east and west Stylobate construction for the Double Colonnades of the Lower Temenos. The Stylobate foundation wall indicated two phases of construction; an earlier of close fitting Nabataean dressed blocks, and a later of coarse blocks with a thick mud mortar and stone fill.<sup>30</sup> Covered by topsoil in Trench 17, the east Stylobate was revealed at an opening elevation of 878.99m. It was constructed of limestone slabs (0.52m x 0.96m) separating larger, square convex-shaped slabs (0.96m x 0.96m) which supported the columns and served as their bases. The 30m area excavated revealed spacing for 12 columns, but we posit that there were a minimum of 14-to-16 that adorned each line of the double-rowed colonnade (refer to Fig. 3).

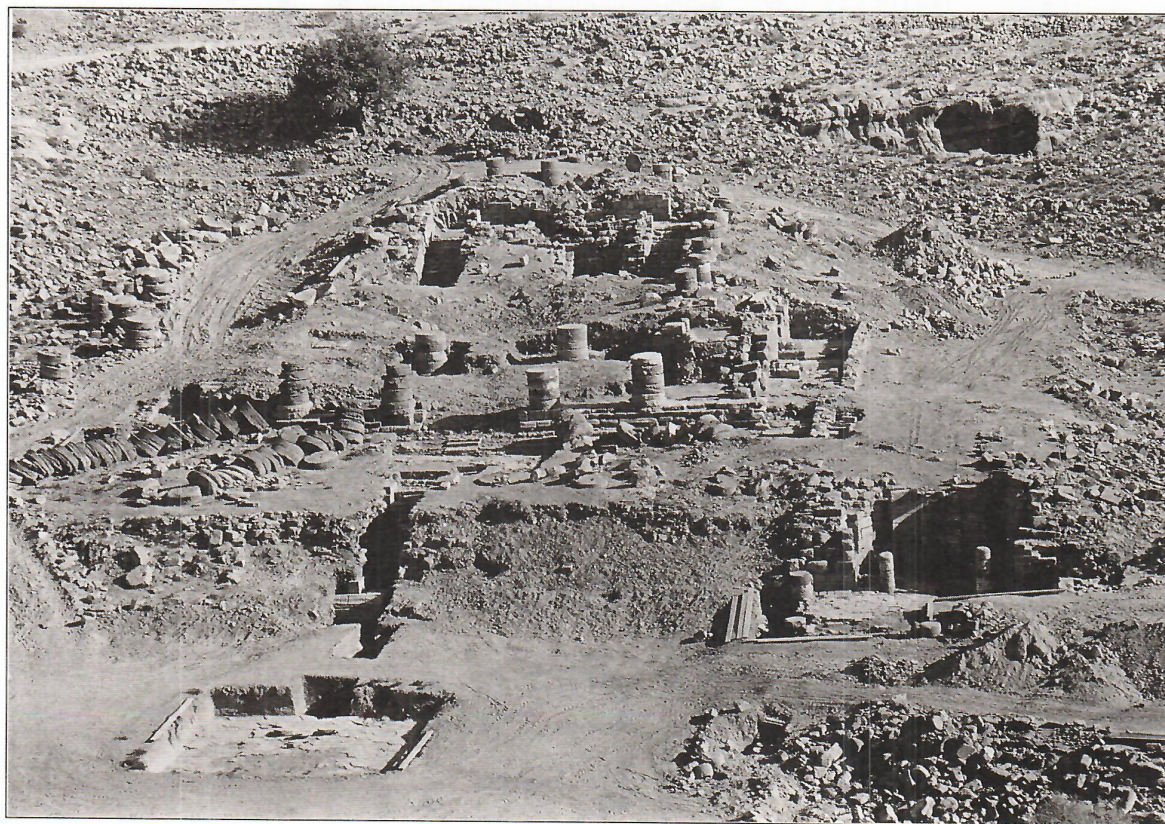
4. Aerial photograph of the Lower Temenos, Exedra and the Southern Temple, looking south (Photograph by A. A. W. Joukowsky).

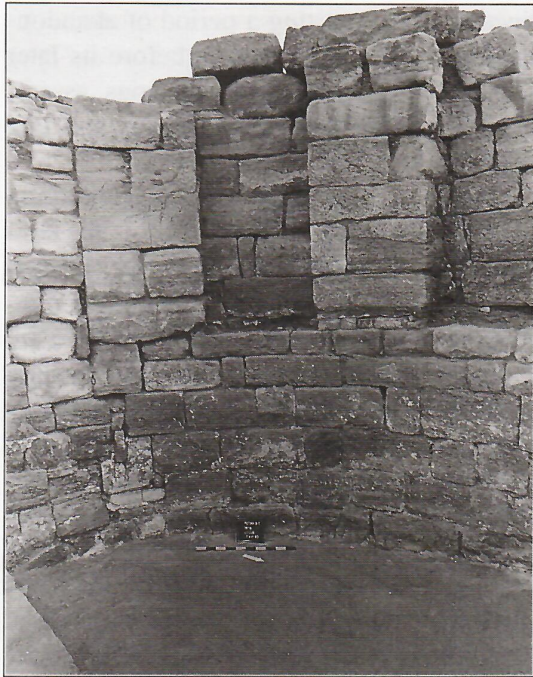
5. West Exedra, looking southwest (Photograph by A. A. W. Joukowsky).

Southern Temple Precinct.<sup>12</sup> Although excavated to a six meter depth, no founding level has yet to be found for this buttressed 13-course structure (Fig. 5). The 1995 excavation of the upper fill layers completely exposed architectural features including the niching and buttressing of the walls and the twin freestanding entry columns. There was further definition of the double columnar entry, the north plaza, the form and depth of the apsidal walls, the staircase discovered in

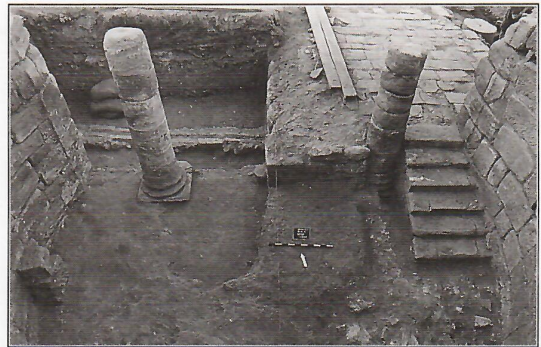
6. West Exedra, looking north (Photograph by A. A. W. Joukowsky).

1994, and the location of floor levels and foundation levels. New architectural components were revealed. As can be seen in Fig. 6, the platform floor uncovered in 1994 did not continue westward, however, a founding floor level for the stairs was recovered. (There was no western engaged column to mirror the east column recovered in 1994 — where the elephant-headed capital was discovered.) Additionally there was the appearance of a north-south wall in the northwestern part of the trench which was partially contemporary with the apsidal wall, and formed a natural boundary in the extreme northwestern corner of the trench. Between two floors of later re-use was a sealed fill layer containing significant numbers of bones, shells, charcoal deposits, and ceramic remains. In addition, under the packed surface north of the West Exedra proper, a shallow water channel (Fig.7) was excavated, resting on a footing of pebbles. There was

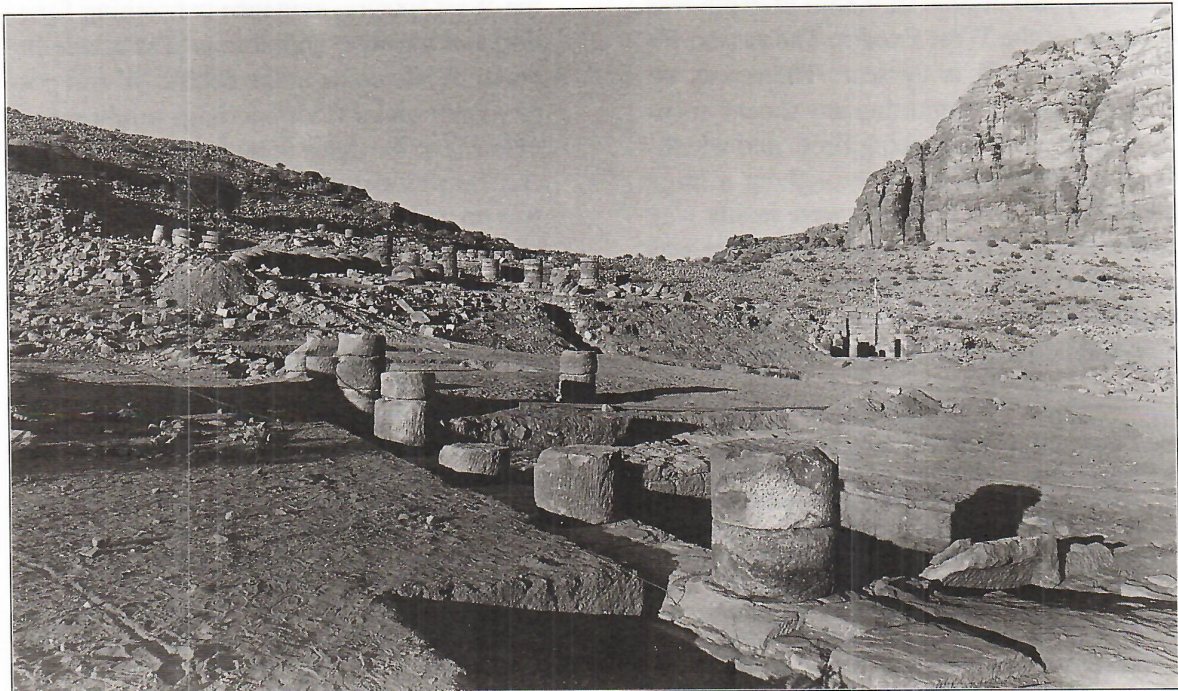
8. Lower Temenos Colonnade looking southwest (Photograph by A. A. W. Joukowsky).

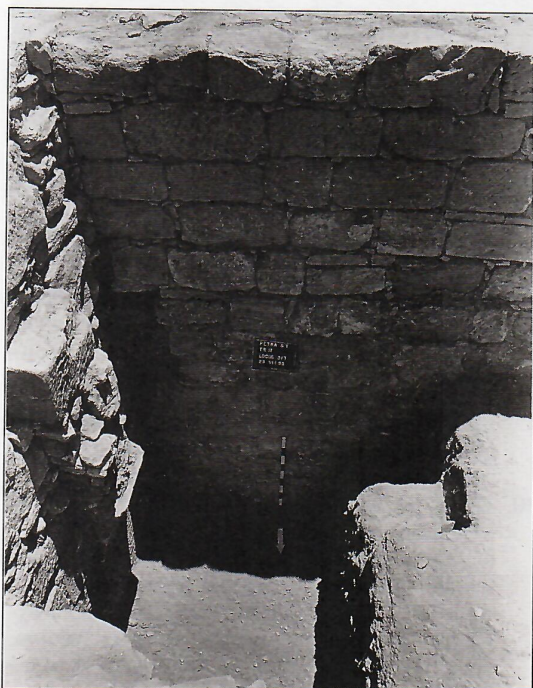
9. Lower Temenos E-W Wall N sondage with N-S wall with arch springers, looking south (Photograph by A. A. W. Joukowsky).

In Phase Vd the Lower Temenos was constructed. This was a time of major rebuilding for east-west walls were erected both in the north, E-W Wall N (Figs. 9 and 10), and south, E-W Wall S. We presume that the purpose of these walls was to provide extra structural support for the Stylobate and serve

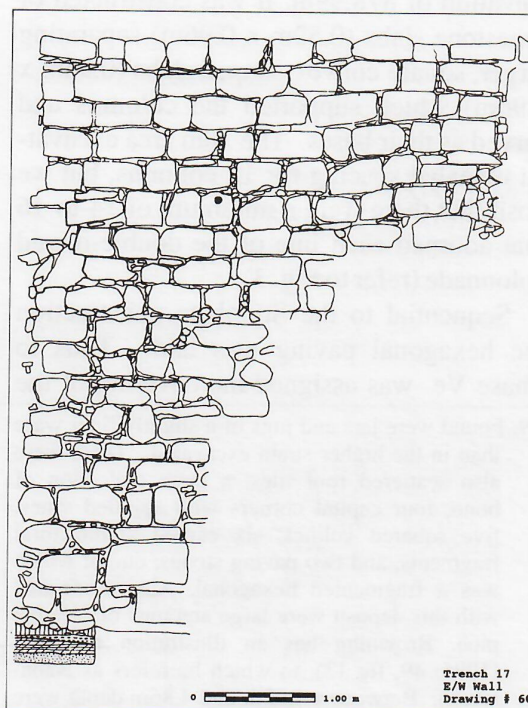
10. Lower Temenos E-W Wall N section (Drawn by L. Payne, Drafted by A. H. Bedewy).

27. The 19 course E-W Wall N opened at 879.07m and closed at 873.67m elevation (5.40m in height). It is 4.43m in length by 2.10m in width, and was built on a level of rubble sandwiched between layers of compressed soil. The top course of this wall overlaps the East and thus post-dates it. The top courses consist of medium sized, rounded sandstones packed in an irregular pattern in a hard mud-mortar. The north face, however, exhibits careful construction technique with a facing of headers and stretchers with neatly packed fill in between them. The average size of the ashlar are 0.31m x 0.28 m (headers) and 0.52 x 0.27 m (stretchers). The majority are diagonally dressed, all from top right to bottom

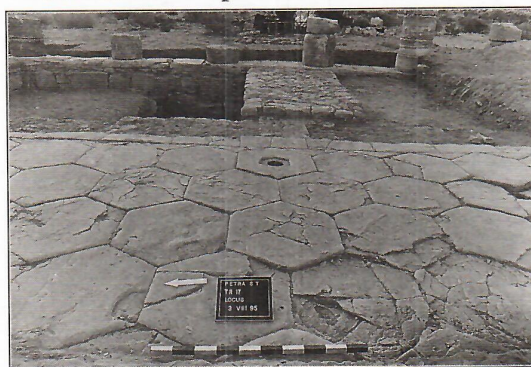
11. Lower Temenos hexagonal pavement with drain, looking east (Photograph by A. A. W. Joukowsky).

Lower Temenos with large hexagonal pavers. These pavers were the eastern perimeter of the hexagonal pavement which extended from the east across to the West Exedra and its Double Colonnade. Set into a complete paver was an hexagonally shaped drain (Fig. 11), 0.28m to a side with a central hole of 0.12m in diameter serving as the evacuation point.<sup>31</sup>

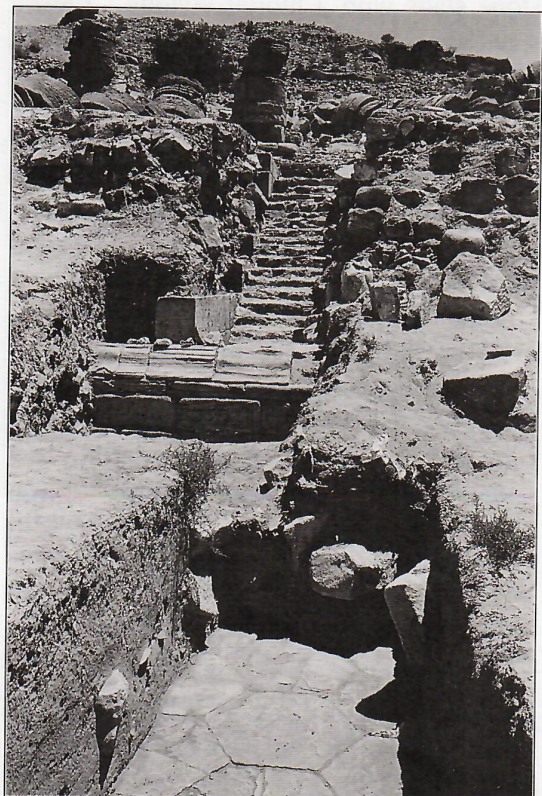
12. 'Grand Stairway' linking the Lower Temenos to the Upper Temenos (Photograph by A. A. W. Joukowsky).

Initiated in 1994, in 1995 we completed the test excavation and surveyed and cleaned a portion of the Stairway bedding from the Upper Temenos to the Lower Temenos. The subdatum was fixed at 882.49m on the seventh step, and the trench was extended 5.6m north to ascertain the length of the Stairway and its east ashlar support wall. The Stairway itself measured 9.5m in length, and the hexagonal pavement at the foot of the retaining wall was 2.5m in width.

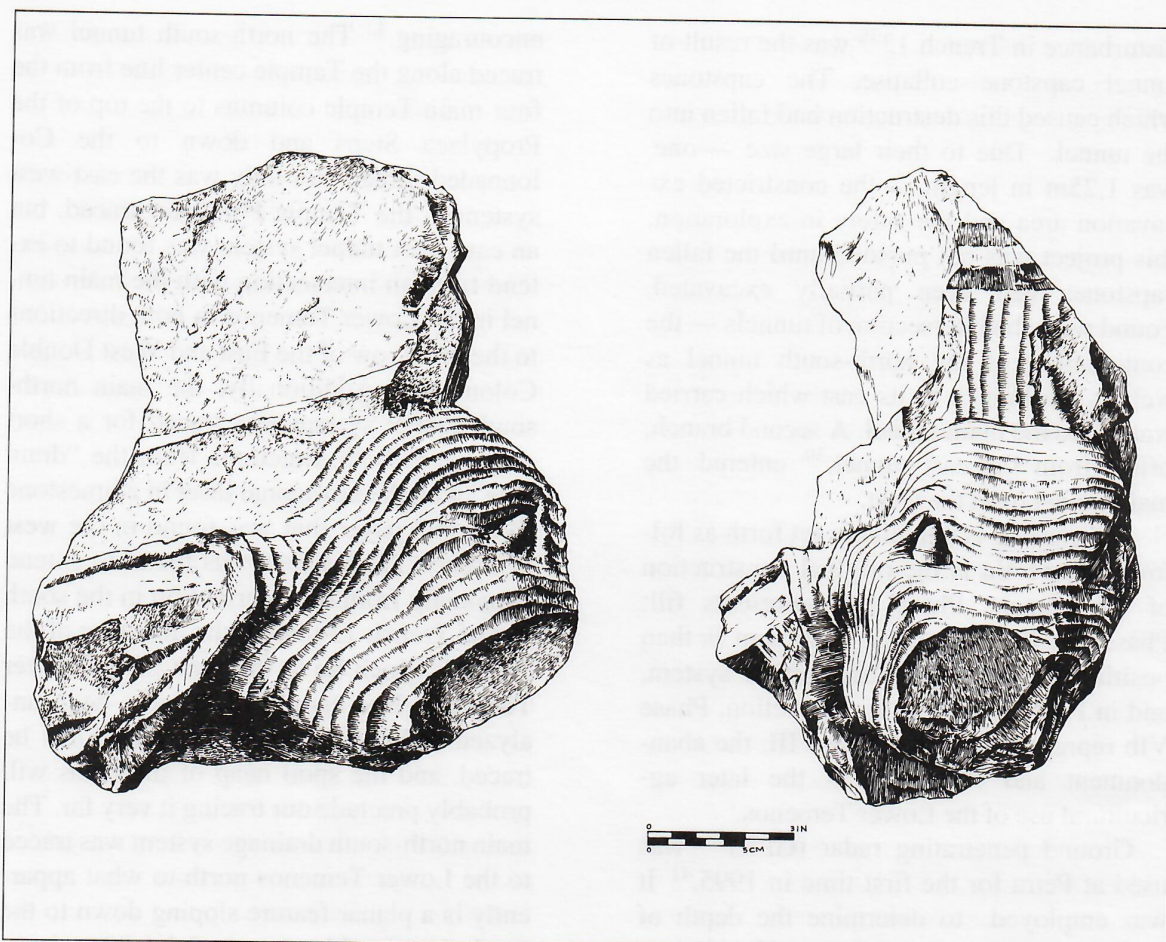
13. Elephant-headed capital fragment (Drawn by L. Sisson, Drafted by J. Blackburn).

A change in soil consistency was noted while excavating the second course of ashlar at an 880.71m elevation. Significant amounts of cultural material unearthed included Nabataean forms as well as jar and jug fragments, along with 23 carved architectural fragments, and a capital fragment of a limestone elephant head (Fig. 13).<sup>37</sup>

37. Catalog no. 95-S-16, measurement L. 28.9cm x W. 29.6 cm. Present is the right ear, two eyes, one with its eyeball, and forehead. Another elephant trunk fragment was found in the same area as the head.

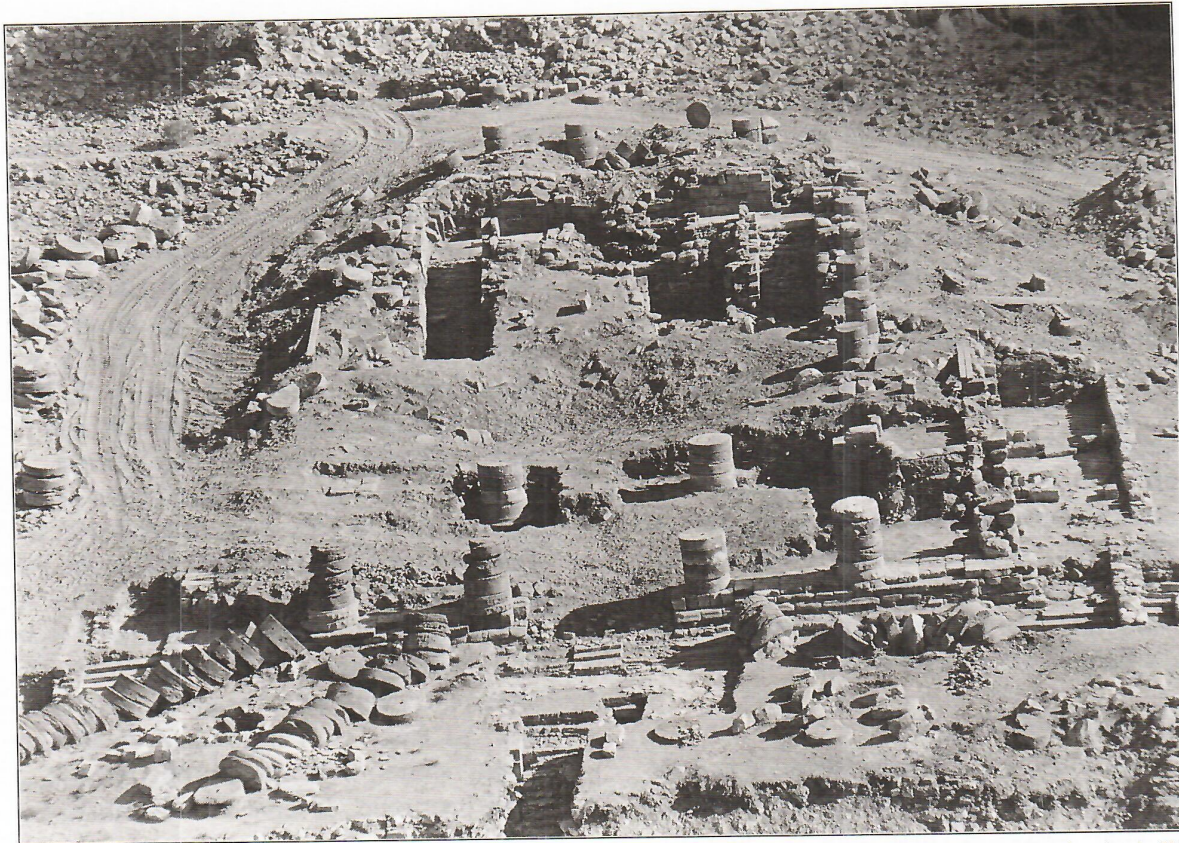
14. Aerial photograph of the Upper Temenos, Southern Temple and Adyton, looking south (Photograph by A. A. W. Joukowsky).

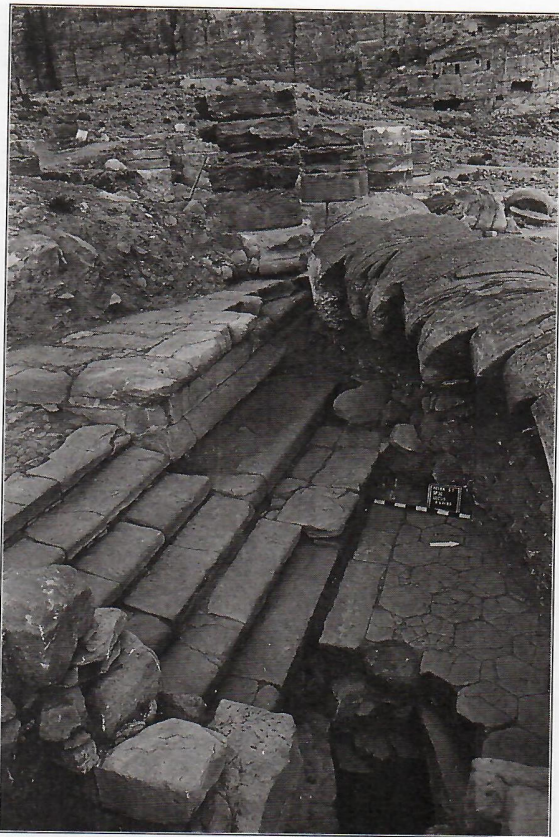
15. East Walkway with Canalization, Temple Podium and Stylobate, looking west (Photograph by A. A. W. Joukowsky).

At elevations of 884.46m and 883.09m, just east of the stairs, the underground canalization was discovered extending north-south with an northerly descent and a slight northeasterly curve (Fig.15). Slightly askew hewn capstones were found at 884.46m, indicating that they had been moved in antiquity perhaps to repair or clean the system. The tunnel walls consisted of three course dressed sandstone ashlar, covered by a 4cm thick mortar. The depth of the tunnel was 1.20m, and its floor width measured 0.63m. Its approximate length was 12m. We assume that this tunnel served as an eastern artery for the main subterranean Canalization system, but the area excavated, unfortunately, was

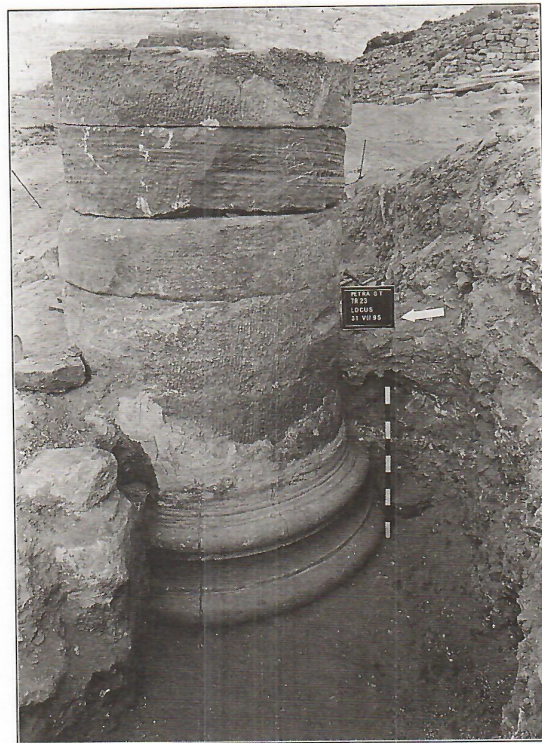
16. Pronaos West Column, looking east (Photograph by A. A. W. Joukowsky).

In Phase Vc the Pronaos plan was clarified. Resting on finely carved Attic bases were massive interior temple columns (Fig. 16) which we have identified with the original Temple construction.<sup>50</sup> Both sandstone columns were supported by well-preserved limestone Attic bases, 2.10m in diameter, carved in two pieces and perfectly preserved to a 0.70m height.<sup>51</sup> The Attic bases rested on leveling blocks, and their elevation confirmed the Pronaos was at the same elevation as the Stylobate. The West Pronaos column's top elevation was 888.64m and its founding

elevation, 886.00m.<sup>52</sup> Traces of white and red stucco up to 11cm in thickness still adhered to the lower diagonally dressed column shafts.

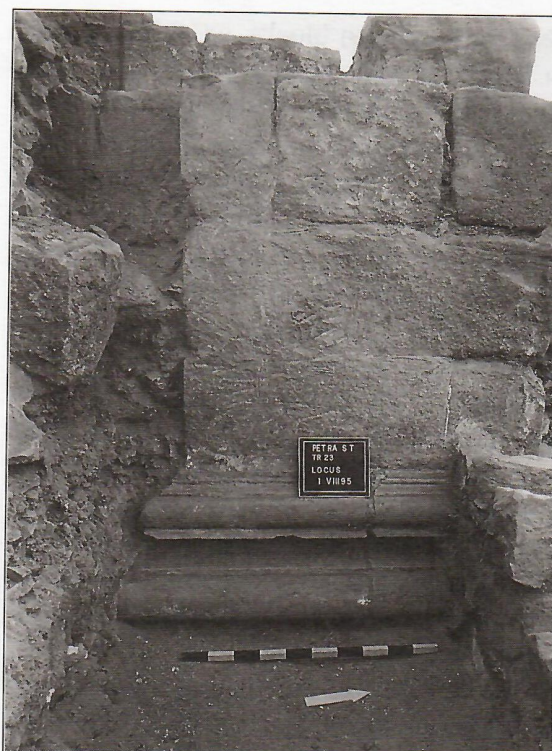
17. Pronaos West Anta (Photograph by A. A. W. Joukowsky).

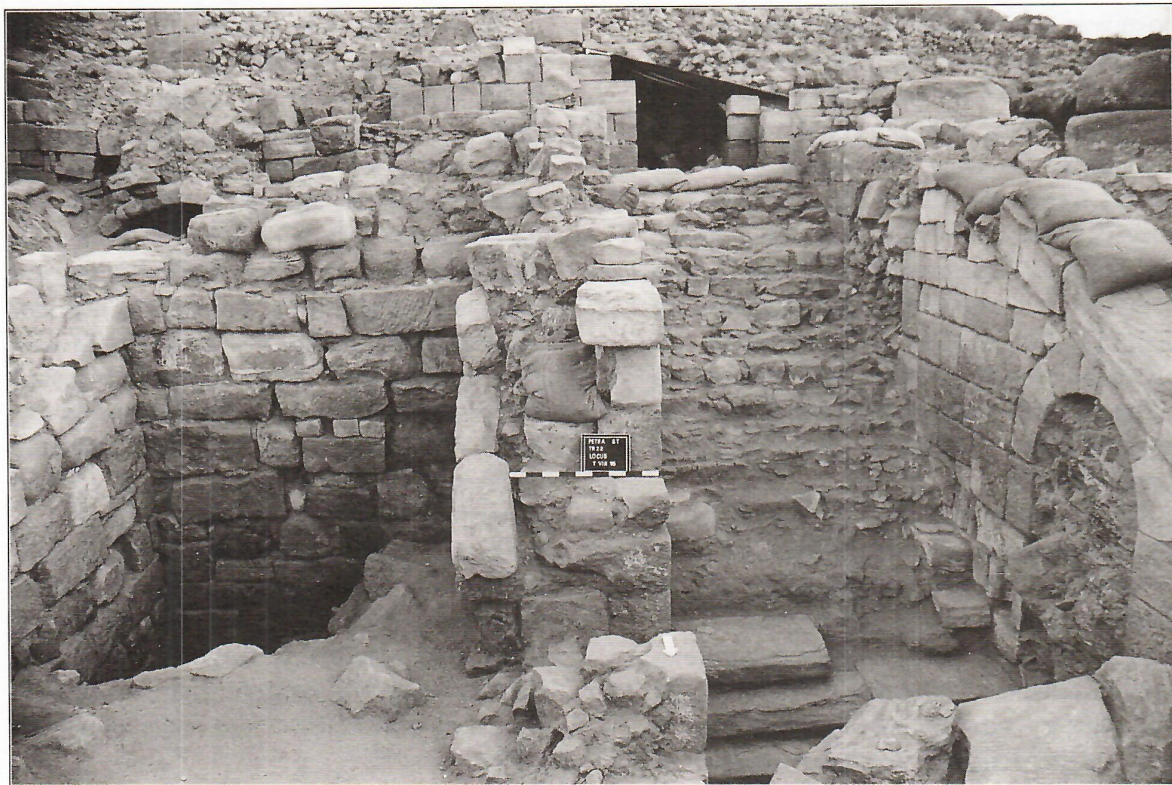
18. Adyton West Stairway and West Vaulted Room, looking south (Photograph by A. A. W. Joukowsky).

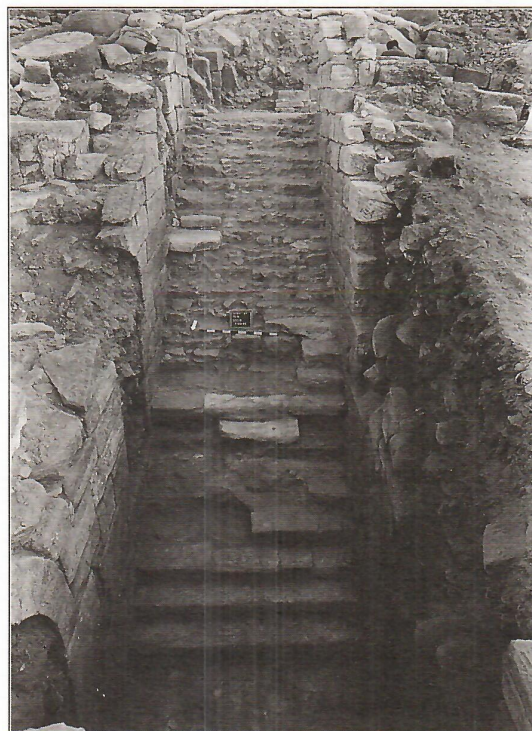
19. Adyton East Stairway, looking south (Photograph by A. A. W. Joukowsky).

shown in (Fig. 19). At a later date, in Phase VIb, there was the re-building of the upper courses the West Adyton as well as other interior walls. Phase VIIb was a period of abandonment with a level of clean fill just above the floor surface; Phases VIIc-VIIId were a series of destruction/collapses, the robbing out of floor pavers; the subsequent accumulation of fill and topsoil occurred in Phases VIII and IX. Each of these phases is briefly discussed with emphasis placed on the more completely excavated West Adyton.

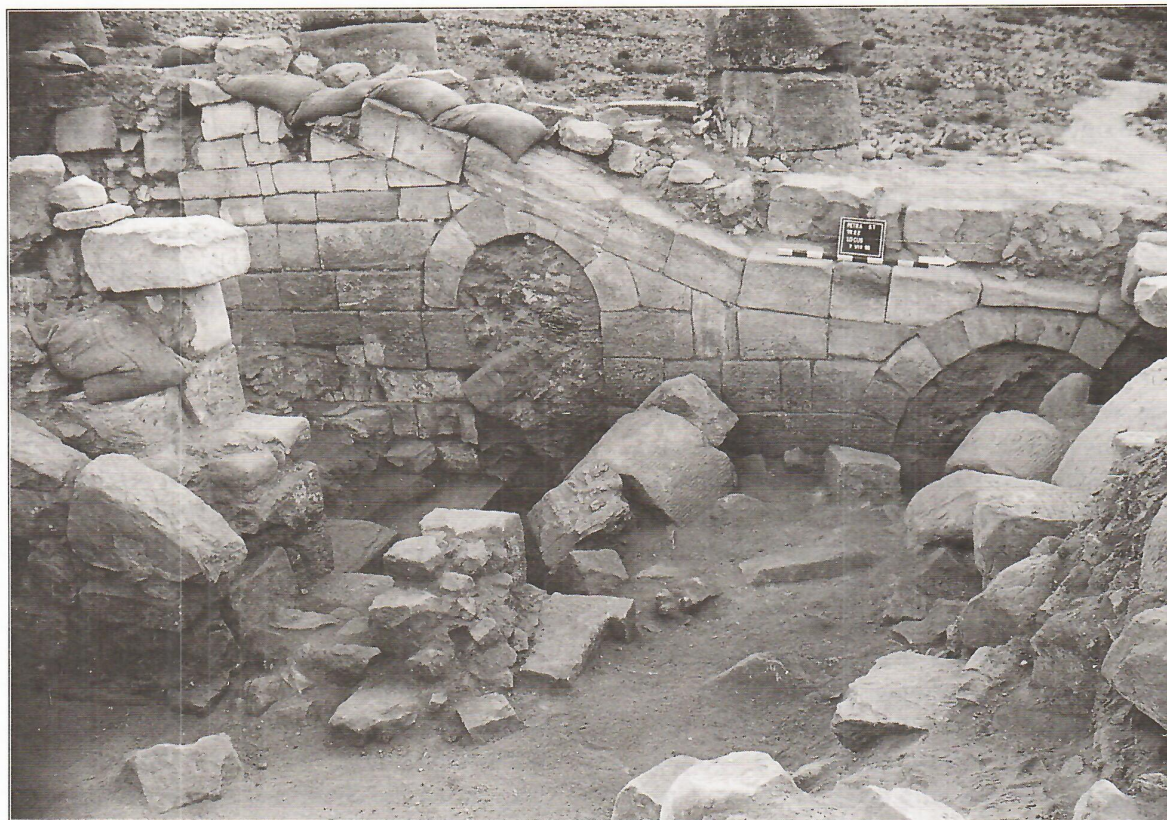
20. Adyton West Stairway with arched window and door, looking west (Photograph by A. A. W. Joukowsky).

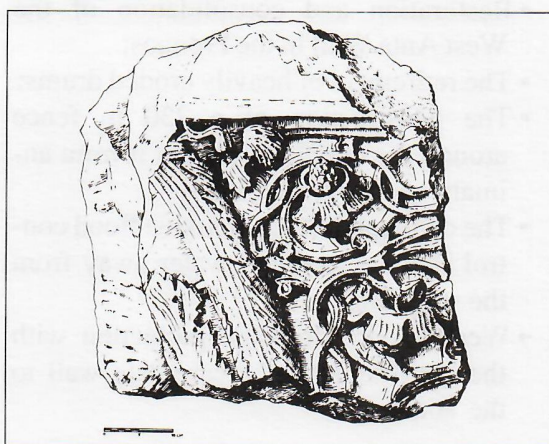
21b. Capital fragment (Drawing by J. Blackburn).

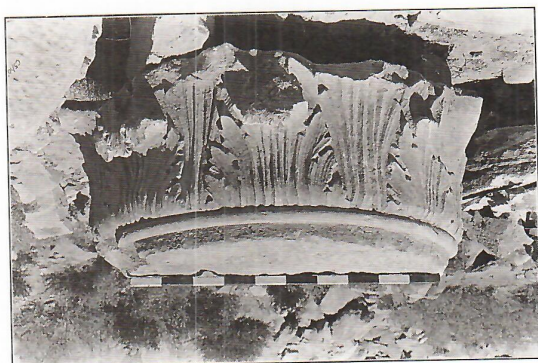
23. Lower order of capital with acanthus leaves found in the West Adyton (Photograph by A. A. W. Joukowsky).

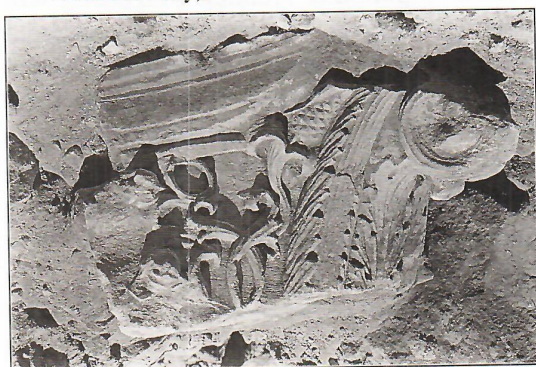
24. Cella Capital (Photograph by A. A. W. Joukowsky).

Other artifactual materials in our computer data base include Nabataean, Late Nabataean, Roman red wares, and Byzantine ceramics — lamps, coins, bone, glass, metal, tesserae, and fragments of molded stucco and painted plaster. But the continued recovery of hundreds of architectural fragments delicately carved with complex floral and fruit designs continues to be overwhelming. The excavation of the West Adyton was made burdensome by the large number of architectural elements, including what we posit may be a complete capital from the Temple Cella Colonnade. The lower order of acanthus leaves (Fig. 23) was sculpted in two parts, and the upper order of crisp floral and

fruit motifs was recovered in four parts, one of which is shown in Fig. 24.
