A PRELIMINARY NOTE ON THE WĀDĪ MŪSĀ SALVAGE EXCAVATION 1996

The opening in February 1996 of a side street through the triangle formed by the main roads in the centre of Wādī Mūsā next to the Arab Bank building revealed the existence of ancient structures in the area. This new street leads to Al-'Anbāt II Hotel that was then still under construction. The pit for the septic tank of the hotel also revealed the corner of a Nabataean water cistern. Excavations were conducted by the Department of Antiquities from 25 February to 12 June 1996 in two areas: Area I included the cistern and area to the south; Area II at the road cut was 31m to the north of Area I. The team consisted of Khairieh 'Amr, director; Sami Al-Nawafleh and Hani Qrarhi, excavators; Luay Mohamadieh, draughts-person and surveyor; Tawfiq Hunaiti, conservator assisted by Qais Tiwaisi and Bilal Al-Salamin, with logistic support from the Petra Antiquities office. Conservation of metal artifacts was done by Ibrahim Haj Hasan and Adel Tushan, and photographic processing was done by Salem Da'ja and Osama Jaber.

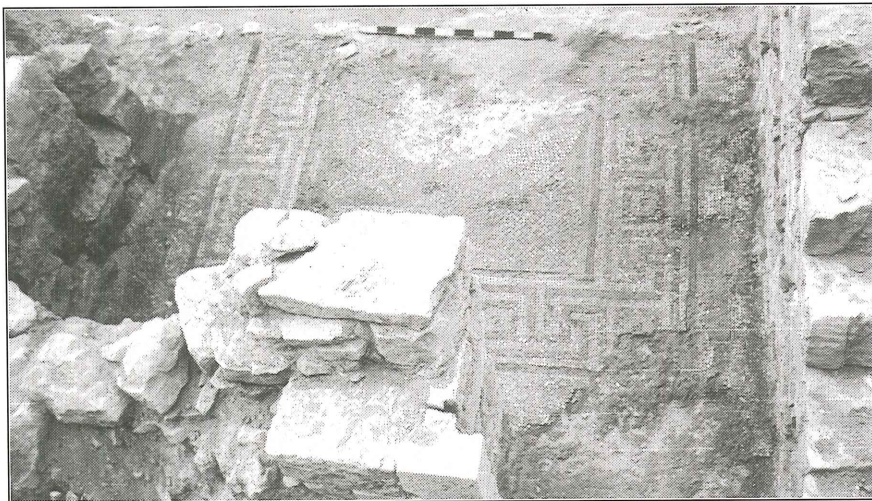
4. Late first century AD mosaic in the Nabataean villa.

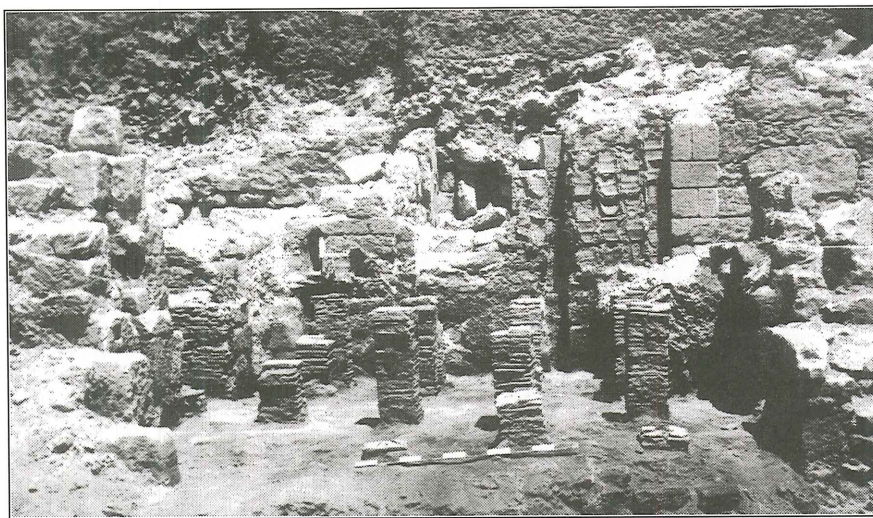
5. The *caldarium* of the bath complex in the Nabataean villa.

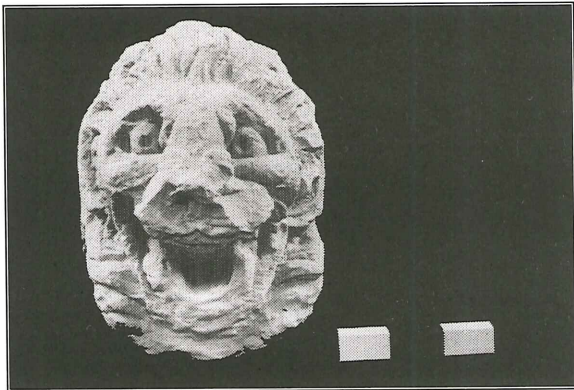
6. Lion head fountain found adjacent to the bath complex in the Nabataean villa (Photo: S. Lapedjian).

As for the plan of the villa (cf Fig. 2), the entrance in the south leads into a large hall (*atrium*) with a flagstone pavement having a central square of hexagonal pavers surrounded by columns. Architectural-style frescos in bright colors of crimson red, golden yellow, olive green, greyish blue as well as black and white decorated the east wall, where an entrance led to another frescoed room, now left intact under a traditional house. An entrance to the north led into another frescoed room (with lively designs of green grasses, bunches of grapes and olive branches). To the west of the hall, there was a latrine and corridor, in which was found decorated blocks including a relief of Helios-Apollo. A corridor leading north from the hall opened onto a room to the west, with a mosaic floor of geometric designs in white, black, yellow and red (Fig. 4), then onto a bath complex. Adjacent to the mosaic room was a room having a *tersia di marma* floor (the *apodytarium*?) leading onto the *caldarium* (Fig. 5). Unfortunately, the furnace was destroyed by the new street. North of the *caldarium*, a large room with flagstone paving had a *ṭabūn* oven, and a complex drainage system under the pavement connecting to the *caldarium* and areas to the north and east. Fine Nabataean bowls were found on this pavement, as well as a limestone "lion head fountain"

(Fig. 6). A corridor north of this room had several cooking pots smashed *in situ*. A large hall occupied the northern exposed end. Its southern wall, exposed to a length of 7.50m E-W, had remains of frescos on its
