PRELIMINARY REPORT OF THE AL-ḤUMAYMA EXCAVATION PROJECT, 1995, 1996, 1998

John Peter Oleson, Khairieh 'Amr, Rebecca Foote, Judy Logan,
M. Barbara Reeves and Robert Schick

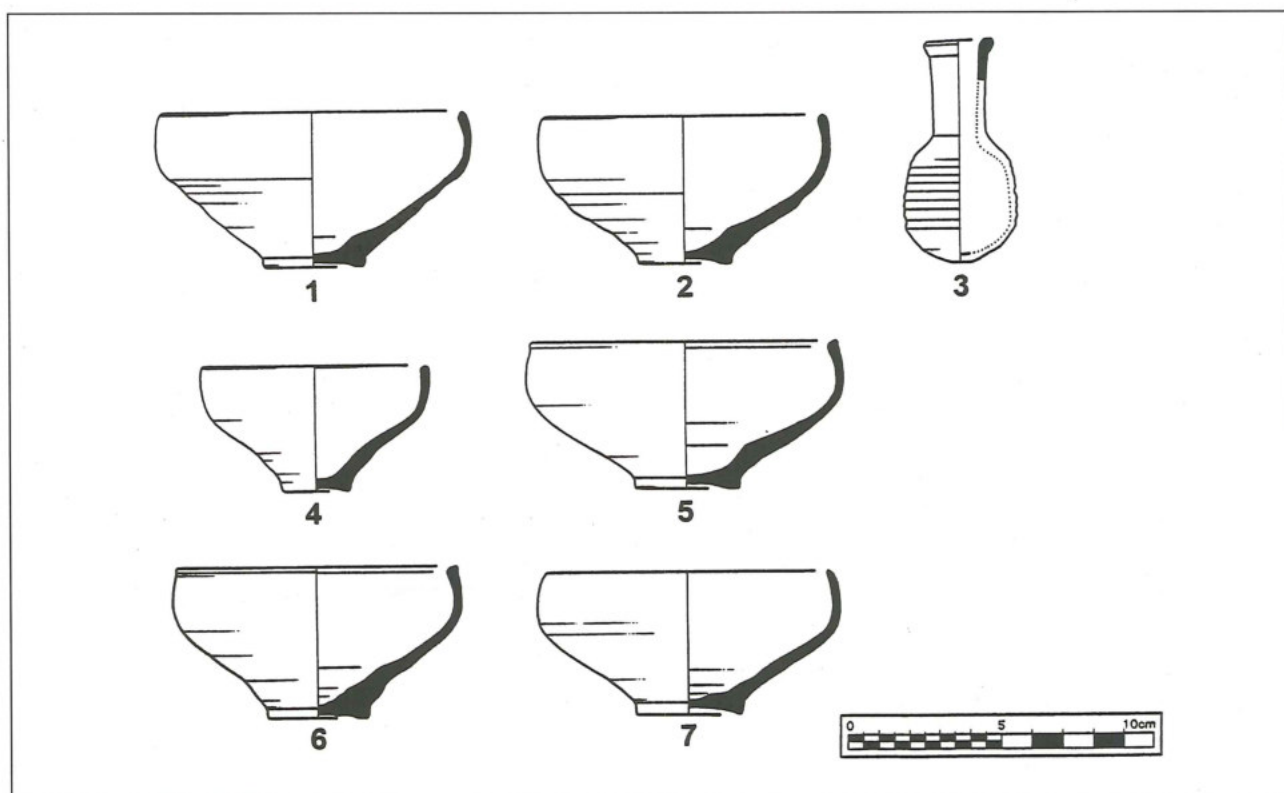
2. Ceramic objects from C124 (drawing by C. Mundigler and Q. Tweissi):

1. H96.0005.01; C124.01.04. Cup with string-cut base, complete and intact. Exterior and interior: 2.5YR 6/6 light red. Many sand and some mineral white inclusions, causing some bloating;

5. H96.0010.02; C124.01.08. Cup with string-cut base, part of rim missing. Ware, exterior and interior: 2.5YR 6/8 light red, medium core: N5/0 grey. Few sand and mineral white inclusions;

7. H96.0011.01; C124.01.09. Cup with string-cut base, part of rim missing. Ware: 2.5YR 5/4 reddish brown, wide core: N4/0 dark grey; exterior: 2.5YR 5/4 reddish brown with patches of 2.5YR 4/2 weak red and 2.5Y 7/4 pale yellow; interior: 2.5YR 5/4 reddish brown with striations of 2.5YR 5/2 weak red. Some sand and many mineral white inclusions, causing some bloating.

of Nabataean ceramics, including numerous intact or restorable vessels, mainly small bowls with string-cut bases, along with part of a lamp, and a small piriform unguentarium (Fig. 2:3).

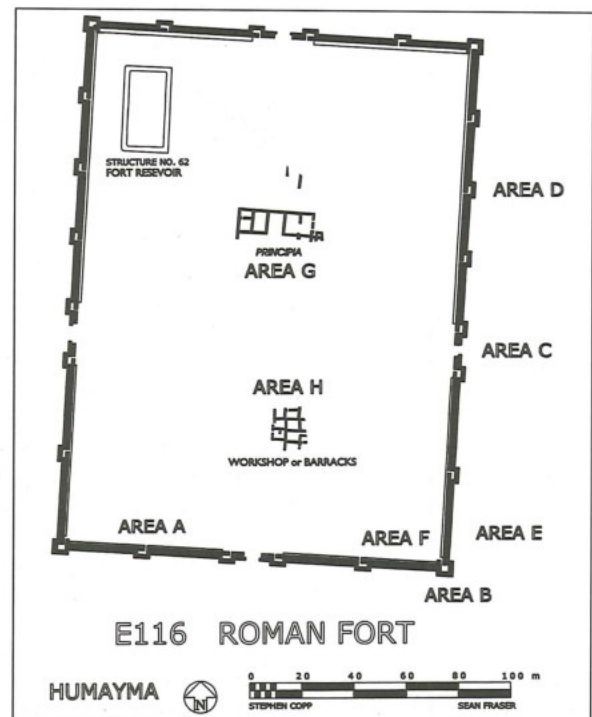
3. E116: overall plan of fort.

The large Roman fort at the very north edge of al-Ḥumayma is one of the most prominent archaeological features at the site (Fig. 1). It has the typical rectangular plan of Roman forts (206.32 x 148.30 m, or 700 x 500 Roman feet), with a gate in each of the four walls, and virtually all the dimensions can be expressed in rational numbers of Roman feet. The entire plan is rectilinear and carefully laid out, but skewed nine degrees east of magnetic north (Fig. 3). Prior to our first campaign in 1993, the only feature clearly visible was a large reservoir in the northwest corner (29.40 x 14.20 x 3.05 m, or 100 x 50 x 10 Roman feet), fed by the Nabataean aqueduct via a branch line. Probes were carried out around the reservoir in 1987, but could only verify a period of Byzantine occupation (Oleson 1990: 160-62). The location of Ḥawar (also called Auara or Havarra in the Roman period) on the *Via Nova Traiana* and its isolation in the Ḥisma, suggested that the fort might date early in the history of the *Provincia Arabia*. Excavation in 1993 was designed to provide in-

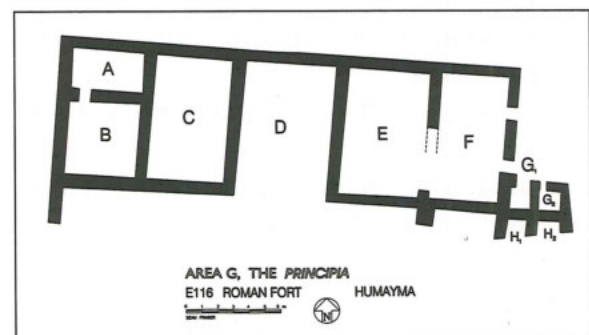
4. E116: plan of Area G, the *Principia*.

In Phase I, the *Principia* consisted of a row of rooms 29.42 m (100 Roman feet) long defining the north end of a rectangular courtyard (not yet excavated) (Fig. 4). The east and west side walls of the *Principia* continue south to frame the courtyard, probably serving as the back walls of two north/south colonnades. Many column drums (averaging 0.54 m diam.) cut from the local white sandstone are found reused in Phase II constructions in the *Principia* and elsewhere around the fort, and the parade ground is an obvious possible source. This colonnade probably passed in front the *Principia* façade, then turned to the south on line with the first crosswall in from either end of the main building, resulting in a courtyard 17.70 m (60 Roman feet) wide (measured from the column axes). A parade ground twice as

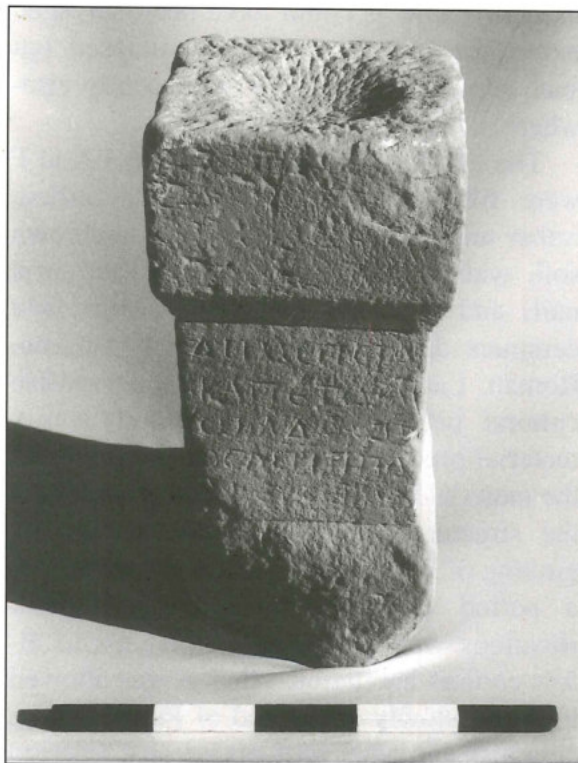
Two inscribed sandstone altars or statue bases with square bodies (0.27 m sq.) flaring to a wider base and top were found in the rubble fill in Room F. One base (95.0599.01) was standing upright next to the Phase II door the east wall of the room, but it was broken and incomplete (H 0.36 m), probably indicating reuse. A Greek inscription was carved in careless letters ca. 0.02 m high: CΩTHP.../ΠIPΩTON.../THN ANEΘHKEN... A steep-sided, shallow oval recess was carved in the upper surface, probably the base for the statue of the political or religious image mentioned in the dedication. A second altar, of identical design and dimensions, but complete (H 0.60m) was found in the rubble fill of the room (Fig. 5; 95.0596.01). A shallow oval recess was pecked into the upper surface, either for a statue base or for offerings. The inscription, which begins ΔΠ ΜΕΓΙCΤΩ / ΚΑΠΙΕΤΩ [ΑΙΝΩ]? / ΗΑ[ΙΟΠΟΛΙΤΗ]/..., may dedicate the altar to Jupiter Heliopolitanus (cf. Rey-Coquais 1967: 59-64, nos. 2728-31,

5. E116: inscribed altar from Area G.

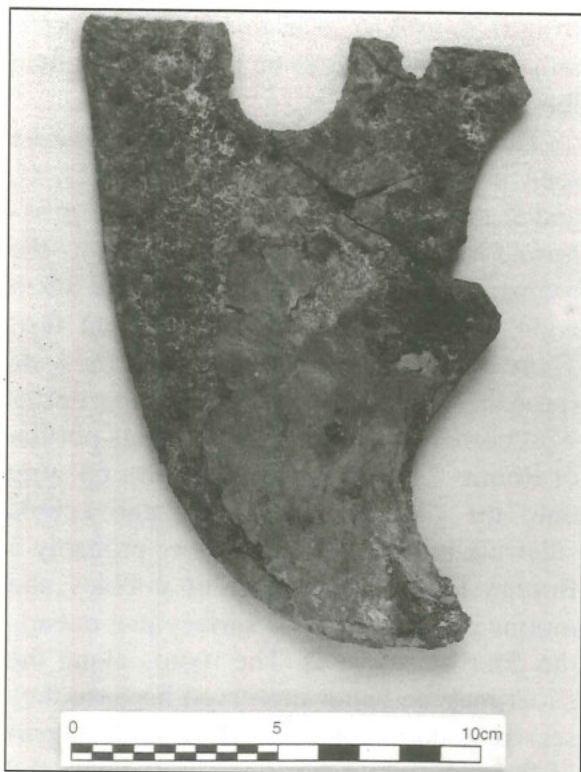
7. E116: cheek piece of helmet, found in Area H.

Room D is the most interesting in the complex. Although we expected the warren of rooms in Area H to be a military barracks, a forge had been installed in Room D, which seems incompatible with sleeping quarters. A thick layer of soft black ash (from charcoal?) covered the paved floor, incorporating small (D 0.08 m), bowl-shaped forging blooms—formed during the working of iron rather than during its refinement. The ash layer concealed hundreds of iron and copper artifacts, apparently mostly scrap metal meant for re-working or resulting from repair: buckles, three-bladed arrow heads, spear points and butts, sections of scale armour, hobnails for boots, and the cheekpiece of an iron helmet, with fragments of leather still adhering to its inside surface (Fig. 7). The presence of a bronze

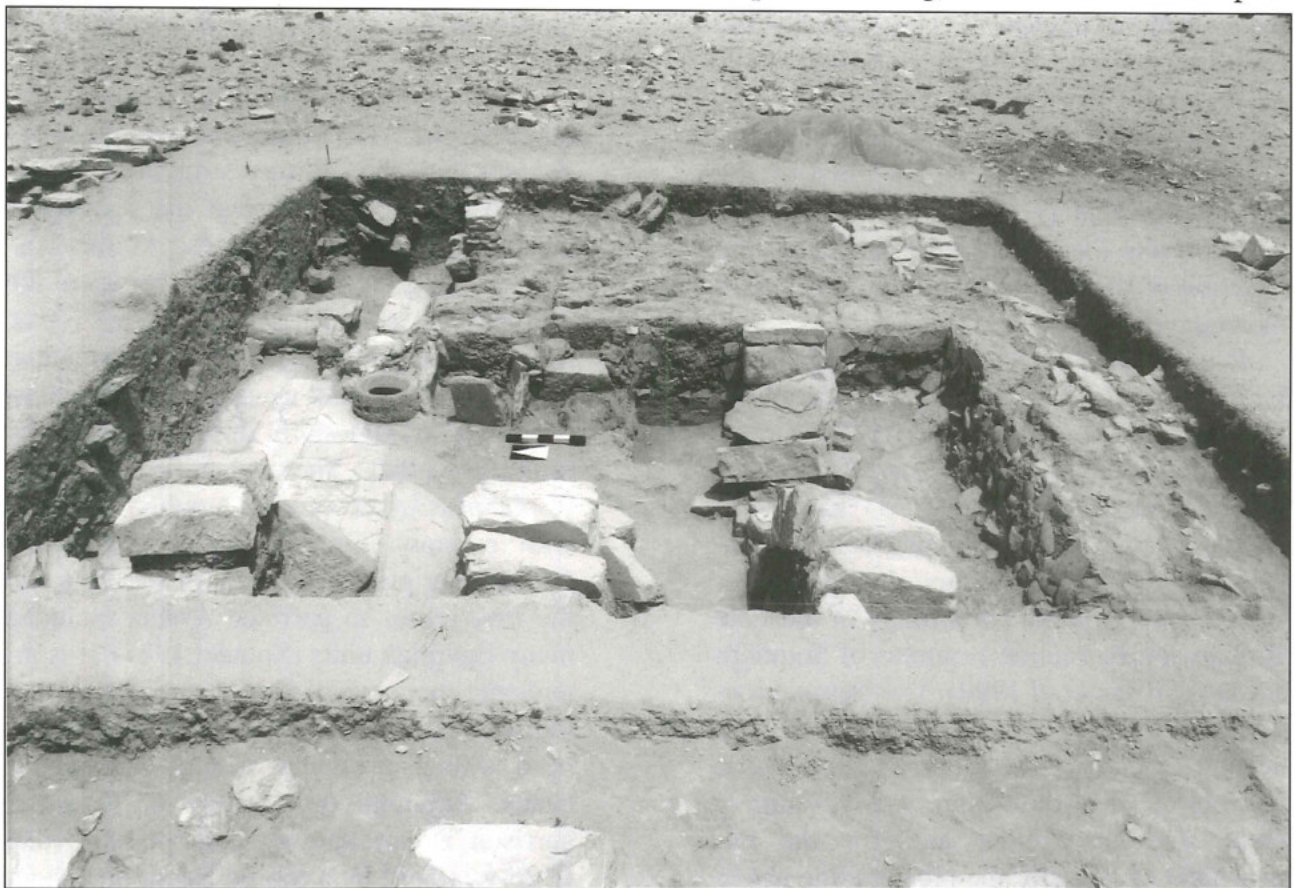
10. E125: Room A (foreground), Room G (background), to east.

Phase II. Major renovations were made to the building during Phase II, but carelessly executed. Many of the mudbrick walls were repaired or reinforced on one or both sides with facings of pottery or cobbles held in place by mudplaster. The north face of the south wall of Room A was faced with

large potsherds set in mud (Fig. 10). Other sections of the walls (often adjacent to renovated sections) were not repaired, but the wall decoration (both figured designs and red lines/daubs) were covered with white-wash. The flagstone pavers were taken up in the southern halves of Rooms A and D.

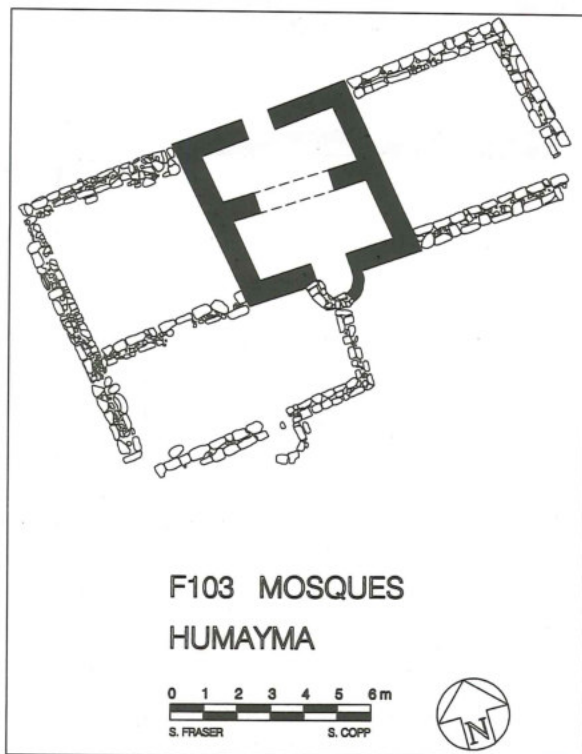
17. F103: plan of Mosques.

referred to as Mosque 02). Mosque 02 is rectangular, measuring roughly 7.50 m x 4.00 m, its north wall formed by the south walls of the west pen and of the original mosque. The other three walls survived to only one course of facing blocks and a rubble core. Although at present the remains resemble those of the open-air mosques well-attested in the Ḥisma and the Negev from the early Islamic period to the present (Finkelstein 1995: 19-21; Sharon *et al.* 1996), the wall construction seems too solid. Further examination is needed. Curiously, its east wall abuts the *miḥrāb* of the original mosque, thereby creating a convex northeast inside corner. The *miḥrāb* of Mosque 02 is 1.03 m wide, 0.75 m deep, positioned slightly west of the center of its south wall (3.40 m from the west wall and 4.43 m from the east wall). Although one block in the southwest corner was oriented perpendicular to the others, no door or doorsill could be identified. Because the walls of Mosque 02 clearly abut the original *miḥrāb* and the west “pen,” it is certainly later than both and indicates a third phase of use (Phase III). Foundation pottery for Mosque 01 was scant and inconclusive, with all sherds very small and non-diagnostic.

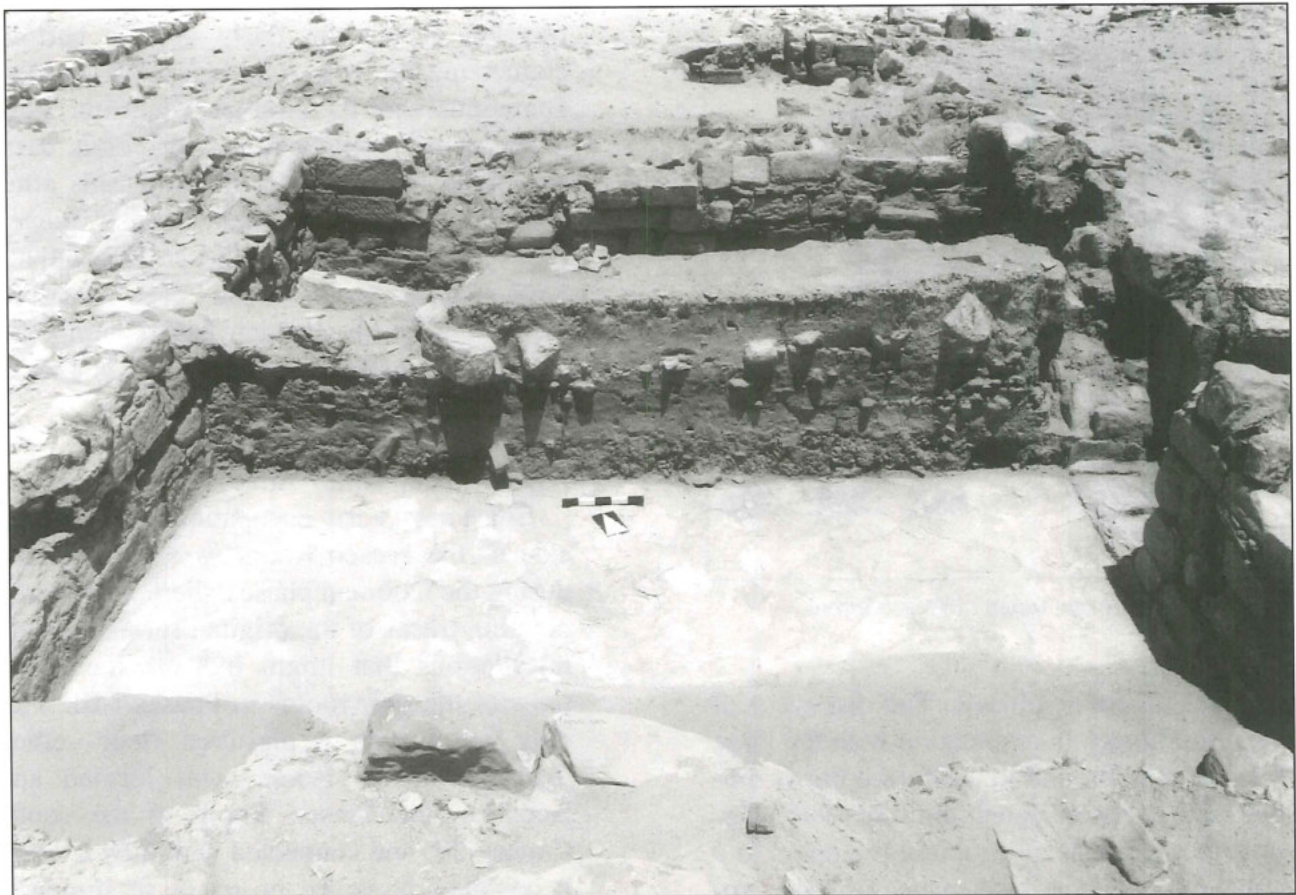
19. F103: Fresco Room, to north.

Painstaking excavation in the "Fresco Room" (Room 02, originally Probe 02) over the last three campaigns has allowed recovery of thousands of fragments of both collapsed wall fresco and ivory veneer panels, plus charred woods, iron nails and fasteners, fine glassware, carved steatite, and an ostrich eggshell vessel painted in red tendril motifs (Foote and Oleson 1996; Foote 1999). All come from the deepest deposit (Locus 13), a destruction stratum caused by fire. The
