Roberto Franchi and Pasquino Pallecchi

The Wall Paintings at Petra and Bayḍa in Jordan: Mineralogical-Petrographic Study of the Causes of Deterioration and Proposals for Their Restoration

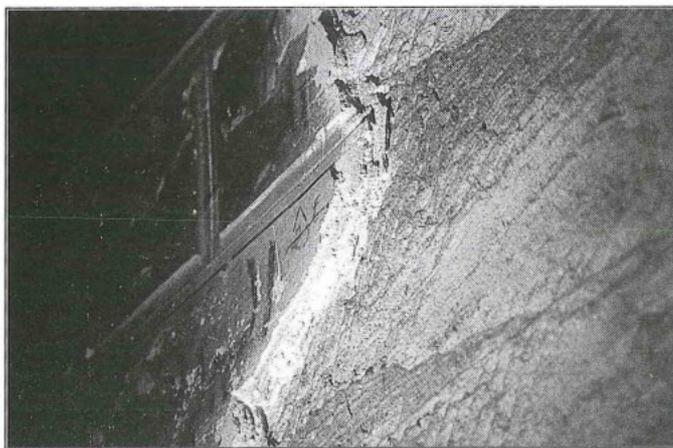
2. Petra frescoes. The triple layer of mortar and the layer of "coating" are visible.

The chamber concerned was dug out using a rather crude excavation technique utilizing a long-handled instrument. Deep curved furrows, irregular and often imbricated, are visible, indicating inversion of the working position (FIG. 1). The base for the paintings is formed by a triple layer of mortar (FIG. 2). The first layer in direct contact with the rock wall is of very uneven thickness and was applied for the purpose of smoothing out the irregularities in the walls. It is uneven, having not been smoothed on the outer face, and has a coarser structure than that of the two layers above it. The second layer has a quite even thickness of about 1 cm and the granulometry of the aggregate is finer and better sorted. The frescoed layer of mortar has a very even thickness of approximately 0.5 cm.

The state of preservation, even upon initial visual inspection, appears extremely precarious. In many zones the layers of mortar are peeling off from the walls. Parts of the frescoes are covered by a layer of straw mixed with small amounts of clay and dung. Where this coating is absent, the paintings are darkened, in some cases to the point of being indecipherable, by encrustations formed of

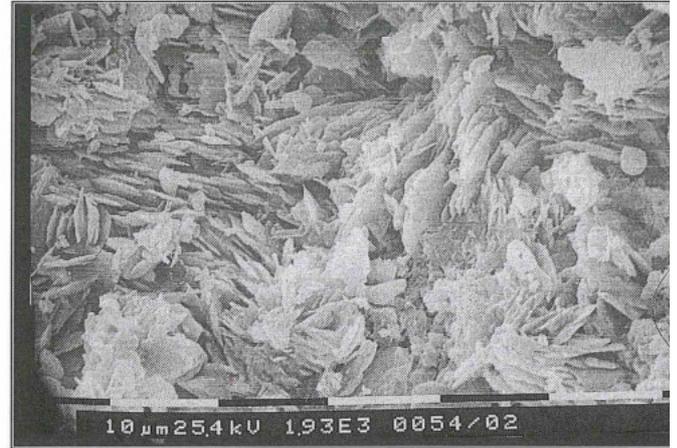
3. Closely packed microcrystals of calcium sulphate (SEM).

only due to the metabolic activity of lichens, but also through the oxidation of organic substances (proteinaceous) that may have been used as fixatives in mixing the colours. The efflorescence was found to consist of calcium sulphate (FIG. 3). This mineral is also present, in different concentrations, on all the surface samples, frequently in association with potassium nitrates (FIGS. 4, 5, 6). O

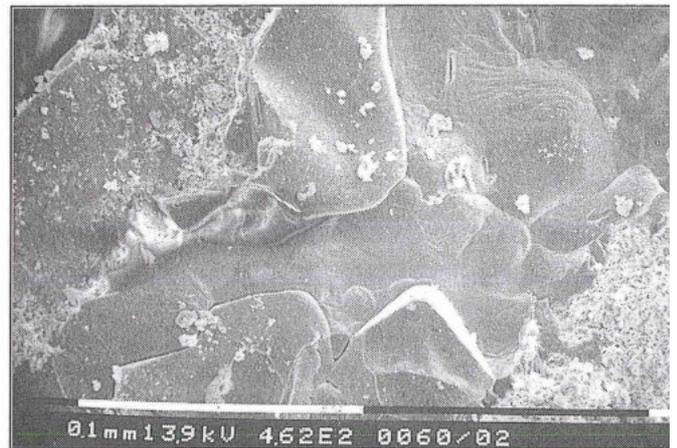
4. Association of calcium sulphate and potassium nitrate (SEM).

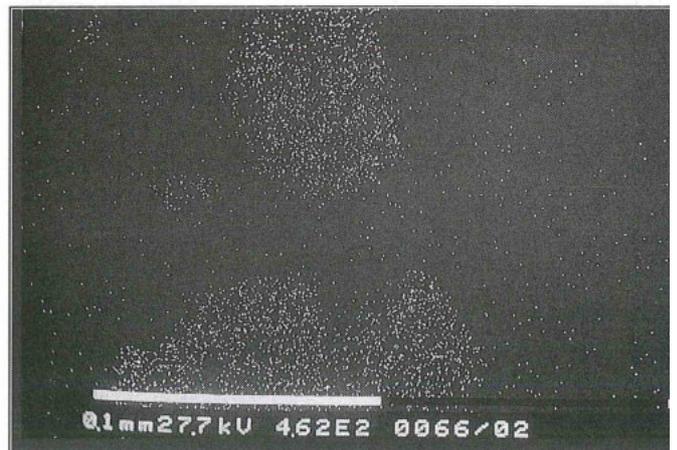
5. X-ray maps of sulphur executed on the same zone as that of FIG. 4.
