From Church to Farmhouse: The Re-Use of Christian Structures in Early Islamic Ḥumayma

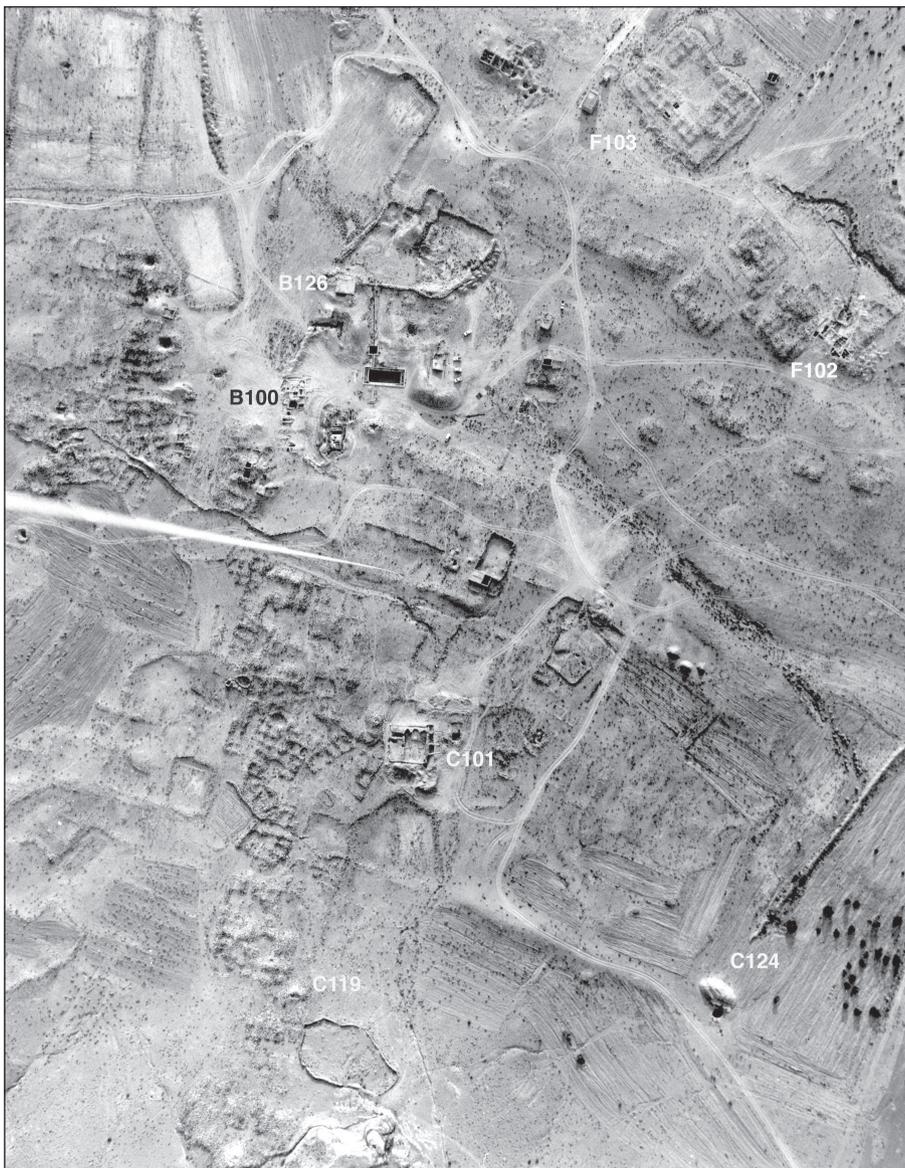
1. Aerial view of Ḥumayma with indication of church locations.

churches, designated C101, C119, B126, B100 and F102, were all most likely constructed over the course of the sixth century, the great period of church-building in the region, although the F102 and C119 churches may date as late as the early seventh century (Oleson and Schick 2013) (FIG. 2). The structures all fell out of use as churches in the course of the seventh century and their furnishings were salvaged, leaving only fragments behind. The C101 and C119 churches were essentially abandoned after being stripped; the B100 and F102 churches were re-used for habitation. The situation in the Early Islamic period remains uncertain for B126. The churches vary somewhat in plan and dimensions, but the types all find parallels in Jordan, Israel

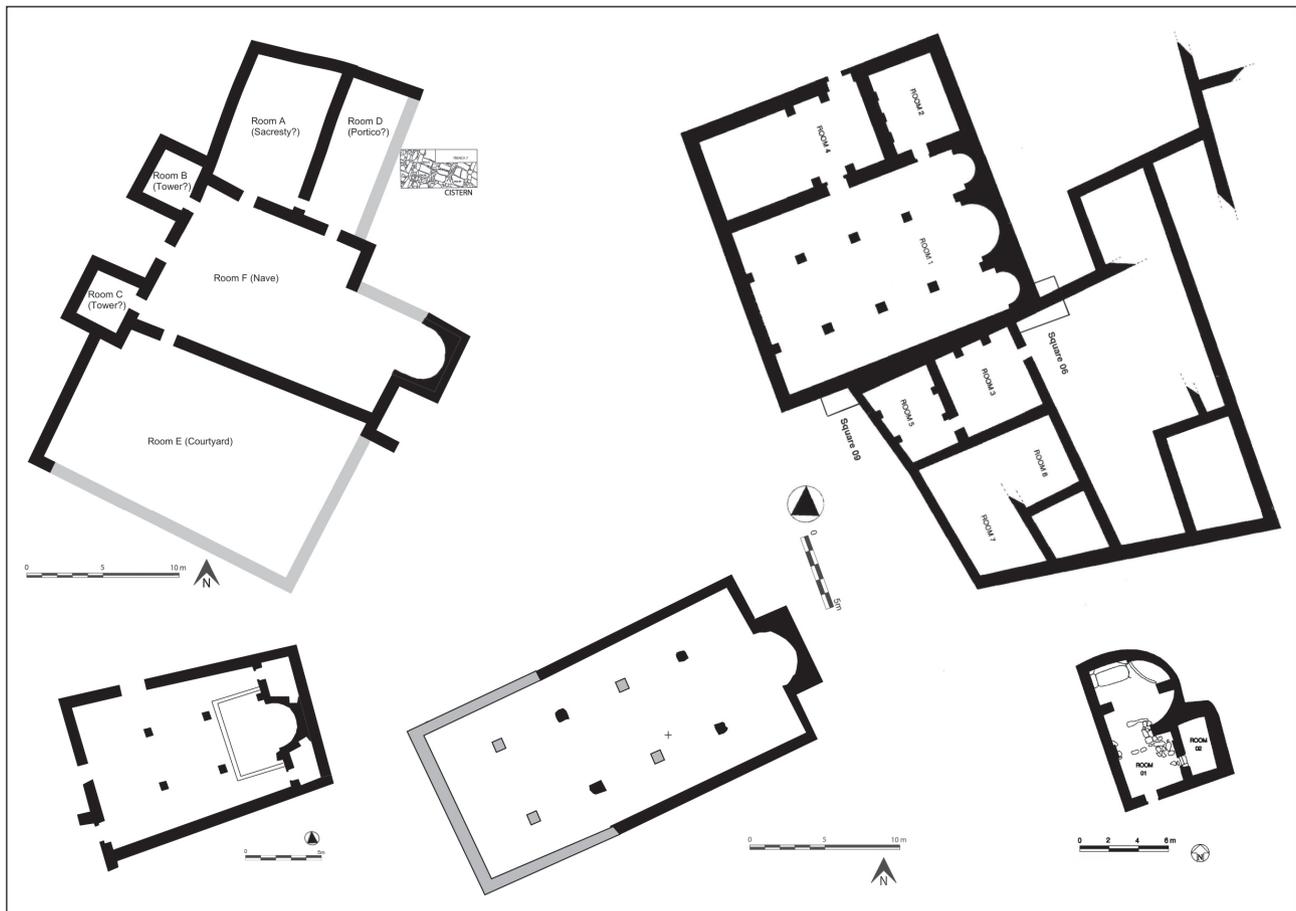
2. Composite plan of Ḥumayma churches.

This quick perusal of the five known Byzantine churches at Ḥumayma brings up a number of questions (FIG. 2). Why were there so many churches at this small, isolated site and what was the relationship between them, and among their clergy and congregations? Why were these particular plans chosen for

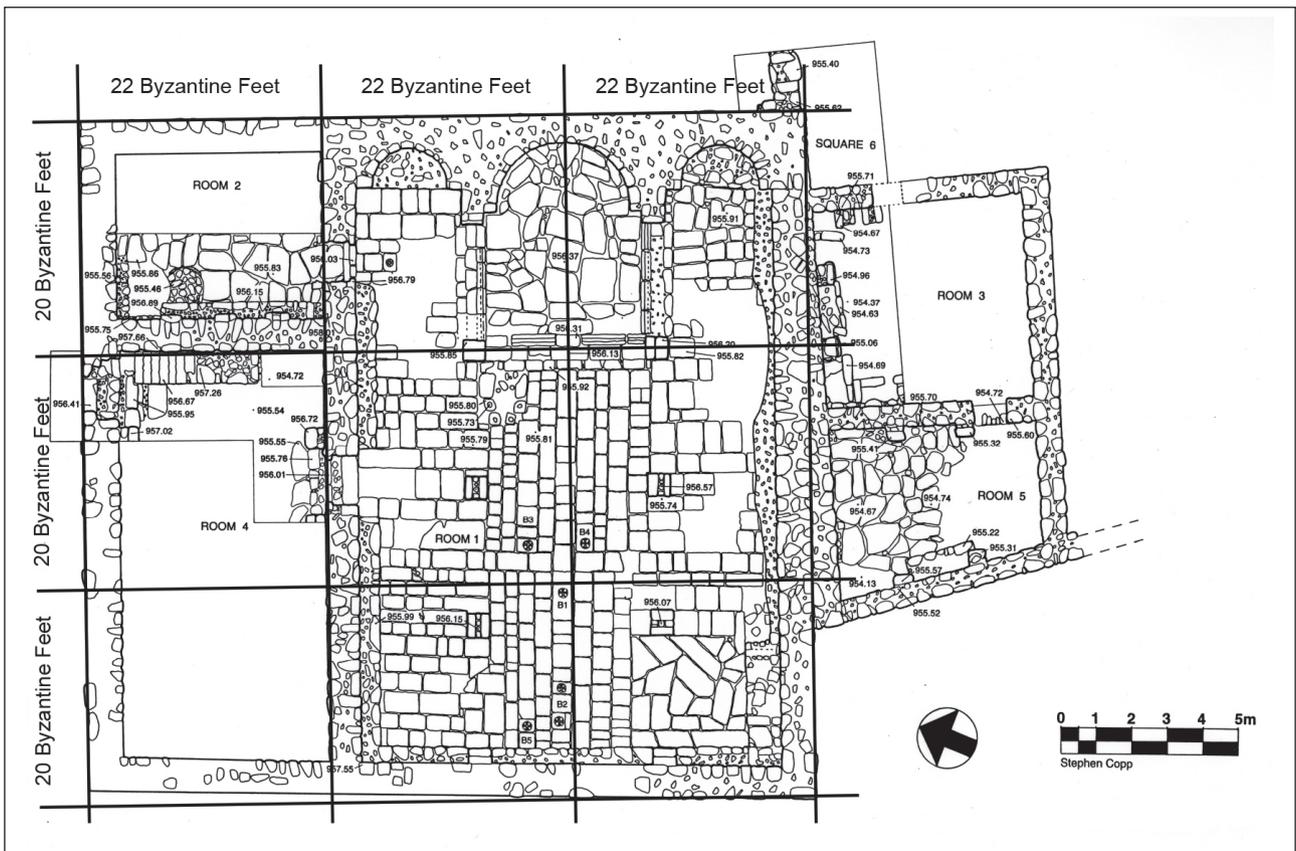
4. C101 church, plan with planning grid (S. Copp; J.P. Oleson).

The core of the church complex – the church, sacristy and entrance hall – were the result of a single construction phase. The planners laid out a nearly square outline, 60 Byzantine feet

to a side, which was divided into three east-west sections laid out in squares of 20 × 22 Byzantine feet (FIG. 4).

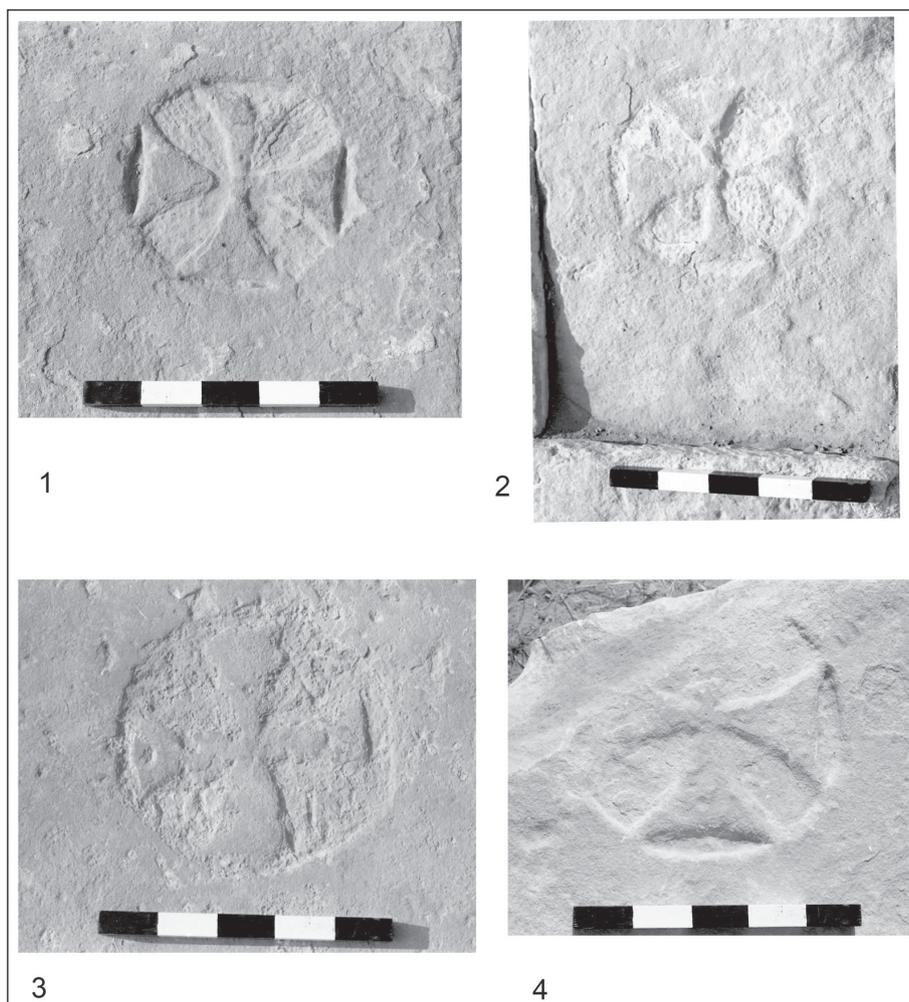
5. C101 church, crosses above Burials 4, 5 and 6.

although it did contain elaborate marble furnishings. At least seven burials were placed below the floor of the nave and side aisles, marked by crosses on the paving stones (FIG. 5). The church appears to have continued in use until around 650 AD, when the building seems to have been peacefully abandoned while still structurally intact. Later on, the marble and other liturgical furnishings were largely robbed out, and the marble broken up for burning into lime. This salvaging took place before the burning and fall of the roof, since some fragments from a single chancel screen were scorched, while adjoining fragments were not (FIG. 6) The only sign of re-use of the building is the installation of a *tābūn* oven in Room 2 during the Umayyad period.

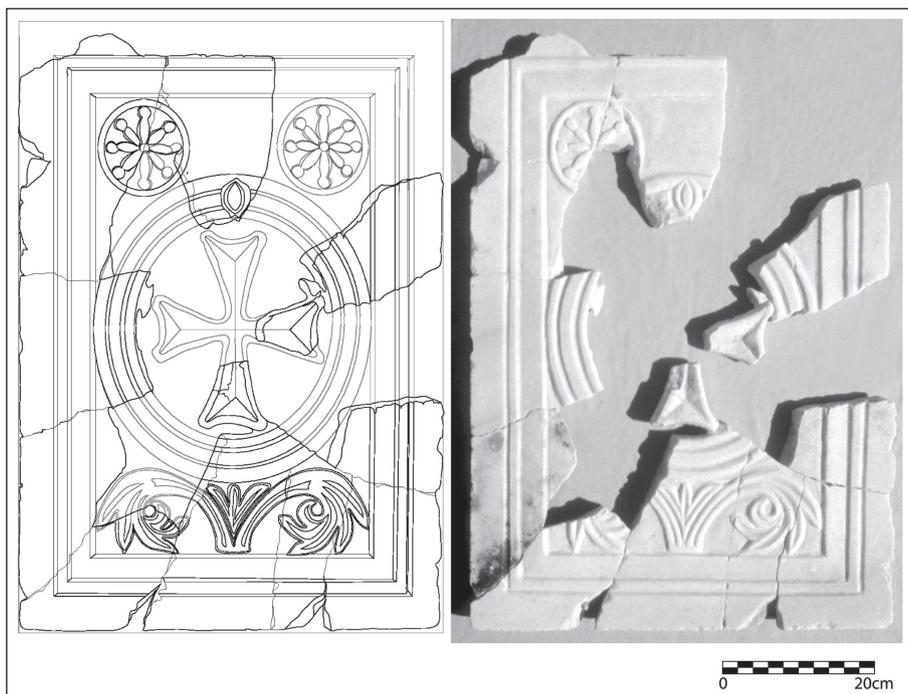
6. C101 church, chancel screen panel 1 (drawing M. Siklenka).

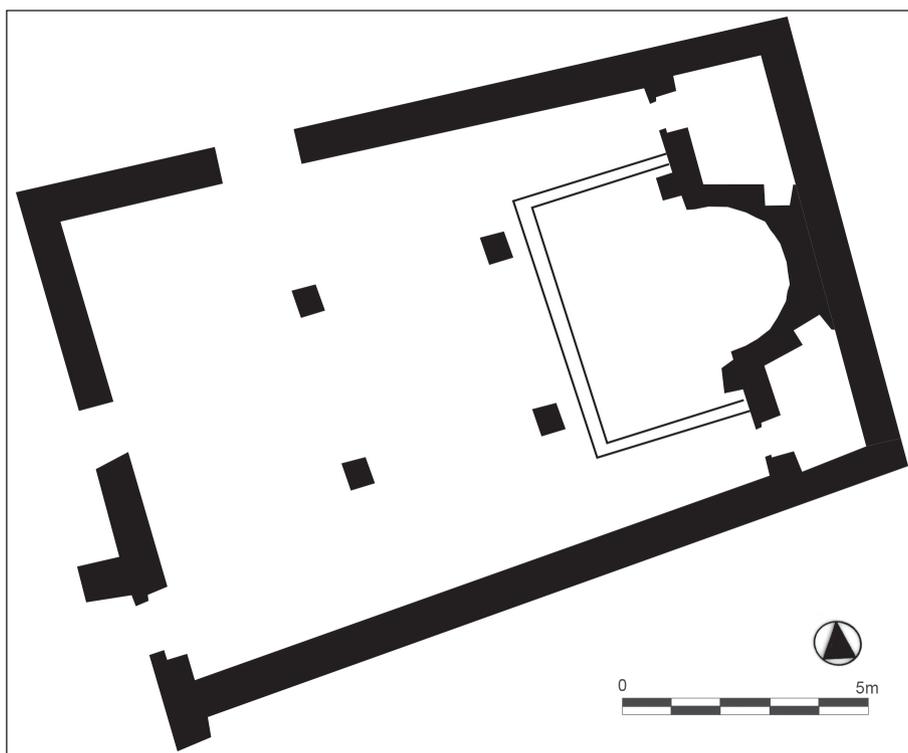
7. C119 church, plan.

visible from the east at a significant distance (Oleson and Schick 2013: 299-307) (FIG. 7). The C119 church is simpler in plan and somewhat smaller than the others, *ca.* 8.25 × 14.5 m, just above the usual dimensions for a chapel (Michel 2001: 17). With the possible exception of the chancel steps, all of the architectural features appear to belong to a single phase, dating generally to the Late Byzantine or early Umayyad period, *i.e.* the sixth or early seventh centuries. The building was a basilica with a single apse flanked by two small *pastophoria*, with its long axis oriented at about 72 degrees. There was a raised chancel in front of the apse, with a marble chancel screen. There was one door in the middle of the north wall, another door in the middle of the west wall and a third door near the south end of the west wall. There clearly are additional rooms to the south and west of the church, but their wall lines remain

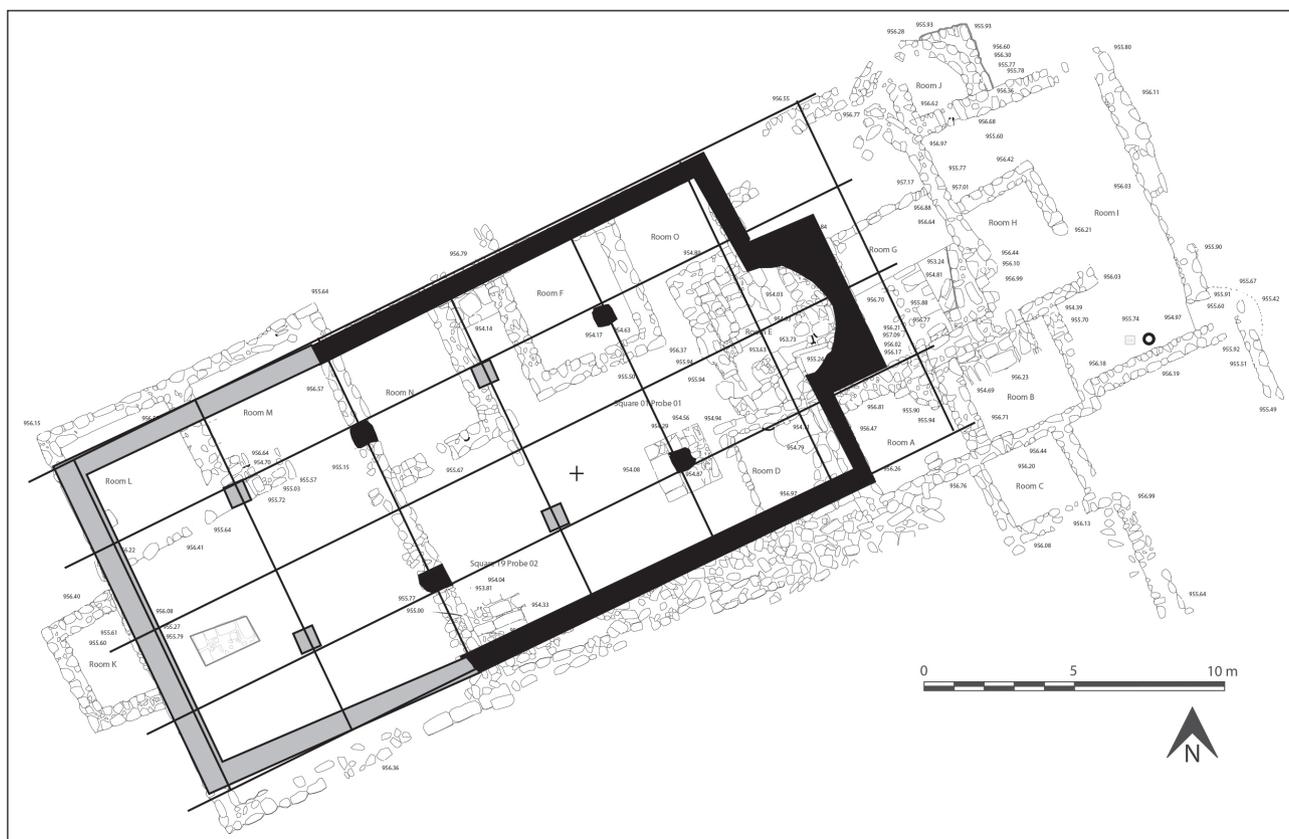
8. B100 church, plan with planning grid.

The B100 church had a central nave and two side aisles separated by block-built piers, and a single apse set into a block of masonry projecting from the east wall. The long axis was oriented at approximately 60 degrees (Oleson and Schick 2013: 161-220) (FIG. 8). The floor was paved

and Room O. The structure of the church was 12.75 m wide (external dimensions) and at least 19 m long. Unfortunately, several probes west of Wall 03 failed to discover any convincing evidence for the original west wall. It remains possible that the west wall of the Church lies beneath the west wall of the Umayyad complex, but that would produce an extraordinarily long and narrow plan. The church was laid out in blocks of 10×15 Byzantine feet.

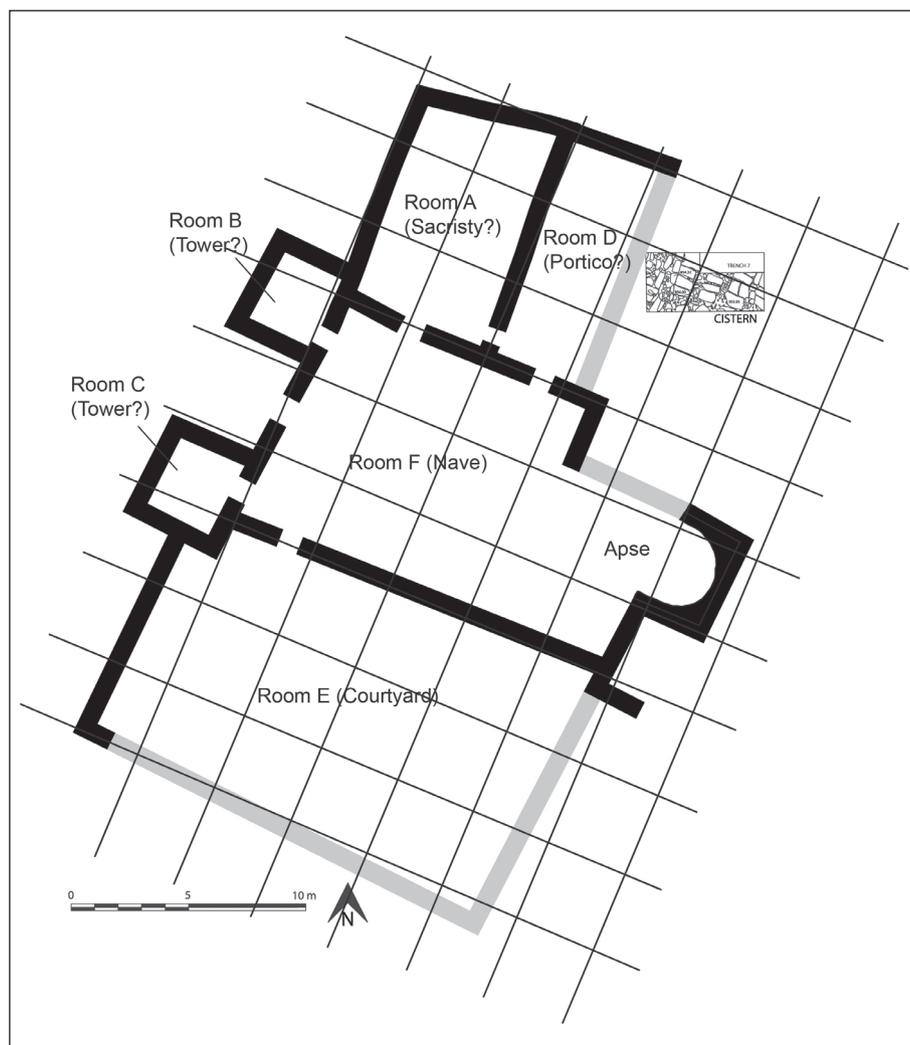
9. F102 church, plan with planning grid.

The church in F102 was at the core of a large complex, all the product of a single construction phase, laid out in squares of 10×10 Byzantine feet (Oleson and Schick 2013: 93-160) (FIG. 9). Unlike the other churches at Ḥumayma, for undetermined reasons it was oriented 20 degrees south of east. The nave and two side aisles were delineated by support piers and focussed on a single apse. There was a raised chancel in front of the apse and a flagstone pavement, which extended through the ancillary rooms and courtyards. The surviving paving in the apse reveals no evidence for installation of a

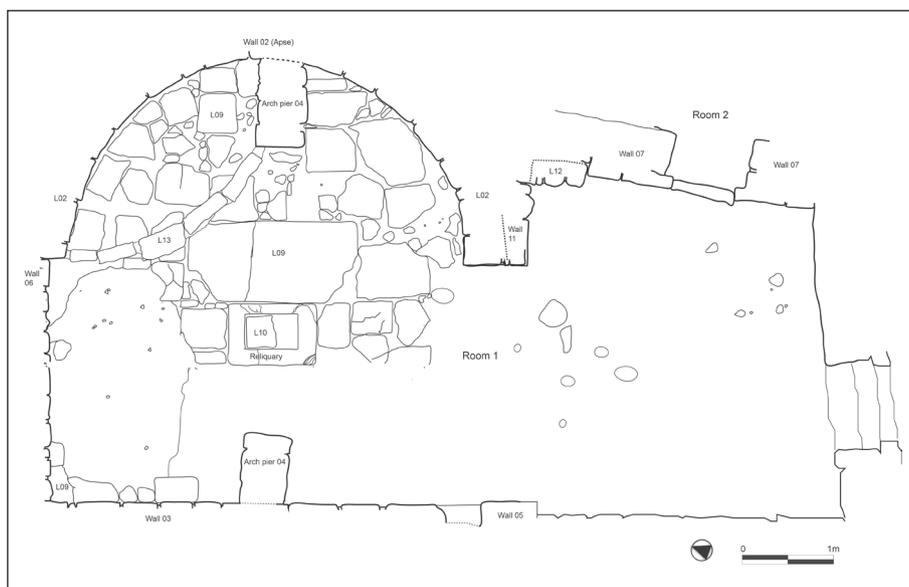
10. B126 church, plan.

by some clandestine digging since 1996. Schick was able to probe only the core of the nave, revealing a stepped chancel in front of an apse, all paved with stone slabs (FIGS. 10 and 11). Unique at Ḥumayma was a reliquary carved into a large stone slab, with access holes from the surface (FIGS. 12 and 13), but no remains of marble furnishings were found. No evidence was recovered that could serve to date the construction, use or abandonment of the church, beyond the generic designation that it must belong to the Late Byzantine or Umayyad period.

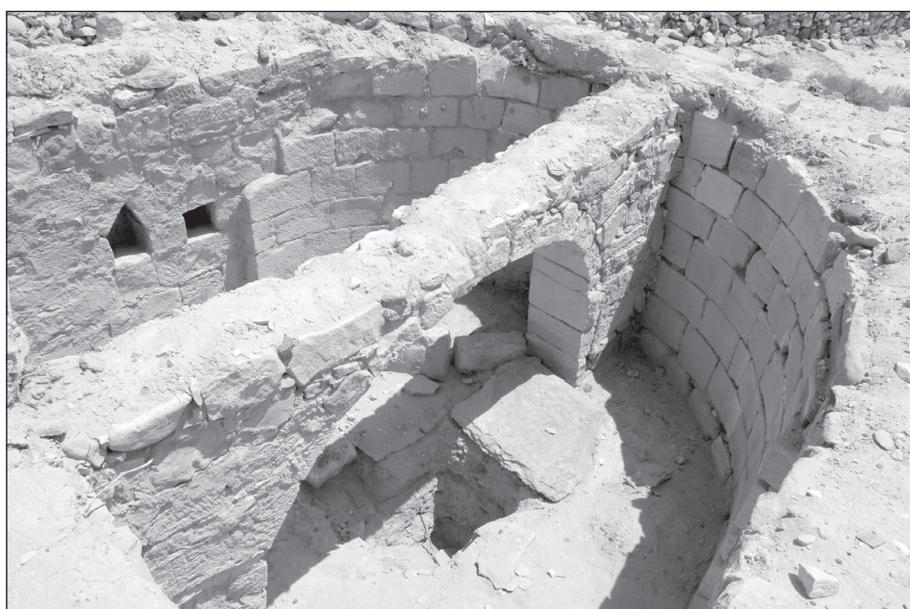
11. B126 church, view of central apse with modern roofing arch.

It is interesting that sometime after Alt's visit to Ḥumayma in 1935, *bedouin* roofed the apse of the Byzantine church B126 in just the same manner as the Umayyad inhabitants had roofed the apse of the B101 church, with an east-west arch springing from an impost built against its back wall (FIGS. 11 and 17). There are, in fact, numerous parallels of design and materials between the renovations of the Early Islamic period at Ḥumayma and those carried out by the *bedouin* during the twentieth century: the erection of transverse arches to carry roof rafters; the construction or re-use of doorjambs oriented so the doors open inward, often to steps leading down to a slightly subterranean floor; the construction of recesses in the walls to serve as cupboards; the assembly of upright slabs of stone next to the walls to serve as bins or earth-filled platforms; the walling up of doors to allow rooms to be filled with rubbish or to keep livestock out; and the installation of *ṭābūns* within rooms, either before or after abandonment. There are many parallels for these details in the early modern houses at Khirbat an-Nawāfla ('Amr and Momani 2011:368), 'Aima (Biewers 1992, 1993) and Khirbat Fāris (McQuitty and Falkner 1993). The arches and bins were characteristic enough to give rise to the modern term ‘arch and grain-bin house-type’, in which bins were

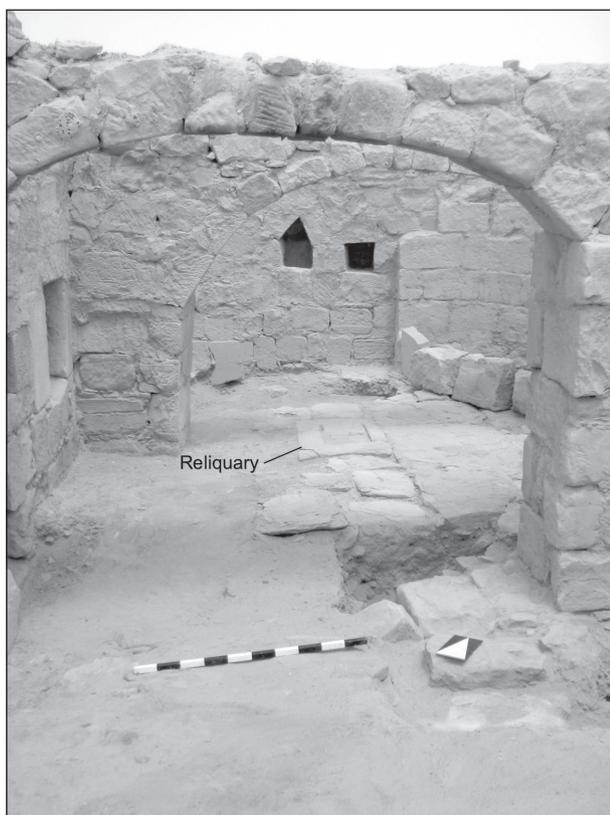
12. B126 church, view of chancel area with reliquary in situ.

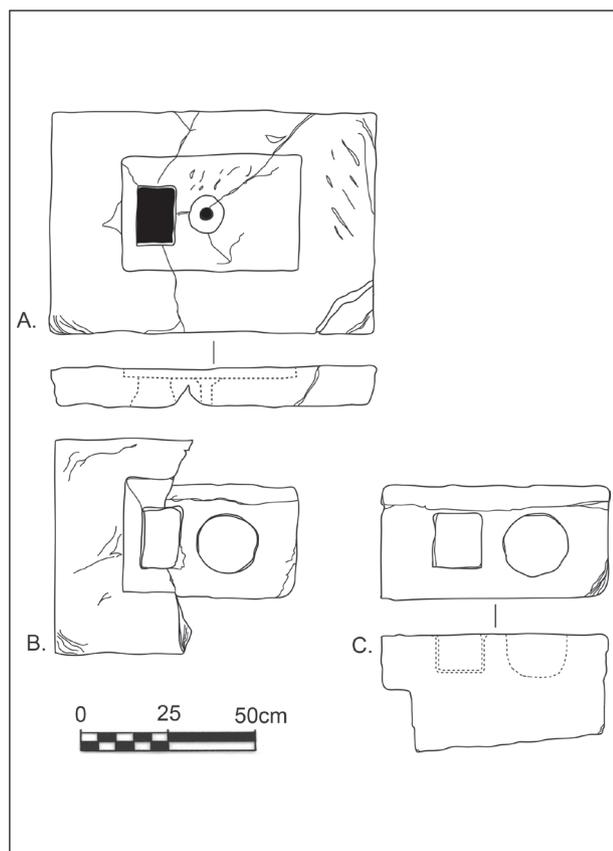
13. B126 church, drawing of reliquary (A. Heidenreich; I. Sturkenboom; M. Siklenka).

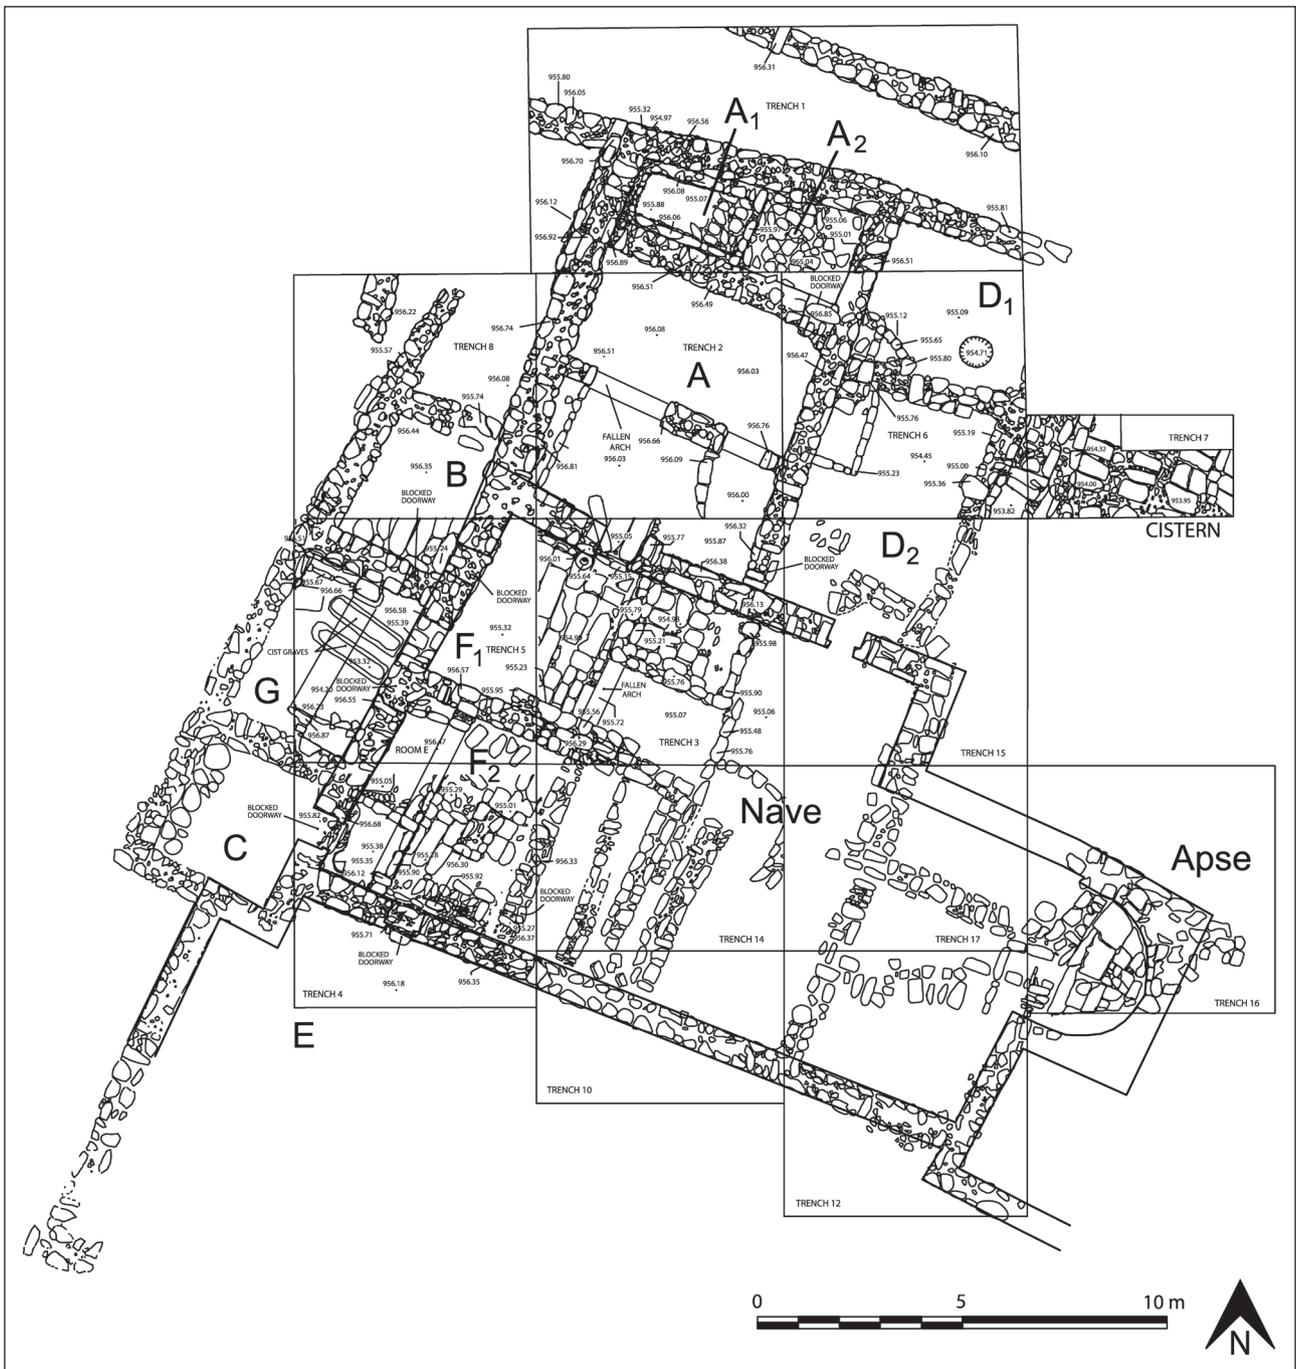
14. Area F102, plan of Early Islamic structure.

The F102 church appears to have remained in use until the early eighth century; its abandonment may be associated with damage from the earthquake of 749 AD (FIG. 14). The growing Islamicisation of the region, along with an economic decline after the departure of the Abbasid family for Iraq in the same year, would have made rebuilding difficult. In any case, the church ceased to be used for religious purposes, although the process of abandonment is obscured by the later reoccupation. The nave, apse and Room A were broken up by partition walls. A cross wall near the north end of Room A formed the long, narrow Room A₁, with a large bin or storage area. Two imposts toward the southern end of Room A supported a cross

arch that helped hold up roof beams or roof slabs. Another bin was built in the south-west corner of Room A, as was some kind of support pier in the centre of the room between the two impost.

wall, forming Rooms F1 and F2, and blocking the in-filled central entrance door to the nave. A large bin occupied the north-east corner of Room F1, the roof of which was supported by at least one north-south arch. A bench was built along the central part of the south wall of this room during this phase. Room B remained in use, accessible from Room F1 through the original door in the west wall of the nave.

Room F2 occupied the space south of the dividing wall, roofed by two north-south arches set on imposts built against the Phase III wall plaster. At some point during this phase the door leading into Room C was walled up, a fire-pit was built in front of it, and ultimately a bin as well. The east end of the room appears to have been closed off by a wall with a door at its south end. A door in the south wall providing access to Courtyard E may belong either to this phase, or to Phase III. A wall built across the face of the apse to create another room may belong to this phase.

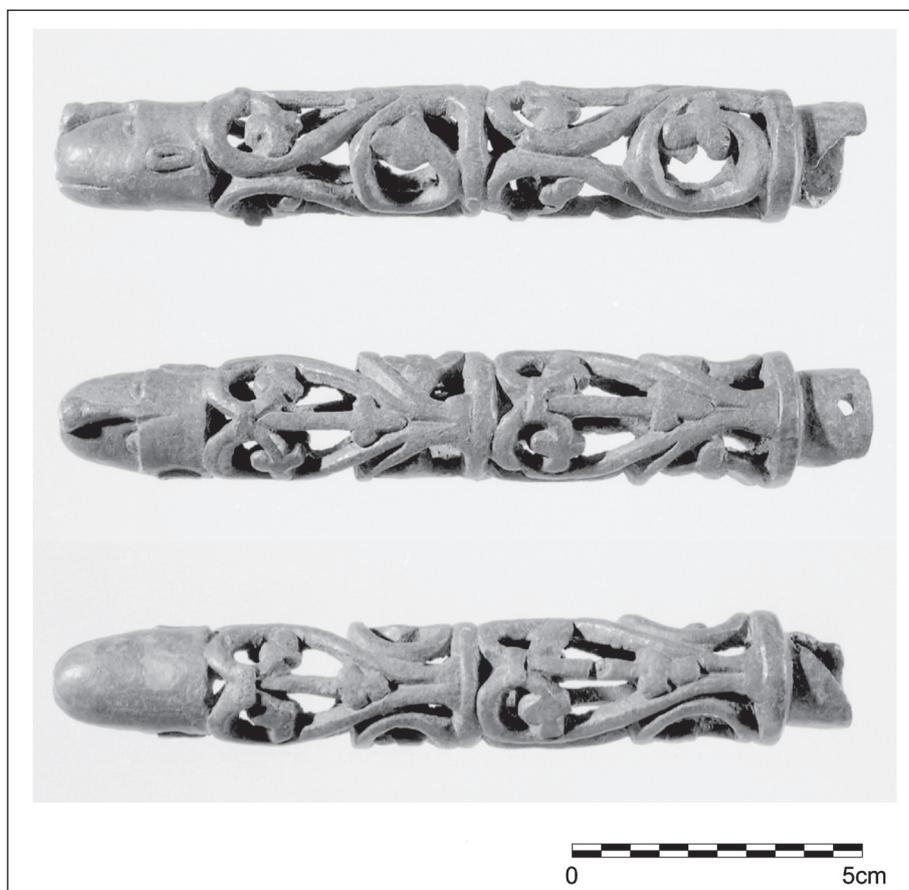
15. Umayyad censer handle from F102.

The artefacts found are typical of a rural farmhouse: fragments of miscellaneous iron tools and fasteners, cooking ware and storage ware ceramics, pounding stones and stone basins, and large quantities of steatite cooking ware, probably imported from Yemen. Some of the designs are uniquely elaborate. An exceptional luxury item is the handle of a bronze incense burner, of a typically Umayyad type (Oleson and Schick 2013: 429-32) (FIG. 15). The openwork handle shows sensitively rendered ivy tendrils and terminates in a

genial lioness head. It is possible that this object originated in the Abbasid manor house and somehow migrated to the F102 structure sometime after 749 AD.

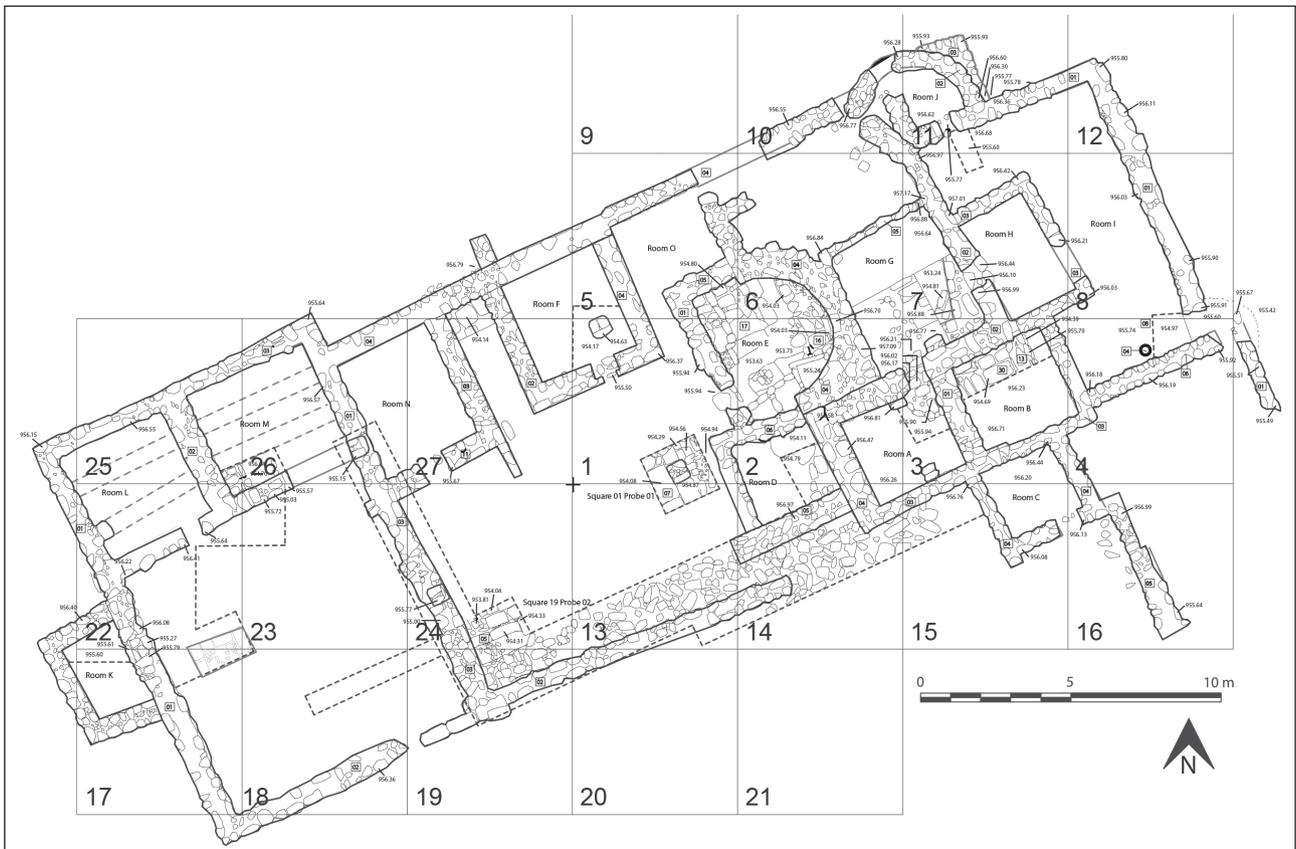
16. Area B100, plan of Early Islamic structure.

Any evidence for the precise chronology of the abandonment or destruction of the B100 church has been compromised by its re-use in the Umayyad period (FIG. 16). The floor was re-laid sometime at the beginning of the Islamic period, and the church remained in use for an unknown period of time until its abandonment, possibly associated with destruction by fire. Two thin layers of ash and plaster fragments above a thin layer of fine sand covered the flagstone pavement. The sand may have been deposited by the wind during a short period of abandonment, the ash by a fire that destroyed the roof, probably during the seventh century. Rubbish was dumped or accumulated in the ruins of the church, but at some point in the later seventh century this fill was levelled off and rooms were built along the north wall of the nave, which was closed on the west by a

new north - south partition wall. The apse was partitioned off as another room. Transverse arches carried the roofs for all these rooms. Room O may have been open to the sky, perhaps as a small animal pen.

During the eighth century the B100 complex was extended west with a second courtyard, again with rooms on the north. The adjacent Room K belongs to the Ottoman period. The complex extended eastward as well, in a more helter-skelter plan which may result from a longer period of agglomeration. There is no evidence to propose a different function for the expanded complex. It is possible that three related families occupied the three units, and that the growth of the structure reflects the expansion by marriage and birth of a family occupying a prime location in the Umayyad settlement. The gradual decay and abandonment of the complex in the later eighth century is reflected in the accumulation of blown soil, the walling-up of doors and the collapse of roof arches and walls.

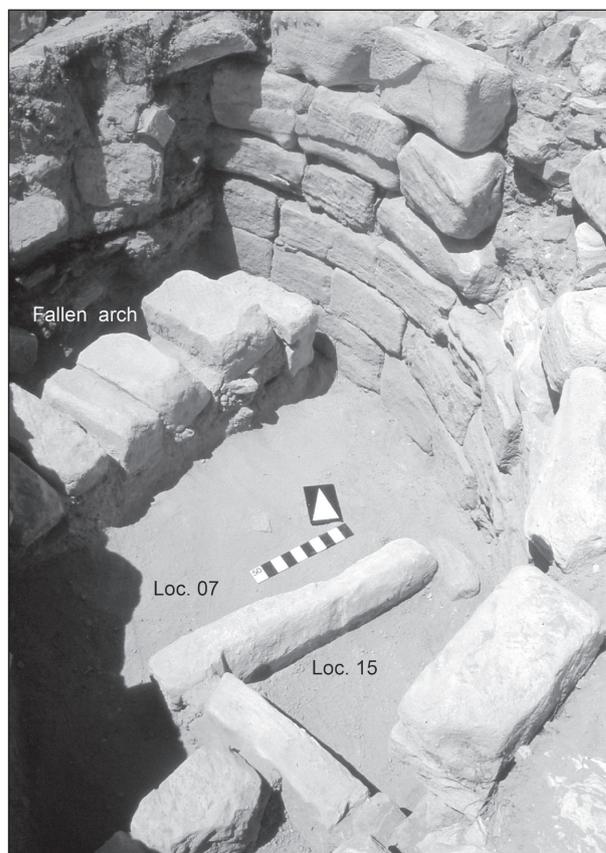
17. Umayyad room with fallen arch, built into church apse.
