## The Petra Great Temple: A Triumph of Conservation, Restoration and Preservation

Brown University excavations conducted at the remarkable Petra Great Temple since 1993 have revealed a colossal Nabataean structure, which is a principal component of the Petra city-centre. This highly visible precinct functioned as a commemorative, dynastic, religious and administrative quarter of the city. Occupied continuously from before the first century BC to the Byzantine period, the project to preserve the site, which extends over an area of 12,092m<sup>2</sup>, began simultaneously with its excavation. In Petra we live with the environmental uncertainties of flash floods, earthquakes and erosive action. To us, conservation is essential for the care and protection of the Great Temple site, although we are sure that these natural disasters will continue to threaten the site and cause widespread damage. It is too soon for us to have any feeling of security about either our short-term or long-term Great Temple site-conservation efforts

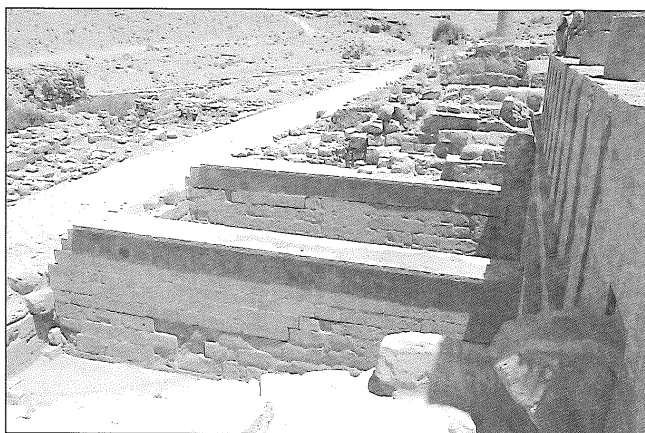
7. Propylaeum walls between Rooms 1 and 3 restored, 2005.

During the 1998 and 2001 seasons, reconstruction efforts moved to the Propylaea East and West, where a number of collapsed arch springers were consolidated and reset into the Cryptoporticus walls. During 2003-2005, restoration concentrated on the Propylaeum East. This involved the restoration of the interior partition walls between Rooms 1, 2 and 3 to a height of 3.2m. An overview of these walls can be seen in FIG. 7. Pointing between the out-of-position ashlar also consolidated the Portico Wall and doorways of these rooms. The 2004 excavation of the Chamber 3 vault posed a significant challenge for restoration, which was undertaken in autumn 2004 and winter 2005. When excavated,

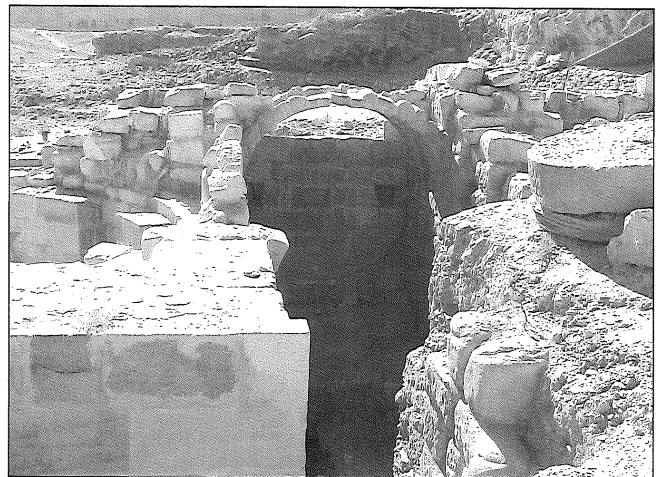
11. Upper Temenos, East 'Cistern' arches restored.

shown in FIG. 11 were reinforced and its arches were re-pointed after their initial consolidation in 1997. In 2001, the south extension of the East Perimeter Wall was pointed and the East Arch was dismantled, consolidated and returned to its original position as can be seen in FIG. 12. The walls and niches of East Perimeter Wall Room A were stabilized. The mouth of the 'Great Cistern' was fitted with a cover to prevent winter rains from collecting beneath the complex. During the 2002 season the south-east ashlar of the South Passageway were consolidated.

In the Upper Temenos, following the 1998 excavation season, the walls of the East 'Cistern'

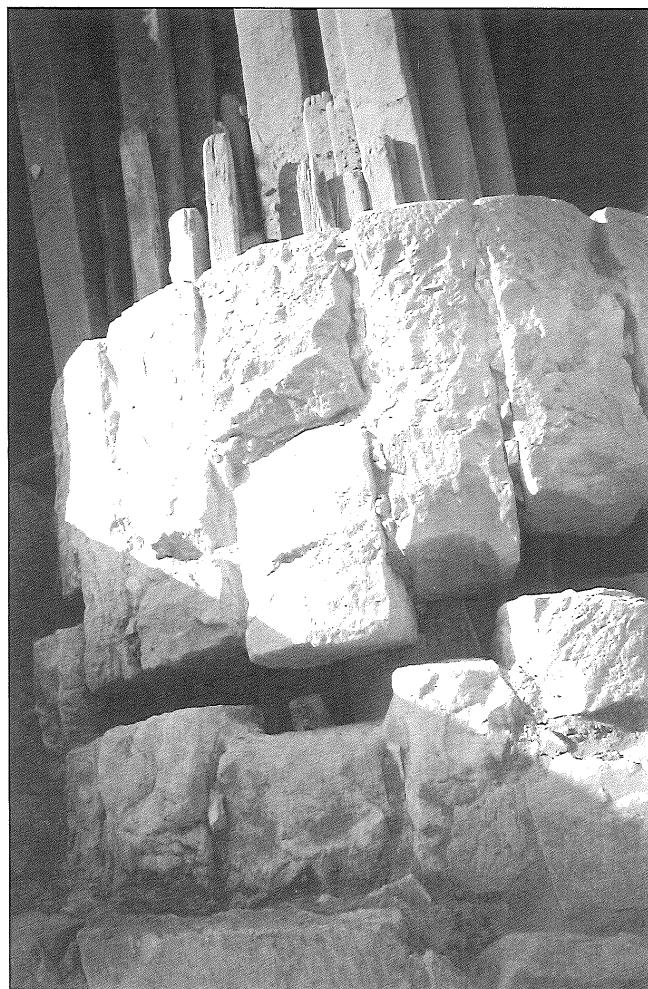
14. Temple, West Corridor wall vault.

In the Great Temple interior, work focused on the conservation of the corridor and walkway walls. During 1996 and 1997, consolidation was undertaken in the temple West Corridor with the resetting of fallen ashlar within the masonry of the north-west wall. The north-west section of the West Corridor with its vault was then dismantled, reconstructed and pointed, both to reinforce the wall and to close large gaps between its ashlar. FIG. 14 dramatically portrays the result of the blocks pulling away from each other. Also in 1997, the central portion of the West Corridor's inter-columnar wall – which had sustained significant earthquake damage – was taken down and rebuilt. Later work in 1998 included the full restoration of the East and West Interior Staircases and the complete *anasty-*

*losis* of the West Corridor inter-columnar wall with its vault and window. It was completely restored, as illustrated in FIG. 15.

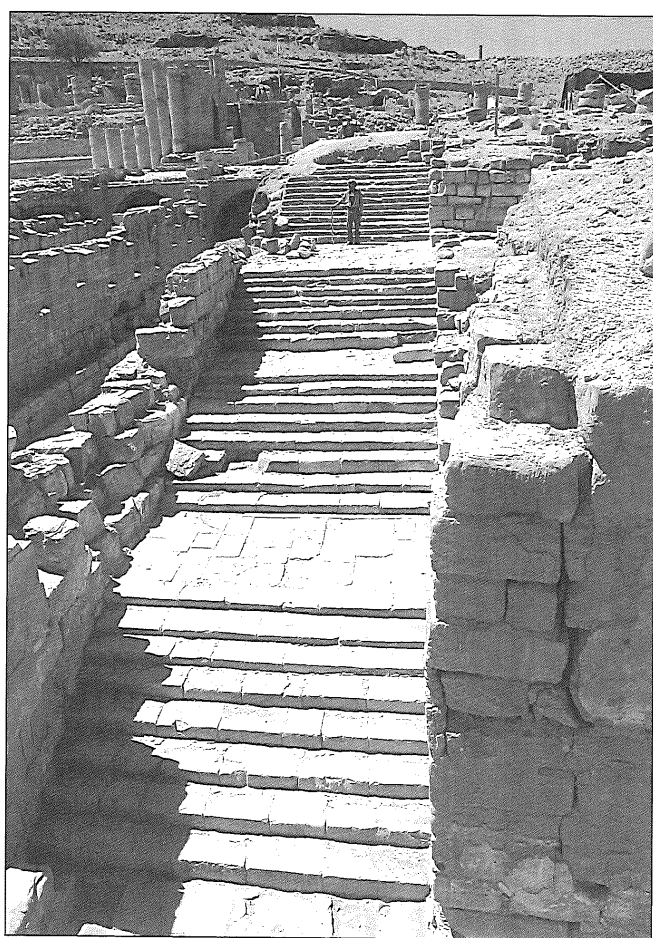
19. Temple, East Interior Staircase restored.

In 2005, the Great Temple entrance steps were lengthened to the full width of the entry in order to facilitate modern access to the structure and to punctuate the original point of entry of the Site Phase IV 'grand design'. Above the Central Arch, the 1998 season also saw the replacement of some 18 or 19 steps at the top of the rear East (East-West) Staircases (FIG. 19), which had been robbed out in

antiquity. In 1999, the East and West Rear Staircases were rebuilt to their full extent to permit visitor access to the second storey of the building.

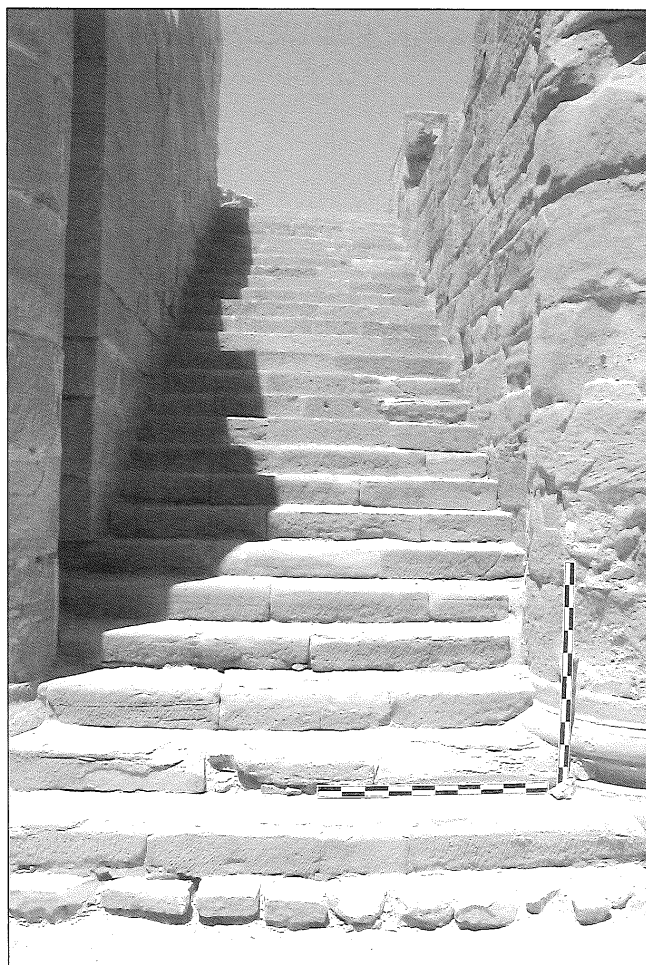
20. Temple, West Interior Staircase restored.

The West Interior Staircase was partially restored to undo erosion damage caused by winter rains. Full restoration of the staircase was completed in 2000 (FIG. 20).

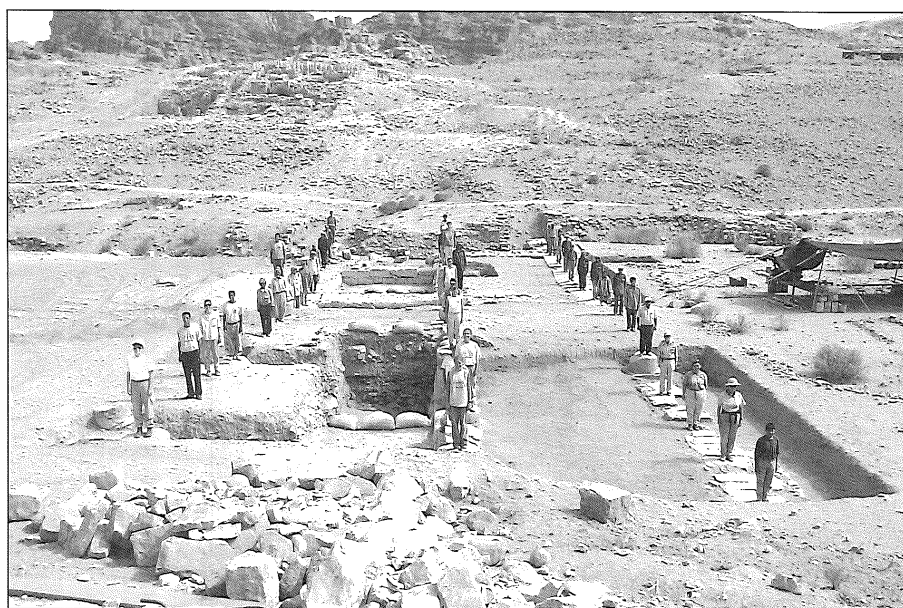
21. Lower Temenos, 1998 Brown team standing in place of columns.

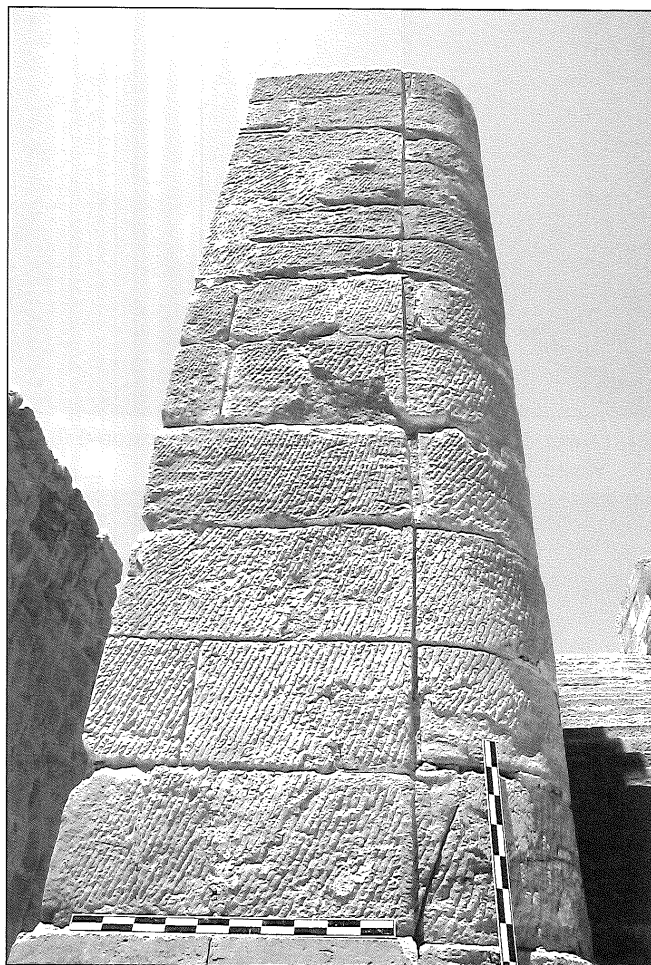
26. Temple, south-east heart-shaped double engaged column restored.

When discovered, the crumbling architectural fabric of heavily eroded, or absent, Porch column drums was removed. The central west column had been knocked off the stylobate in the Great Temple collapse and needed to be completely replaced. Be-

cause its Attic base was missing we replaced it and the columns with re-stacked porch drums without mortar. *In situ* plaster fragments found on the columns themselves or on the walls were treated with sealant to bond the decoration and forestall further deterioration. In a two cases, capital components were restored on the Corridor columns only, because no capital elements could be securely identified as belonging to the Porch columns.
