# A PRELIMINARY NOTE ON THE WĀDĪ MŪSĀ SALVAGE EXCAVATION 1996

Khairieh 'Amr, Sami Al-Nawafleh and Hani Qrarhi

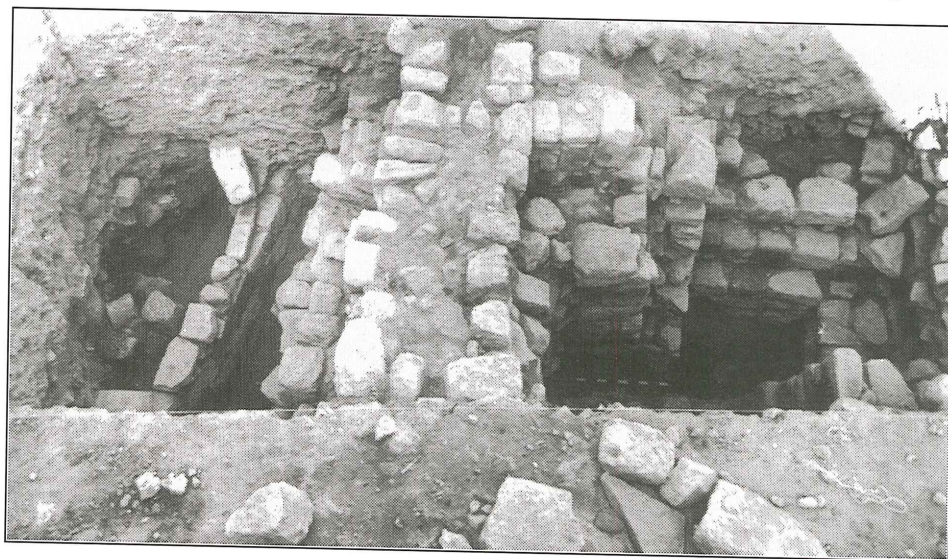
1. Area I, Trench 2 showing complexes of walls from various periods built on top of each other.

Excavation to the south of the cistern, across the side street, was only possible in a 3 x 7m trench due to the presence of a traditional modern building to the east, a private house to the south, while the west was already destroyed for a terrace. Excavation went down 5.40m without reaching virgin soil, but showed complexes of walls from several periods (Fig.1). The earliest excavated deposits dated to the turn of the first century BC/AD and the area was in continual use up to the Late Byzantine then re-occupied in the Ayyubid/Mamluk and Ottoman periods. Unfortunately we could not determine the nature of any of the buildings due to the small area available for excavation.

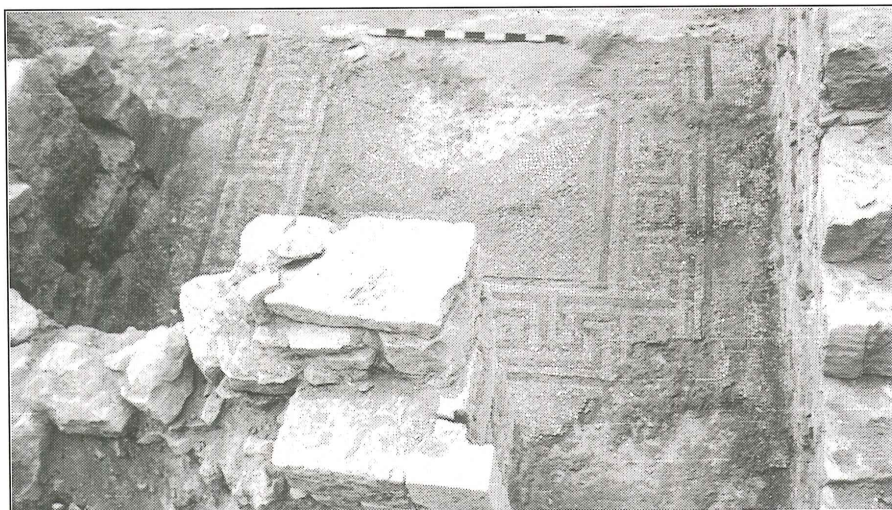
4. Late first century AD mosaic in the Nabataean villa.

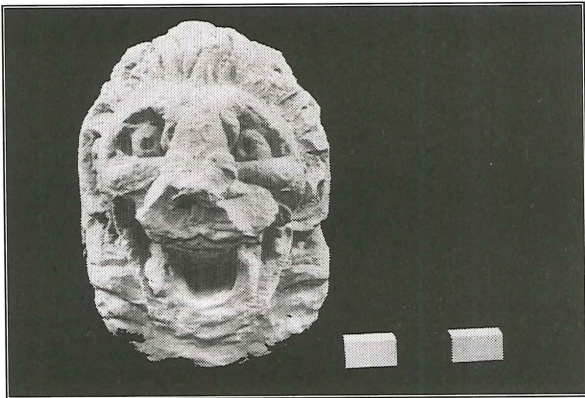
6. Lion head fountain found adjacent to the bath complex in the Nabataean villa (Photo: S. Lapedjian).

As for the plan of the villa (cf Fig. 2), the entrance in the south leads into a large hall (*atrium*) with a flagstone pavement having a central square of hexagonal pavers surrounded by columns. Architectural-style frescos in bright colors of crimson red, golden yellow, olive green, greyish blue as well as black and white decorated the east wall, where an entrance led to another frescoed room, now left intact under a traditional house. An entrance to the north led into another frescoed room (with lively designs of green grasses, bunches of grapes and olive branches). To the west of the hall, there was a latrine and corridor, in which was found decorated blocks including a relief of Helios-Apollo. A corridor leading north from the hall opened onto a room to the west, with a mosaic floor of geometric designs in white, black, yellow and red (Fig. 4), then onto a bath complex. Adjacent to the mosaic room was a room having a *tersia di marma* floor (the *apodytarium*?) leading onto the *caldarium* (Fig. 5). Unfortunately, the furnace was destroyed by the new street. North of the *caldarium*, a large room with flagstone paving had a *ṭabūn* oven, and a complex drainage system under the pavement connecting to the *caldarium* and areas to the north and east. Fine Nabataean bowls were found on this pavement, as well as a limestone "lion head fountain"

(Fig. 6). A corridor north of this room had several cooking pots smashed *in situ*. A large hall occupied the northern exposed end. Its southern wall, exposed to a length of 7.50m E-W, had remains of frescos on its
