PELLA / TALL AL-ḤUṢN EXCAVATIONS 1993 THE UNIVERSITY OF SYDNEY - 15TH SEASON

Pamela Watson and John Tidmarsh

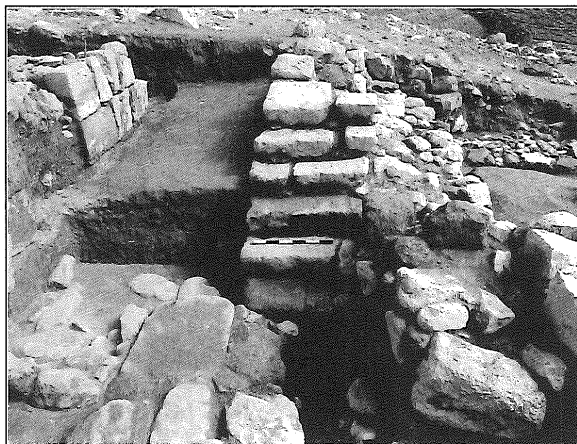
3. Byzantine complex, staircase at the eastern end of corridor, unit 6, with pavement in foreground, view east.

Only one room, unit 1, opens into the sixth century complex. The remaining rooms open into each other or to the south, where a long paved corridor space (unit 6), running east-west, contains staircases ascending from the lower exterior surface on the west (unit 24, in Plot N), to a higher level at the eastern end (Plot Z, Fig. 3). South of this corridor, in units 7, 8, and presumably 9, the surface level drops sharply, with roughly 3.0m difference in height (Fig. 4). The corridor surface is also higher than the floors of the rooms to the north, by approximately 0.5m. The corridor and three of the five rooms excavated to floor level (units 1, 2, and 8), were paved with stone slabs (Fig. 5). In the mid-northern room, surface level was only reached in a small 1.0 m² sounding. In this area it was hard-packed earth. A similar surface was reached in Plot O in the room directly south of the corridor (unit 7), although there was some evidence of paving further

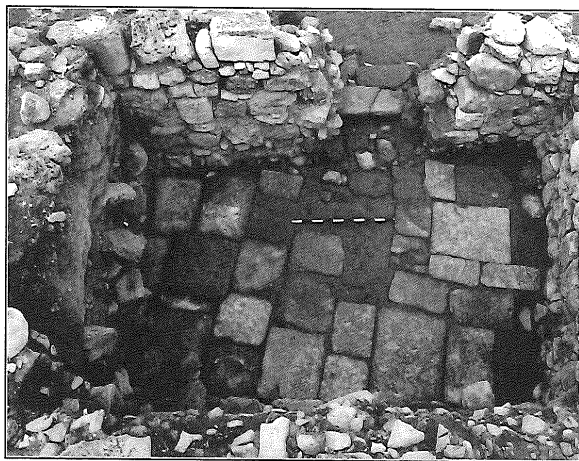
5. Byzantine complex, partly exposed stone-paved room, unit 1, view west.

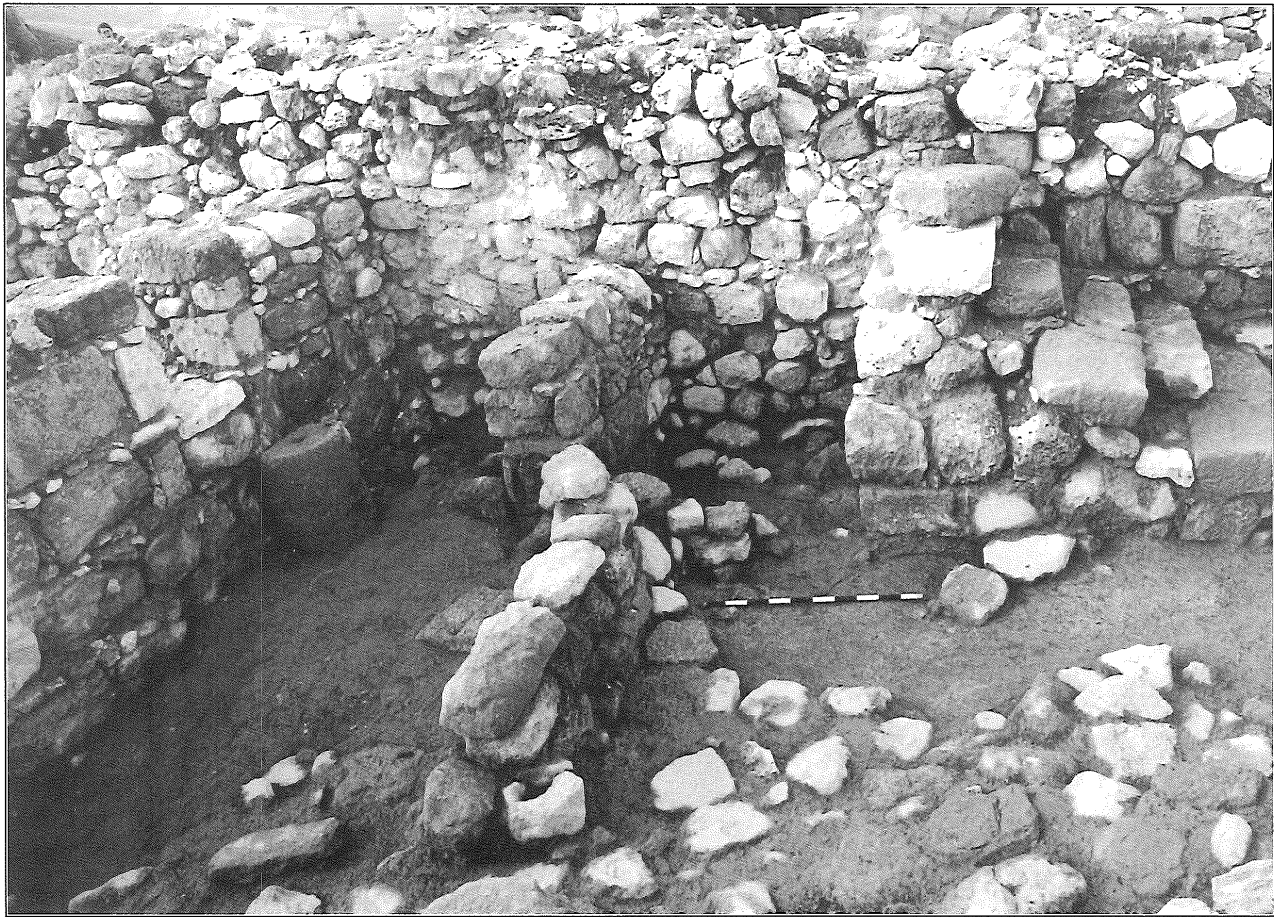
6. Byzantine complex, eastern wing of courtyard, unit 10, showing the staircase abutting wall L-4 with the cantilevered seventh and eighth steps removed, the courtyard pavement, and the protective wall around the oven (the oven has been removed). View south.

The staircase against wall L-4 proved to be partly solid and partly to span an open space about a metre wide, below the seventh and eighth steps from the bottom (Fig. 6).

Remnants of these upper steps were cantilevered over a large amount of collapse. How this space was originally spanned is not immediately evident. No wooden timbers survived, and no shaped voussoir blocks indicating vaulting, were present in the collapsed mass. However the courtyard surface continued beneath the stone tumble into this space.

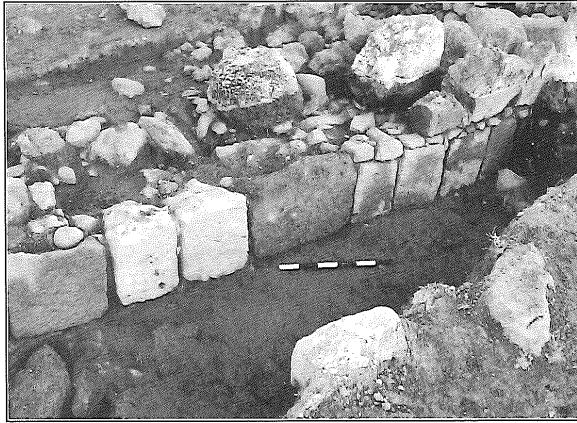
7. Byzantine complex, wall Z-2 in unit 4, view north west.

blocks are generally medium large but irregular in size; courses are levelled by a layer of small stones. Walls in this style were identified in Plot Z (walls Z-1 and Z-2, bonded, Fig. 7)⁴ and form the lower two courses of wall L-1 (unit 1). Wall Z-1 becomes wall C-3 in Plot C (excavated 1988). Another wall of well-coursed, squared (but not ashlar) blocks is found in wall O-1, whose extant height from the floor is 4.0m (Fig. 4). This well-built wall may belong to the third group, although it is less regular and contains some snecking stones. It appears that this third style forms part of the original building which has been rebuilt, and possibly radically altered at some stage prior

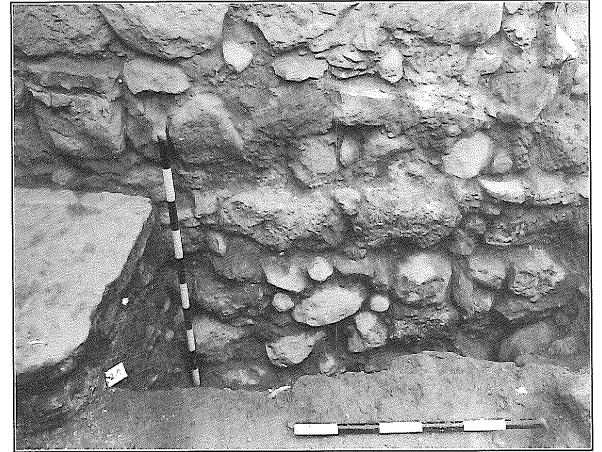
8. Byzantine complex, the foundation trench and foundations of wall L-2, with the paved floor on the left, in unit 1 sounding. View west.

- 2) The sounding in unit 1 revealed a foundation trench for wall L-2 cut from underneath the pavement packing (Fig.8). However wall L-1 has a small foundation trench cut from the same level, but the wall itself continues down. This foundation trench must be for a rebuilding of wall L-1 at the time wall L-2 was built and the pavement floor was laid. The finer masonry of the lower two courses of wall L-1 continues down to an earlier floor level which meets this wall (Fig. 9). Removal of this floor revealed the base of the wall which partly lay on top of an earlier wall emerging at an angle at the south end of the sounding (Fig. 10). Excavation ceased at this point and the sounding was backfilled. Pottery from the earlier floor can be dated generally to the Roman period (first - second centuries AD), but a more specific identification awaits a full analysis of the finds.

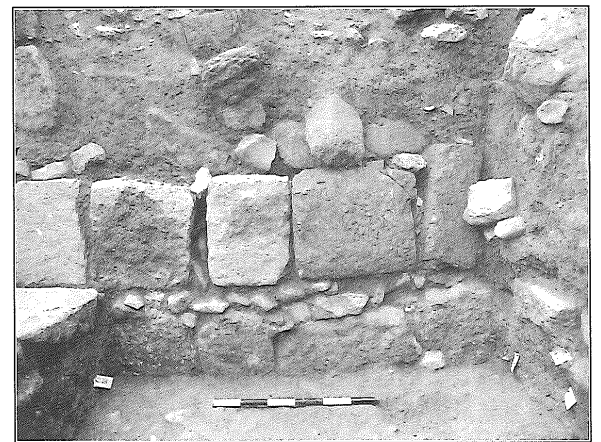
9. Byzantine complex, wall L-1 lower courses and earlier floor, in unit 1 sounding. The later paved floor is on the left. The wall face of the upper courses had collapsed into the room, exposing the rubble and mud core. View east.

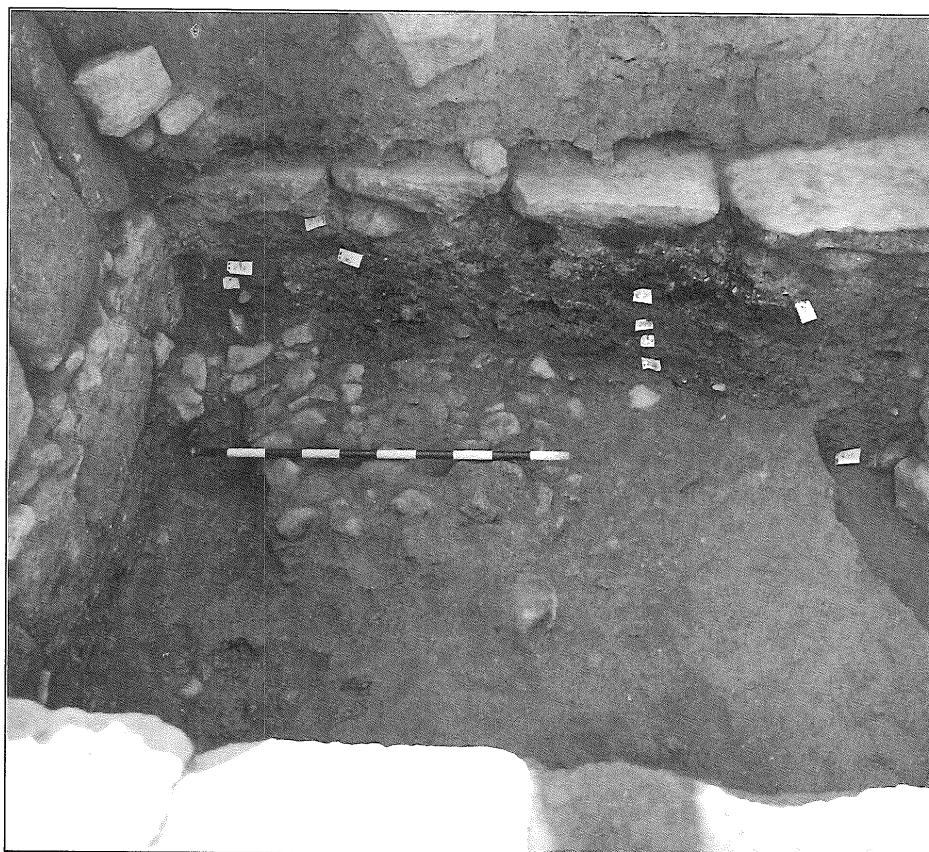
10. Byzantine complex, sounding below the paved floor in unit 1. Wall L-1 is on the left and L-2 on the right. The collapsed wall stones and pisé fallen on the paved floor are visible in the background. A wall of an earlier period, on a different alignment, is appearing beneath the scale. View south.

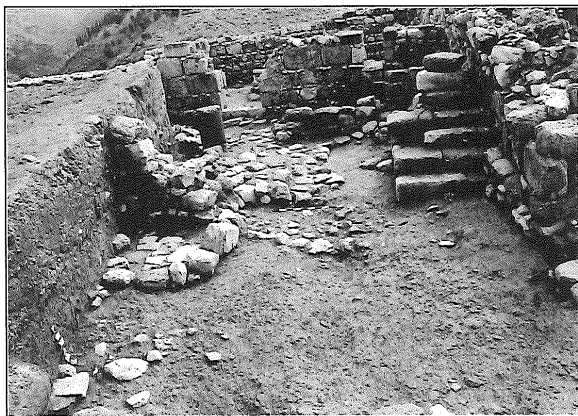
11. Byzantine complex, eastern wing of courtyard, unit 10. Wall L-5 and abutting platform are on the mid-left, the staircase abutting wall L-4 on the right. View east towards unit 11.

The southern termination of wall L-5 which extends for a short way south into the courtyard, is ill-defined, due to collapse. The wall has no return at this point, and merely acts as a dividing mechanism rather than an enclosure. The eastern courtyard pavement ends here and the surface becomes one of gravelled clay, full of small pottery fragments. This has been eroded by a shallow wash gully which runs westwards, exposing what appears to be an earlier wall continuing exactly along the line of wall L-5, as if the latter were built directly on top of an earlier wall.

A stone platform abuts wall L-5 in the north of the plot, continuing into the north baulk. Another platform lies against the west face of wall L-2 and forms part of the step up to the doorway into the paved room behind. A small low enclosure lies to the north of this step/platform. The partial excavation of Plot GG revealed that the western wall of the courtyard entrance passage formed the south jamb of a rough threshold which was flanked on the north by a narrow structure. This has proved to be the eastern side of a large bin-like structure whose north-east corner is defined by an upright column drum. The opening through the rough threshold permitted access to the doorway into unit 17, although the arrangement is again, clumsy and narrow. Benches abut both the western and eastern walls of the passage into the main courtyard.

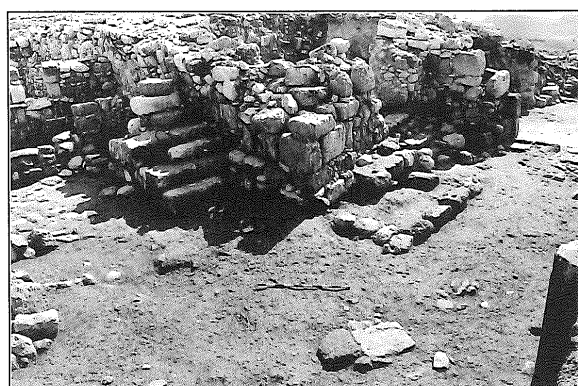
12. Byzantine complex, courtyard, unit 10. View south-east towards the entrance and unit 1.

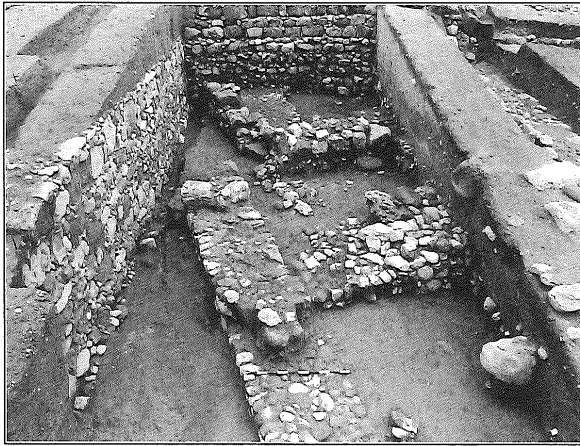
14. Plot XXXIVG. View to east of Late Hellenistic/Early Roman domestic architecture.

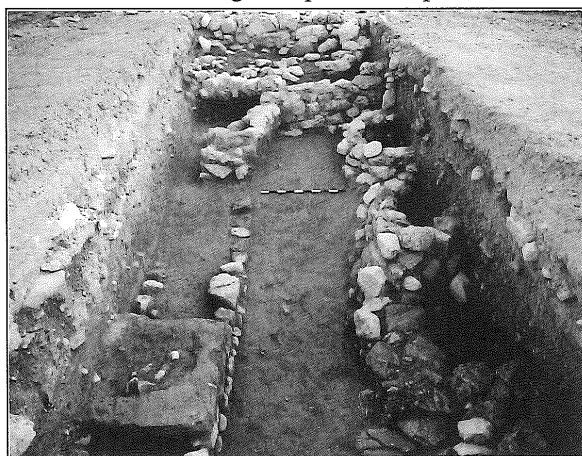
19. Plot XXXIVF. View to north of the Middle Bronze Age domestic area. The storage bins are to the east of the plot.

What has been revealed so far, therefore, seems to be a Middle Bronze Age domestic area (Fig. 19) with evidence of cooking on the occupation surfaces which are bounded by a series of storage/rubbish bins (Features 4,6,7) and by Walls 8 and 10. The evidence for cooking is represented by blackened sherds, charred bones and small areas of burning on the floors themselves. The occupation surfaces are of tamped earth with no evidence of plaster or stone paving.

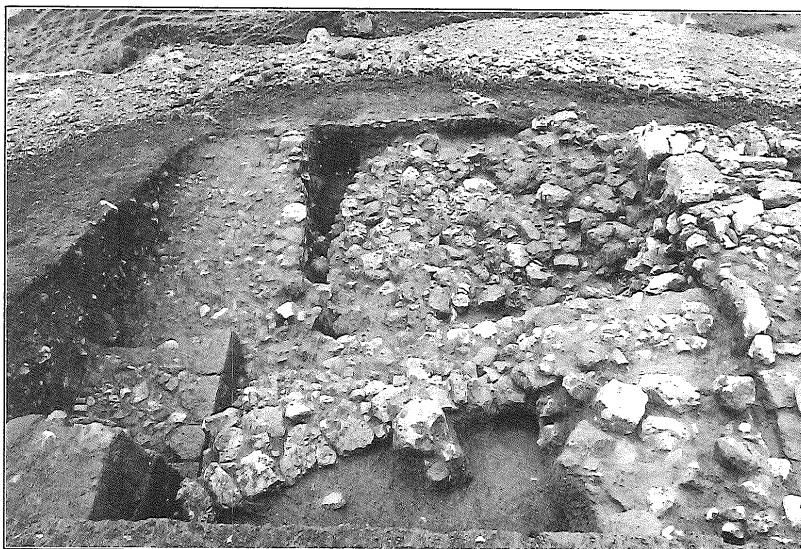
20. Plot XXXIVT. View to south. The stone platform is well seen at the south end of the plot. Wall 7 is in the north-east corner.

Plot XXXIVT lies on the south side of Tall al-Ḥuṣn, just below its summit (Fig. 20). The purpose in opening this plot was to investigate the possibility that an apparent gap in the perimeter wall located during the planning of the summit this season (see below p. 15) may mark the position of a gate. The upper courses of several walls (Walls 1,4, 5) already visible prior to excavation revealed the presence of relatively well cut masonry which may have marked the position of a tower or bastion. In the event, neither gate nor tower were found.

Excavation between Wall 1 and Wall 7 revealed a large, and as yet incompletely defined, platform (F2) consisting of loosely packed unworked field stones of 10 - 30 cm in diameter which were chocked with smaller stones and clay. It is at least one metre thick and so must have had some supporting function. The platform is bounded to the north by three narrow terraces, made of rough fieldstones bonded by clay, which appear to be of

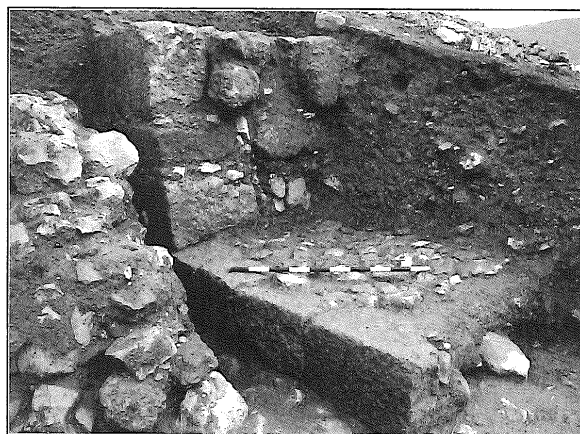
21. Plot XXXIVT. Wall 7 from the south-west.

To the east of the stone platform, Wall 7 (Fig. 21) runs in a north-south direction. Its most northerly part has four courses of pseudo-isodomic masonry on its west face while its eastern face has not been revealed. There is no binding mortar or external plaster but rather a central core consisting of clay and small unworked stones. The southern part has been robbed in its upper courses although the trace can be identified by following the undisturbed rough stone foundation course (F1) underneath.

Wall 7, including its foundation course, has been cut through the stone platform (F2) as well as the three narrow terraces mentioned above and so must be later in date. On superficial examination, the latest pottery from the wall's foundation trench (14.1) seems to belong early in the Roman period and this is consistent with its style of masonry.
