Craig A. Harvey

A Preliminary Typology of Brick and Tubuli from the Late Roman Bath at ‘Ayn Gharandal, Jordan

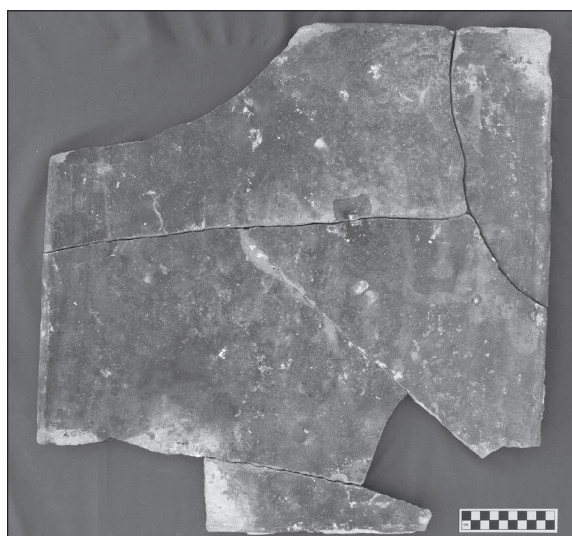
7. Covering brick - 3002 (C. A. Harvey).

Covering bricks were the largest but also least common bricks found within the bathhouse. These bricks rested on four adjacent *pilae*, with each of their four corners on a separate *pila*, much like a table on four legs. Two layers of these covering slabs topped with a thick layer of mortar and stone paving slabs formed the suspended floor in the *tepidarium*. Excavation uncovered only one fragmented covering brick (no. 3002) and a few fragments of suspected covering brick.

measures of 52.6cm by 52.7cm and ranges between 3.0cm to 3.4cm in thickness. Although only about 85% complete, the fragments of this brick weigh a total of 9115g. The fabric is light red (10R 6/8), and the surface is pinkish grey (7.5YR 7/2), although fragments of suspected covering bricks show that the fabric can also be light red (2.5YR 6/6) or reddish brown (5YR 5/3), a grey (5YR 6/1) core can exist, and the surface can also be white (10YR 8/2). Typical inclusions are coarse to very coarse sub-rounded and sub-angular multicoloured sand, with some white inclusions, a few small pebbles, and some angular rock inclusions up to 0.4cm in diameter. It also has many small to very small voids. The top surface is typically flat, even, and smoothed. The smoothing is evidenced by lateral strokes across the face and smoothing along the edges. The bottom surface is also flat and even, but not smoothed. The sides are flat, even, and smooth, with outward protruding ridges at the top and bottom. The nearly complete brick has two finger impressions on the bottom of one of the sides. It also has trace amounts of mortar on its bottom face and the sides. This brick was evidently face-down and rested directly upon the *pilae*, as there is heavy soot staining across its top face with the exception of the extant corners, which rested on *pilae* and were thus not exposed to smoke.

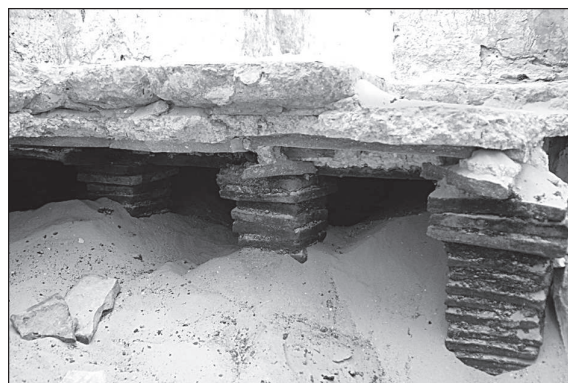
Though none of the collected bricks were found *in situ*, photos of bricks in the extant hypocaust system reveal their use (FIG. 8). Stacks of *bessales* formed the *pilae* upon which the elevated floor (*suspensurae*) rested. Two or three capping bricks placed on top of each stack of *bessales* served to broaden the *pilae* and concentrate the weight of the supported floor upon them, just like column capitals. Covering bricks rested on four adjacent *pilae*, with each of their four corners on a separate *pila*, much like a table on four legs. In turn, each *pila*, excluding those in corners or against walls, helped to support the corners of four separate covering bricks. Two layers of these covering slabs topped with a thick layer of mortar and stone paving slabs formed the *suspensurae* in the *tepidarium*.

8. Cross-section of hypocaust in *tepidarium* (Th. Fournet).

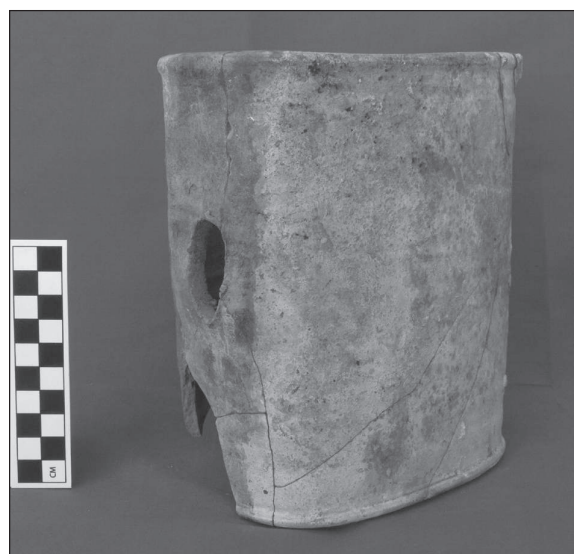
The first type of *tubulus* is the most common type found during excavation and is characterized by its squat oval vents and its fabric, which is unique from the other types in that it is not of the typical Petra ware type. The following description is based on nine partially reconstructed pipes (nos. 60008, 60009, 60019, 60034-36, 60041, 60043, and 60045).

Nine full heights range from 17.6cm to 20.0cm and have a mean of 18.9cm. Four full widths range from 16.3cm to 18.4cm, with a mean of 17.45cm. Five full depths range from

8.0cm to 10.6cm and have a mean of 8.9cm. The wall thickness varies from 0.5cm to 0.9cm. The fabric is light red (2.5YR 6/6) or reddish yellow (5YR 6/6), and the surface is most often light grey (10YR 7/2), light brown (7.5YR 6/4), or very pale brown (10YR 7/3). One sample has a grey (2.5YR 6/0) core. Typical inclusions are fine and medium clear quartz, with a few small white flecks. Macroanalysis suggests that this fabric is not Petra ware, but rather of an unknown source. Rims on the rectangular top end tend to be thickened with a rounded overhang

9. Drawing of Type 1 *tubulus* - 60045 (C. A. Harvey).

10. Photo of Type 1 *tubulus* - 60045 (C. A. Harvey).

on the exterior and a rounded edge on the interior that has a slight overhang on some samples, while those on the oval bottom are thickened and slightly flattened with a rounded overhang on the exterior and a rounded but rough edge on the interior that has a slight overhang on some samples. Lateral vents are oval, and range in height from 2.8cm to 4.6cm and in width from 1.8cm to 2.9cm. The presence of off-white mortar with carbon inclusions on the exterior and soot staining on the interior of reconstructed examples indicates that this type was used in the wall heating system.

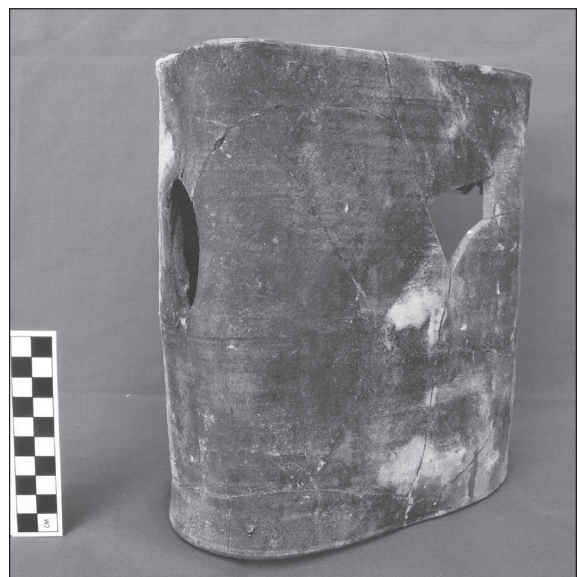
The third type of *tubulus* is characterized by its relatively large size. The following descrip-

tion is based on only two partially reconstructed pipes (nos. 60026 and 60039).

The only surviving full height is 24.2cm, two full widths are 21.7cm and 22.5cm, and two full

depths are 9.8cm and 9.6cm. The wall thickness varies from 0.4cm to 1.0cm. The fabric is light red (2.5YR 6/6) or reddish yellow (5YR 6/6) with a grey (7.5YR 5/0) core and a very pale brown (10YR 8/3) surface. Typical inclusions are medium sub-rounded clear quartz, with a few small white flecks. Macroanalysis suggests that this fabric is Petra ware. Rims on the rectangular top end tend to be thickened and slightly inverted with a rounded edge on the exterior and interior and a slight overhang on the

13. Drawing of Type 3 *tubulus* - 60039 (C. A. Harvey).

14. Photo of Type 3 *tubulus* - 60039 (C. A. Harvey).

interior. The rims on the oval bottom are thickened and rounded with a rounded edge on the exterior and a rounded but rough edge on the interior. Lateral vents are oval or irregular oval and are located in the centre of the side, closer to the top than the bottom. The vent size ranges between 5.9cm and 6.2cm high, while the only preserved width is 2.9cm. The presence of off-white mortar on the exterior and soot staining on the interior of reconstructed examples indicates that this type was used in the wall heating system.

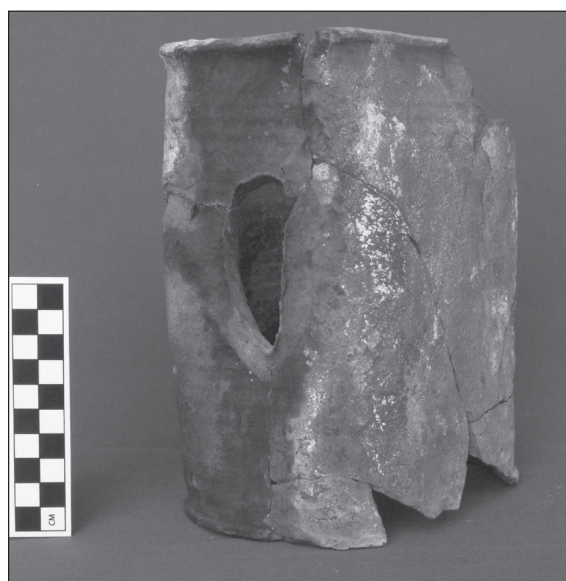
The fourth type of *tubulus* is characterized by its large and irregularly shaped lateral vents. The following description is based on only one nearly complete reconstructed and one partially reconstructed pipe (nos. 60016 and 60037).

The full heights of these samples are 19.4cm and 19.5cm, the only surviving full width is 15.1cm, and the only surviving full depth is 10.4cm. The wall thickness varies from 0.5cm to 0.8cm. The fabric and surface is yellowish red (5YR 5/6). Typical inclusions are fine and medium sub-rounded clear quartz, with a few small white flecks. Macroanalysis suggests that this fabric is Petra ware. Rims on the rectangular top end are thickened with a slight overhang on the exterior coming to a rounded point, and a rounded edge on interior. Rims on the oval bottom are thickened with a rounded overhang on the exterior, sometimes ending in a rounded point, and a rounded but rough lip on interior that can have a slight overhang. Lateral vents are irregular or pointed ovals and are located in the centre of the side, slightly closer to the top than the bottom. The vent size ranges between 6.4cm and 6.8cm high, and 2.3cm and 2.7cm wide. The most complete of these examples (no. 60016) fell from the wall during excavation, proving that this type was used in the wall heating system. Both samples have a relatively high amount of soot and heat damage compared to the other *tubuli*.

15. Drawing of Type 4 *tubulus* - 60016 (C. A. Harvey).

16. Photo of Type 4 *tubulus* - 60016 (C. A. Harvey).

With the exception of a single *tubulus* that collapsed from the eastern wall of the *tepidarium* during excavation (no. 60016), none of the *tubuli* available for study came from *in situ* contexts. As a result, it is impossible to say with complete certainty exactly how and where the *tubuli* discussed above were used, which is unfortunate as the variation in sizes may have reflected different or specialized uses. Like other wall heating systems, however, the *tubuli* lined the walls to create a continuous void through which hot air from the hypocaust could rise, circulate, and heat the walls (FIG. 19). One curious feature of the *tubuli* within the *caldarium* is that they were placed in staggered rows (like bricks in a wall), rather than in linear columns as done elsewhere, such as in Wādī Mūsā where mortar impressions attest this arrangement ('Amr *et al.* 1997:472, fig. 5).

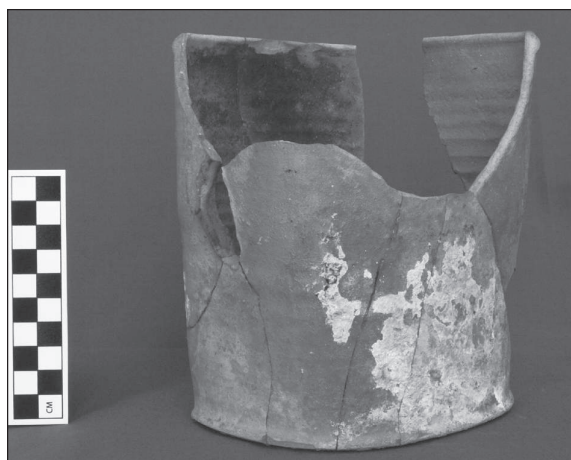
The fifth type of *tubulus* is characterized by its distinctive rim. The following description is based on only one reconstructed example (no. 60010); however, fragments from other examples of this type exist. A complete specimen of this type was uncovered during the 2010 excavation of the bath and previously published (Darby and Darby 2012: fig. 112; 2015: fig. 7).

The full height of the *tubulus* is 16.0cm, the

width is 13.3cm, and the depth is 10.2cm. The wall thickness is 0.5cm. The fabric is reddish yellow (5YR 6/6), and its core is grey (7.5YR 6/0). Typical inclusions are medium sub-rounded clear quartz, with a few small white flecks. Macroanalysis suggests that this fabric is Petra ware. Rims on the rectangular top end are triangular and can appear hooked as they come to a rounded point that curves to the interior with a slight overhang. On the exterior, the top rim has a rounded overhang. Rims on the oval bottom are thickened and flattened with a rounded overhang on the exterior that can end in a point

17. Drawing of Type 5 *tubulus* - 60010 (C. A. Harvey).

18. Photo of Type 5 *tubulus*- 60010 (C. A. Harvey).

and a sharp and rough edge on interior. Lateral vents are oval and are located in the centre of the side, slightly closer to the top than the bottom. The best-preserved vent measures 4.1cm high and 2.1cm wide. The presence of mortar on the exterior and soot staining on the interior of this pipe indicates that this type was used in the wall heating system.
