Wādī al-Jarra Dam Rehabilitation Project, Petra

Introduction

WĀDĪ AL-JARRA DAM REHABILITATION PROJECT, PETRA

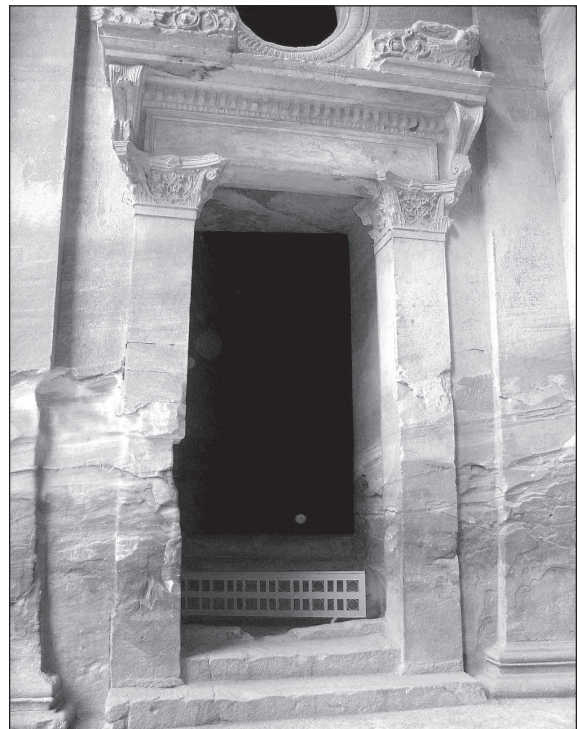
3. View at the doorway in the southern wall of the entrance hall of al-Khaznah, showing the heavy erosion of the sandstone, reaching almost half of its height. This erosion is due to the crystallization of salts during the evaporation of the rising ground humidity in the void of the stone structure in the warm seasons (Photo U. Bellwald).

Khaznah courtyard have been destroyed and swept away, including the sophisticated drainage channel network assuring a safe and non-destructive outflow of the storm water retained by the lowest dams Nr. 4 and 5. By the centuries the entire courtyard has been backfilled by more than 3m of rubble. This huge backfill works like an enormous sponge, retaining a huge amount of the runoff water sweeping in during the rainy period. In the warm seasons part of this water stored in the underground of the courtyard penetrates into the porosity and capillarity of the sandstone cliffs, rises up and finally evaporates. In the evaporation level the salts dissolved in the water crystallize. As the dimensions of the salt crystals are much bigger than the diameter of the pores and capillaries in the sandstone, the natural voids are bursting and the surface of the cliffs and hence also of the monuments like the treasury are eroding (FIG. 3).

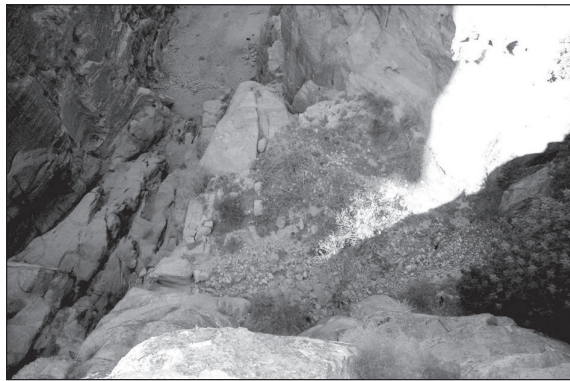
5. View from the rock terrace of the diversion channel below the second dam onto the catchment basin of the third dam. Photo taken in June 2005 during the first survey study. It shows the area before excavation started (Photo U. Bellwald).

The exact location where dam nr 3 was built benefitted from a very distinguished topographical situation: At the inlet of Wādī al-Jarra into the rock terrace its straight course was broken twice in the shape of a Z before leaving the terrace in the direction of al-Khaznah Courtyard. Flowing straight down from South to North the outflow water bounced against a cliff and was hence diverted to the West, where, after a distance of 30 m it bounced against another cliff and only then it flew out from the terrace down to al-Khaznah Courtyard. Taking advantage from the reduced velocity of the twice diverted outflow water the Nabataean hydraulic engineers closed the exit from the terrace with dam nr 3, intending to reduce further its outflow velocity and hence reducing its destructive energy (FIGS. 5, 6, 7).

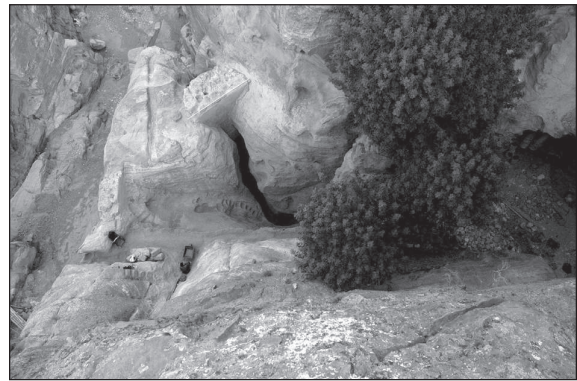
6. View from the rock terrace of the diversion channel below the second dam onto the catchment basin of the third dam photograph taken on December 11th, 2014 upon completion of the excavation (Photo U. Bellwald).

As the interior of the catchment basin had to be cleaned from the alluvial deposits after every winter rain season, a maintenance staircase had to be built for reaching its bottom. The steps of this staircase were hewn into the surface of the western cliff, starting at the northwestern abutment of the small western dam (FIGS. 6, 7, 12, 13).

the central section of the channel is elaborated as a cascade of 13 steps. The main section of the spill-over channel is straight in course with a length of 10.5m, at the end it is curved and bends for 90° towards the rim of the terrace, from where the water was precipitating into the lower part of the stilling basin downstream the main dam (FIGS. 6, 7).

The stilling basin, built for taming down the energy of the water splashing out from the outflow valve or falling down from the spill-over channel, has a length of 10 m and a maximum width of 1.7m. At its downstream end it was closed by a barrier which had a height of 1.4 m and a thickness of 80cm (FIG. 7). In order to enable the workmen to get up to the area where dam nr 3 and its auxiliary constructions had to be realized, a walkway with stepped sections had to be built, starting at the southern end of al-Khaznah Courtyard, first following the western cliff of the western branch of Wādī al-Jarra, then continuing in its central part and from there crossing over to the East, where a narrow walkway was hewn in a vertiginous height into the cliff, without any handrail or similar safety measurements. For preventing unauthorized people from reaching this walkway, it could only be reached with help of a ladder. From the narrow walkway a flight of 4 steps was leading down to the work site (FIGS. 6, 7).

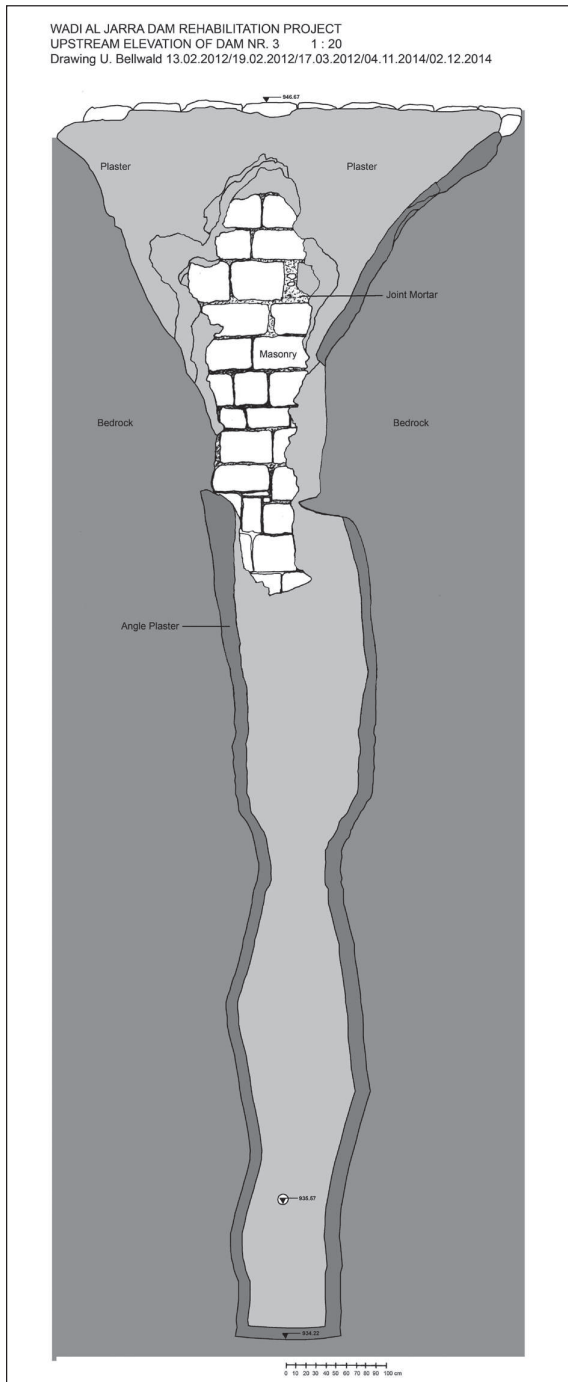
8. Elevation of the upstream face of dam nr 3 upon completion of the excavation of the retention basin. The plan reproduced here is not to scale (Drawing U. Bellwald).

Originally the dam had a height of approximately 12.9m. As the uppermost layer of the masonry is nowadays lost by erosion, the actual height of the dam from its crest to its bottom is 12.45m (FIG. 8). The excavations in 2014 have clearly shown that the constructive interventions inside the catchment basin upstream dam nr 3 were minimal and mainly restricted to a narrow outflow channel with a depth of 50cm and a width of 85cm at the bottom of the natu-

The close examination of the masonry of dam nr 3 has given that, due to learning by doing, it was built in two phases: As the flanking cliffs at the location where the dam was built were very close to each other (the maximum width at the top line of the dam being only 4.78 m) and even conical in shape with the wider opening upstream, the constructors thought a dam with double sided coursed ashlar masonry in a thickness of 80cm would be sufficient for withstanding the water pressure. This was obviously to the case, as several displaced sandstone blocks in the downstream face of the first dam are attesting. As no cracks in the mortar embedment around the displaced blocks may be detected, the damage must have hit the dam even before the lime mortar was carbonized, which means shortly upon completion of the construction. The dam-builders were therefore obliged to reinforce the dam considerably by extending its thickness downstream by 2.36m in the main body and by 1.92m in the uppermost 2.6m. After such intervention the total thickness of the dam squeezed between the conical shaped cliffs reached 3.16m which proved to be sufficient, as no damages in the masonry due to excessive water pressure occurred anymore (FIGS. 6, 8). In order to make the dam water proof its upstream elevation was completely plastered with a hydraulic plaster built up in four layers, reaching a total thickness of approximately 5cm (FIG. 8).

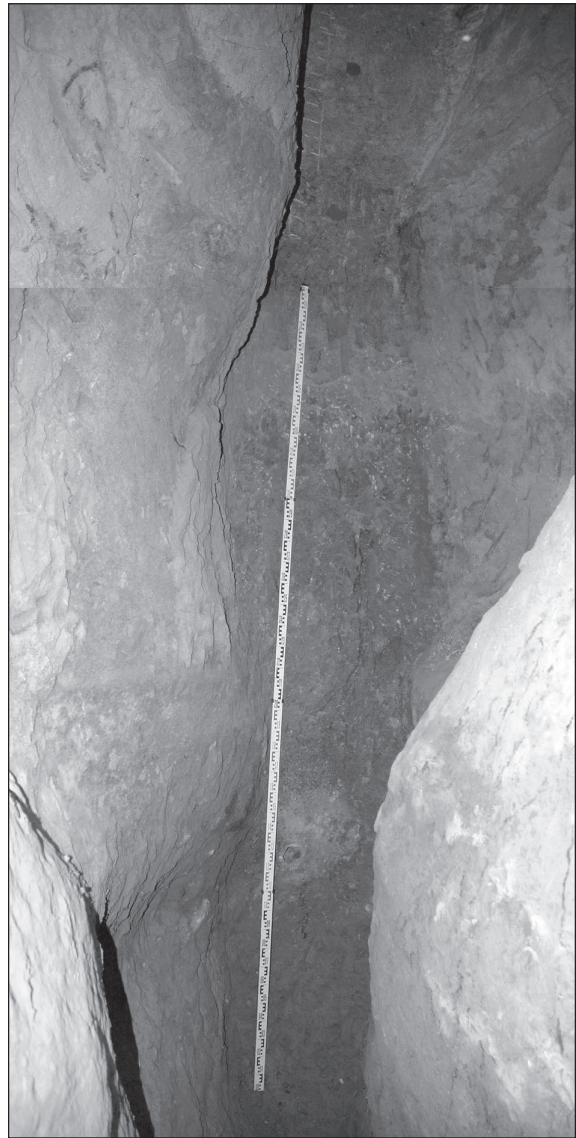
9. View onto the lower part of the upstream face of the main dam with the outflow valve (Photo U. Bellwald).

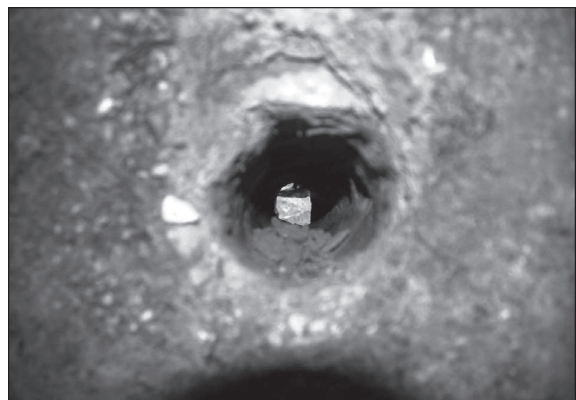
10. View from the retention basin through the outflow valve at the bottom of the dam in direction of the treasury (Photo U. Bellwald).

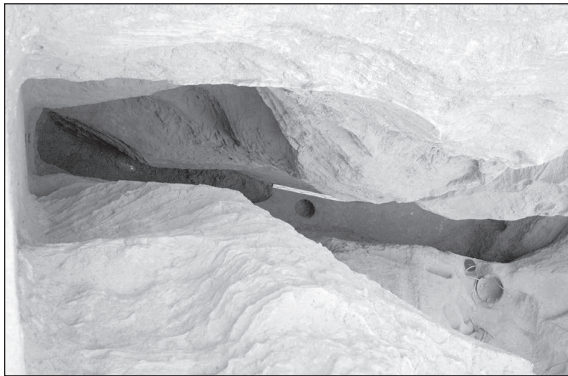
11. View from the top of the main dam down into the outflow channel at the bottom of the retention basin (Photo U. Bellwald).

ral *wadi* bed (FIGS. 7, 11). Besides this outflow channel and a stone collection tank with a depth of 1.5m and a length of 3.5m in front of the upstream bottom of the dam no other

in the characteristics of the aggregates, which were very rough in the first and rather fine in the top layer. For assuring a perfect adhesion between the layers, layer 1-3 had a very irregular, rough surface, whereas the top layer was meticulously smoothed down. In order to prevent the plaster from being weakened by cracks, crushed charcoal and pottery shards were added to the mortar mix. As a result of the addition of crushed charcoal, which was acting like color pigments, the plaster got a distinctive grey appearance. The plastering was not only restricted to the surface of the dam, but also covered the joints towards the bedrock. In order to avoid any water infiltration along the joints, these were diagonally covered with thick layers of plaster, filling grooves and fissures in the adjacent surface of the bedrock and using rock pinnacles as protective covers. For assuring a constant outflow of the runoff water from the catchment basin an outflow valve was inserted into the masonry of the lowest part of the dam. The valve is only a spare opening with a diameter of 10cm crossing the masonry slightly sloped towards the downstream face with no insertion of terracotta pipes. Its position is in the vertical axis of the dam, 1.35m above its bottom for protecting it from being obstructed by stones which were held back in the tank at the end of the outflow channel (FIGS. 8-10). For hindering mud from backfilling the stone collection tank a small barrier was built inside the outflow channel. Its location was 7m upstream the main dam, its height 85cm and its thickness 20cm (FIGS. 7, 11).

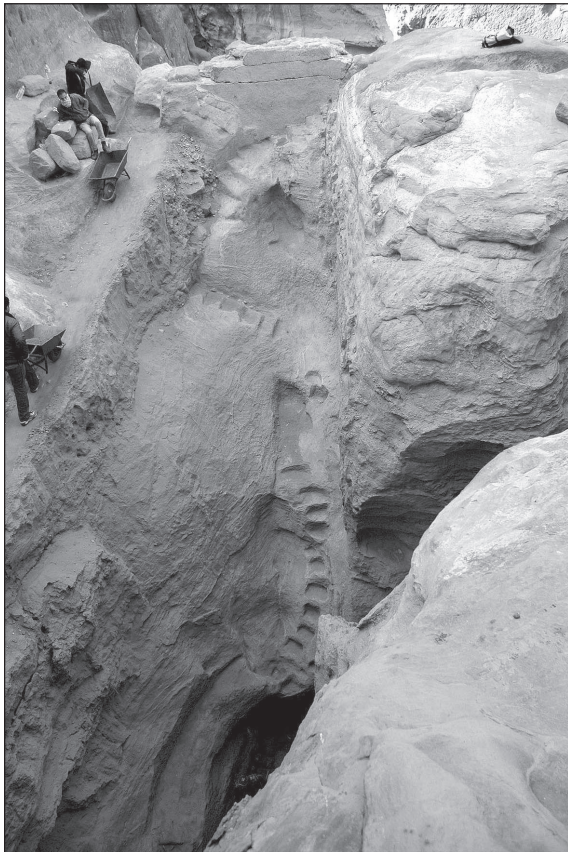
13. View from East onto the Western dam and the maintenance stairs leading down into the retention basin (Photo U. Bellwald).

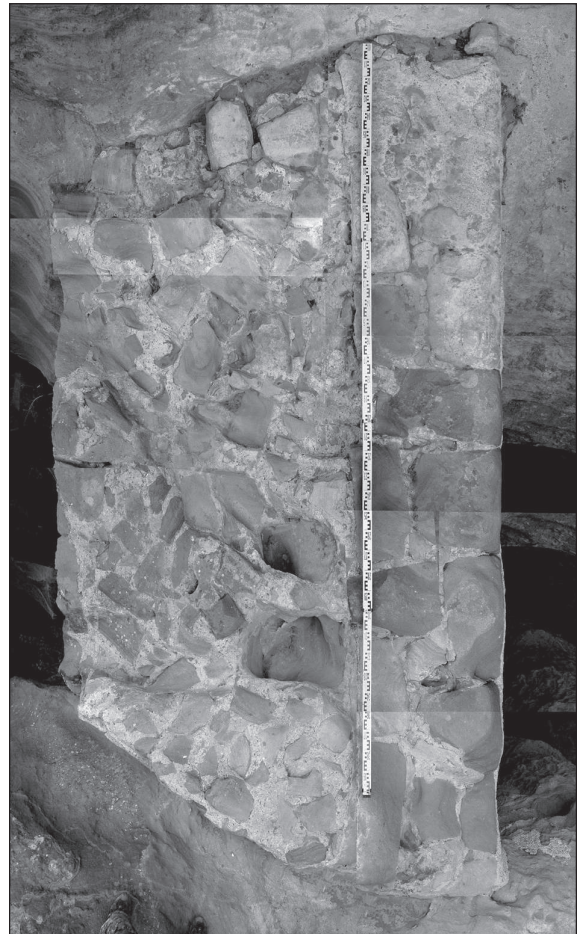
15. View onto the crest of dam nr. 3, assembly of orthogonal photo shoots. The illustration shows well the double sided masonry of the first dam (bottom) and its downstream extension (top) (Photo U. Bellwald).

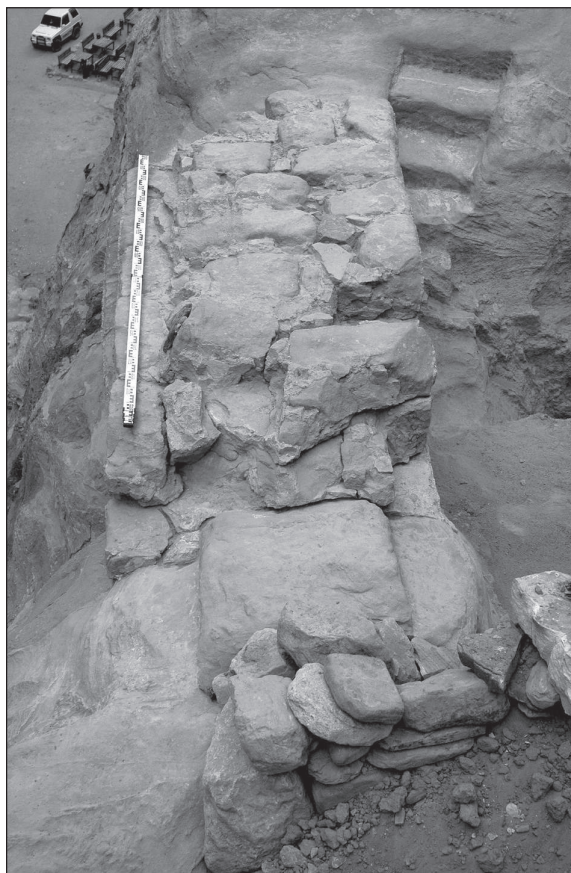
16. View onto the fully exposed and cleaned crest of the western dam in April 2012 (Photo U. Bellwald).

features for increasing the storage capacity of the catchment basin could be verified. The only contribution for increasing the retention capacity of the catchment basin upstream dam nr 3 was the construction of the small auxiliary dam on top of the western cliff. As the surface of the bedrock flanking dam nr 3 was approximately 2 m higher than the top of the western cliff, the western delimitation of the catchment basin had to be elevated by a dam to the same level in order to prevent the runoff water from spilling over to the western branch of the *wadi* (FIG. 16).

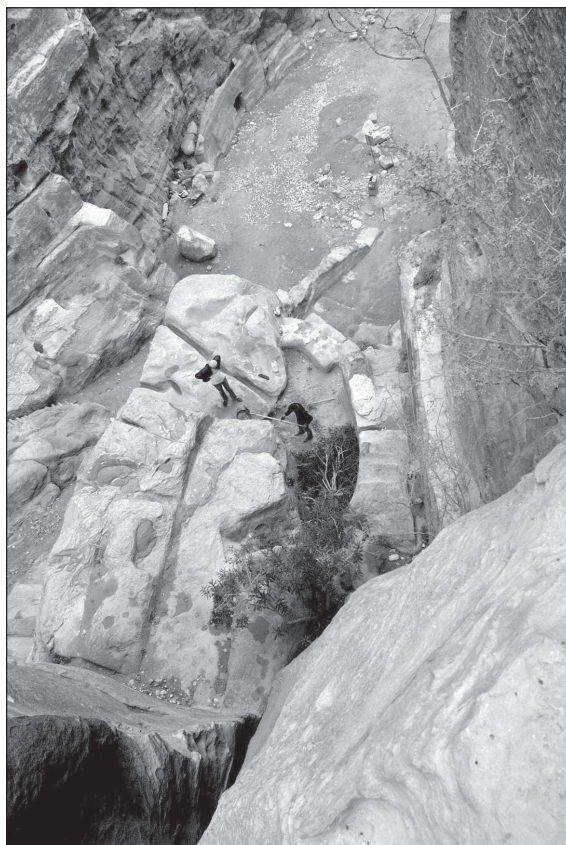
17. View from the top of dam nr 3 down onto dam nr 4 and al-Khaznah Courtyard, photograph taken on November 25th, 2014 (Photo U. Bellwald).

In a distance of 18m and 14.4m lower dam nr 4 was built at the very inlet of Wādī al-Jarra into al-Khaznah Courtyard (FIG. 17). It has a height of 8.9m, a width of 3.5m at the top and a thickness of 94cm at the eastern and of 2.3m at the western abutment. From the catchment basin upstream dam nr 4 a spill-over channel leads in a straight course into the western branch of Wādī al-Jarra (FIGS. 6, 7). As in dam nr 3 the outflow valve at the bottom of dam nr 4 ends in a rectangular valve chamber. A maintenance staircase hewn into the eastern cliff leads from the level of al-Khaznah courtyard up to the crest of dam nr 4.
