Insights into Investigation and Building Conservation in the Old Village of Al Hārah Al Fawqā in Umm Qays, Jordan: Reconstructing the Historic Roof of Al Madāfah in Bayt Ar Rūsān

Al Maḏafah: Reconstruction of the Historic Roof Structure

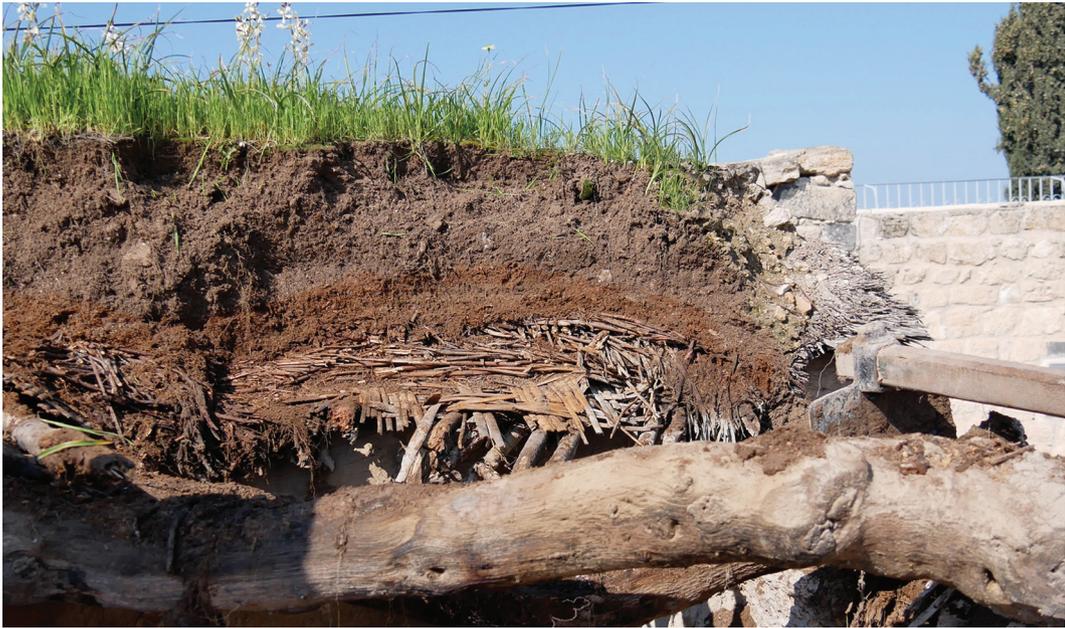
Unused for years, Al Maḍafah was only preserved in parts (FIG. 4). The main façade in the north had almost completely collapsed, and the material had disappeared. The roof was preserved in parts but was in acute danger of collapse.

4. Al Hārah Al Fawqā. Al Maḍafah: condition of the historic roof structure, 2018 (photo by Peter Sistig, courtesy of DAI).

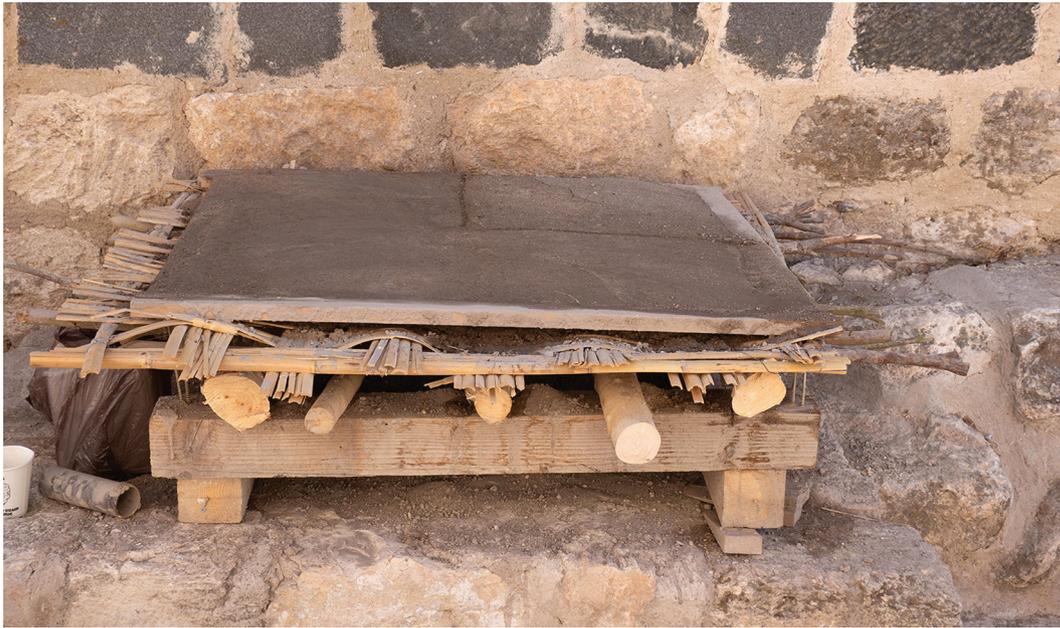
The first step in the construction process was to produce a test roof that simulated the roof structure (FIG. 6). We tested how the materials behaved and determined their drying times. We also studied and tested the exact composition of the earth layers. Applying one layer per day proved to be practical. Watering the mixture before and after placing it on the roof gave us good results.

6. Al Hārah Al Fawqā. Al Maḍafah: Test roof, 2021 (photo by Olga Zenker, courtesy of DAI).

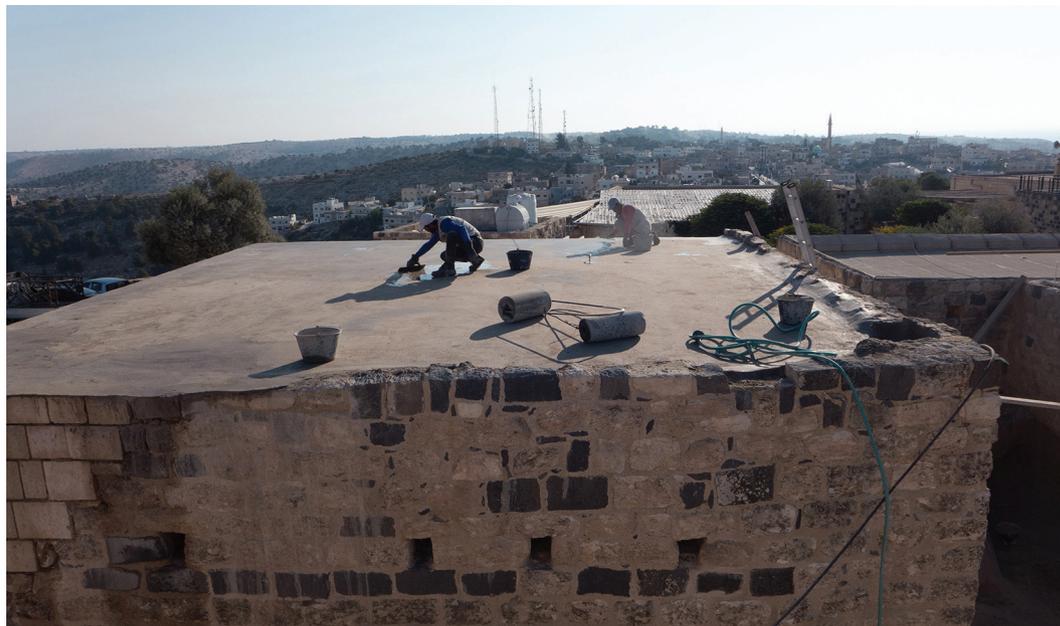
This compaction and levelling of the roof's surface was originally done with heavy basalt rollers, but no one in the village remembered using such a tool, so

we commissioned new rollers from one of the stonemasons of the team. Local residents from the surrounding areas visited the site regularly while the work was going on; when they saw the rollers on the roof, they told us of how they now used similar tools to crush up old bread. Yet the original use of these tools had been forgotten. The rollers were no longer linked in the collective memory to the construction of a roof—until visitors saw these heavy stone tools in action (FIG. 7).

The last two layers of our reconstructed roof were made solely of earth, lime, and water. The fine components of the lime were gradually pressed upwards by the compaction of the rolling process; these particles formed a sintered layer resistant to water and weather.

All steps were carried out by two trained workers (see FIG. 7), who gained more experience as the construction process progressed. Towards the end, they developed an even finer sense for the characteristics of the construction and its materials. Now that the roof has been completed, both of these Umm Qays local residents have become qualified specialists in historic roof construction.

7. Al Hārah Al Fawqā. Al Maḍafah: Heavy basalt rollers compact and level the roof surface, October 2021 (photo by Claudia Bührig, courtesy of DAI).

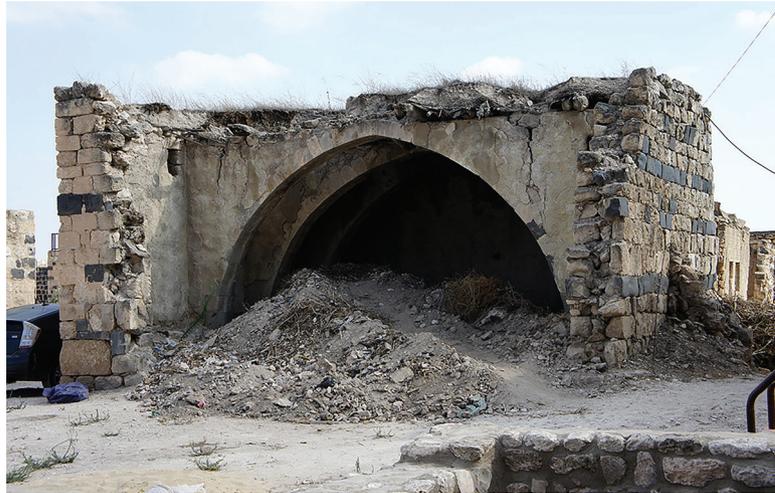
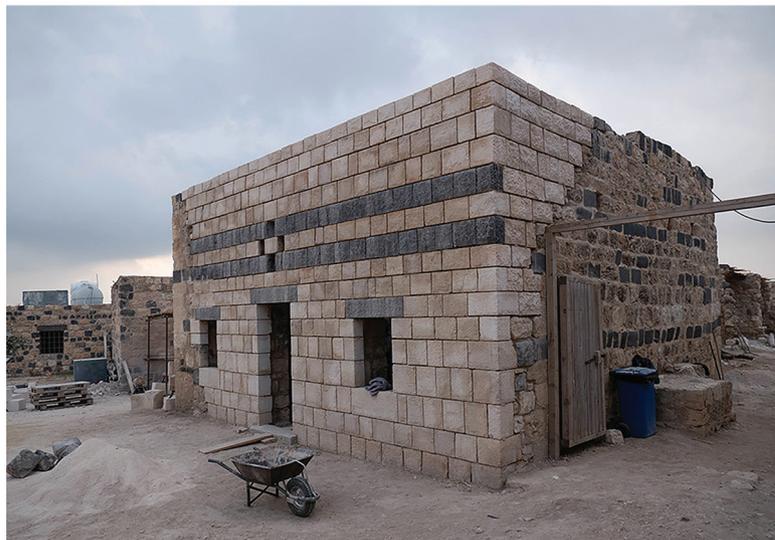
The missing façade and roof of Al Madafah (FIG. 8) were rebuilt in September and October 2021, the time of year when temperatures are moderate and solar radiation is relatively low (Zenker and Bührig 2022).

8. Al Hārah Al Fawqā. Al Maḍafah: The condition of the roof before (spring 2018) and after the reconstruction, 2023 (photos by Claudia Bührig [top] and Olga Zenker [bottom], courtesy of DAI).

We inspected the roof structure in May 2022. The surface of the roof had remained almost undamaged through the rainy season; only at the edge and along the arches had cracks formed and allowed water to penetrate the interior. These cracks appeared for several reasons, but foremost that the smoothed

roof skin was not flexible enough to support the shifts caused by the shrinkage of the material.

The cracks occurred at the transition from roof to masonry because the roof structure has a different expansion behaviour than the hard stones in the masonry. The roof covering should therefore have been made flexible enough to compensate for this behaviour. Instead, however, the intensive compaction with stone rollers had hardened the surface as intended, creating a water-repellent layer: the material resisted any compressive load but was unable to absorb the tensile forces of the swinging roof, which in turn caused the cracking.

It became clear that the layer of thorns was originally applied to cushion the movements in the roof. In our reconstruction of the roof, we had underestimated the cushioning function of the thorns. The continuous compaction of the layers compressed the thorn layer to such an extent that a dense, almost monolithic roof was created. The whole roof had become an inflexible structure, and its inevitable movements could no longer be absorbed.

Although the material used corresponded in structure and composition to the materials identified in the historic roof structure, and the appropriate tools were also used, the compaction was too intense: it changed the structural interaction of the materials in such a way that consequential damage occurred. We addressed this by making a new recommendation that only the last layers should be compacted in order to maintain the flexibility of the materials, and we put this recommendation into practice. The cracks were closed to prevent any further water penetration. A new layer was applied to the roof, but first

the whole surface had to be roughened to ensure a good connection with the new material. We will complete the roof in 2023, thanks to the participation of a great many workers, project stakeholders, and other partners.
