Conservation and Community Participation at the Palace of Prince An Naq Al Jamdār in Historic Cairo for Use at Similar Sites

Abstract

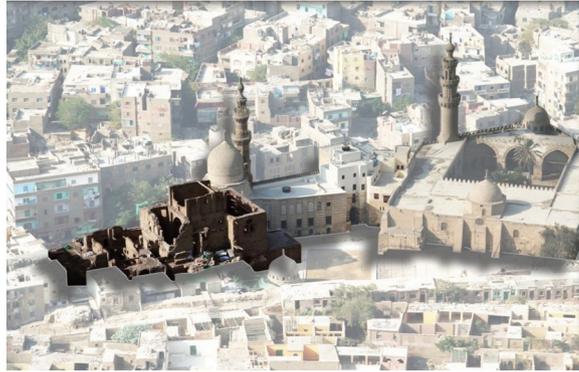
1. Aerial photograph of the general site of Qasr Al-Naq (photo by Aga Khan Cultural Services, Egypt, November 2004.)

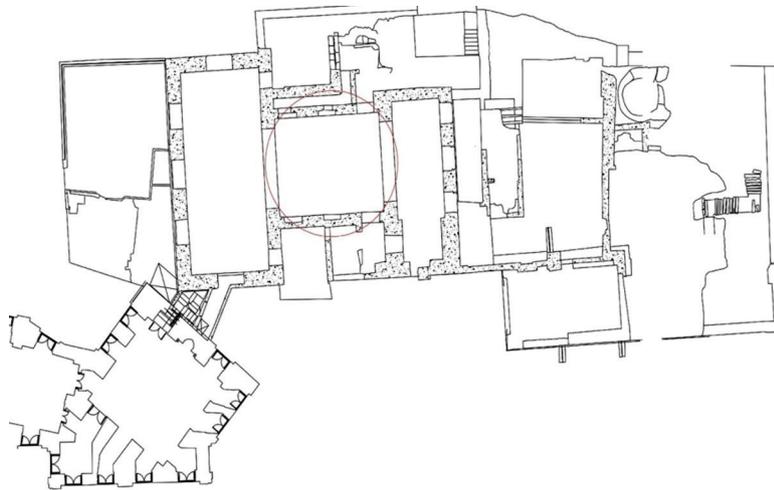
2. Plan of Prince An Naq palace showing the ground floor (drawing by Aga Khan Cultural Services-Egypt, November 2004).

The external and internal facades were built out of fine equal-sized limestone blocks. Previous interventions were carried out by the Comité de Conservation des Monuments de l'Art Arabe from 1881 to 1961 by removing additions that were not original to the palace, in addition to restoring some of the walls. The main entrance, located on the western facade, was decorated by stone muqarnas (stalactites), in addition to green and white marble. The entrance square is covered by a painted wooden ceiling decorated with an inscription recording the name and titles of the owner. This type of ceiling is one of the rarest types of Mamluk ceilings that survives, using a unique technique combining canvas over wood covered with painted and gilded plaster. The ground floor consists of the main entrance hall marked by stone muqarnas bearing paint remains. The ground floor also contains the courtyard, stable, and a passageway between the courtyard and the stable (FIG. 2). The first floor consists of the Main Hall of the palace and its annexes represented in the Northern and Southern Iwan and Darqa (FIG. 3).

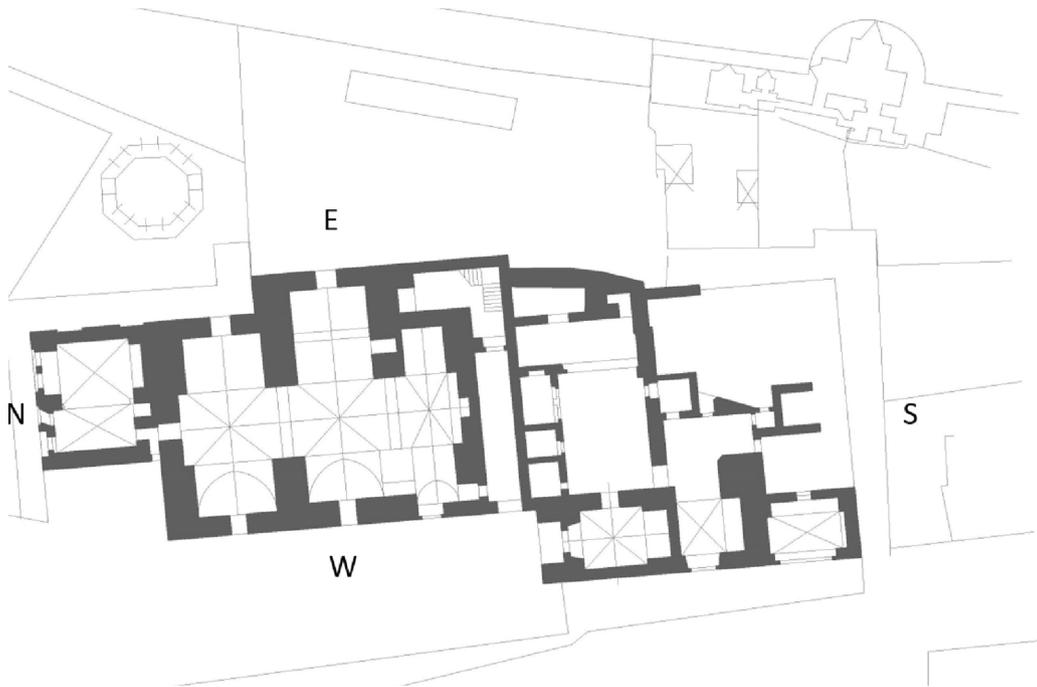
3. Plan of Prince An Naq palace showing the first floor drawing by by Aga Khan Cultural Services–Egypt, November 2004).

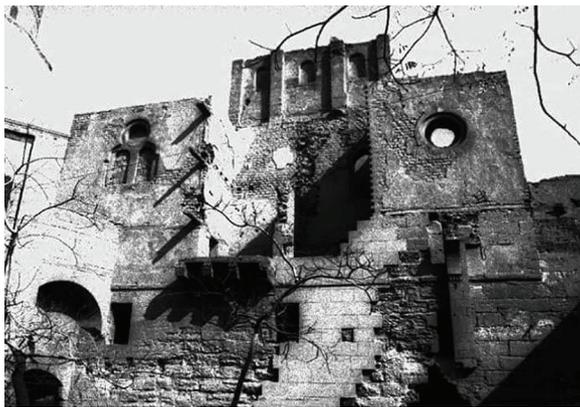
4. An Naq palace, west façade (20th century) (photo from the Archives of the Antiquities Registration Center in the Citadel, 2002).

At the beginning of the documentation process, which was followed by training operations, all available old documents and previous studies were collected. This process succeeded with assistance from responsible authorities such as the Ministry of Tourism and Antiquities (known at the time as the Supreme Council of Antiquities, affiliated with the Ministry of Culture). A group of glass slide photographs from the early twentieth century and the late nineteenth century was also collected. These documents were considered in the evaluation of the palace's state at the beginning of the twentieth century up to the time of restoration in 2004. Exam-

ples are shown in Figures 4 and 5 dating between the years 1900 and 1983.

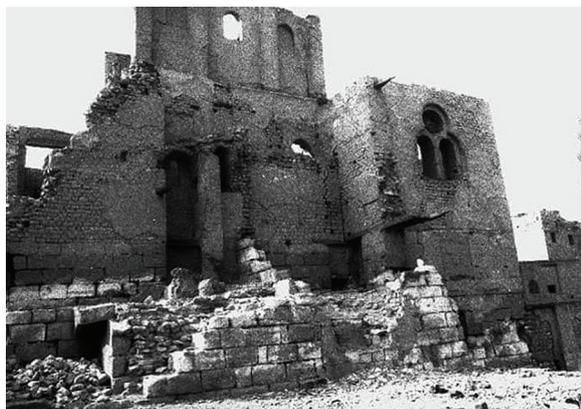
5. An Naq palace, east façade (20th century) (photo from the Archives of the Antiquities Registration Center in the Citadel, 2002).

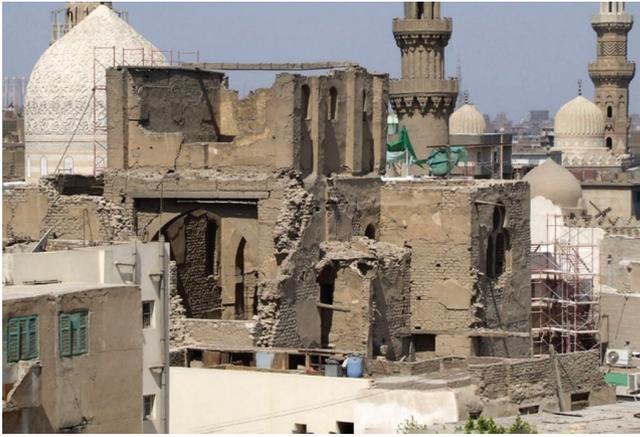
- Partial and total loss of large areas from the wall structure (FIGS. 6 and 7).
- Calcifications and color change on stone surfaces, both external and internal (FIG. 8).
- Deformation of artistic elements, such as hidden stucco windows.
- High water content in external facades.
- Deterioration of external and internal plaster coatings.
- Loss of all wooden ceilings in the halls on the first floor.
- Wood and metal elements, as well as marble wall decorations.
- Blurring of writing features and the decorations of the interior walls.
- The presence of cracks and vertical breaks in walls.

6. An Naq palace, external walls conditions (photo by Aga Khan Cultural Services-Egypt, December 2004).

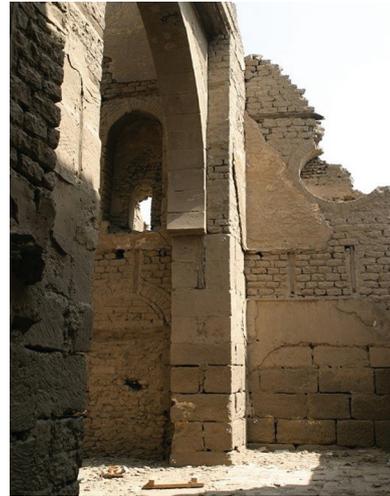
7. An Naq palace, internal wall conditions (photo by Aga Khan Cultural Services-Egypt, December 2004).

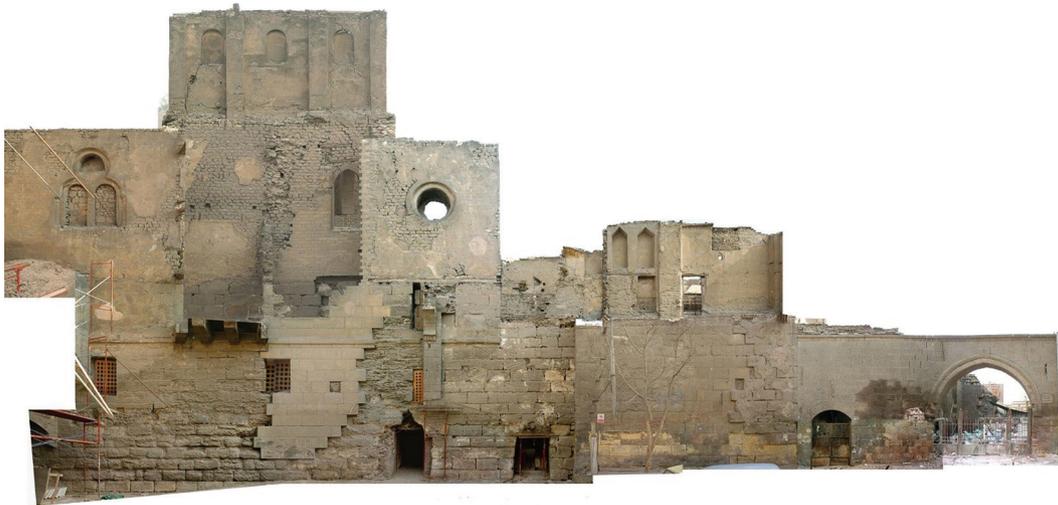
8. An Naq palace, condition of walls consisting of stones, bricks and plaster (photo by Aga Khan Cultural Services-Egypt, photogrammetric team, January 2003).

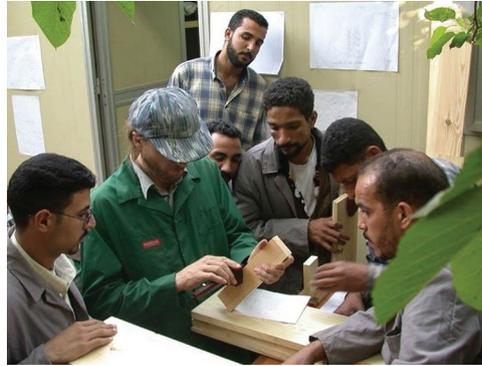
9. Activities of the restoration and training workshops with specialists in craft art (photo by Aga Khan Cultural Services–Egypt, October 2002).

The start of the restoration project involved training the people of Ad Darb Al Ahmar to increase the knowledge of the local population, utilizing social participation to create a cooperative generation that is bound to preserve its material heritage and history. The process of fully documenting all the elements of the building was carried out to record and monitor the level of deterioration and the current condition of the structural, architectural, and artistic elements of the palace (FIG. 10). This included risk analysis and development of restoration, preservation, and restoration solutions. This knowledge was applied in the training workshops that were coordinated on site and in work with local individuals with architectural, artistic, historical, and archaeological educational backgrounds under the supervision of specialists.

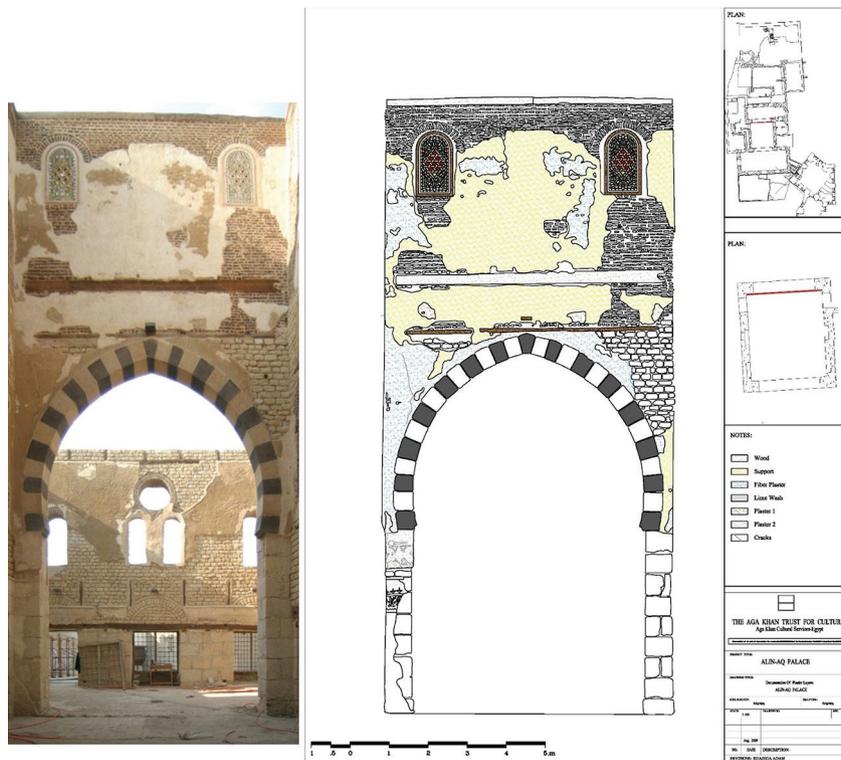
10. Example of the documentation processes of an internal wall from the An Naq Palace (photo and drawings by K. Adam, Aga Khan Cultural Services-Egypt, May 2007).

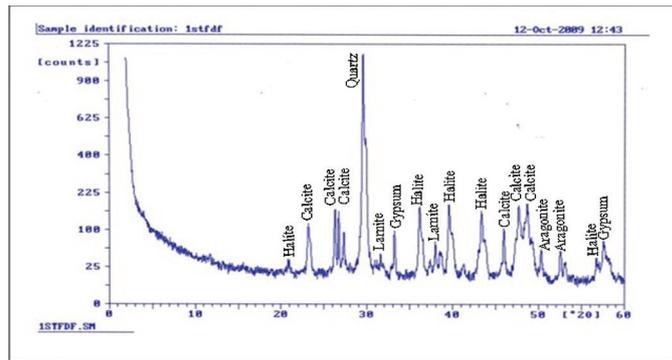
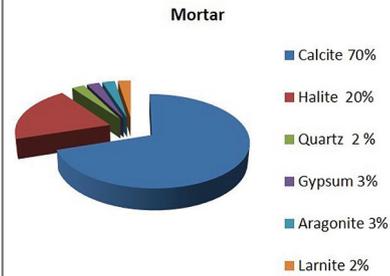
The building materials were studied and analyzed and their qualities were evaluated using non-destructive samples and techniques (FIGS. 11 and 12). After that, restoration materials were

X-Ray diffraction

chemical analysis

- Examples of tests and examinations of building materials that were carried out on the original building elements (image from mineral investigation lab report, Egypt, 2005).

Layer No. 1	Canvas with dark brown color 350 μm	الليف المنسوجة بلون بني شامق 350 μm
Layer No. 2	Light brown layer 400 μm	طبقة ذات لون بني فاتح 400 μm
Layer No. 3	Light brown layer 475 μm	طبقة ذات لون بني فاتح 475 μm
Layer No. 4	Red color 75 μm	لون أحمر 75 μm
Layer No. 5	Dark brown layer 25 μm	طبقة ذات لون بني شامق 25 μm

- Examples of tests and examinations of ceiling wood paints back to the beginning of the era of the construction of the palace (photo from Blaise Pascal University lab report, France, 2005).

proposed for use based on the results of previous material tests, including the application of practical test samples that preceded actual application on the archaeological building.

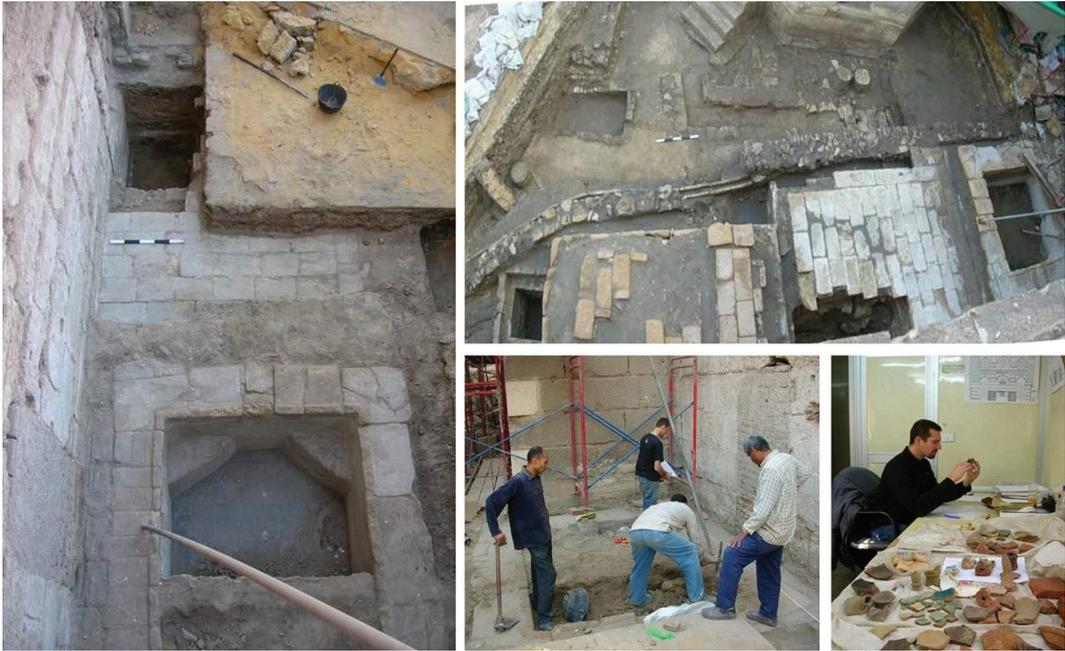
13. Excavation activities with the specialists and local community members in An Naq palace (photos by Aga Khan Cultural Services–Egypt, May 2005).

Excavations were conducted in the building by international and local specialists in the field (FIG. 13). Selected trainees from the local community were combined with students who study archaeology and excavations with regional Egyptian universities. The objective was the documentation of archaeological material to provide additional historic information on the archaeological aspects of the building, to use in the implementation of the restoration.

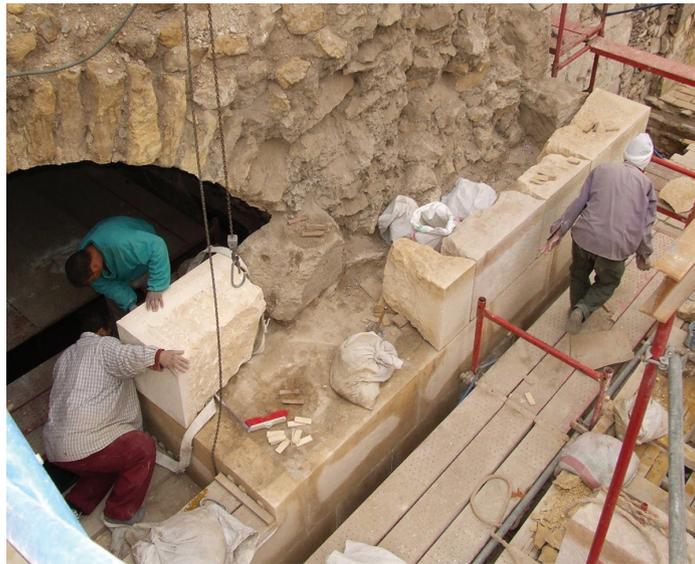
14. Masonry work activities with the specialist and local community members in An Naq palace (photo by Aga Khan Cultural Services–Egypt, March 2008).

Among the most important traditional crafts in Islamic buildings was the art of building with stone, and the wonderful Islamic structures left to us illustrate this, especially in the Mamluk period. The restoration process for the crumbling walls of the palace was one of the most important, difficult, and dangerous parts of the training school for technicians and craftsmen specialized in building with heavy stones and bricks (FIG. 14). The stone restoration training process included a large area for education in the arts of building and architectural craft with the transfer of experiences. All the building materials that were used in the restoration operations of the palace were of the same quality as the original building materials that were studied, and their components were identified using correct scientific methods. We were also able to implement the goal of field training for participants from the region during the implementation of the restoration operations in their various stages. There was also a cooperative effort combining the craft of building masonry and the craft of carpentry in making wooden forma-

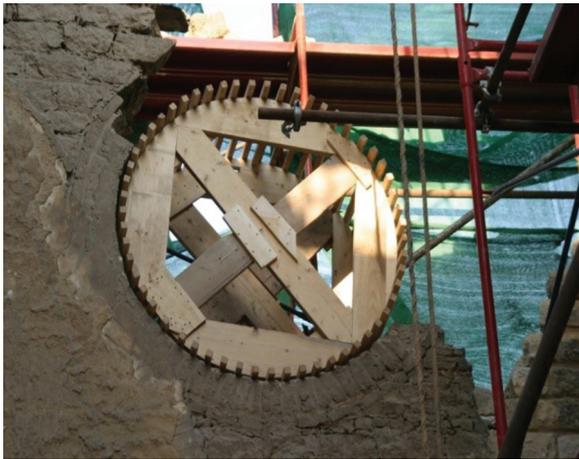
15. A project showing the application and synergy of carpentry and masonry in An Naq palace (photo by Aga Khan Cultural Services-Egypt, March 2008).

tions that were used to set up rounds for the openings in the walls of the Mamluk buildings, so that the builder and stone cutter could rotate around them and build the required shape (FIGS. 15 and 16). It is known today as the "Farma."

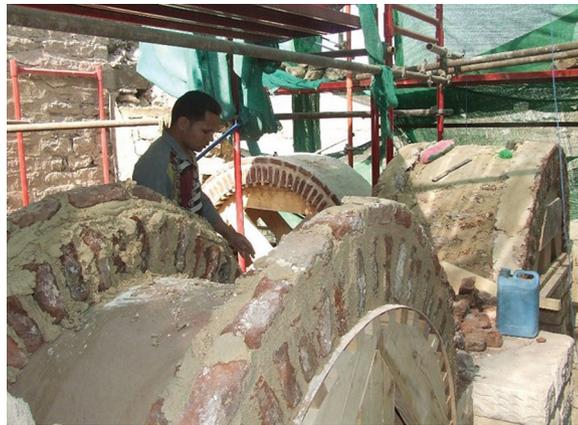
16. A craftsman at work with the “Farma” in An Naq palace (photo by Aga Khan Cultural Services-Egypt, March 2008).

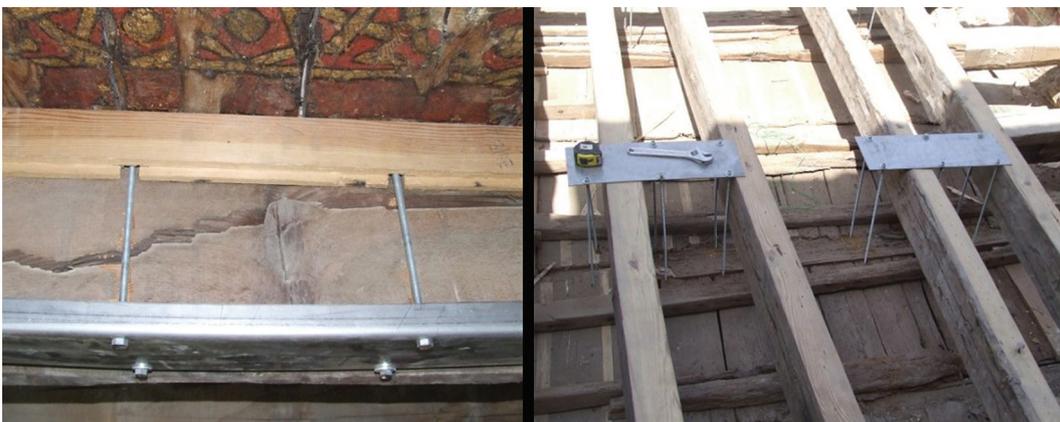
17. The wooden ceiling suspension and support system for An Naq palace entrance (photo by K. Adam, Aga Khan Cultural Services-Egypt, April 2005).

Along with the training and restoration programs that were applied and implemented in the reconstruction and restoration of the Mamluk palace, there was another aspect necessary in the process of preserving the historic building: the use of modern building techniques to preserve certain features. One these techniques was an isolation process that had to be implemented to protect the ancient archaeological ceilings from further decay, especially the ceiling of the entrance that was shown to be a distinctive and unique style. It used canvas covered with a layer of colored plaster that was applied to barrels and panels of Azizi wood.

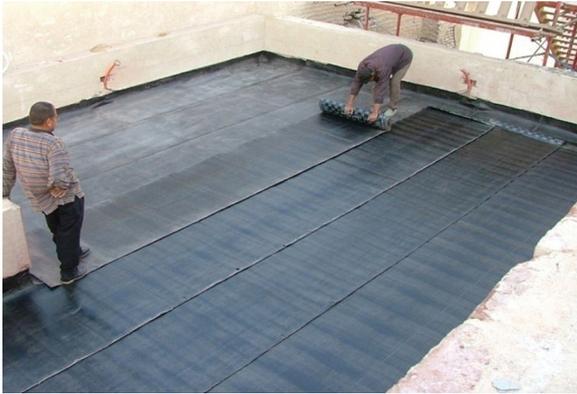
Restoration operations that were carried out on the ancient wooden ceiling of the palace entrance revealed complete damage to the upper insulation layers, in which organic materials such as mats and baskets were used, that led to damage and leakage of rain over continuous periods of time. As a result, the layers of canvas and paints were damaged. The correction process involved removing the old loads and the backfill that damaged the ancient roof. The next step was the consolidation and bonding process by hanging the old roof in a relief roof above it. The new roof was supported from above with walls that passed a structural study (FIG. 17). Roof insulation materials, such as polyethylene, were used to protect against moisture, and heat-insulating foam sheets were also employed. These were placed on top of the new layer of panels, which were used to cover the suspension bolts that were used to support the

18. The modern isolation treatment for the palace entrance wooden ceiling to protect the historic canvas and paints (photo by K. Adam, Aga Khan Cultural Services-Egypt, April 2005).

original roof (FIGS. 18 and 19).

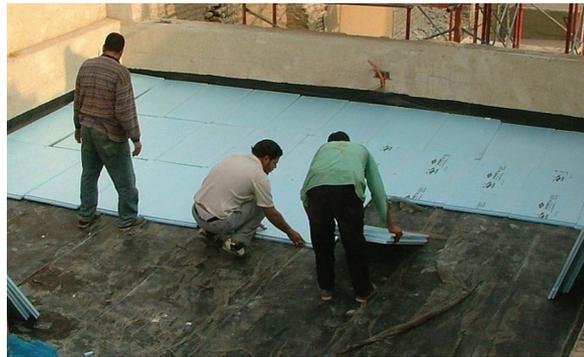
19. The modern isolation treatment for the palace entrance wooden ceiling to protect the historic canvas and paints; second view (photo by K. Adam, Aga Khan Cultural Services-Egypt, April 2005).

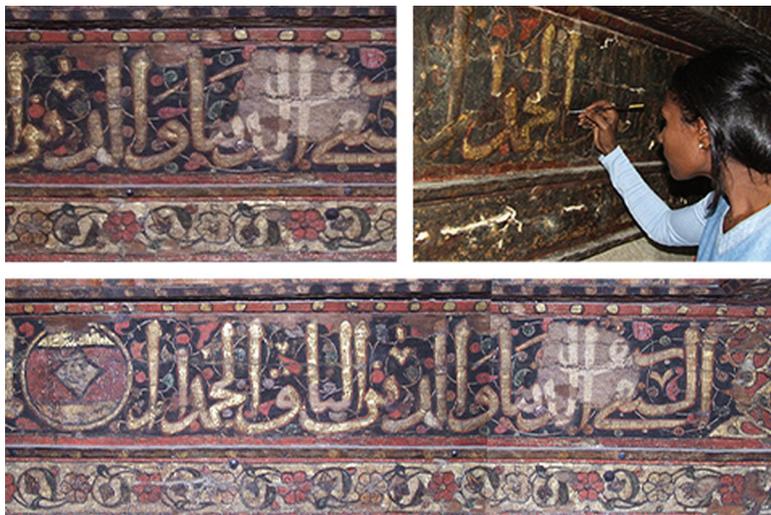
20. The painted wooden ceiling during and after conservation of the An Naq palace entrance (photos by Aga Khan Cultural Services-Egypt, April 2005).

This was followed by the treatment and restoration of the decorated ceiling from below, including the restoration of wood, layers of canvas, paints, and layers of gilding (FIG. 20). This was done by applying the field school training method in which specialists in the field, recent graduates, and technicians and trainees from the region worked together. Studies and analysis of the ancient craft methods used on this ceiling have revealed one of the masterpieces of Mamluk art: the wooden ceilings covered with a layer of colored canvas from that era. Further details can be read in Adam (2012).

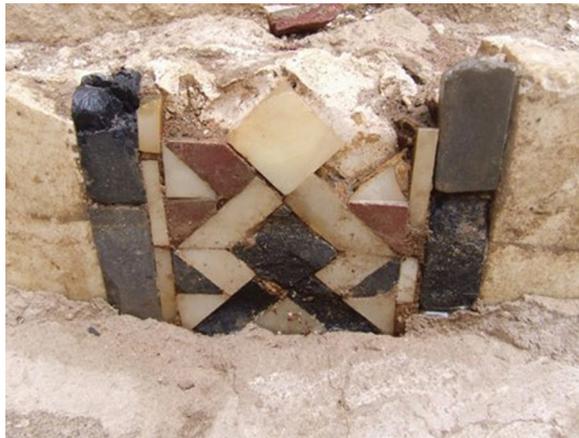
21. Traces of the marble decoration from interior walls at An Naq palace (photo by Aga Khan Cultural Services–Egypt, April 2005).

This program also focused on training in and the practice of one of the most important crafts that characterized Mamluk buildings, marble for floors and walls (also known by some as scrap marble) (FIG. 21). Revault and Maury (1982) describe the use of marble inside structures from the Ottoman period as an extension of Mamluk decoration. The marble in the palace exists as remnants and facades, and there are also remains of scrap marble inlaid with mother-of-pearl in the interior walls of the palace.

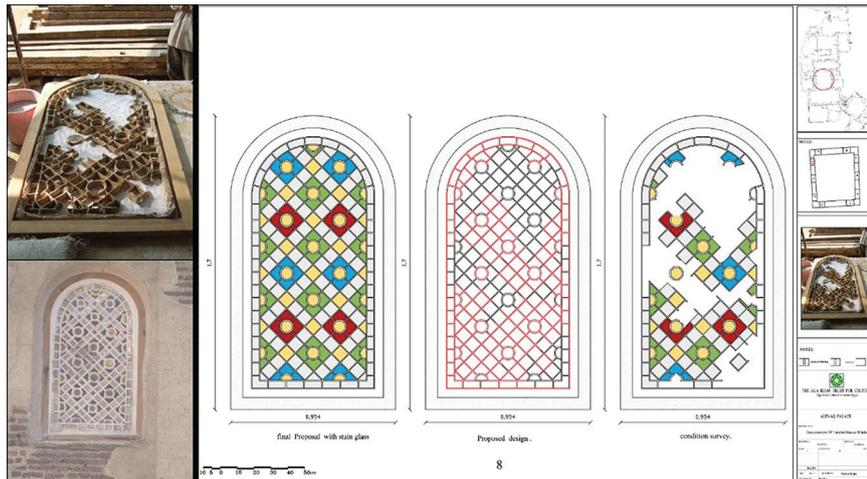
22. The stained-glass windows conservation process at An Naq palace (photos and drawings by K. Adam, Aga Khan Cultural Services–Egypt, March 2008).

Another of the handicrafts that the training program worked on preserving and reviving was the craft of stained-glass plaster (FIG. 22). This craft was widespread in other Mamluk structures and was one of the key aspects that gave the buildings something of a distinctive spirituality, due to the penetration of sunlight through the colored glass with a geometric design. Many of these stained plaster windows were detected in the palace. They were hidden under the layers of mortar high on the interior walls of the halls. This is one important part of the full detection documentation that assisted in the restoration and revealed historic information.

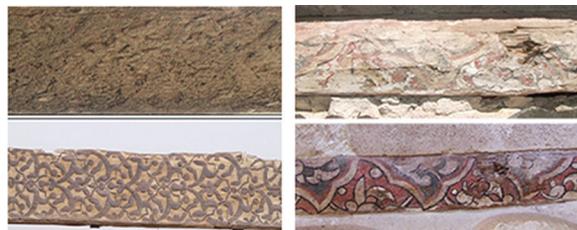
some cases reached eleven layers. The wood that was used in construction was discovered inside the walls and that discovery revealed that it had distinctive decorations. This indicated that the wood pieces were re-used from previous buildings, or parts that were renovated inside the palace. Figure 23 show examples of decorated wood.

23. Discovery of decorated re-used wood found in interior walls from An Naq palace (photos by K. Adam, Aga Khan Cultural Services–Egypt, March 2008).

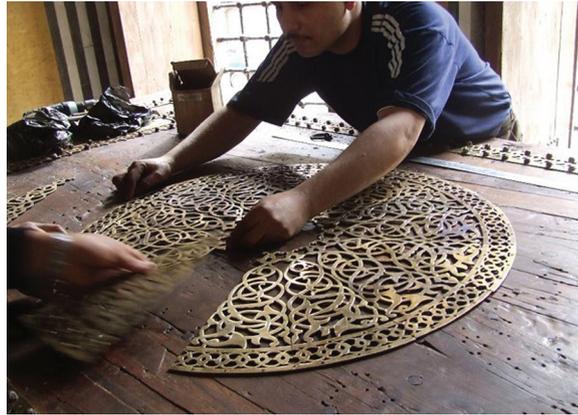
24. Part of the training workshop on the ornamentation of copper repose on wooden doors (photo by K. Adam, Aga Khan Cultural Services-Egypt, July 2008).

The writings on stone that were in the process of disappearing, especially in the entrances, went through a process of detection, documentation, and restoration. The writings mainly consisted of Quranic verses, dates of creation, and some supplications. Ultraviolet light was utilized to enhanced imaging to read the size and shapes of the scattered lines, using the same technique as Villers (1981). Finally, training in metalcraft, especially copper (FIG. 24), was also done by specialized craftsmen as it was always used in the decoration on wood, a phenomenon that was characteristic of the doors of Mamluk buildings.

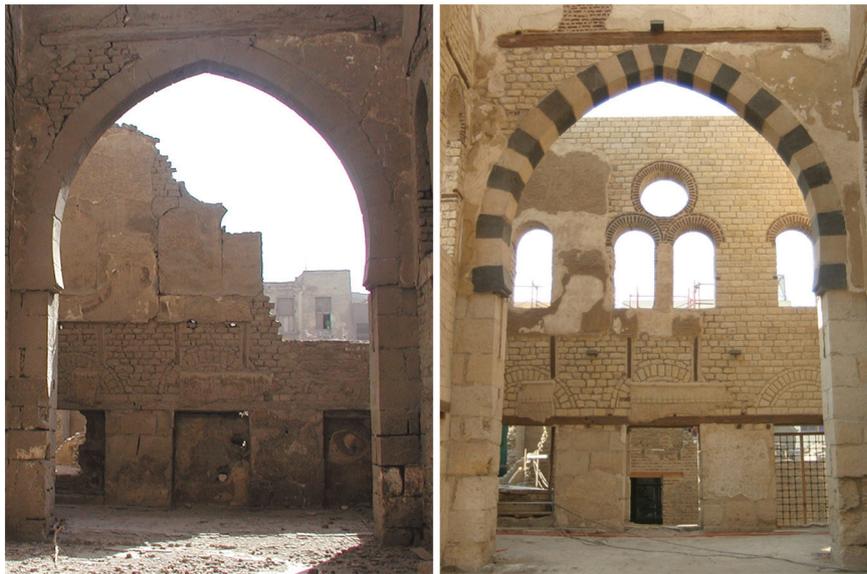
25. Photograph of one of the walls in the palace, showing before and after restoration (photos by K. Adam, Aga Khan Cultural Services-Egypt, July 2008).

This project contributed to the rehabilitation of an important historical neighborhood suffering from limitless problems of neglect (FIGS. 25 and 26). Recently, there has been a cultural shift to turn the area into a tourist attraction and international destination. Coordination was arranged between the Ministry of Tourism and Antiquities with the Aga Khan Foundation to train Egyptian youth from the Ad Darb Al Ahmar community, in order to transfer the experience and knowledge from the older generation to the younger generation and to help ensure the continual fabrication of historical regional crafts.

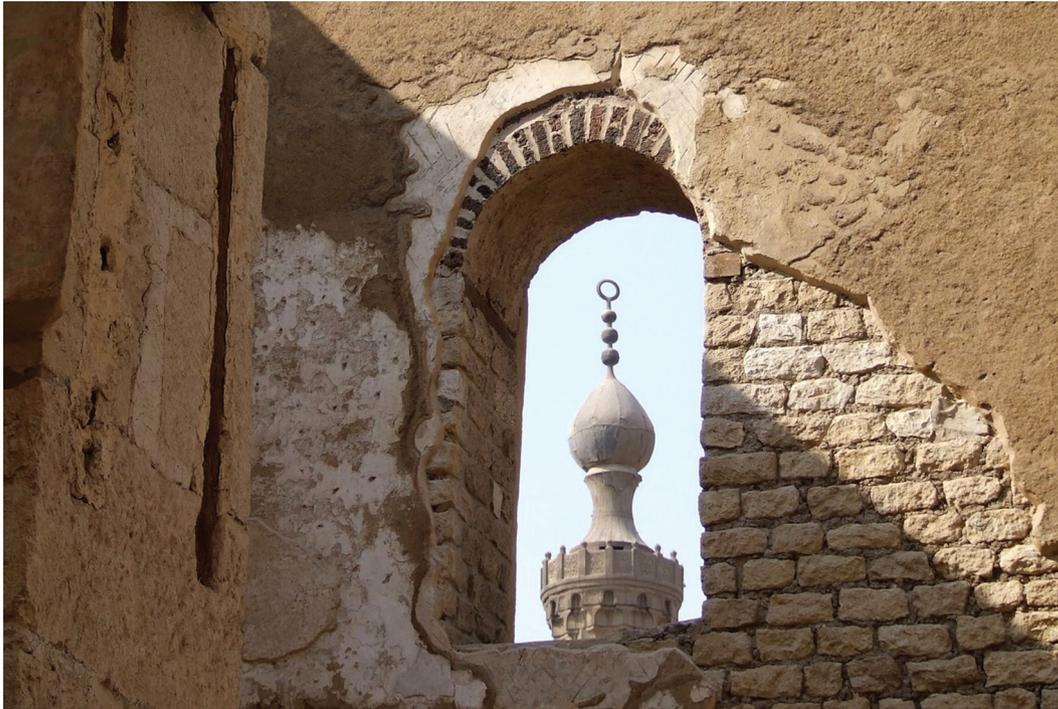
26. Photograph of one of the walls in the palace after restoration (photo by K. Adam, Aga Khan Cultural Services-Egypt, January 2009).
