THE SECOND SEASON OF EXCAVATIONS AT UDHRUḤ PRELIMINARY REPORT

Fawzi Abu Danah, Mansour Shqiarat and Hani Falahat

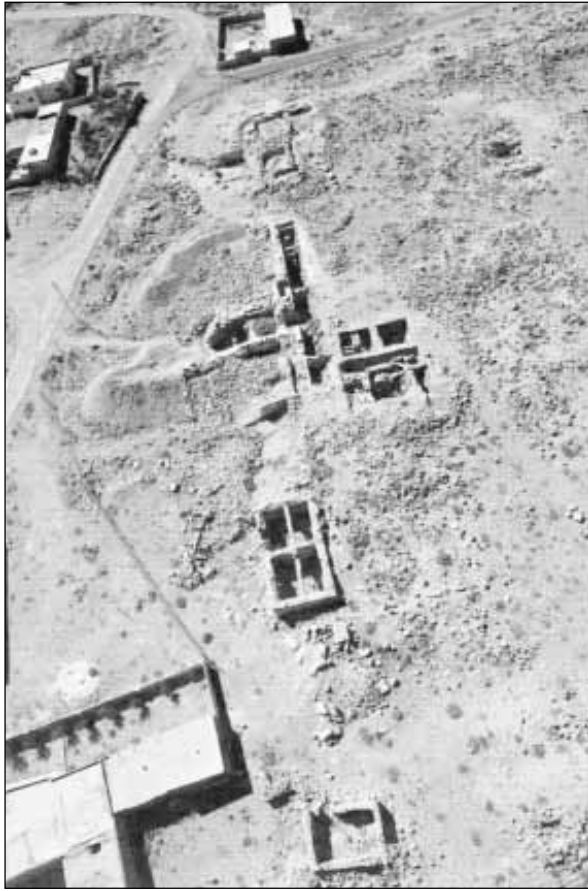
2. Oblique aerial photograph of the excavation area, taken by D. Kennedy in 2009 (Ref. APAAME_20090930_DLK-0299).

At the beginning of the season an area, designated Area 2, was chosen for excavation. Towards the end of the project, the team decided to excavate the interval tower adjacent to Area 2 as an open area. The area of excavation was located within the fortress on its eastern side, along and very close to the curtain wall. Five squares, each 4 x 4m, were laid out. To the east, the baulk line was located almost in the middle of the thick curtain wall; at least 1m of the curtain wall was therefore included within the squares. The excavation area was both relatively free of stones and debris, and relatively flat. There was also space for a spoil heap outside the site, yet very close to the excavated area.

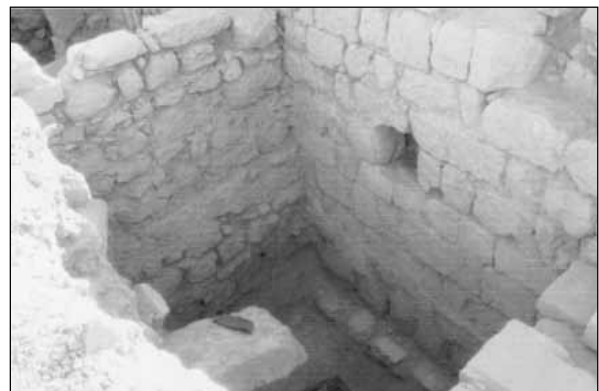
3. The walls and foundation stones in Area 2, Square 05.

The joints between the stones appear to have been originally coated with plaster, but this is not well preserved along the entire wall. Having cleared the topsoil, a few stone alignments started to appear in Squares 03, 04 and 05. These turned out to be shallow and were probably the remains of animal corrals built against the curtain wall in the 18th or the 19th centuries. Some alignments were even located above the uppermost preserved course of the curtain wall of the fortress. The progress of work revealed proper walls, fairly well preserved, which about the pe-

rimeter wall and extend westward. They were documented in Squares 01, 02, 03, 04 and 05, but vary in stonework, height, width and function. At the same time, it can be recognised that some of these walls belong to the same period and have a specific function. For example, the two walls in Squares 03 and 04 are parallel and have what seem to be arch springs. The space between the two walls is about 9m. These and the other walls also seem to have undergone some restoration and reconstruction. The function of these walls can be quite confusing, as in Square 05 where three walls within the square abut the curtain wall, but the one in the middle does not run all the way through the west baulk. It just projects for *ca.* 1.5metres from the Roman wall. In Square 03, a stairway was discovered in the north-east corner and is still intact. It clearly leads through a doorway to the upper floor of the interval tower excavated in the open area, giving access to the walkway along the top of the curtain wall between the towers. In a later, post-Roman, period, the door was blocked by a two row wall preserved to a height of almost 2m (**Fig. 4**).

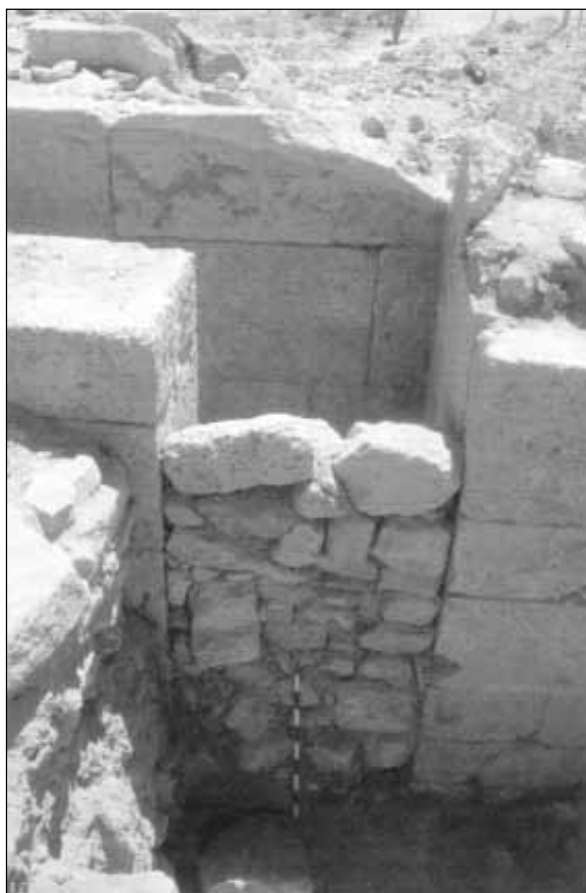
4. Roman staircase in Square 03, blocked by a later wall.

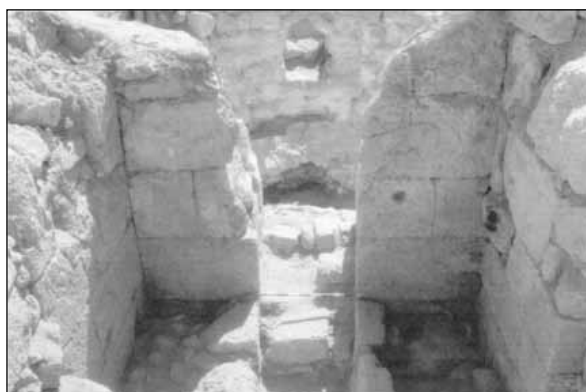
5. Doorway of the interval tower in Square 02.

Significantly, the area within Square 02, which is accessed by the doorway is paved with rectangular slabs. Right in the north-west corner of the same square and contiguous to the paved floor, a twelve metre deep hole was discovered. The shaft opening was covered with a large

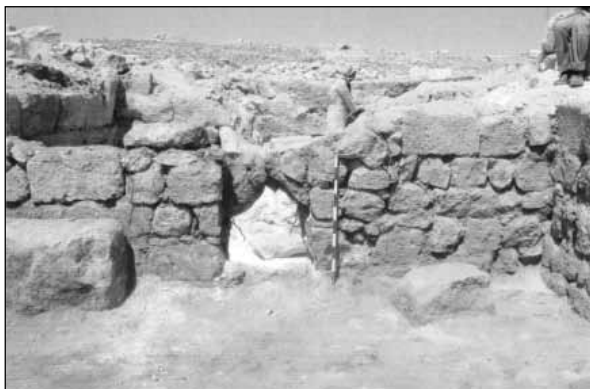
6. Partition wall in the centre of the interval tower, in the open excavation area. The lime kiln is behind the wall; the aperture in the centre was used to feed the kiln with charcoal.

stone, under which is an arrangement of stones bedded into the ground to form an entrance or 'mouth'. The function of this hole is puzzling and, at this stage, it can be suggested — amongst other hypotheses — that it was part of a drainage system, or perhaps simply a cistern to collect rainwater. The architectural features in the open area around the interval tower are indeed remarkable. The tower's original architecture

consists of a U-shaped projecting tower built against the curtain wall. Its wall has two rows filled in with rubble; both the internal and external rows are constructed of limestone ashlars. Like other interval towers at the site, it had a vaulted roof and there is a possibility it consisted of two floors. In a later period, this interval tower was clearly re-used for industrial purposes. It was divided into two parts, separated by a two row wall. The first part, between the doorway of the tower and the later wall, was used as a lime kiln. The kiln itself was constructed of small stones fixed with mortar, and was almost circular and approximately three metres deep. Immediately below the topsoil was a soft, white layer of lime, which continued down to a considerable depth, almost to the bottom of the kiln. Underneath the lime layer was a layer of ash and charcoal. Towards the bottom of the kiln, the circular wall narrowed; in other words, the diameter at the base is far less than that of the top. The second part of the tower appears to have been used to produce charcoal for the kiln, high temperatures being required for lime production. Excavation in that part of the room exposed a wide layer of ash. The charcoal seems to have been shovelled into the kiln through a small aperture located in the centre of the partition wall (**Fig. 6**).
