JARASH. EXCAVATIONS OF THE TRAPEZOIDAL SQUARE IN THE SANCTUARY OF ARTEMIS: PRELIMINARY REPORT OF THE 1999-2000 SEASONS*

Massimo Brizzi, Mariella Mastrogiacomo and Daniele Sepio

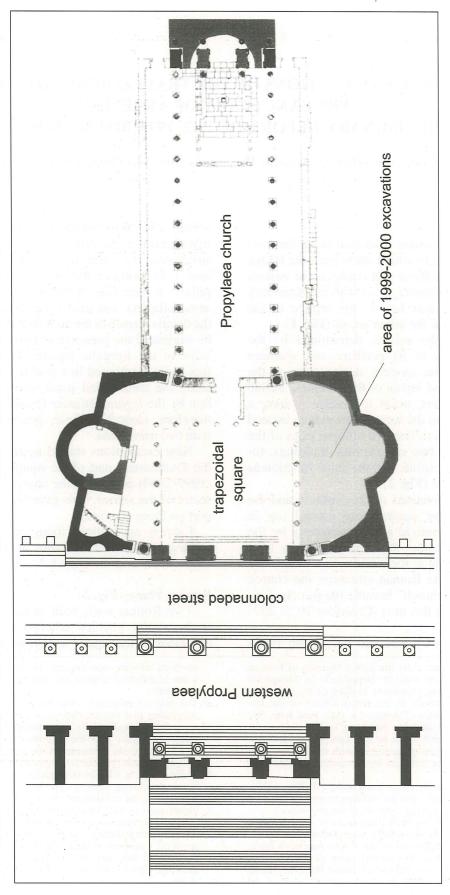
1. Jarash. Via sacra of the Artemis Sanctuary and position of the trapezoidal square.

The trapezoidal square is located along the lower part of the *via sacra* which starts from the bridge on the Chrysorhoas River and connects the eastern part of the city of Jarash (جرش) with the Sanctuary of Artemis. The latter lay on the terrace in the northwestern part of the urban sector (Fig. 1).

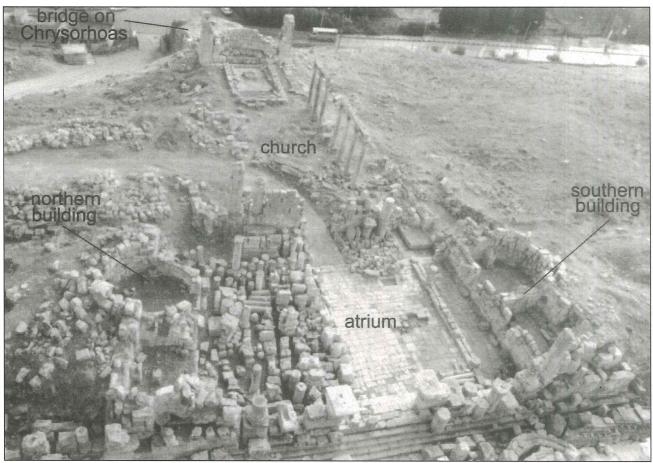
2. Jarash. View of the lower part of via sacra of the Artemis Sanctuary, from the west.

The shape of the square, determined by the oblique orientation of its northern and southern sides, suggested the modern designation of the area. The fan-shaped layout of the complex, beside the colonnaded street, made it possible to have a wider view across to the western *propylaea* located on the opposite side. The two oblique sides of the square, formed by two symmetrical buildings, today only partially visible, had the same function as the wings of a scene (**Fig. 2**).

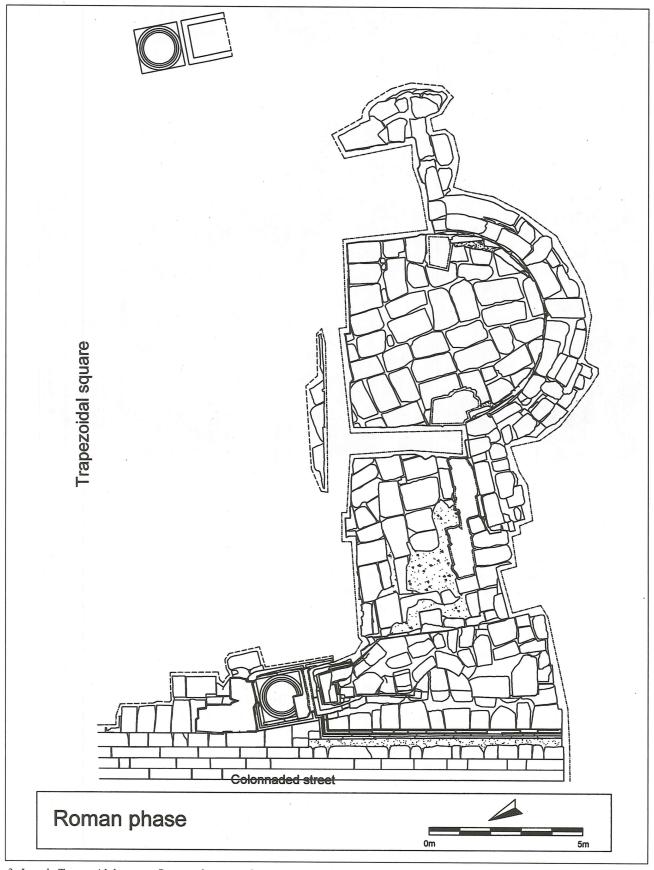
3. Jarash. Trapezoidal square. Roman phase top plan.

Roman Phase (Fig. 3)

Two Roman walls built in square blocks found in the 1930s, enabled scholars to reconstruct the two sides of the square as symmetrical. The struc-

ture is visible on the northern side of the area as a central semicircular exedra placed between two walls finishing with two anta pillars preceded by two columns on pedestals.⁶

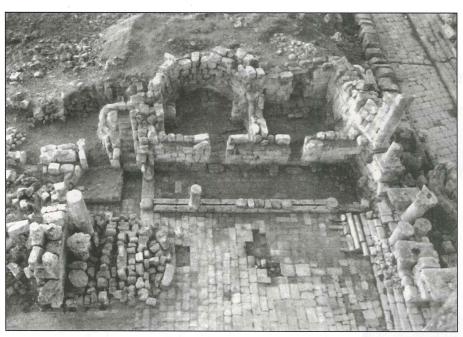
4. Jarash. Trapezoidal square. Excavation area from the north.

The new excavation of the southern part of the square revealed the imposing foundation platform of the wall already visible, dated to the Antonine period (Fig. 4). This structure, delimiting the southern part of the area, was built above a large surface constructed in limestone blocks, displayed in superimposed courses in the sector between the two anta pillars. The excavation has identified the presence of at least five courses (Fig. 5). It was not possible to excavate under the blocks. The building material is soft limestone cut in blocks of irregular quadrangular shape, with a flat upper face. Each block measures 0.90-1.40m in length and 0.65-0.80m in width. They are joined with sandy mortar mixed with ash, spread also on the upper part to receive the blocks of the course above, only partially

preserved in the western part. The visible blocks of this course (about 0.50m in height) are more regular and smooth than those of the lower one. There does not seem to have been particular concern for obtaining a regular surface. Instead, in the lower part a general arrangement might be suggested of a series of blocks laid in pairs alternately as headers and stretchers, although their irregular dimensions do not enable this pattern to be clearly seen. Occasionally in fact smaller blocks have been inserted to regularize the course. Despite these small insertions, the pattern of blocks follows the same orientation as a chord drawn across the exedra.

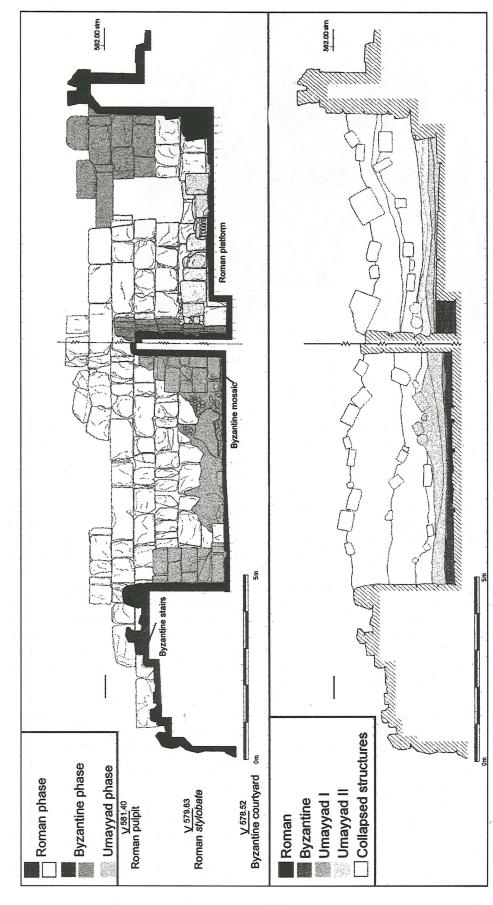
5. Jarash. Trapezoidal square. Southern building east-west sections showing: (upper) the elevation of the Roman wall with central exedra, the foundation platform and later structures; (lower) stratigraphy from the western and central apsed rooms.

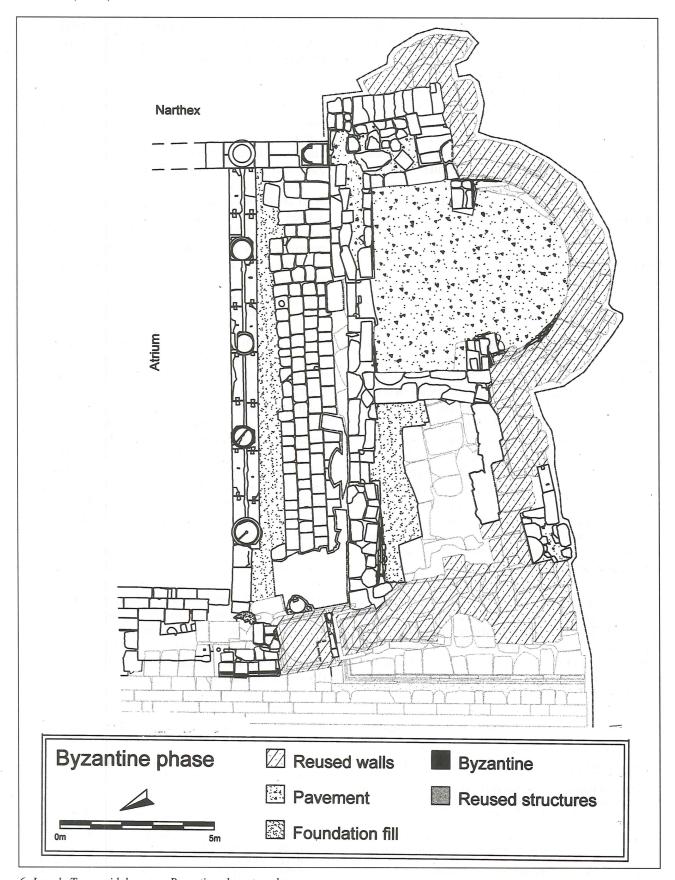
${\it 6. Jarash. Trapezoidal\ square.\ Byzantine\ phase\ top\ plan.}$

Byzantine Phase (Fig. 6)

The Antonine buildings did not show any particular evidence of transformation before the interruption of the via sacra, which brought about many modifications in its course between the bridge and the colonnaded street and in the function of the structures. The change was caused by the building of a church, located between the triumphal arch and the trapezoidal square. The area of the Roman square became the atrium of the church. Because the church was built at a lower level, the paved level in the trapezoidal square was lowered in height by about 1.10m, and so was the floor level of the lateral buildings. The western part, which opened onto the colonnaded street in the Roman phase, was blocked up by a wall with three passages. The same organisation was obtained on the east side, transformed into the front of the church. The narthex, paved with bicoloured stone tiles, was then constructed against this part.

The platform of the two lateral buildings was partially robbed and their function was changed.¹¹ Only the limiting wall and the central exedra were preserved. The entire platform was deprived of its upper four courses of blocks. The blocks of the foundation, sticking out of the masonry, were cut off and regularized, becoming themselves a part of the standing structure.

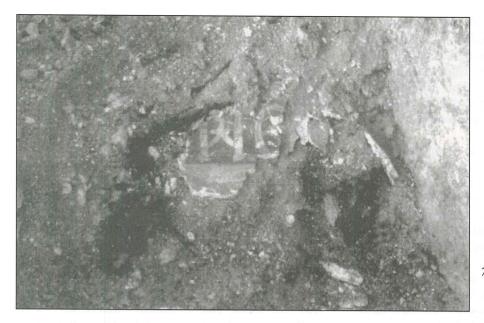
Jarash. Trapezoidal square. Inscribed plaster from the abandonment sand deposition in the apsed room.

Related to this restoration, but in any case carried out after the building of the arch, a new layer of coloured plaster, featuring geometrical and naturalistic subjects, was applied to the walls of the anteroom. On some fragments of this decoration found in the collapsed levels Greek inscriptions have been identified (Fig. 7). In the western room three blocks bearing some red painted Greek in-

After this occupation came a phase of abandonment, attested by the presence of aeolian sand deposition along the walls. On top of this layer were found fragments of painted wall plaster, which probably fell off the wall. Similar evidence appeared in the western room: here again a thick layer of sand mixed with clay attests to the abandonment of the area. A partial collapse of the building has been recorded in the apsed room, where the Byzantine arch fell down together with column fragments, probably from a colonnaded structure on the upper floor. Related to this first limited collapse, a partial use of the area has been recorded in the western room only. Here elements of the collapse were reused to create two benches

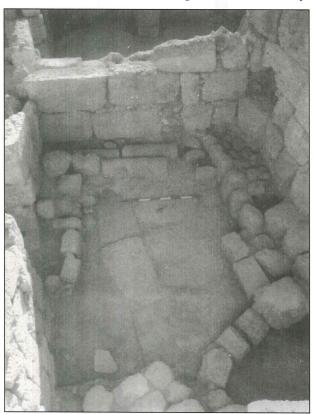
Jarash. Trapezoidal square. Late Umayyad phase: collapsed elements reused in benches in the western room.

along walls (Fig. 10).
