## THE PETRA GARDEN AND POOL COMPLEX, 2007 AND 2009

*Leigh-Ann Bedal, Kathryn L. Gleason and James G. Schryver*

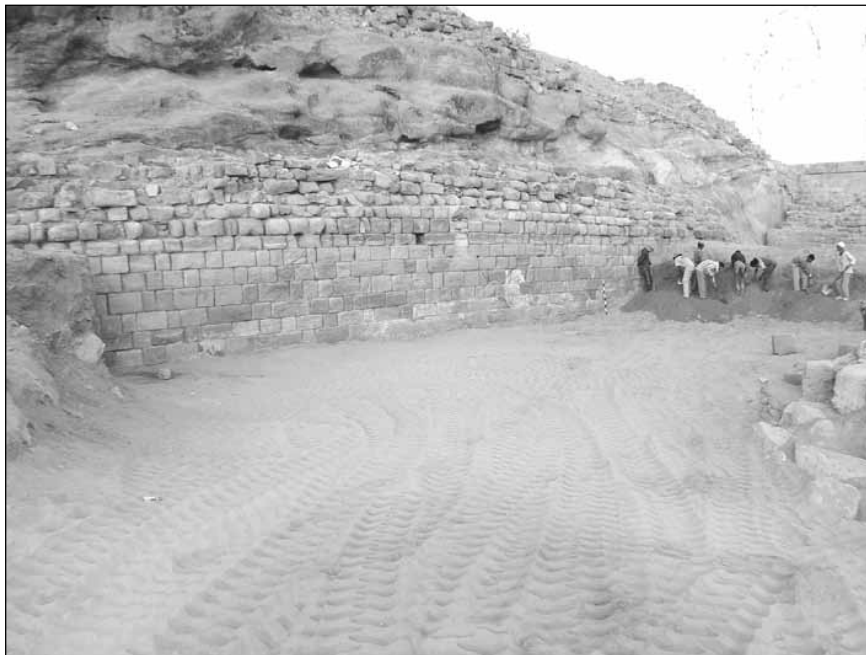
2. Excavating the sandy fill overburden between the island-pavilion (lower right) and south wall.

Working from east to west, the sandy fill layer was removed by setting a team of workers to excavate with picks and hoes, followed by the immediate removal of the soil with the help of heavy machinery (**Figs. 2 and 3**). A single course of stones running 6.5 meters east - west near the top of the fill (elev. 903.07 - 903.88 m) was documented and removed. These stones were probably laid down by early *bedouin* as a diversion wall for controlling water runoff. In addition to numerous large stone blocks and other architectural elements (including a complete Nabataean-style capital), material finds consisted of five bronze coins (all illegible except for one Nabataean coin of Aretas IV), several fragments of Nabataean- and Roman-period lamps, and pottery sherds of mixed dates, all of which are presumed to have washed down from az-Zantūr. At present, approximately one meter depth of collapse debris and sediment remains covering the pool's southern perimeter.

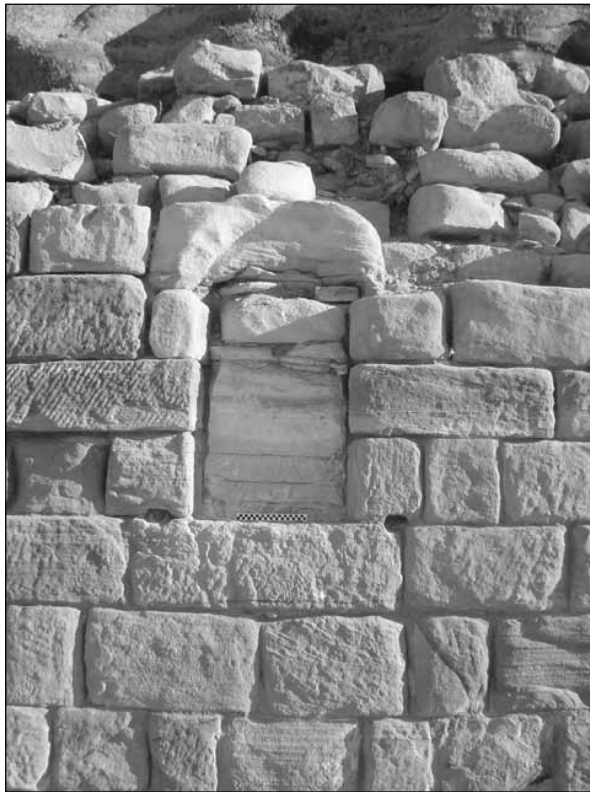
4. Central niche (*nefesh*) in the south wall façade.

height (the lowest courses remain unexcavated) and creates an imposing backdrop for the pool and garden. If originally covered in white plaster, as we assume, it would have shimmered with the reflections of the light off the water of the pool. At the center of the wall, about 3 meters above the floor level, is a *nefesh* with a simple limestone block set into it and topped by a badly eroded carved arch stone (**Fig. 4**). Two holes bored into the wall stones near the niche's bottom corners may have been used to hold a

shelf, or perhaps a plaque, in position below the niche. The location of this *nefesh*, at the southern terminus of the site's central axis and visible through the island-pavilion's southern doorway, indicates its symbolic importance in the overall design of the garden and pool complex.

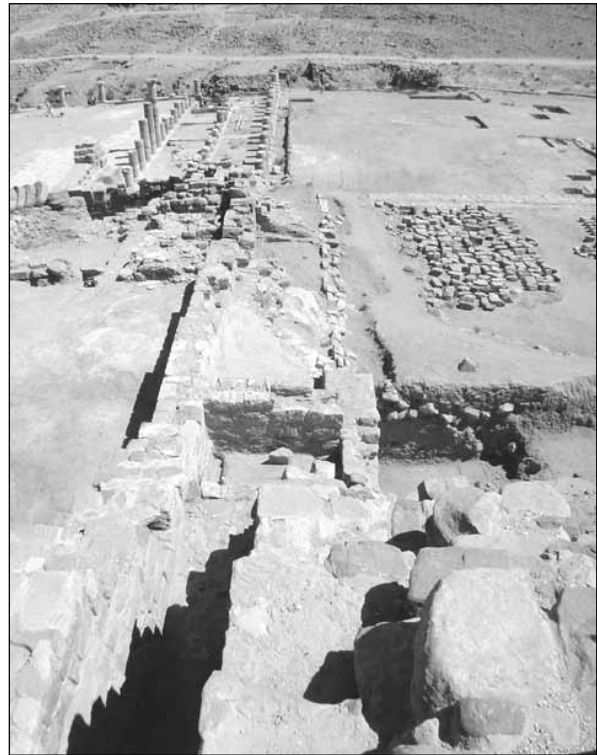
6. *The Great Temple east perimeter wall separates the Great Temple upper temenos (left) from the pool complex (right).*

Another area that required attention during the 2007 and 2009 field seasons was the western boundary of the pool area that adjoins the Great Temple upper temenos (Fig. 6). The west face of the GTEP wall was uncovered by the Brown University excavations, along with two of the intermural rooms (Room C and the small reservoir)<sup>5</sup>. However, the continuation of the wall to the north of the small reservoir remained unexcavated.

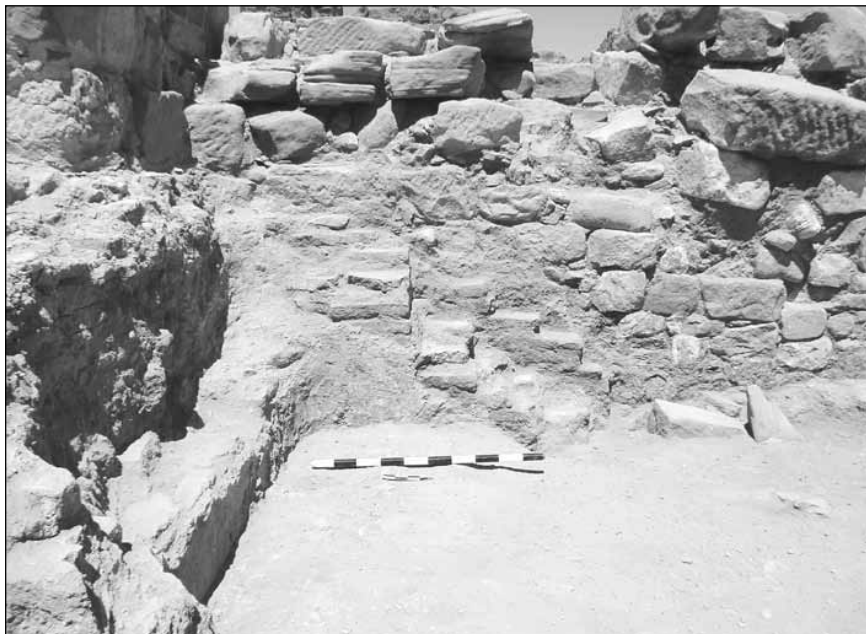
7. *Trench 20: the south end of the brick pool (with steps) built inside an intermural space in the Great Temple east perimeter wall.*

Trenches 20 and 21 were opened to define the eastern face of the northern extension of the GTEP wall (the southern portion was exposed in 2004, Trench 12) and to begin excavating the intermural spaces. Trench 20 defines a single intermural room immediately to the north of the small reservoir. Work here revealed the upper courses of a baked brick construction that lines the interior walls (dimensions 7.25 x 2.20 m). The walls are single brick width (36 cm) on all sides, with steps measuring a single brick width

in the southwest corner (Fig. 7). The interior face is lined with a thin coating of plaster. The bricks,

which measure 36 x 36 x 6 - 8 cm, are poorly fired with heavy chaff and are cemented with a crumbly grey mortar tempered with small pottery fragments (primarily Nabataean fine ware). Diagnostics include Nabataean painted pottery dating to the second century AD providing a *terminus ante quem* for the construction of this installation in the second quarter of the second century AD. The brick construction is similar to some of the construction in the bath complex west of the Great Temple that has been assigned to the Roman - Byzantine period (Joukowsky 2007: 154-8). It can thus be deduced that the brick feature represents a secondary use of the intermural space within the GTEP Wall dating to the second or third century AD at the earliest. The heavy use of mortar and plaster, in addition to the presence of steps in one corner, suggests its function as a water basin or pool. The center of the basin is badly damaged by a large pit, filled with large stones in a greyish - brown ashy matrix. The trench was closed and sandbagged to protect the poorly preserved bricks pending future study.

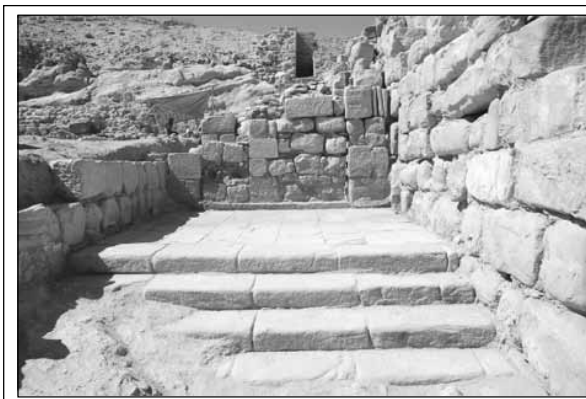
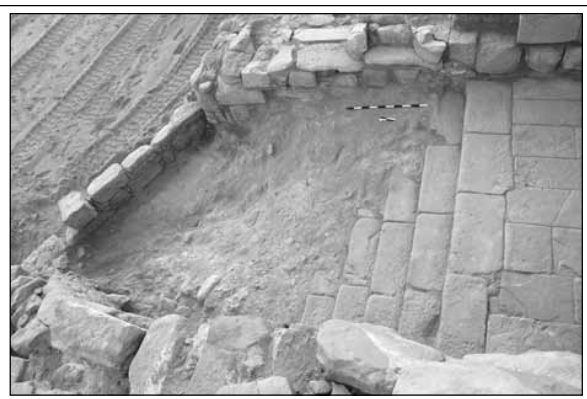
8a and b. Staircase leading from garden terrace up to the pool-level landing and the door to the foyer (a), which was later narrowed and blocked. A deposit of grey clayey soil covers the lower steps and extends into the Great Temple east exedra.

the bottom of the stairs (**Fig. 8b**) and the exedra floor, suggests that the material originated from the pool - perhaps an effort to clean rubbish and stagnant water accumulated in the now unmaintained pool - and was thrown (or poured) down to fill the staircase and the exedra. Later the foyer doorway was completely blocked and the staircase landing and foyer spaces partitioned with narrow dividing walls constructed of re-used stones, possibly representing a squatter settlement that likely coincides with the Late Roman - Byzantine squatter settlement (PGPC Phase VI, forth-fifth centuries AD). Above this lies a deep accumulation of collapsed debris consisting of stone rubble and large architectural blocks in a sandy matrix (PGPC Phase VII) (Bedal et al. 2007: 166).

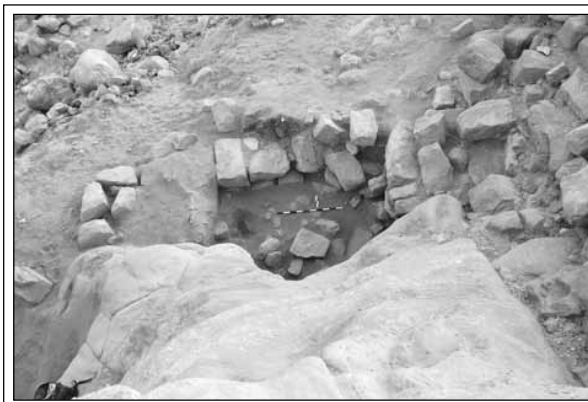
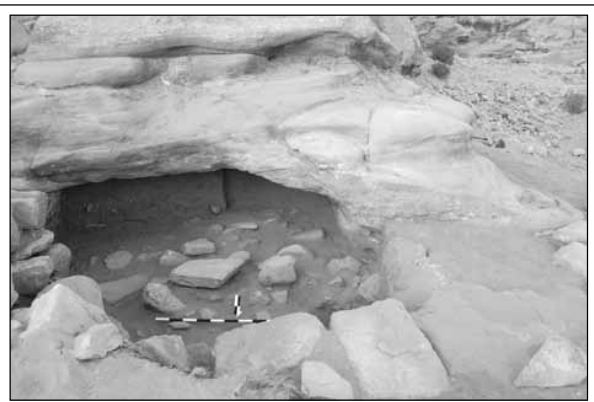
9a and b. Trench 24: looking down from the east cistern to the top lip of the cave mouth at center (a). The Nabataean wall runs parallel to the cave mouth. View into the top of the cave / cistern (b).

An exploratory sounding measuring 3 x 4 meters was opened at the base of the bedrock escarpment, with all sides confined by rocks and stones (**Fig. 9a**). The fill of this trench was likewise composed of a mix of large boulders and other stones that had fallen down from the east cistern and the bedrock ledge originally supporting its northern end, and wind- and water-born sand that had accumulated over the centu-

ries. After removing about a meter of this rubble fill, the top of an alignment of stone ashlar consistent with Nabataean-style masonry was discovered at the northern end of the trench, as were two shallow hearths filled with ash, one of which contained some sherds of coarse cooking ware of the Medieval period. To the south, the top lip of a cave appeared in the vertical face of the bedrock (**Fig. 9b**). This cave may have functioned as a cistern to catch the flow from the waterfall. Another possibility is that the cave functioned as a grotto, a popular feature in Hellenistic - Roman period luxury gardens, used for banquets or revered as sacred or mystical spaces. The possibility of a grotto is compelling. The elevation of this feature provides stimulating views of the pool and garden below and is also within line of sight of important features on the Petra skyline. However, the appearance of the top course of a monumental ashlar wall built east - west across the front of the cave opening reveals that the cave's view was blocked at some point and leads to some doubt of the waterfall hypothesis.

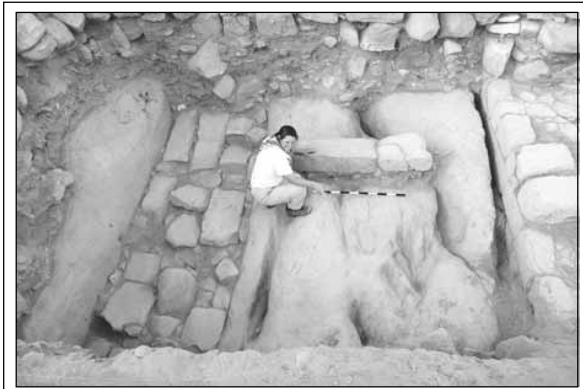
10a and b. Trench 22: (a) bedrock with covered east channel (left of Jennifer Ramsay) and in situ paving stones (step?) east of the Nabataean wall (far right); (b) channel with slab capstones west of the Nabataean wall.

Further excavation to the east of the Nabataean wall in Trench 22 revealed that the 'large stone structure' visible in the GPR data was actually a bedrock shelf that slopes downward from south to north and is cut to form a foundation for the retaining wall and to accommodate an underground water system (**Fig. 10a**). A channel running north - south was cut into the bedrock and covered with capstones of mixed size and shapes supported by arches (**Fig. 11**). The bottom of the channel had not been reached when the trench closed at 1.55 meters depth. Owing to its alignment with the cave / cistern in Trench 24, it is possible that this channel transported water from that water catchment feature down to the Colonnaded Street or the wadi. Two large, cut sandstone blocks were found *in situ* on the bedrock between the channel and the Nabataean wall providing evidence for a pavement (ramp?) or perhaps a staircase constructed over the channel.

Immediately to the west of the Nabatean wall, a second water channel capped with stone slabs (*ca.* 1 meter in length) runs parallel to the exterior (west) face of the Nabataean wall (**Fig. 10b**). A space of several centimeters between the capstones and the top of the soil fill gives a view of approximately two meters northward along the length of the channel interior where it is possible to see the intersection with a third channel that originates from the south-west. The general orientation of this third channel suggests that it may be the outflow from the underground cistern that is indicated by the GPR but eluded us this field season. The channel's capstones are covered by stone packing and a deposit of sandstone chips in a sandy red matrix that represents

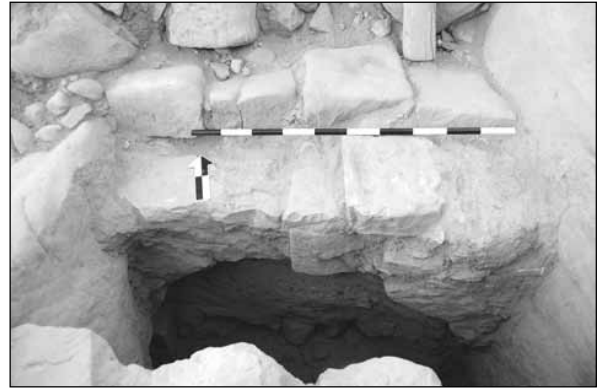
11. Trench 22: arch support for capstones on east channel.

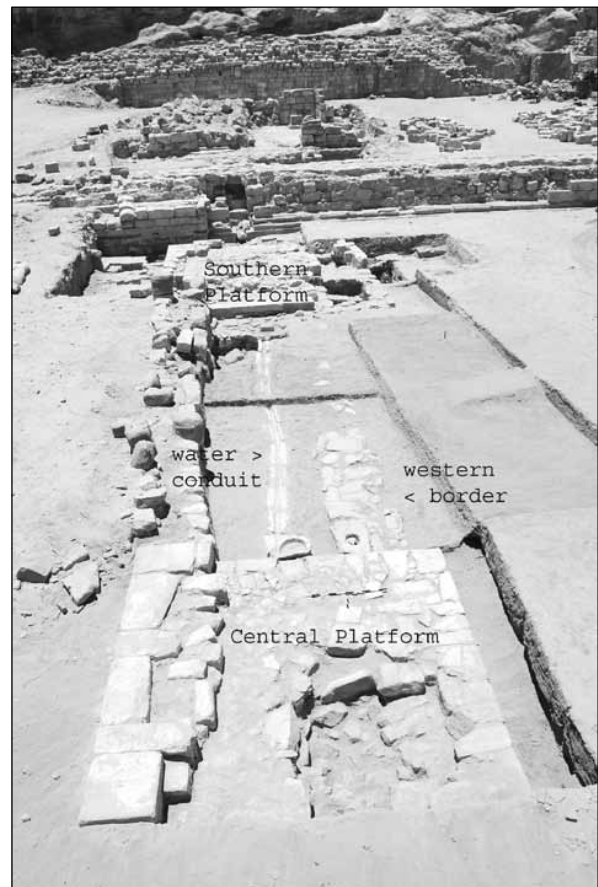
14. Trench 23: looking south along the central axis toward the pool (background).

Running parallel to the conduit to the west is a course of roughly dressed sandstones (**Fig. 14**) similar to the pathway border stones in Trench

17 and probably serving as the western border for a comparable pathway that runs north - south along the central axis, between the pool and the center of the garden terrace. A parallel line of stones revealed in the trench's east baulk, directly underneath the later field wall, likely belongs to this pathway's eastern border. Careful scraping of the yellow - brown soil in a gap in the stone border revealed a patch of darker soil that may be a planting pit. A soil sample was collected and floated for archaeobotanical analysis.
