# UMM QAYS: PRELIMINARY REPORT ON THE 2008 SEASON

*Ken Matsumoto and Jafar Telfah*

## **Introduction**

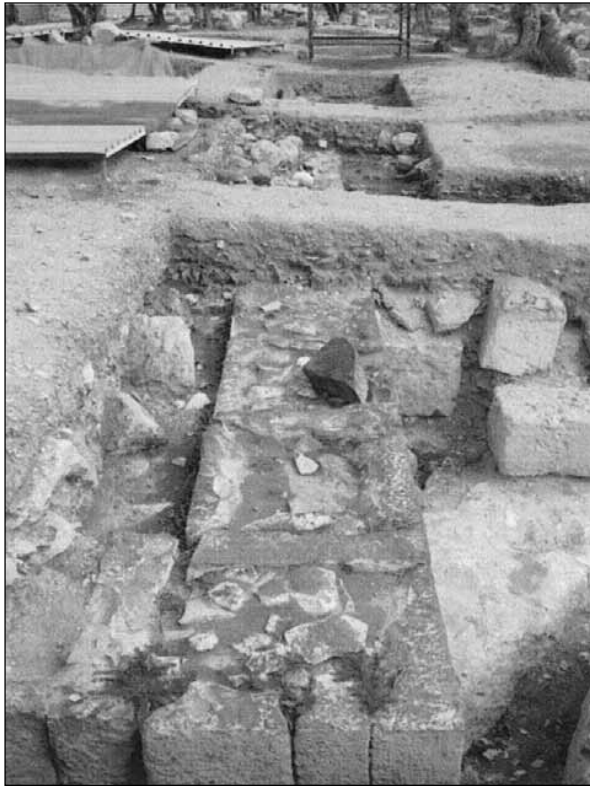
2. Foundation basalt wall (square G11).

The foundation of the basalt wall (**Fig. 2**) was excavated during the 2007 excavation season, and was the subject of further exploration this season. Upon excavation, it became clear that this wall is part of a huge structure associated with a mosaic pavement. Approximately 40m. of this east-west wall was excavated; its eastern end hadn't been reached by the end of the season. The wall turned to the north and was constructed of limestone blocks approximately 0.45m wide; the mosaic pavement was laid alongside it. Erosion has probably destroyed its north-west end, but in the north-western part of the excavated area almost three courses of stonework were preserved. Bedrock was reached at grid N11.

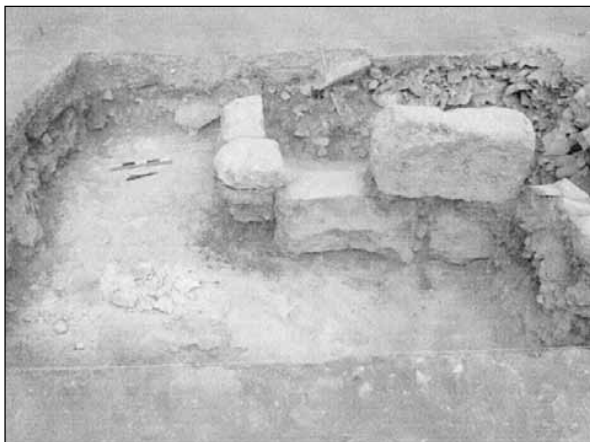
3. Defensive as a fortification on top of calcite layer (I15).

Excavation in the area north of the main street revealed a mosaic pavement, which was damaged or destroyed by military installations in squares I15, I14, J14, I13, H13, H15 and G16. These probably date back to 1967 (**Fig. 3**). It was decided to remove some of these installations, which exposed a hard, thick layer of white cal-

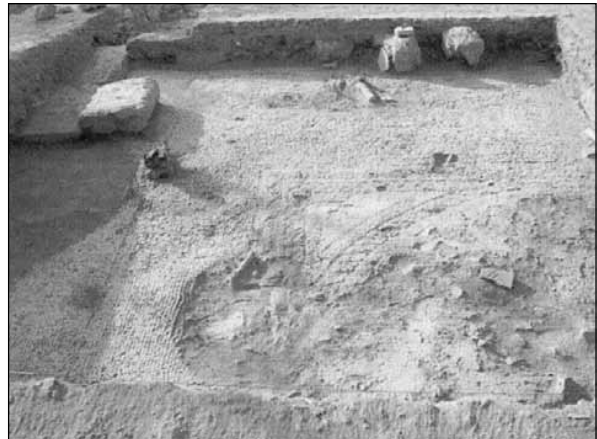
4. Mosaic Floor , Main Carpet (H12).

cite underneath. This deposit contained considerable quantities of plain white tesserae, many in clusters adhering to their original cement. Only scattered remains of mosaic patches associated with the paved foundation remained *in situ*. The original paving in the eastern part of the structure was a mosaic floor, paved with large plain white tesserae, which had unfortunately been completely destroyed during construction of the military installations. However, a partially preserved polychrome mosaic floor was excavated along the western part of structure (**Fig. 4**). The western part of the excavation area was entirely covered by a mosaic pavement. An almost complete floor was excavated in square H12; it was set within a double frame, with a central pattern that was hardly damaged. The colors of white, black, red and grey were used (**Fig. 5**).

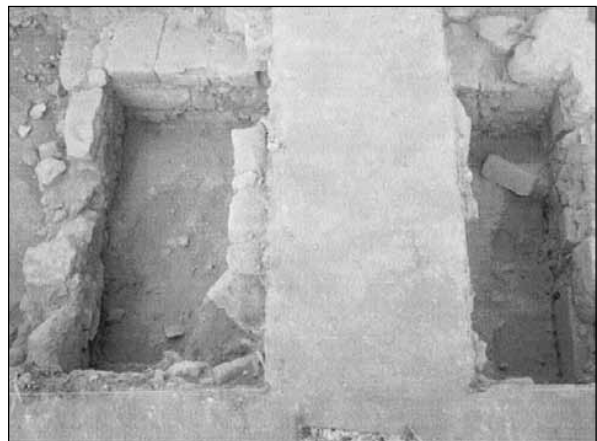
6. Top view showing the plastered rooms (H15 and I15).

It was decided to remove this layer completely, which exposed the remains of a series of walls (Fig. 6). The main wall was located under the eastern balk of square H15, ran north-south and was built of both basalt and limestone. It is part of complex of four walls, forming the sides of a square structure consisting of two rooms adjacent to each other. These were partly excavated; the walls varied in height from 0.40 to 0.50m and were built of large and medium sized limestone and basalt blocks; small chippings of basalt and limestone filled the spaces in between. The interior faces of the walls display extensively preserved white plaster over a thick layer

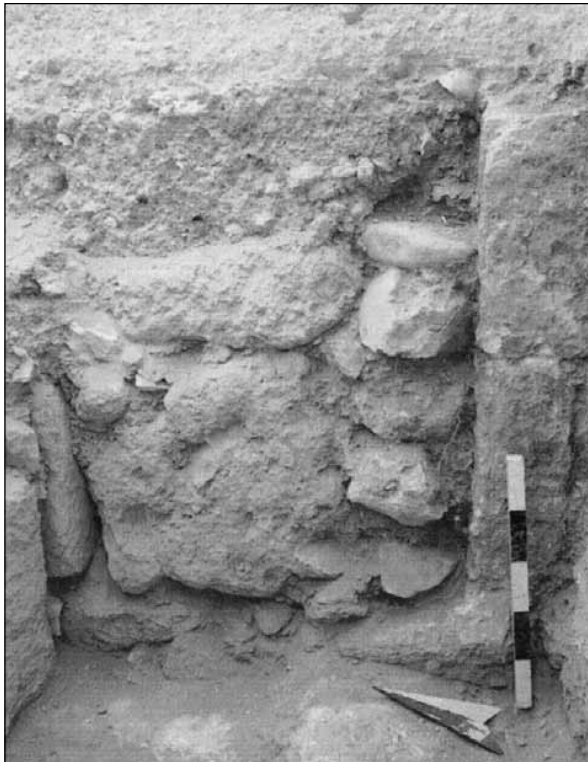
7. Blocked doorway in main eastern wall (I15).

high, was completely blocked, probably during later phase (**Fig. 7**). The fill inside these rooms was a thick layer of compact reddish soil, with several fallen large limestone blocks retaining traces of white plaster (**Fig. 8**). Numerous fragments of collapsed cornice and soft lime plaster

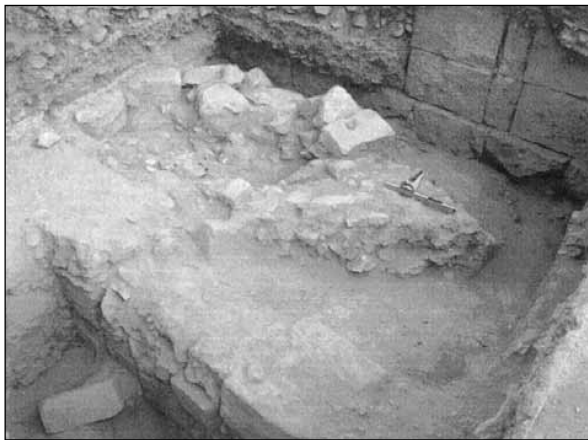
8. Debris inside room, including fallen blocks and plaster (I15).

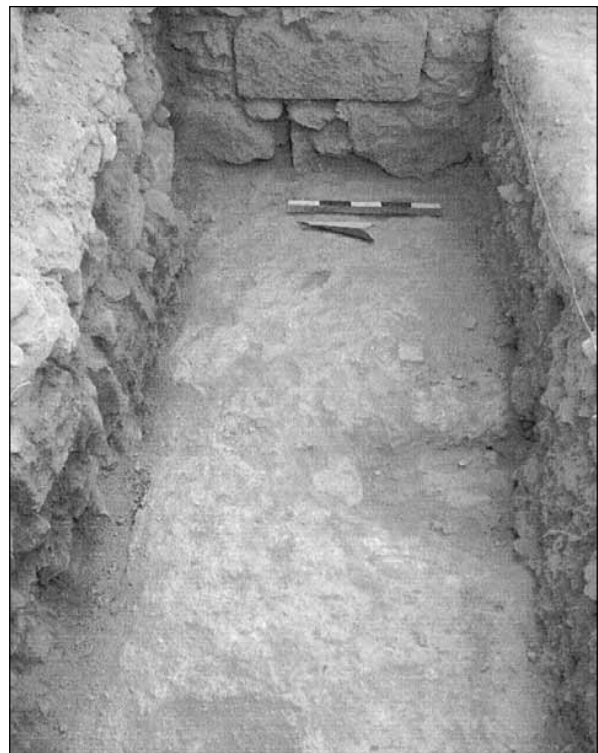
9. Room compacted soil level (I15).

Excavation in square I15 reached a possible floor level at the base of the structure (**Fig. 9**). This consisted of small and medium stones, covered with a layer of compact white clay. It was decided to excavate a probe near the north-west plastered wall, located in the middle of square H15, in order to reach the foundations and recover some material with which to date the wall. Underlying this possible floor level, several east-west alignments of rectangular limestone and basalt blocks were found; these blocks averaged 0.40 by 0.60m in size. One was removed, and an east-west wall of large, well-cut limestone blocks was excavated. It was noticed that this wall extended along the eastern parts of squares H15 and I15, upon which the main east wall of the rooms was erected. According to its location, construction and orientation, it is probable that this wall represents an earlier phase of construction. Furthermore, it seems that the occupants of these rooms reused this earlier wall as a foundation, for their structure.

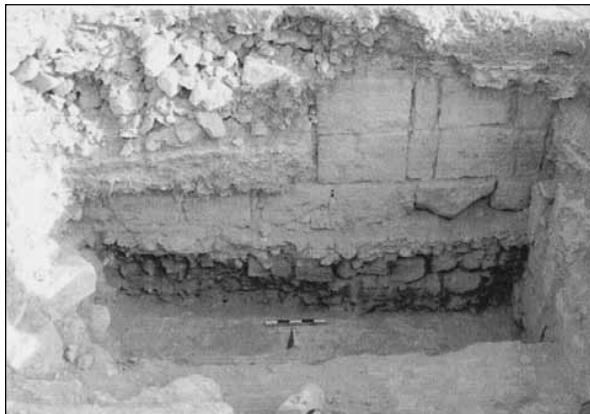
10. Basalt wall, and its foundation cut into floor level. Note the fortification's foundation to the left (H15).

Further to the north, excavation revealed huge basalt wall (**Fig. 10**), located under the northern balk of square I15. The wall survives to a maximum height of 0.80m. The upper courses were probably removed and reused by the Army

for military purposes. The bottom of the wall was reached, where traces of ashy material were noticed. It became clear that the wall's foundation cut into the room's floor. The exact function of this wall is uncertain. Owing to the limited area of excavation, military installations and presence of irremovable mosaic patches, it was difficult to expose and date an entire house plan. This will be attempted next season.

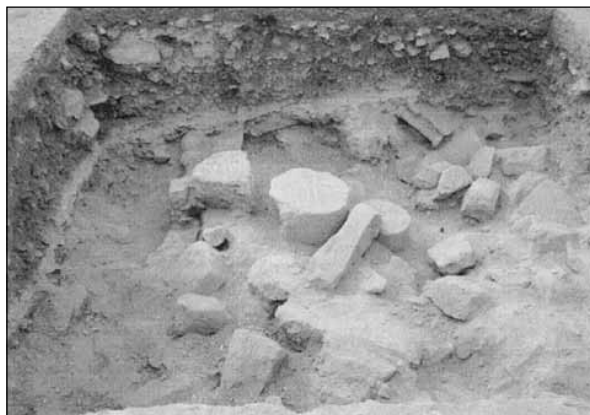
11. Debris of square H16, fallen stone, Ionic column in the right corner.

It was decided to excavate a square, H16, located east of square H15 in order to expose a blocked doorway and debris from square H15. This included various architectural fragments, e.g. blocks, limestone column drums etc. Moreover, it was noticed that these fallen stones (**Fig. 11**) included a complete Ionic basalt column which had fallen from east to west, indicating that these stones originated from a fallen structure located in square H15 to the east.

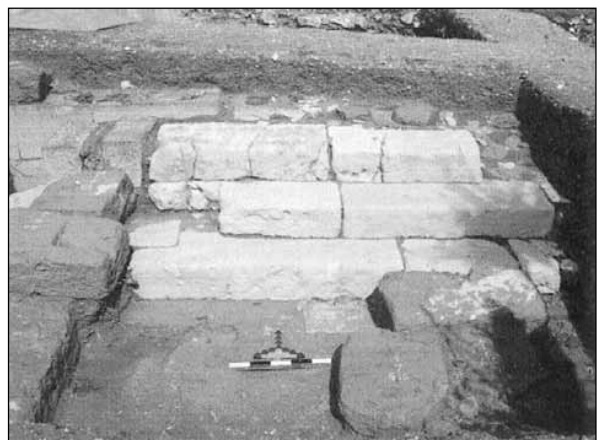
12. Staircase (G15).

These two squares were opened in the southern part of excavation area, in order to expose the extension of the basalt wall foundation. In square G15, excavation revealed a staircase (**Fig. 12**) leading from the northern stylobate of the street to the north. It was attached to the outer face of the basalt wall, and was 2.70m wide. Three limestone steps were preserved *in situ*, with more being scattered across the excavation area. The full extent of the staircase to the north could not be determined, and no remains of an associated structure were found. The function and date of this feature is still obscure, although the stairs probably belong to a later phase of construction. Further evidence of a later phase(s) of construction appeared in square G16, where several simple walls were constructed of reused architectural fragments, e.g. shaft column, capital and large blocks. These were associated with a compact light brown surface, from which a large quantity of animal bones was recovered. The most interesting discovery in this square was an inscription (**Fig. 13**) found on a limestone column framed by a *tabula ansata*.

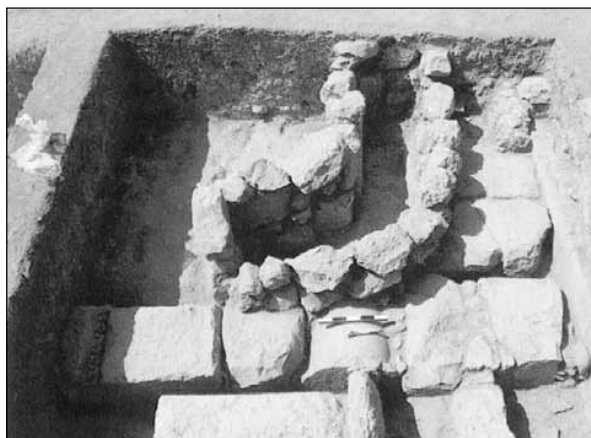
13. Latter phase of construction. Inscription on lay out shaft column bottom of figure (G16).

*Inscription:* One soft limestone column, with nine scratched Greek letters framed in a *tabula ansata*, was found in square G16, in a simple structure located behind the northern stylobate of the main street. The column was reused as part of a wall. It awaits analysis.
