FROM 'GUARD HOUSE' TO CONGREGATIONAL MOSQUE: RECENT DISCOVERIES ON THE URBAN HISTORY OF ISLAMIC JARASH

Hugh Barnes, Louise Blanke, Kristoffer Damgaard, Ian Simpson, Mette Low Sørensen and Alan Walmsley

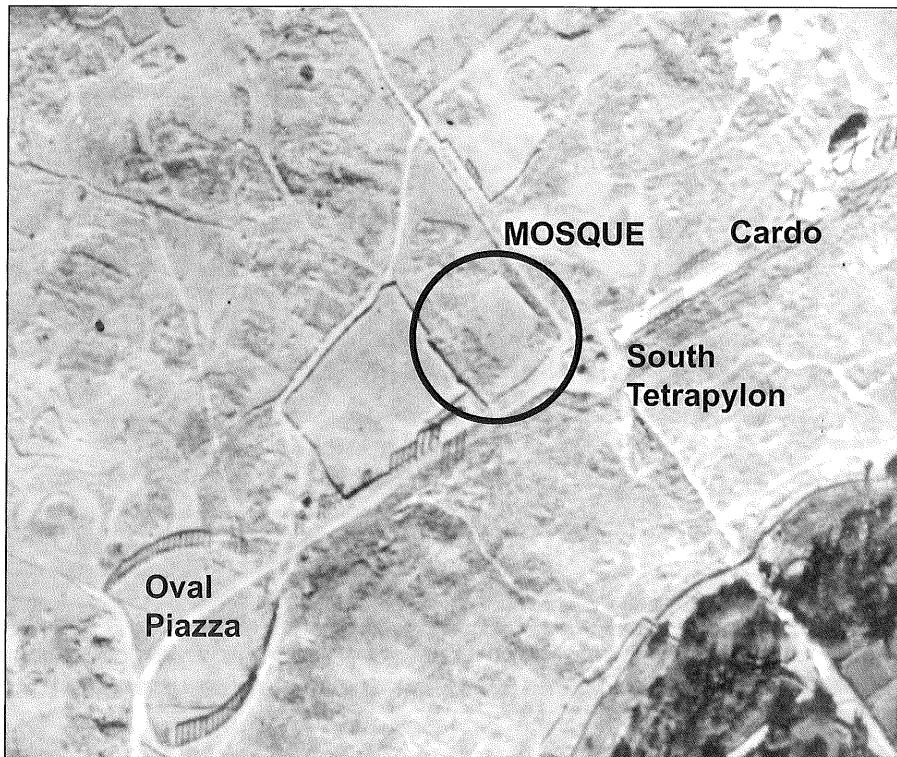
2. Detail of the mosque area at Jarash from an aerial photo of ca. 1930, on which the rectangular enclosure wall and northeast tower are clearly visible.

it. From the photograph a building measuring roughly 43.32 by 38.4 metres in size could be identified, with good evidence for a substantial tower at its northeast corner (**Fig. 2**). Along the south wall the remains of a separate room could be discerned, running the full width (east-west) of the structure, seemingly the *qiblat* (prayer) hall of the mosque. Especially revealing was the orientation of the building, which intentionally diverged from Jarash's Roman-period grid in favour of another, more pressing, social requirement: orientation towards the *qiblat*.

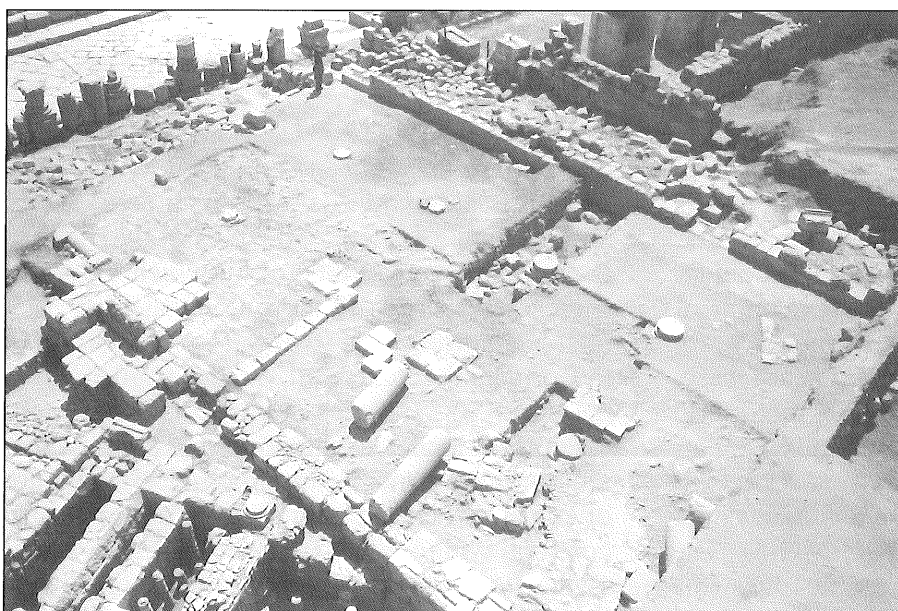
5. Overview of the mosque area at the end of the 2004 season, showing the central qiblat hall with central mihrāb and a section of the earlier bathhouse to left (compare Fig. 11, below).

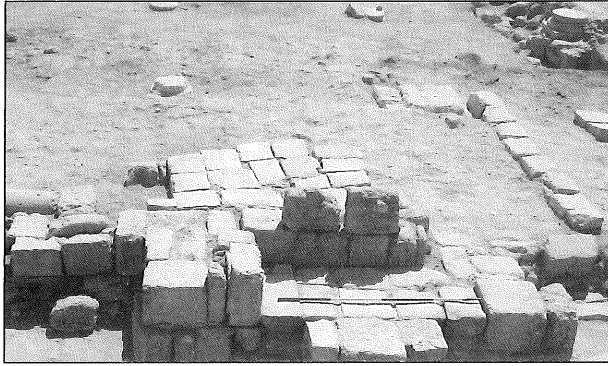
6. Platform area in the northeast quarter of the mosque's qiblat hall. In foreground, to left: east portico-qiblat hall doorway; centre-left: T-shaped pier of portico arcade; right: surviving segment of courtyard pavement; middle ground: surviving elevated qiblat hall paving with, to right, stone edging for the paving. Note the sub-paving packing terminates at the first line of the hall arcade (middle distance).

On the south side of the courtyard once stood the central feature of the mosque: the *qiblat* hall, which probably extended the full width of the building and had a total depth (N–S) of 13.8 metres. Excavation of the *qiblat* hall has identified two parallel colonnades in front of the *qiblat* wall, with an open entrance from the courtyard (*Ṣaḥn*) featuring arches on solid piers. Their deep and substantial foundations indicate they were designed to carry the considerable weight of a tiled roof. Many fragments of ceramic tiles have been recovered, and in total over five tonnes of smashed roof tiles have been excavated within the *qiblat* hall area. A most interesting and unusual feature is the discovery of evidence for solid walls at the point where the east and west courtyard porticos joined the façade of the hall. They probably helped to support the porticoes, which were also tiled, at their south ends. On the east, the wall was pierced with a doorway, the threshold of which survives. That doorway led to an enigmatic raised paved platform in the northeast section of the *qiblat* hall (Fig. 6).

At the east end of the façade to the *qiblat* hall are the remains of a doorway leading from the east portico into the hall (Fig. 6). One half of a stone threshold remains, behind which there is step structure consisting of a half-buried column piece laid horizontally flanked by stones. The doorway appears to be part of the original building design, and led to an area of paving that appears to have been part of a raised platform in the northeast corner of the *qiblat* hall. About 20 stone flags of the paved platform remain, elevated slightly above the level of the few other remaining areas of paved floor in the *qiblat* hall. The surviving paving of the raised floor clearly continued over a larger area, the western limit of which is delineated by a single row of building stones oriented north-south. This feature ends at the first (northern) colonnade in the *qiblat* hall, suggesting the raised floor terminated at this line of columns. Further evidence for the area covered by the elevated floor was found in the form

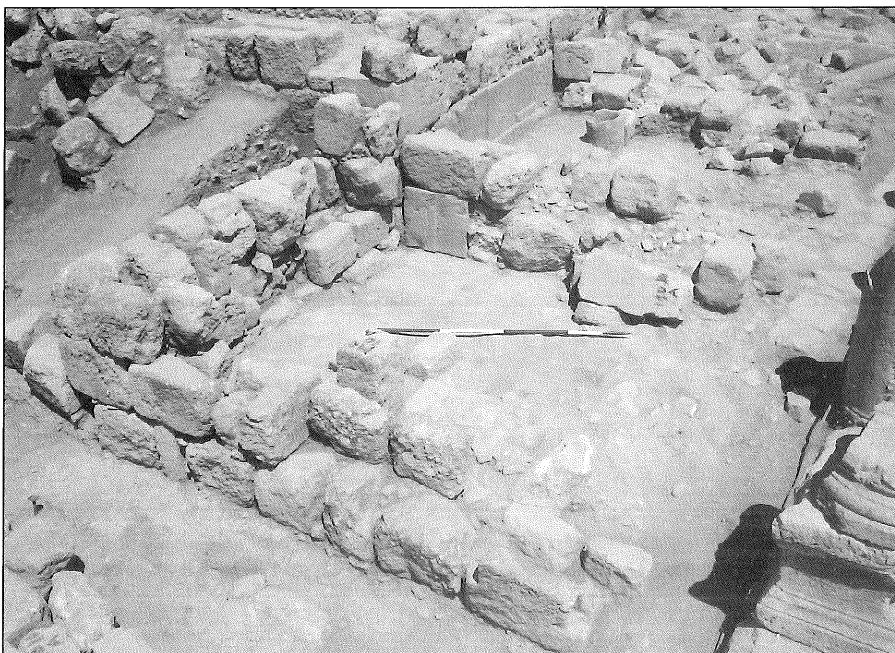
7. View of the shops east of the mosque, looking northwest.

a row of shops (Fig. 7). These projected south of the qiblat wall, but were aligned with the lane that ran between the mosque and the macellum, along a line drawn from the main *mihrāb* to the south wall of the shops. The shops were built to butt against the mosque's east and south walls, and faced eastwards out onto the *cardo*. Their eastern limits are not preserved, and seem to have been removed when the *cardo* was cleared in the earlier part of the twentieth century. To the northwest and the north of the mosque, elevated terraces originally gave access to the doorways of the mosque. While evidence for this has large-

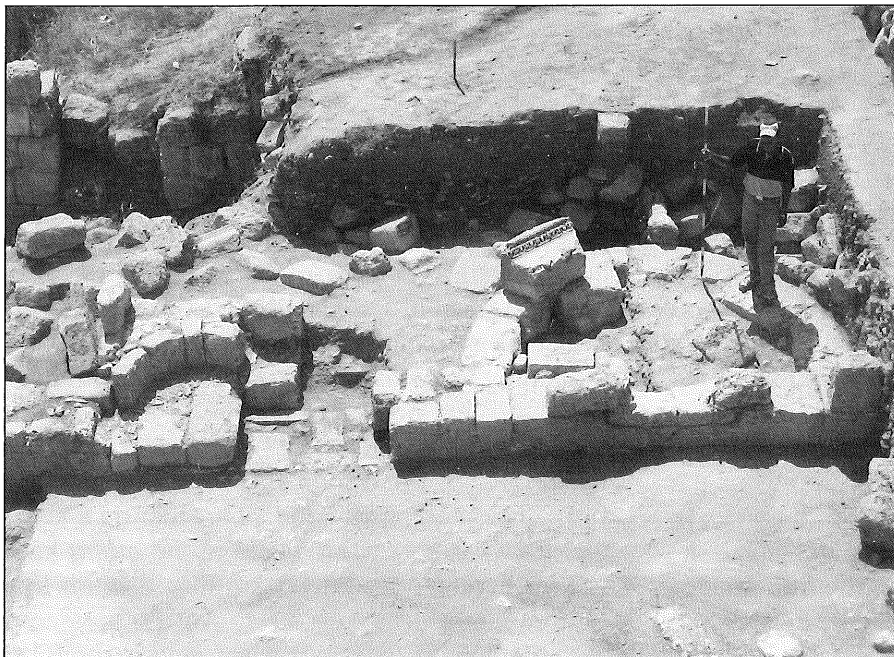
8. The primary axial *miḥrāb* and a secondary (substitute?) *miḥrāb* to its east.

ond *miḥrāb* immediately to its east (Fig. 8), and a third *miḥrāb*, slightly larger than the eastern one and situated towards the end of the *qiblat* wall some twelve metres west of the central *miḥrāb*. The central and western *miḥrāb*(s) each have a round salient, while the small *miḥrāb* east of the central axis has a square external projection. The central *miḥrāb* – originally the main *miḥrāb* – was blocked in a later phase, leaving a small doorway within the blocking. This change may suggest the use of the *miḥrāb* as a place of storage. It is logical to suggest that this modification was made at the same time as the eastern *miḥrāb* was inserted into the *qiblat* wall. The western *miḥrāb* appears to be contemporary with the original building. It is separated by some distance from the other *miḥrāb*(s), pointing to differential use of space at this end of the *qiblat* hall. If an important building is located west of the mosque it may have had direct access to the *qiblat* hall or courtyard via an entrance in the western wall, although no evidence of this has been found so far. The *miḥrāb* recesses do not appear to be framed in any way. No evidence of a *minbar* has been found, but if there had been one it is likely that it was made of wood and has not survived.

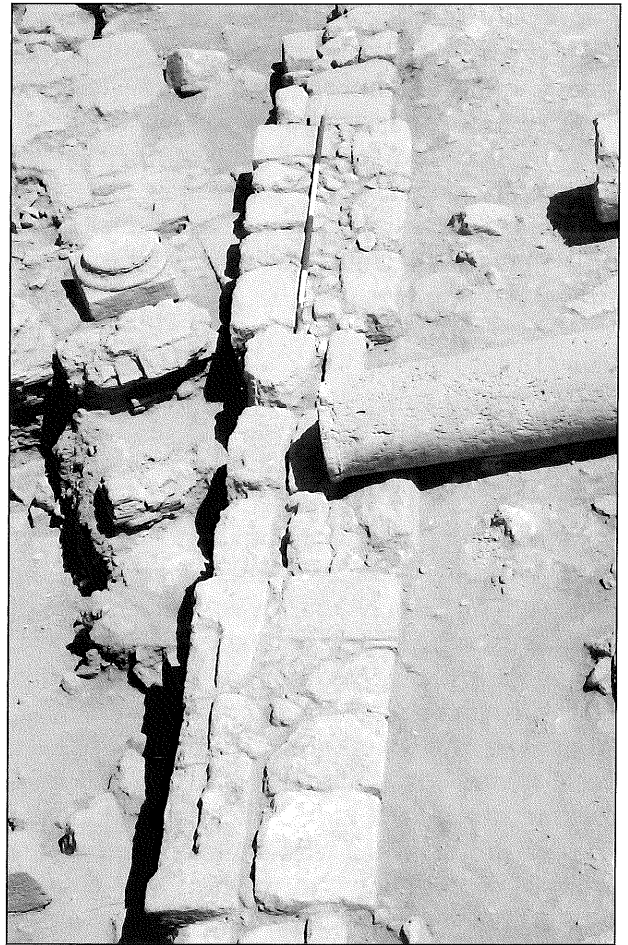
9. Foundations of the load-bearing façade of the *qiblat* hall.

The piers stand on a substantial foundation wall that runs the full span of the mosque (Fig. 9). The foundation wall is made up of pier bases that run four courses deep and are slightly larger in plan than the piers, with lengths of shallower foundation bracing walls between the bases. The piers at the east and west ends of the entrance façade have a short buttressing wall on their courtyard face, meaning these two piers have a T-shaped plan. The buttressed piers are located at the two points where the portico colonnades of the courtyard join the piers at either end of the hall entrance façade, and the buttressing is thus designed to support the end of the porticoes. The substantial foundations and sturdy build of the piers show that they were designed to carry the weight of a tiled roof over the *qiblat* hall. Excavation has also revealed that the colonnades inside the *qiblat* hall were also built on sizeable foundation bases.

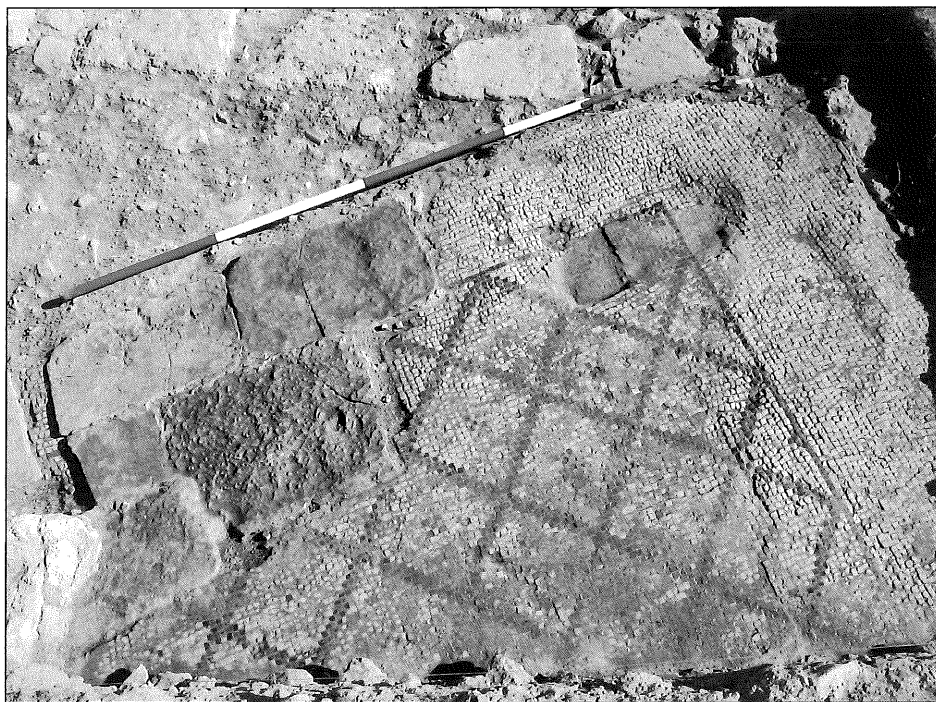
10. Mosaic panel in the south of the sondage in Unit MO/3.

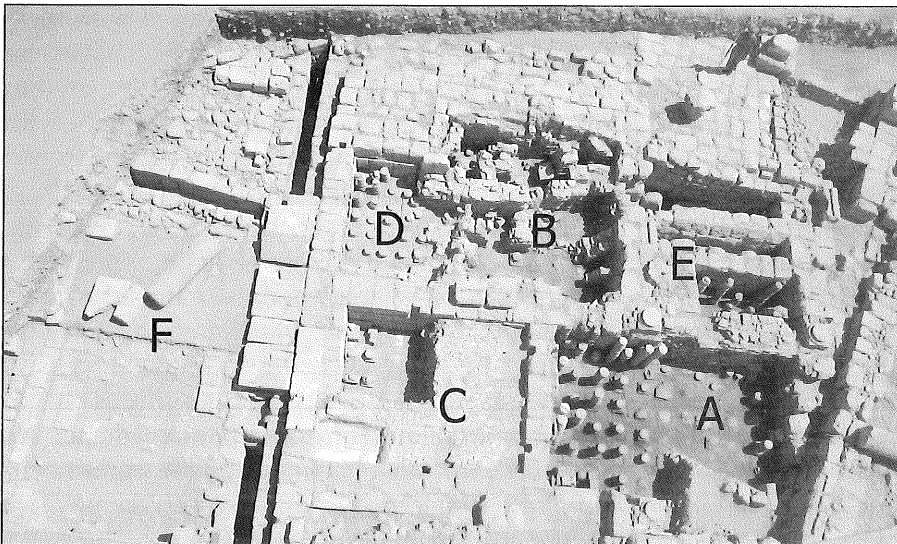
11. Overview of the bathhouse, showing sector designations.

Generally, the bathhouse consists of single-row limestone walls. Most of the hypocaust rooms (Sectors A, B, C and D) are lined with wall tiles, while all the rooms contain floor tiles and round ceramic hypocaust pillars made of stacked tiles. In order to connect the rooms for heat circulation, brick arches were built into the limestone walls. Except Sector D, tile constructions were erected in order to support the weight of the *suspensura*, these constructions consisting of *tegulae* (flat rectangular tiles), *pilae* (solid round tiles) and square bricks. *Tubuli* (box flue tiles) were found *in situ* in Sector E and in the filling of Sectors A, B, and C. In the following each area will be described in detail, before any comparison is undertaken, in order to establish a

This part of the hypocaust is positioned directly north of Sector A; it is defined on all sides by limestone walls (**Fig. 11C**). It is connected to Sector B through two tile arches in the eastern wall. Sector C has not been completely excavated, but a probe was made in the north-eastern corner. An upper paved surface in Sector C consisted of small tiles and plaster, associated with which was a basin in the north-western corner of the room (**Fig. 13**). Excavation of the room revealed that this surface was laid over a homogeneous fill very similar in character to the filling found in the room of Sector B. Most probably the two areas were filled up at the same time.

This room is situated to the east of Sector C and directly north of Sector B (**Fig. 11D**). It is connected to the rest of the *suspensura* through the tiled arch connecting the rooms of Sectors B and D. The room originally consisted of approximately 25 tile pillars. As this part of the hypocaust system had already been excavated by Mr. Ali Musa, no conclusions can be made about the filling and paving, if any, that were originally there. The Sector D room is raised, compared to the rest of the area, by approximately 0.5 metres. Furthermore, while the rooms in Sectors A,

Sector F is situated in the northernmost part of MO/1 north of the east-west wall of the bathhouse (**Fig. 11F**). So far the work in this area has focussed on the easternmost and the westernmost part. The most noteworthy architectural find in this area comprises parts of the sewage system, sections of which have been excavated in both the eastern and western parts.

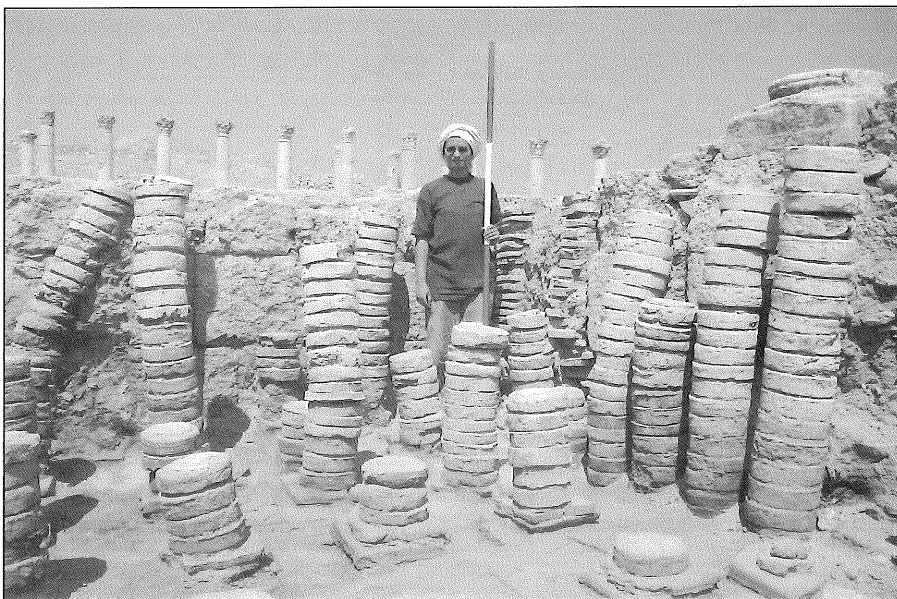
12. View within the hypocaust room in Sector A of MO/1.

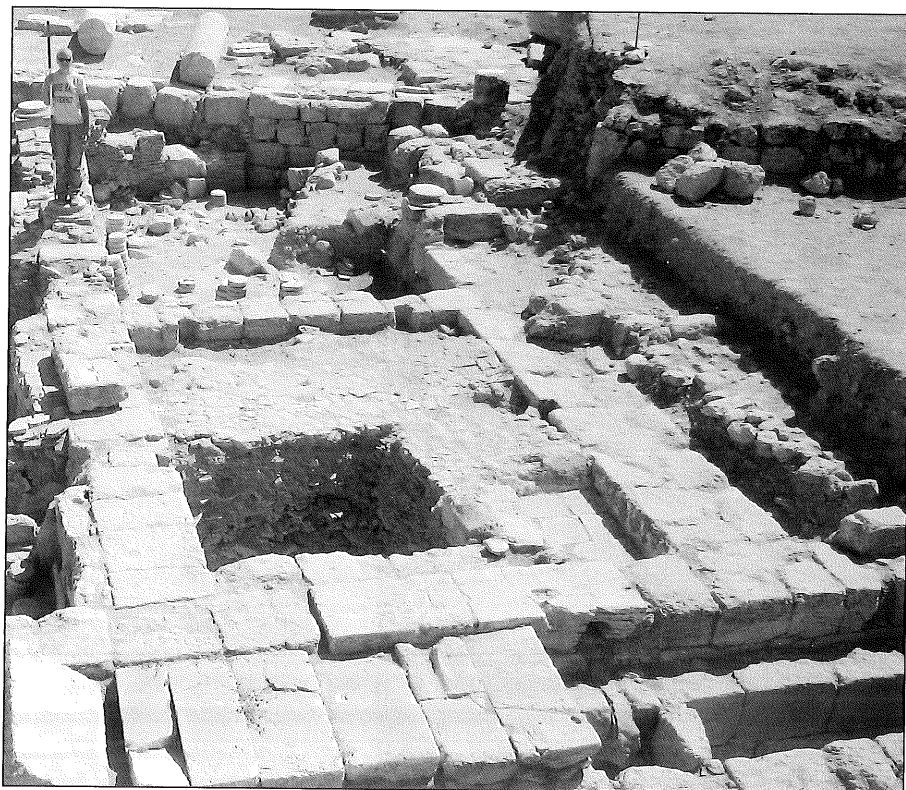
13. Basin and upper paved surface in the room of MO/1 Sector C.

As described earlier, a basin was located in the north-western corner of Sector C. From the northwest corner of this basin, an outlet led into the raised (western) part of the east-west drain. Deposited in the outlet as it flowed into the drain was a thick, multi-layered lime deposit, similar to that found inside the northern wall of the basin. The discoveries in the drain and basin clearly indicate that the northern part of MO/1 stopped functioning as a bathhouse and supported instead some sort of industry in the last period of use, a change of use noted at other sites in late, such as Baysan/Scythopolis (Tsafirir and Foerster 1997).

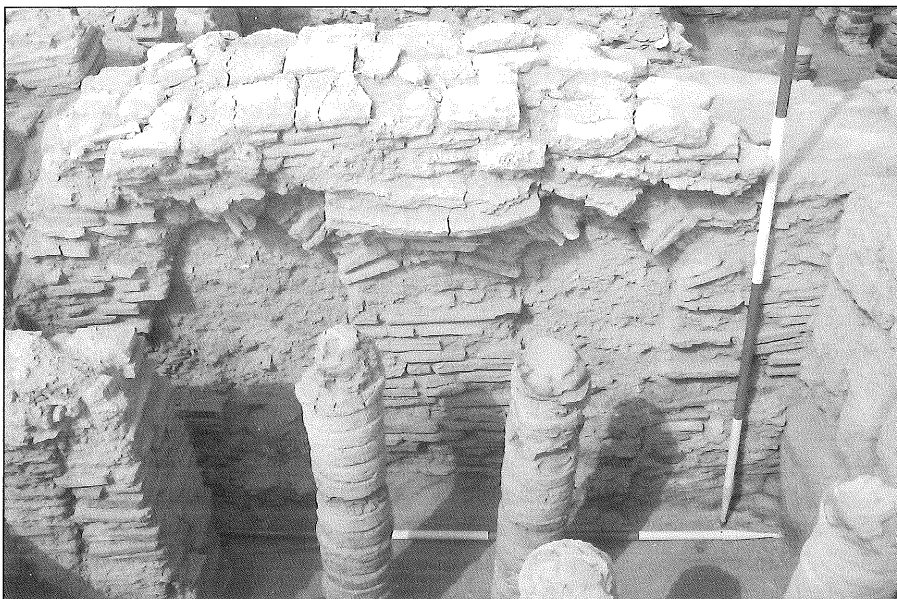
14. Arched vents connecting the hypocaust rooms of Sectors A and E (the fill in the vents has been retained to support the arches).

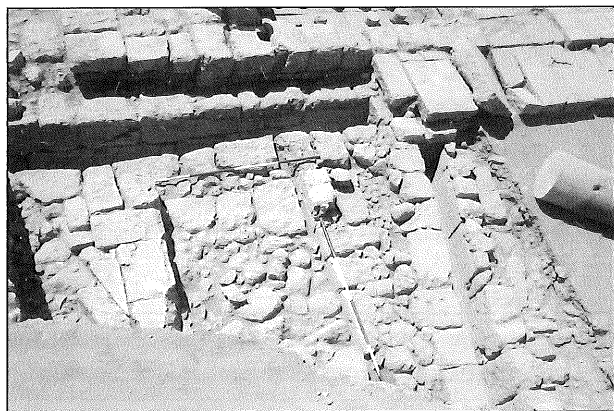
15. Stone-lined drains in Sector F of MO/1.

system (**Fig. 15**). Two drains were uncovered, one running east-west against the east-west bath wall and the other, a later addition, running north-south and connecting to the first. Both drains are constructed from limestone blocks with cement bottoms. The east-west drain has been identified in both the eastern and western part of MO/1, where it continues into the baulks. Large stone slabs, still *in situ* in the centre of Sector F, were originally used to cover the drain. The excavation of the east-west drain revealed several interesting issues. Firstly, it was discovered that several large stones were deliberately placed in order to block the drain at the junction with the north-south drain. This could indicate that the east-west drain went out of use at the same time as the north-south drain was constructed. Furthermore, the excavation revealed that the east-west drain was completely blocked by a wall at its easternmost visible end. The top of this wall is at the same level as a paving, consisting of plaster and fist size stones, which was constructed between the two drains and the wall. Obviously this wall was constructed at a time when the east-west running drain was no longer in use and most likely after the north-south running drain replaced the first. Finally, the east-west running drain was filled up in one event, according to the finds from the filling.

The construction of the north-south running drain differs from the construction of the original drain, which is both wider and almost one metre deeper. Furthermore, the north-south drain produced some very interesting finds. Near the bottom of the drain, numerous potsherds, nails, coins, beads and rings were found, seemingly not part of the filling but naturally deposited,

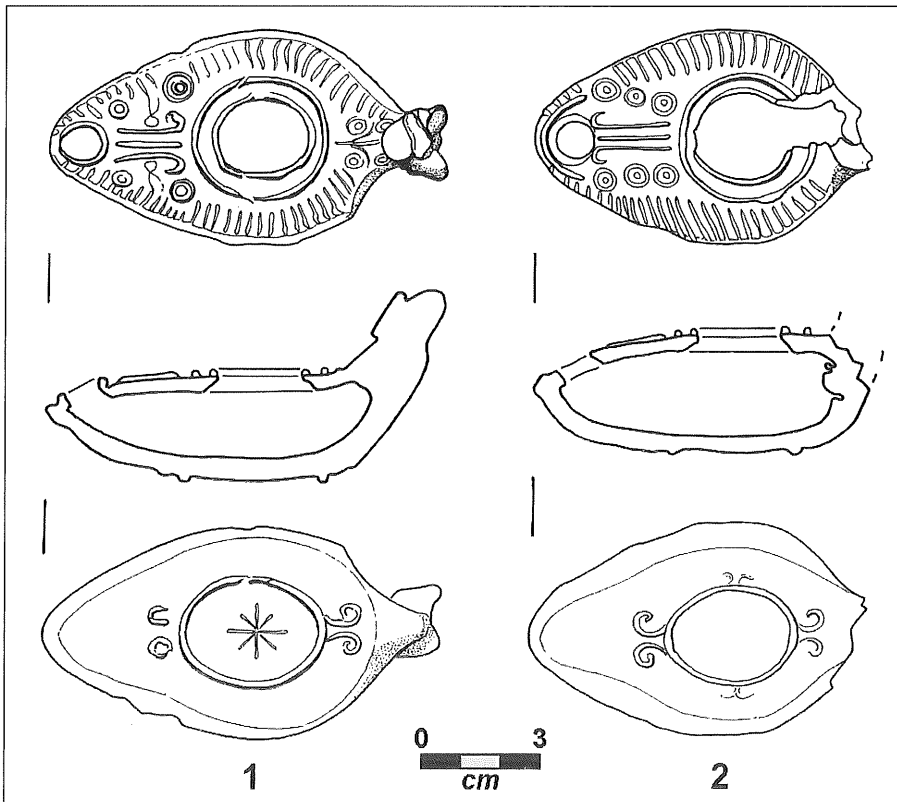
16. Two 'Jarash Lamps' from the mosque excavations. 1. IJP-PCN 1; 2. IJP-PCN 2 (drawings by Judith Sellers).

A complete ceramic oil lamp (IJP-PCN 1, **Fig. 16.1**) and a nearly complete lamp, missing only the handle (IJP-PCN 2, **Fig. 16.2**), were recovered in the 2002 season from unstratified topsoil and an in-filling deposit of the Byzantine bathhouse respectively. Other oil lamp fragments were recovered from the mosque excavation.

All the oil lamp specimens belong to the well-known Jarash lamp type. Lamps IJP-PCN 1 and IJP-PCN 2 are tear-drop shaped with a central filler hole in the top and a wick hole at the pointed end, made in a mould in two halves and joined at the outer edges. The decoration on the top part of both lamps consists of three straight parallel lines between the wick nozzle and the filler hole. The outer two lines end in hooks at the filler hole. Three dotted circles flank the three lines and striations are running around the upper edge of the lamps top. At the wider end of Lamp IJP-PCN 1 is a tall arched handle with a finger-moulded top, finished off by pinching, which make it look zoomorphic. The base of both lamps has a round ringed foot,

consisting of a centrally placed large open circle with two outward facing hooks on the long axis of the lamp. Lamp IJP-PCN 1 has an asterisk in the centre of the circle.

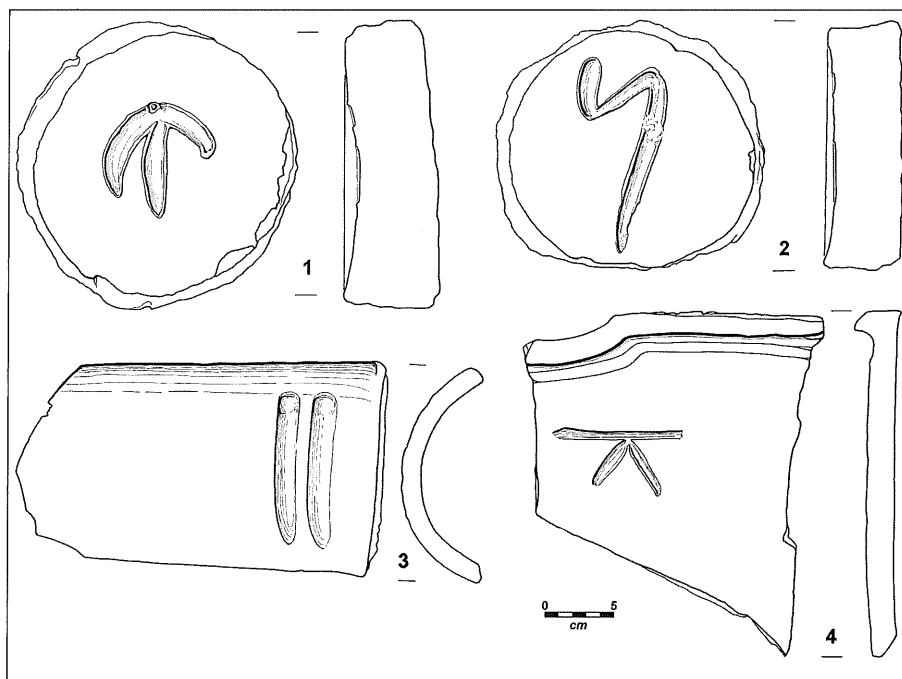
17. Potters' marks on tiles from the bathhouse (1, 2, 4) and mosque (3) (drawings by Judith Sellers).

Some of the roof tile fragments of the mosque, along with construction tiles from the bathhouse, are incised with potters' marks. The marks include wavy finger impressions, crosses, straight lines and incised Greek letters (Fig. 17). The marks are similar to those found on tiles from the Civic Complex church in Area IX at Pella, also dated to before the earthquake of 749AD (Smith and Day 1989: pl. 28.A-C). Like at Jarash, the tiles recovered from the church at Pella were found in fragments, which could indicate that the complete tiles were carried away after the destruction of the church for reuse (Smith and Day 1989: 40).

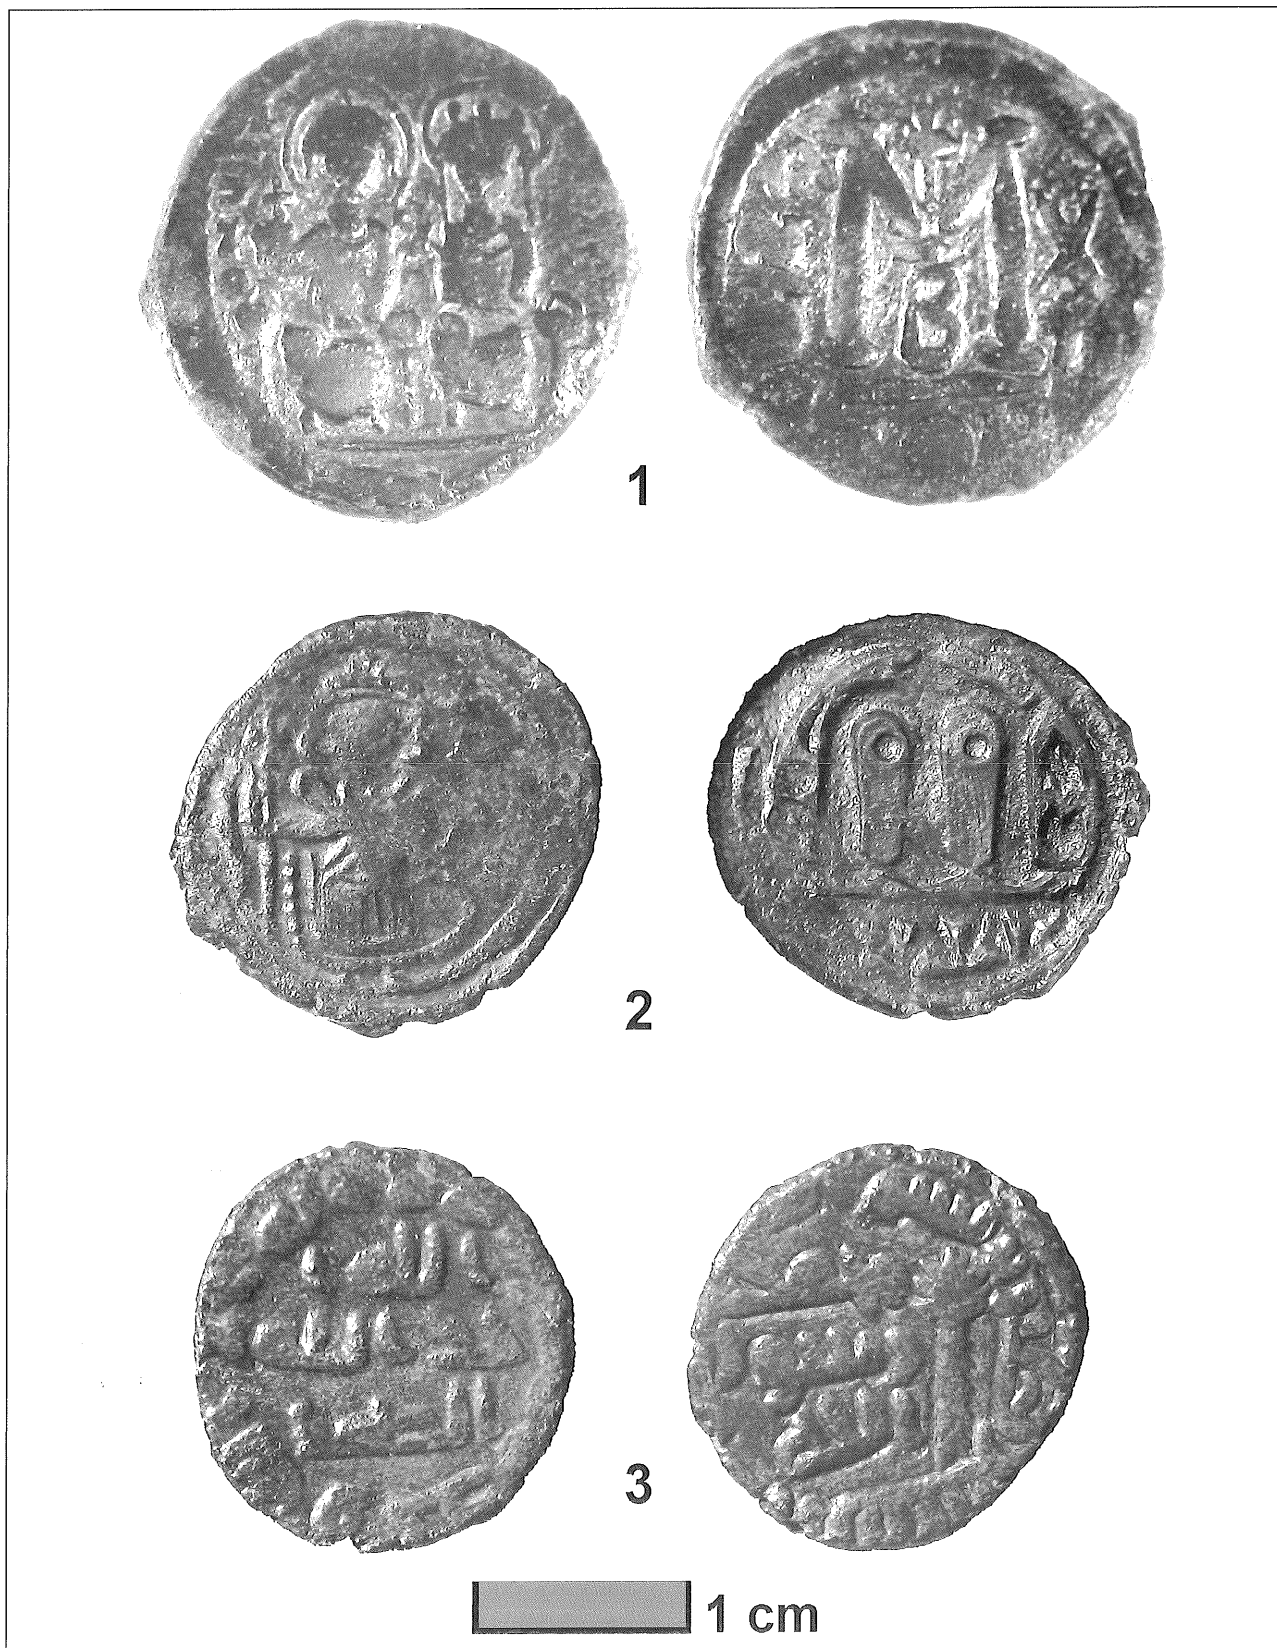
18. Three coins from the mosque/bathhouse excavations at Jarash. 1. IJP-FCN 70, surface find, follis of Justin II and Sophia minted at Constantinople, officina 'B', dated to Year 12 (576/7) (Bellinger 1966: 213.42b); 2. IJP-FCN 354, MO/1.108, fals of the 'Pseudo Damascus Mint', ca. 660-680 (Album and Goodwin 2002: 87, pl. 39); 3. IJP-FCN 173, MO/3.9, fals from the mint of Ṭabariyya, undated, ca. 700-750+ (Walker 1956: 269.898).

Better preserved and often identifiable after cleaning, are the coins of the sixth to eighth centuries, belonging to the three broad categories of early Byzantine, Arab-Byzantine (pre-Reform Islamic) and post-reform Islamic issues that typified the period (Fig. 18). The predominance of
