# THE CITADEL OF AMMAN

## THE CONSERVATION AND RESTORATION OF THE AYYUBID TOWER\*

by  
Antoni A. Ostrasz

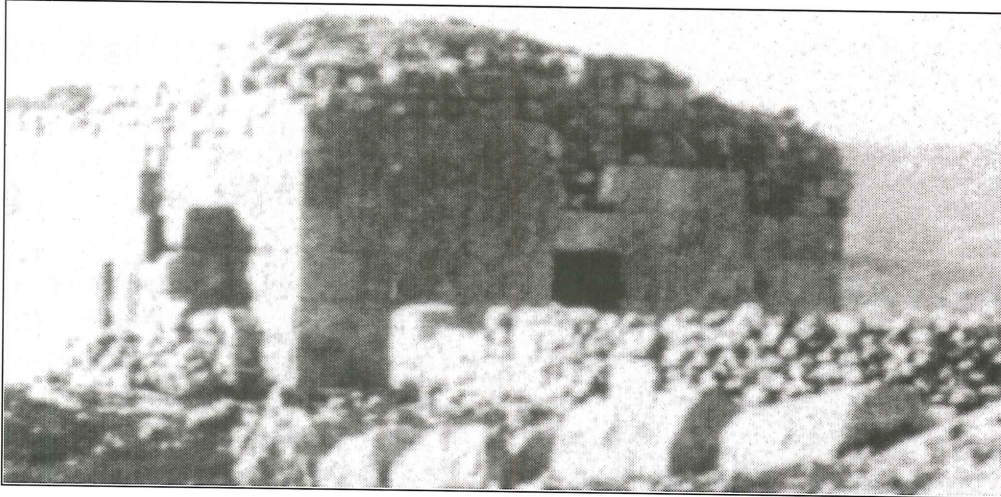
1.

The earliest record of the Tower, a photograph taken by Bonfils in the 1870s (see Figs. 1-2), shows that since that time, the state of preservation of the monument worsened dramatically. The photograph features the east and north façades of the Tower. In the 1870s, the stonework of the east façade was preserved to the level of course 5. By 1996, all stones of the north section of this course were missing (see Figs. 2-3). The

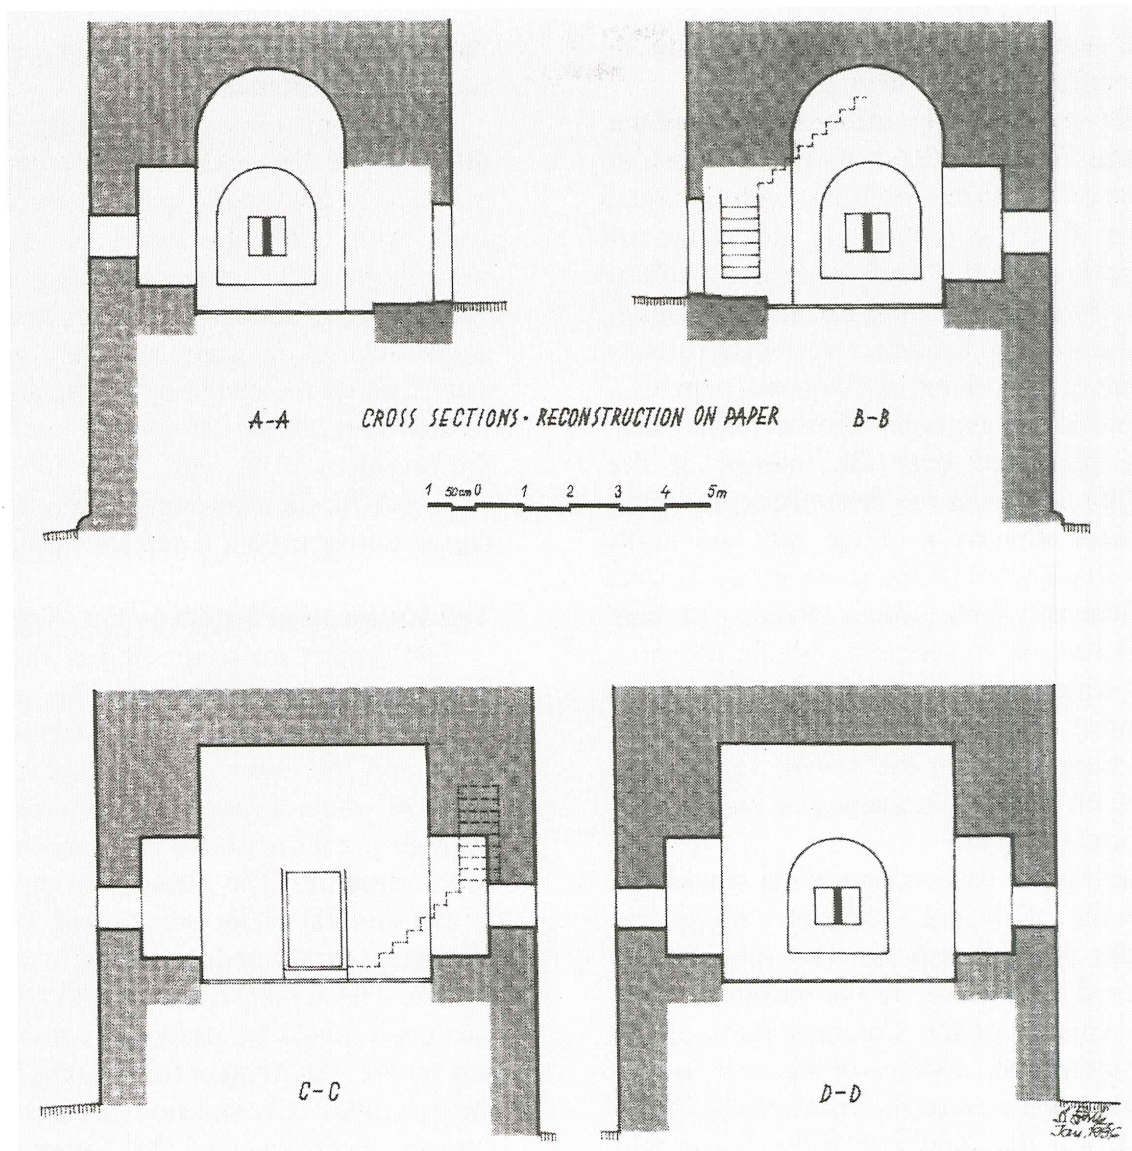
4.

In less precarious, yet endangered, condition were the remains of the uppermost masonry of the median parts of the east and west walls. Only the stones of the facade were in place. The three surviving masonry courses were almost 2 m high, the stones were only 0.5 m wide, and they were not stabilized on the inside by the facing stones of the room nor by the mortar core between the two faces of the wall (Figs. 6-7; courses 3, 4, and 5). That masonry could have collapsed during even a moderate earthquake.
