# THE CITADEL OF AMMAN

## THE CONSERVATION AND RESTORATION OF THE AYYUBID TOWER\*

Antoni A. Ostrasz

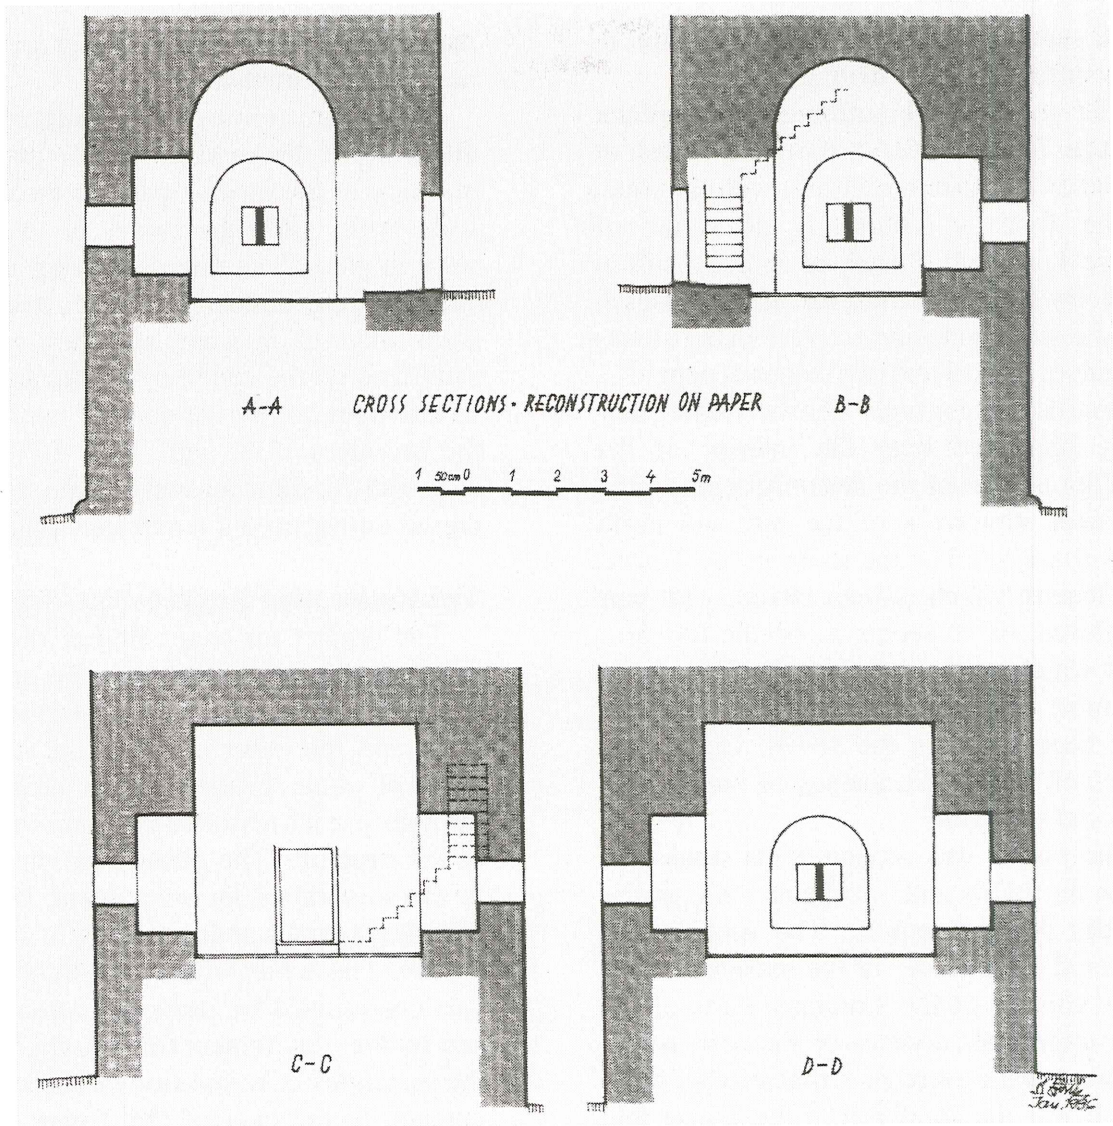
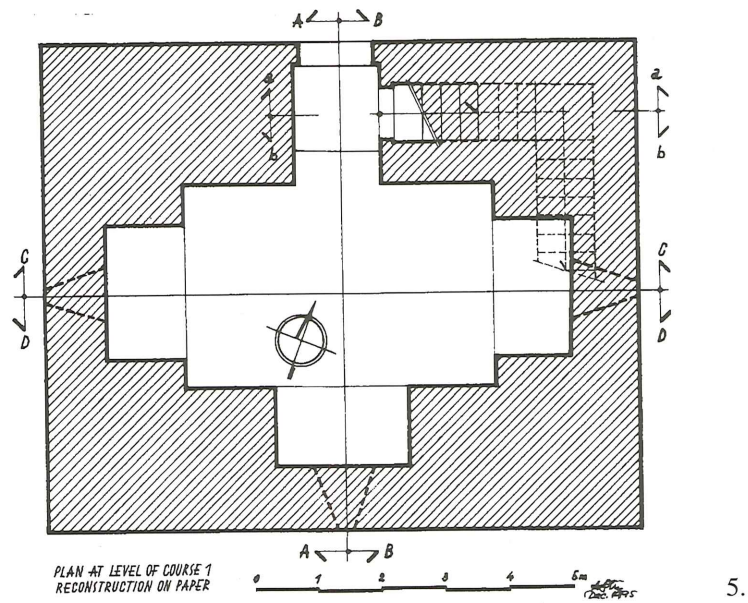
north section of the west facade seems to have suffered similar damage.

The north facade suffered much greater damage. In the 1870s, it stood to the level of course 6 (the eastern section), with the lintel of the doorway (course 4), all stones of course 4, as well as many of course 5 still in place. By the 1990s, most stones of courses 4, 5 and 6 were gone and so were many stones of courses 2 and 3 and two stones of course 1.
