How Deep Those Foundations; How Tall Those Walls; How Strong That Roof: Building Practices In An Early Islamic Mosque At Jarash

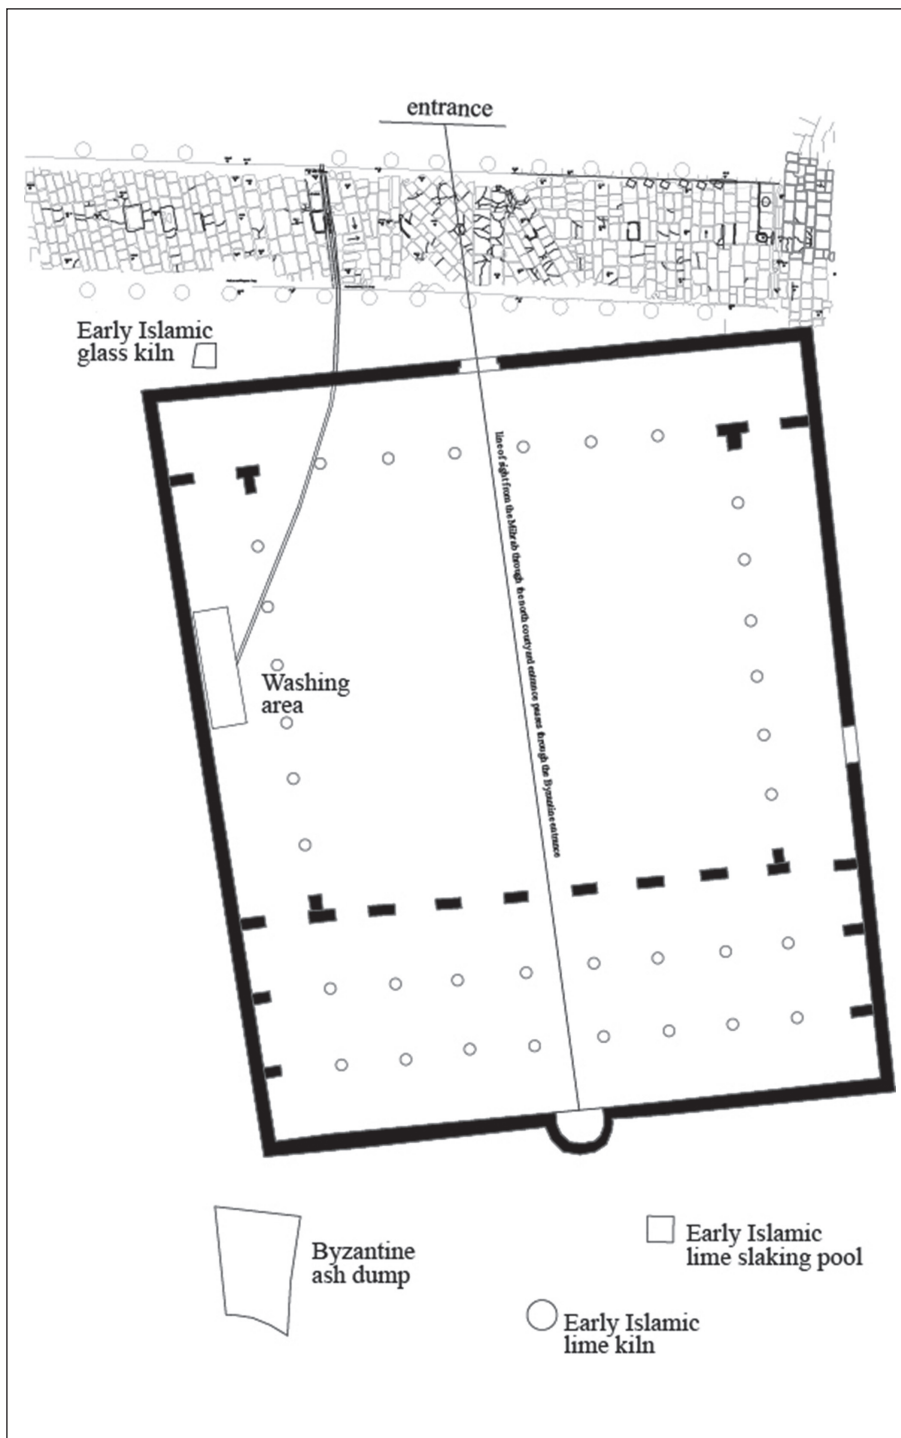
3. Groundplan, orientation and construction site facilities of the Phase 1 mosque.

Phase 1 is typified by deep foundations and expert masonry work in terms of *spolia* choice, stone-cutting and laying, all of which encompassed conceptual planning (FIG. 3).

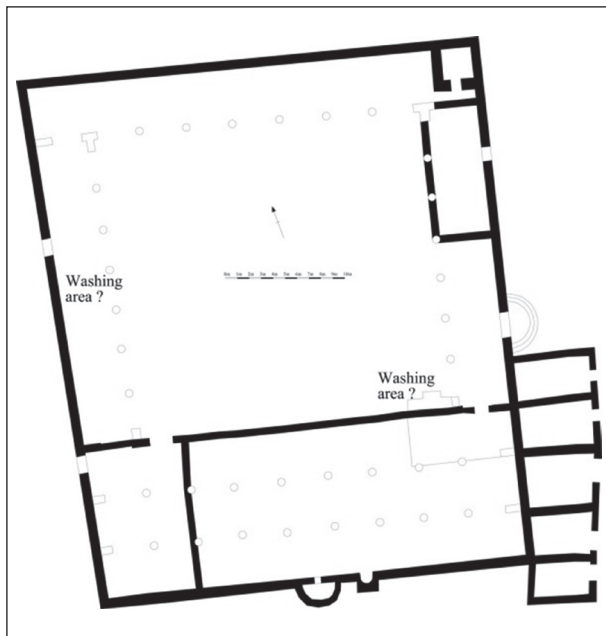
4. Phase 2, groundplan.

The architecture of these two phases collapsed in an earthquake, undisturbed remains of which were found outside the south (*qiblah*) wall of the mosque. Nearly all useful stonework from within the building was robbed at an early date indicating a very active building period elsewhere in Jarash (FIG. 4).

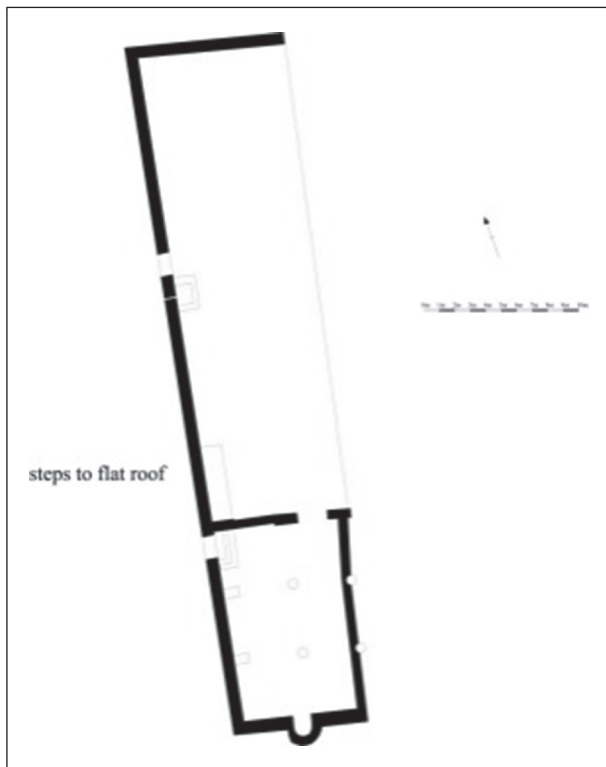
5. Phase 3, groundplan.

Phase 3 involved the clearance of collapse material from Phases 1 and 2 from around the west room of the prayer hall and its rebuilding as a new mosque, with the creation of a new *mihrāb*, again central to the *qiblah* wall of the period (FIG. 5).

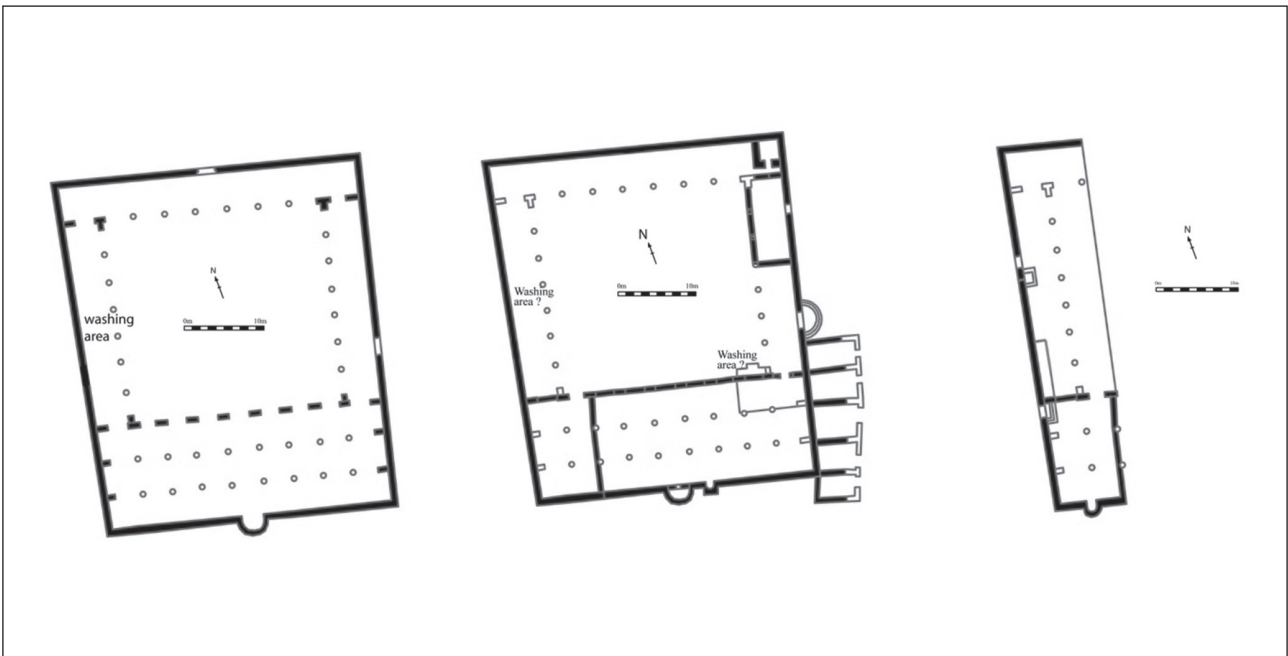
7. The three phases of the mosque: (left) Phase 1 - approx. 710 - 730 AD; (centre) Phase 2 - approx. late 8th to early 10th century; (right) Phase 3 - approx. early 10th to 11th century.

The sequence of *mihrāb* use was confirmed by the excavation of sections behind all three *mihrābs* (FIGS. 7, 8).

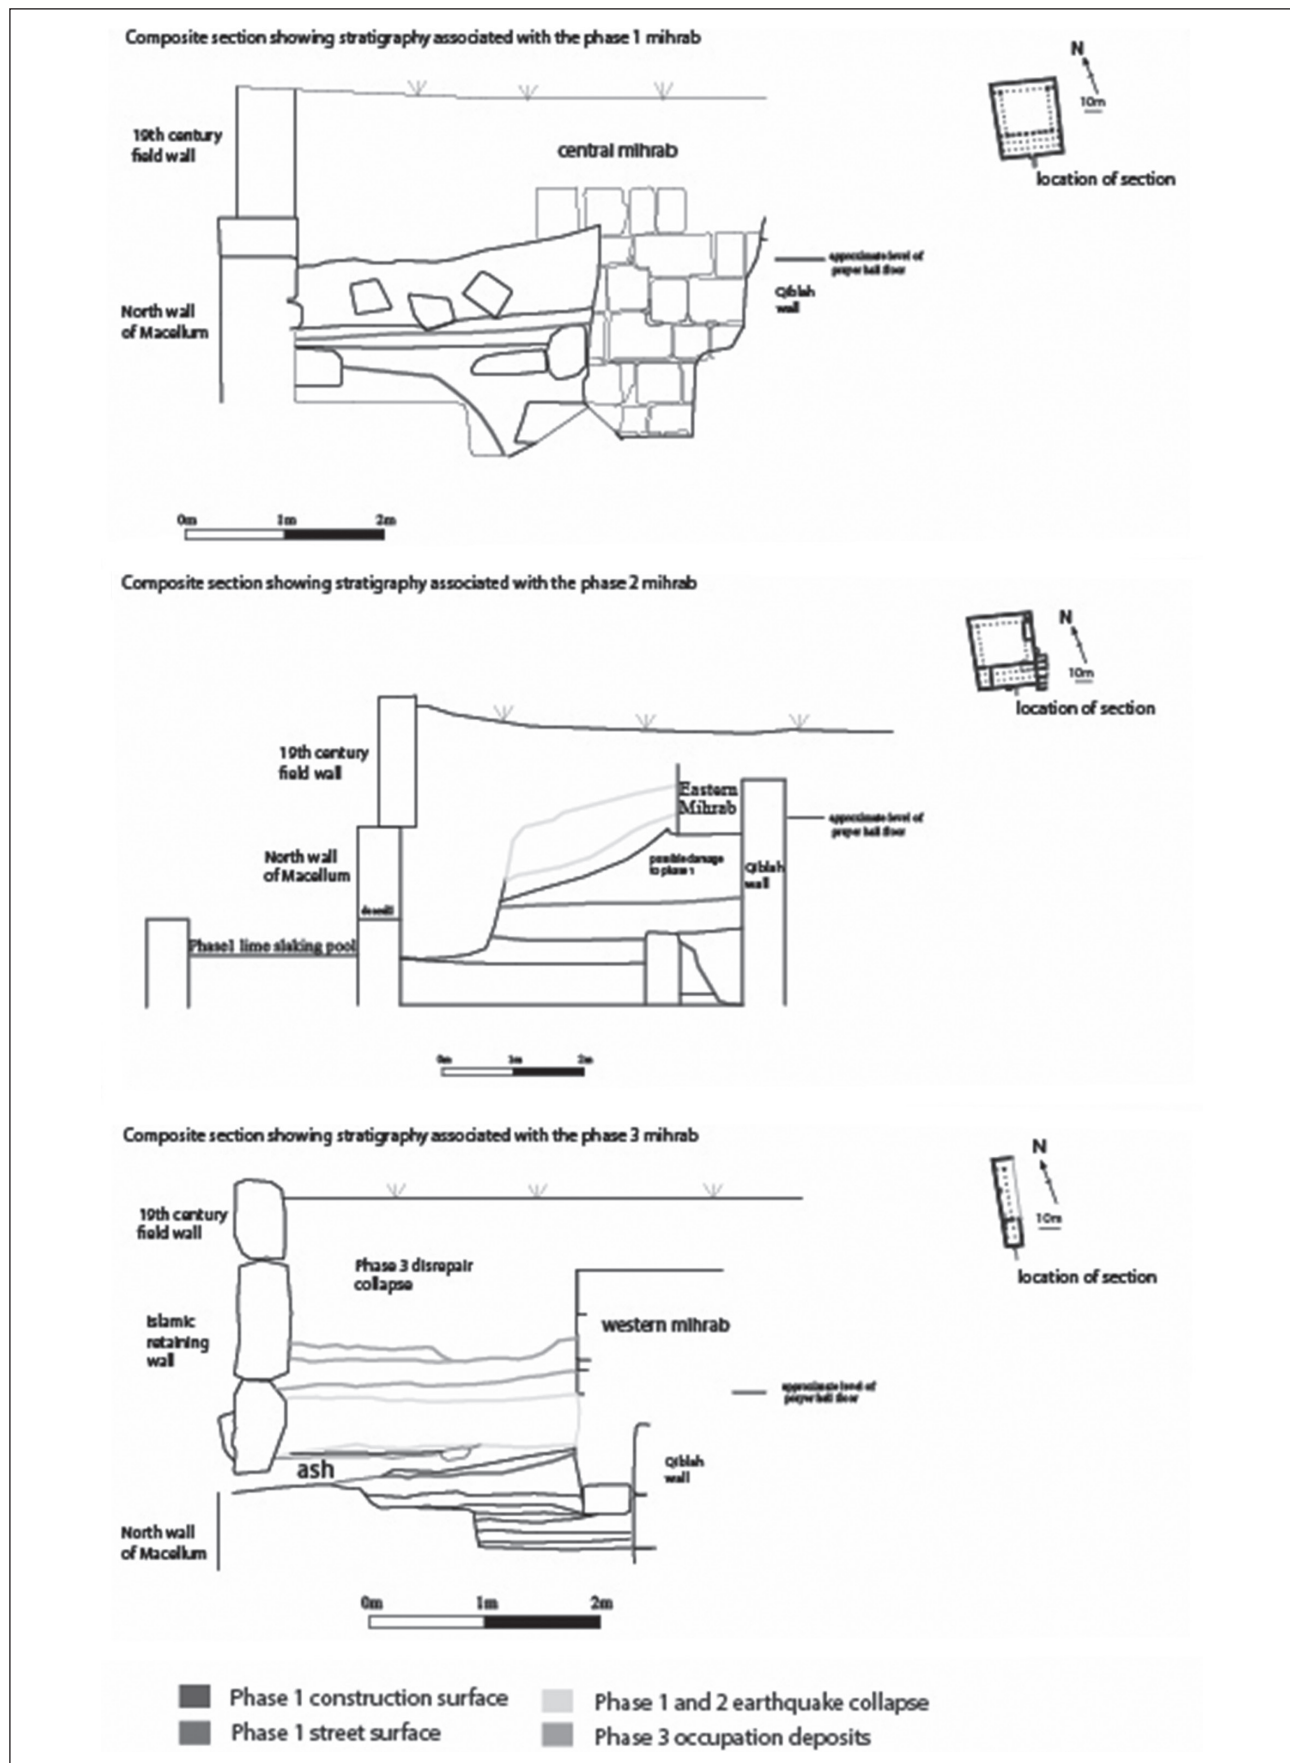
8. Stratigraphy behind all three *mihrābs*.

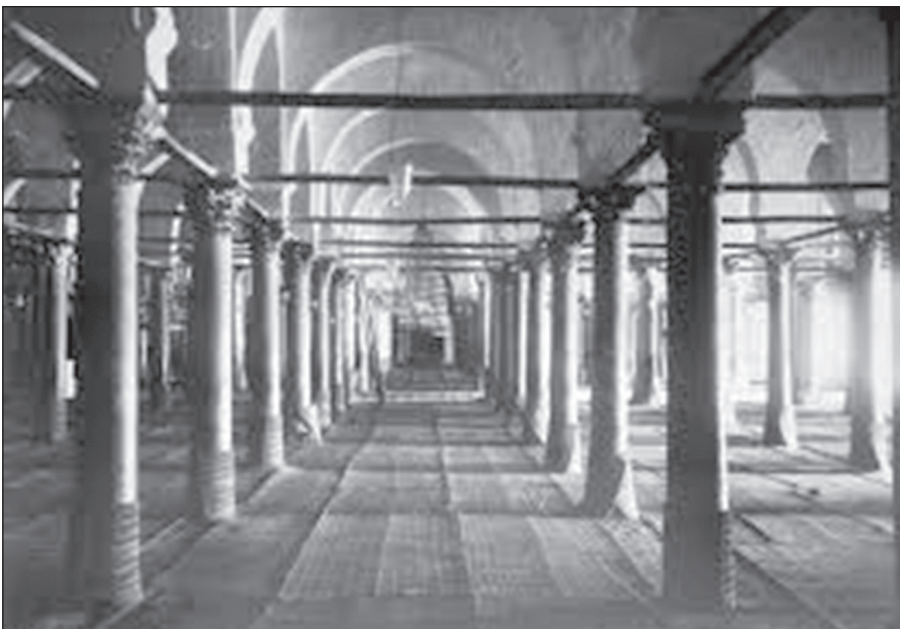
9. Pillars and capitals still surviving in the Sidi Oqba mosque, Kairouan, Tunisia.

although there was a lavish use of *spolia* around the doorways and in the pillar and capital supports for the roof. From photographs, the foundations also appear to be stonework. In this case the *spolia* pillars and capitals still survive and show the roof support given by the capitals and the importance of maintaining the level of the top of the capitals rather than the bases (FIG. 9).

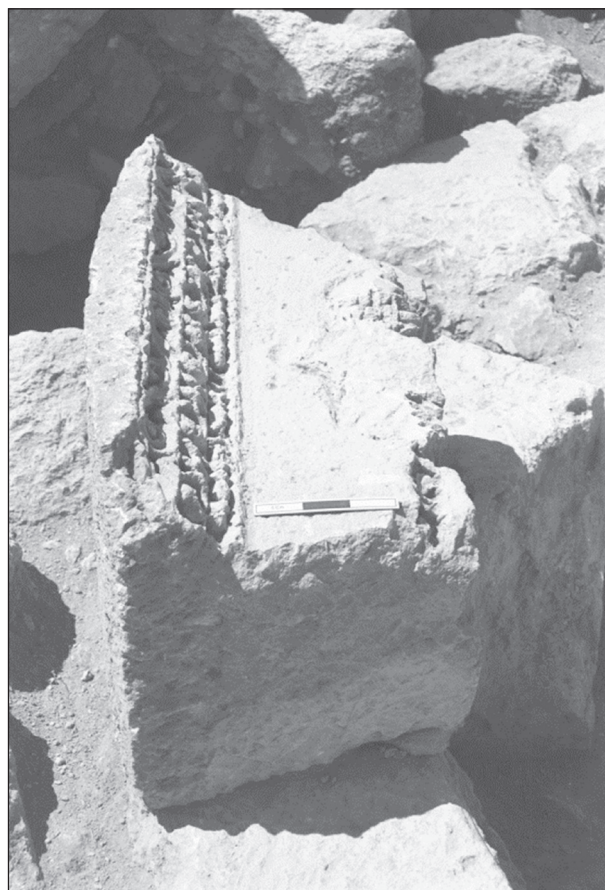
10. *Spolia* block used in central *mihrab*.

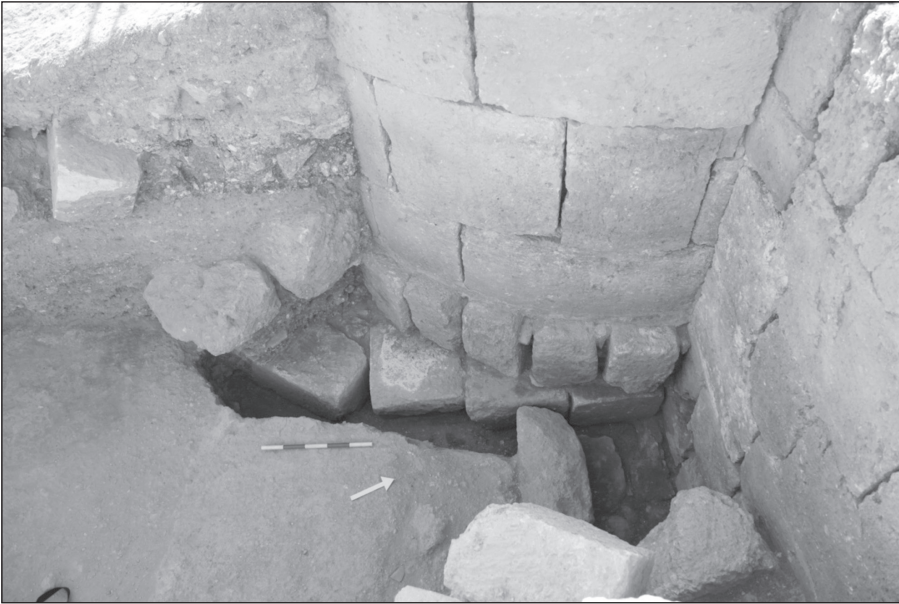
11. Foundations and walling of central *mihrab*.

The foundations of the west wall of the courtyard (the wall which would have had to be set back from its originally planned foundations) were constructed on a shelf of stones, heavily bonded with clay (FIGS. 11, 12). The use of column drums in the initial courses of the foundations help to bond the wall and again create a ledge for the walling. It is unclear whether the column drums have a purely functional or a validating purpose, as the architrave blocks used in the *mihrāb* seem to do. The origin of the column drums

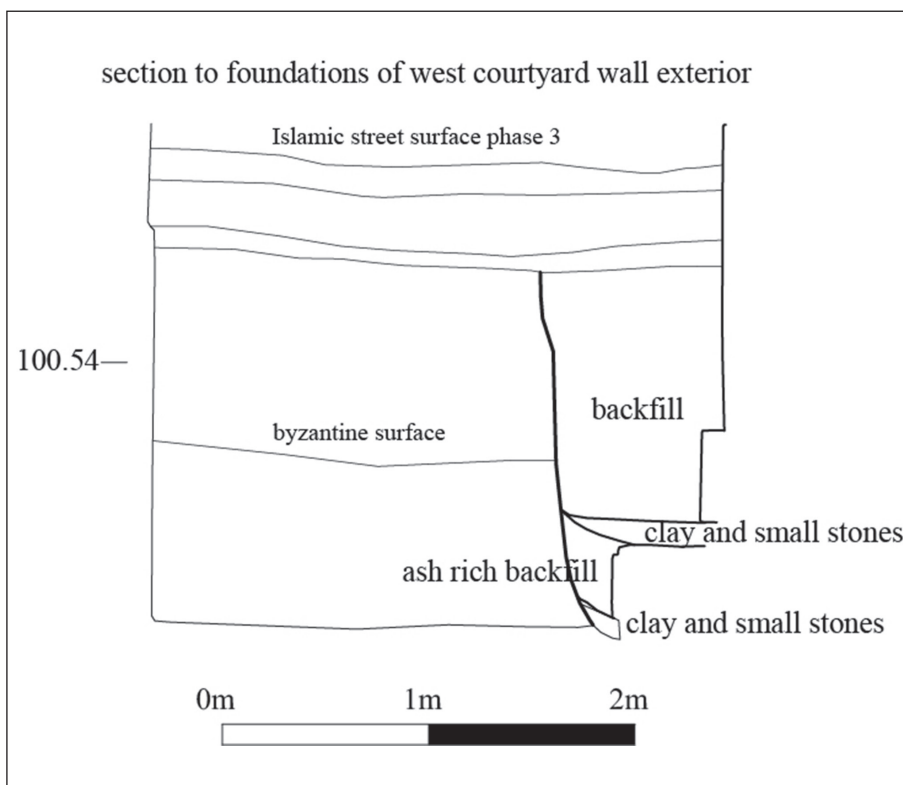
12. South-facing section showing deposits against the exterior of the west wall.

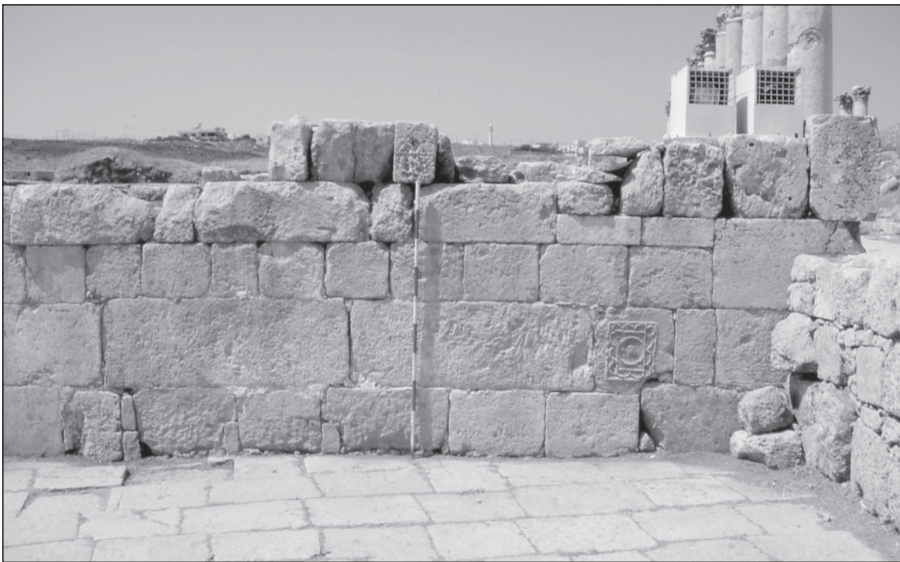
13. Exterior elevation of the north end of the courtyard's east wall.

The ornamental *spolia* used in the west exterior wall may be from Phase 3, but the ornamental block used in the east wall (see FIG. 13) is a Phase 1 feature that would have been just above ground level, though it would have been covered by an earthen platform in Phase 2. The design on the block was slightly damaged when the block was laid, so it appears to be a conscious re-use of *spolia* rather than cut for the purpose.

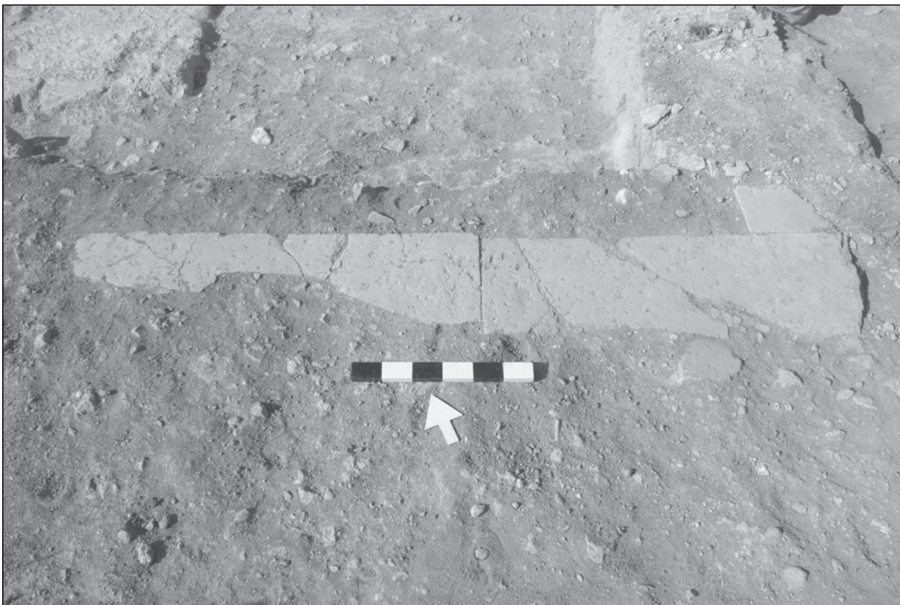
14. Surviving flooring from Phase 1.

Only one fragment of flooring from the first phase of the mosque seems to have survived (see FIG. 14).

A section of orange, 4 - 6 cm-thick marble, smoothly finished, was found close to the central *mihrab*. These surviving fragments are the remains of three separate slabs. They were

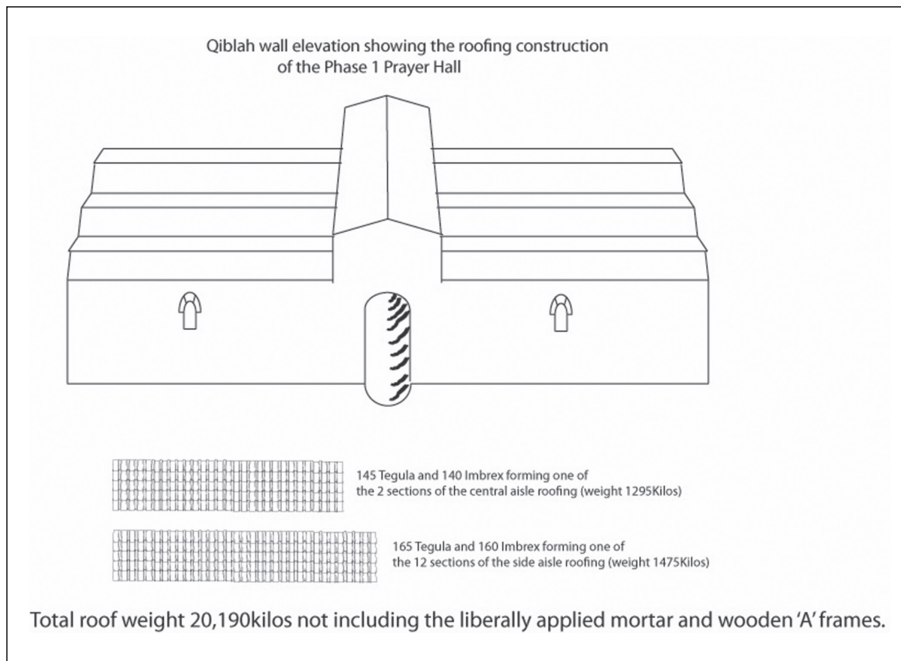
15. Phase 1 roofing reconstructed from evidence in the collapse material and the prayer hall groundplan.

Our reconstruction of the proposed roofing of the initial construction is based on the remains from the collapse of Phases 1 and 2. A tile roof would have been supported on a wooden frame sitting on top of the exterior wall and arches which sprang from the piers to pillars, (the arches being constructed of trapezoidal blocks with grooves on the sides to allow bonding material to flow between them). A keystone from an arch, along with nails bent at 6 - 8 cm originating from the timbers of the roof support, were found in the collapse material to the south of the *qiblah* wall (FIG. 15).

This and the spacing of the pillars in the prayer hall suggest an original higher central roof running north - south, while the side roofing runs east - west. The side roofing is based on the support given by the side walls and arches, and would have comprised three A-frames supporting a slightly sloping three-ridged roof flanking the higher ridged roof spanning the central aisle. The only roof tiles excavated from mosque deposits were *tegulae* and *imbrices* with evidence of a heavy application of mortar used as bonding between the tiles. The quantity of mortar bonding the tiles together must have considerably increased the weight of the roof.

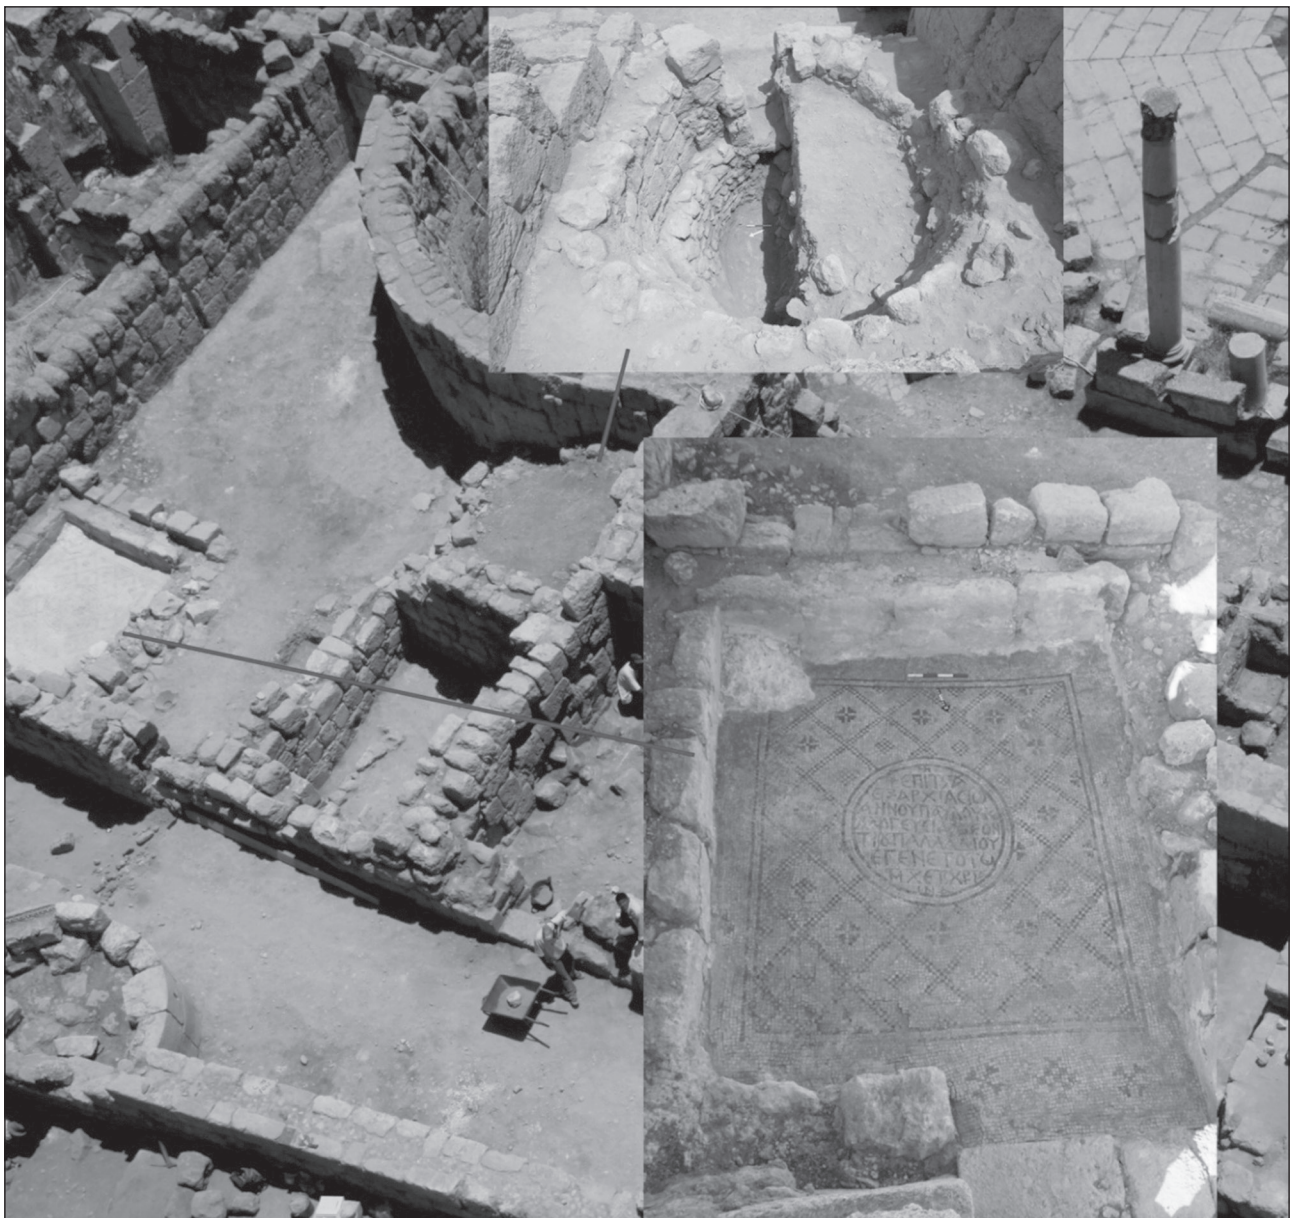
16. Lime kiln and slaking pool from Phase 1.

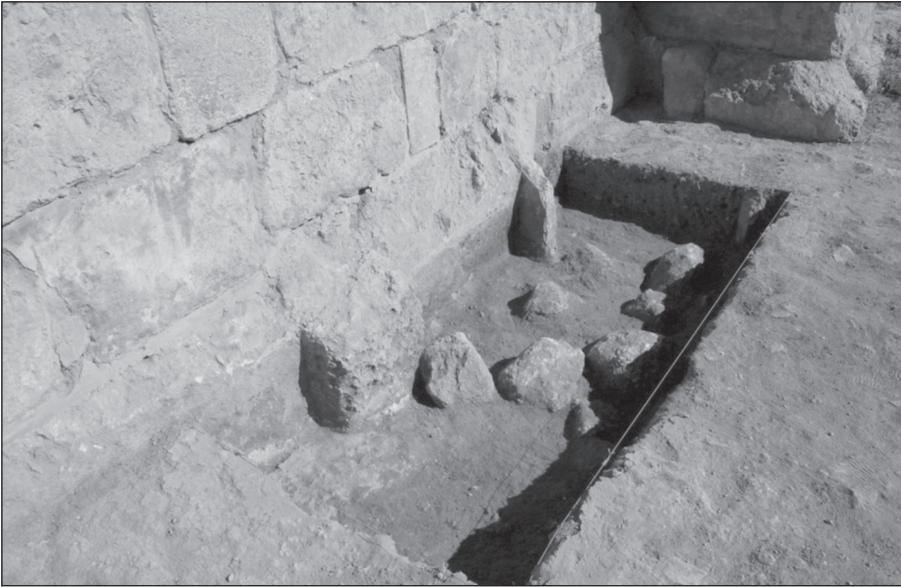
17. Foundations of feature central to the west wall of the prayer hall.

FIG. 17 shows the heavily chipped away foundational remains of a feature that decorated the west wall of the Phase 1 prayer hall. The walling above this feature appears to be a Phase 3 rebuild. This feature was presumably removed in Phase 2 when the prayer hall was

divided into two. It appears to be the remains of a shallow alcove, possibly intended to contain a decorative or donative plaque as the back of the feature is flat.

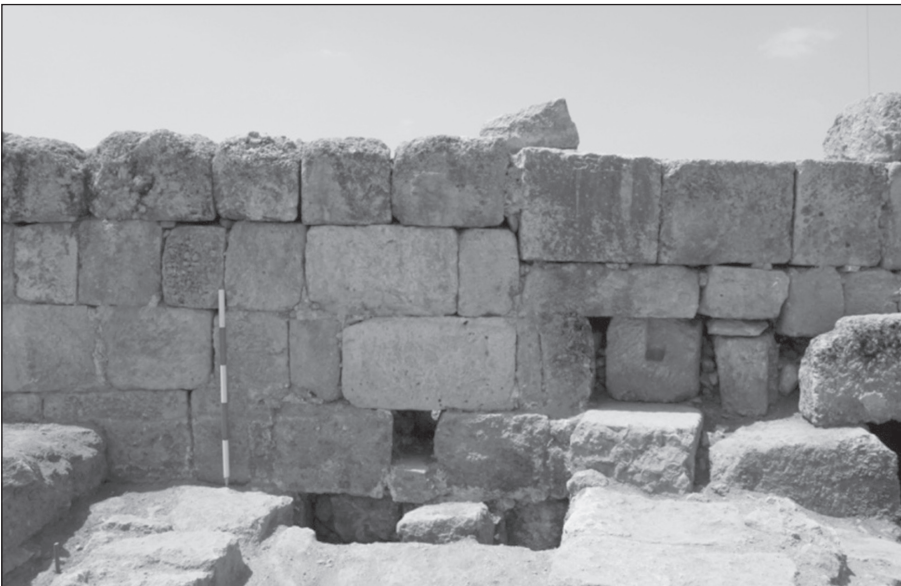
18. Phase 1 waterpipe entrance (centre) and Phase 3 drainage hole (right).

A small hole was constructed in the north courtyard wall to allow access to a water pipe (see FIG. 18). The remains of a heavily mortared ceramic pipe were found inside the courtyard leading to the area of the presently exposed Phase 3 water basin. This water pipe appears to have come through a cut in the

These drainage holes in the north courtyard wall (one from Phase 1 [see FIG. 19] and one from Phase 3 [see FIG. 18]) would have been below ground-level at the lowest point of the courtyard then in use, and in both cases have a recognizable *spolia* block above them on the interior elevation to indicate their location, and a large, loose-fitting blocking stone to stop animals burrowing into the building. They are another indication that the mosque was not linked to the main drains and that these drains may have ceased to be used in this part of the city by the time of the mosque's construction. They also appear to indicate an important

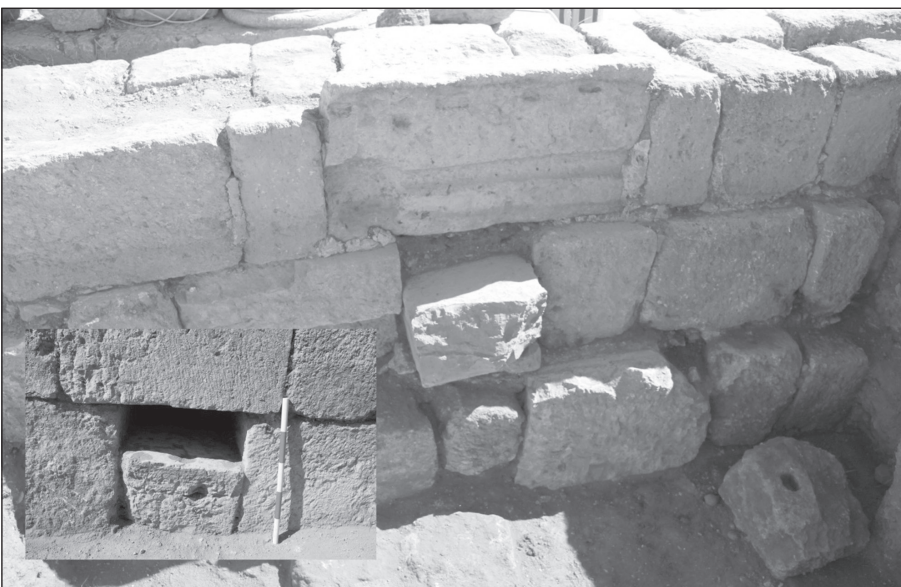
19. Phase 1 drainage hole showing interior elevation with exterior entrance as inset.

A drainage hole was also created in Phase 1 (see FIG. 19) at the low point of the courtyard in the north courtyard wall (at the east corner), presumably for use on the building site as the water supply was laid but left for later use should there be flooding within the building. This drainage hole was uncovered during the 1930s by the Yale University excavations, which
