PRELIMINARY REPORT ON THE FIRST SEASON OF CENTRAL PETRA EXCAVATIONS

Adnan Shiyyab

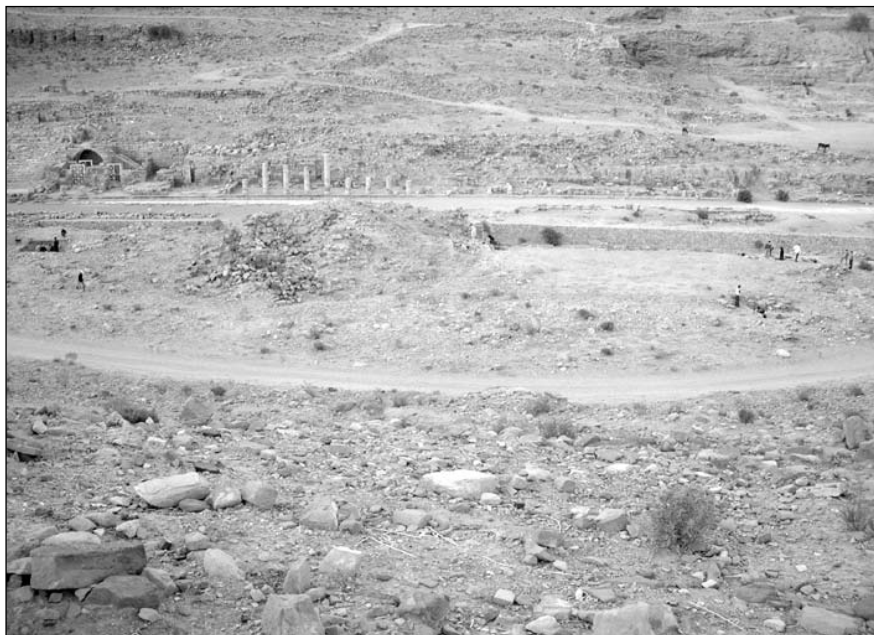
1. The excavation site (looking southward).

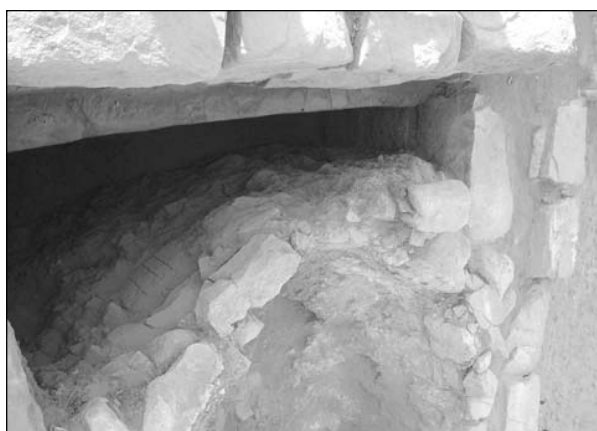
A wall built of large, dressed stones was found at the eastern side of the square. Excavation reached a depth of 2m along this wall. The wall (running north-south) intersects, at a right angle, with another wall (running east-west) uncovered at the southern side of the square. It appears that the two walls were constructed in two different structural periods since the lower courses of each wall have different types of stones and the construction methods in these courses differs from those in the upper courses. Between the southern and eastern walls and in a northwest direction, a small oval-shaped structure was uncovered. Its walls are constructed of mud and small, undressed stones. Considerable portions of the walls and the floor are covered with plaster, indicating, it could have been used in a later period to collect rainwater (**Fig. 2**).

2. The southern and eastern walls border the oval-shaped structure in Sq. 001.

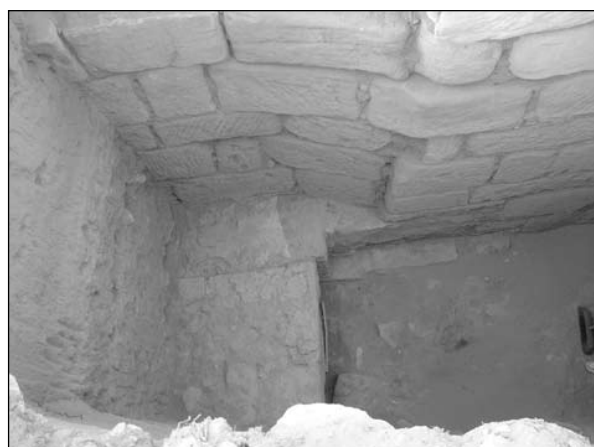
In this square the digging process led to the discovery of a wall running west-east. Nine courses of this wall were uncovered and the bedrock was still not reached. The two upper courses are different from the lower courses in terms of their nature and the dressing method used; however, they all seem to have been built during one period. The western part of the wall was constructed of dressed stones vertically laid whereas in the eastern part there is a projection which looks like an apse (**Fig. 3**). In front of this possible apse and on the level of the sixth course, the team discovered a square platform (partly excavated) which will be excavated during the next season. The exposed stones of the assumed platform are marked by some decorations. Its lower course has a square hole closed from inside while the upper surface is covered with mortar. The presence of the platform in front of the suggested apse may indicate a functional link between the two features.

3. Apse-like structure with a platform in Sq. 003.

There is also evidence from square 003, indicating the presence of a possible apse in one wall. Additionally, a platform was found in front of the assumed apse. The proposed apse may somehow be functionally related to what was subsequently discovered in square 004. A bath is most likely the main feature in the latter square and the use of the apse is probably related to the use of the bath.

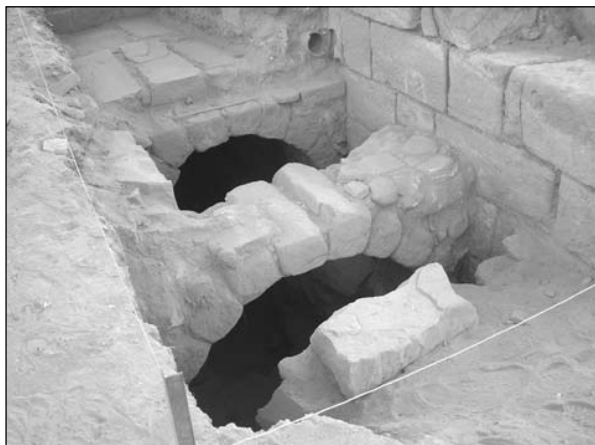
able architectural features on the surface east of Squares 001 and 002 and southeast of Square 003. In this section, a wide, rocky surface about 9m square was discovered. This surface ends on a wall (running east-west) in the north side of the square. The wall consists of six courses built of dressed limestone ashlar. The bedrock could not be reached along this wall due to the presence of a significant number of mud bricks. This wall also intersects another wall in the west side of the square. The latter wall was constructed of dressed stones in its southern end and was covered with mud bricks in its northern end in order to hold and protect the ceramic pipes. The pipes were vertically and horizontally laid and can be easily seen. At the level of the third course of this wall, small arches join it to the wall in the western baulk. Future work will focus on this area to understand the function of the arches and their relation to the wall in the baulk (**Fig. 4**).

Three arches in the northern part are built of perfectly constructed dressed stones. The arches were laid not on the wall but on a stone beam projecting from the wall. It was difficult to trace the end of the vaulted area during this season because it continues northward outside the square and the excavator lacked sufficient time to dig another square along that side (**Fig. 4**). The depth of the vaulted area is about 2.5m and its length (within the square) is about 3.5m, its floor is paved with undressed and unshaped stones. The roof of the three arches mentioned above is made of well dressed slabs extending outside the square.

4. Vaults and ceramic pipes in Sq. 004.

The fourth arch appears not to be related to the other three arches as it is wider and has different stones and is laid on the wall perhaps indicating that it belongs to another architectural phase.

It is quite difficult to answer questions regarding the site's function and nature based on preliminary results obtained during the first season. However, the available evidence allows for some hypothesizing: part of the site may have been a public bath as indicated by the existence of the vaults and mudbrick posts in what appears to be the heating room.

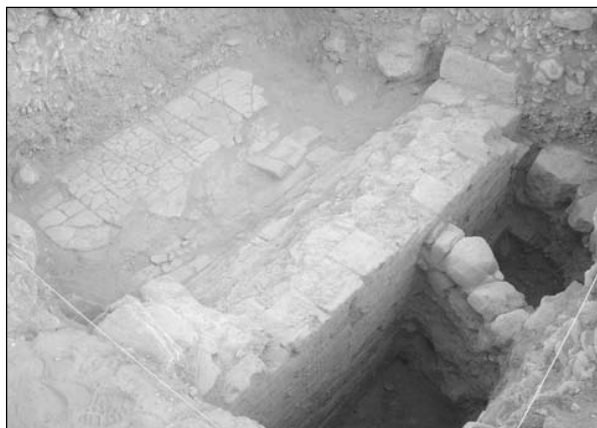
with a length of 30cm. Despite the fact that the marble tiles received a great deal of destruction due to the pressure from the ground, most of the tiles are still in place. The marble floor extends in different directions and continues outside the square. Further work and investigation in the next season should help to understand the site which appears to be one of the more significant sites in Petra. Rows of stones were also uncovered in this square which are horizontally linked to the wall, but neither the stones nor their masonry resemble the stonework of the wall and this might suggest that this feature is from a later phase (**Fig. 5**). Digging continued between the eastern baulk and the external face of the wall to a depth of about 1.5m but the bedrock could not be reached in this season while the floor between the internal face of the wall and the western baulk is paved with marble tiles, and the latter might extend outside the baulk.

The archaeological features in this square are difficult to identify; they appear to belong to different architectural phases. The mud brick wall is one phase, the wall which has holes and channels is another phase and the rows of stones that run horizontally towards the main wall in the square may belong to a third phase.

5. Three structural phases (marble floor, a wall and irregular walls) in Sq. 001, Area B.
